Robert Squires - Squires Consulting LLC
Landowner Advocate

Opening Statement for May 5, 2021 Subcommittee on Civil Rights and Civil Liberties Hearing:
“Pipelines Over People (Part II): Midship Pipeline’s Disregard for Landowners in Its Pathway”

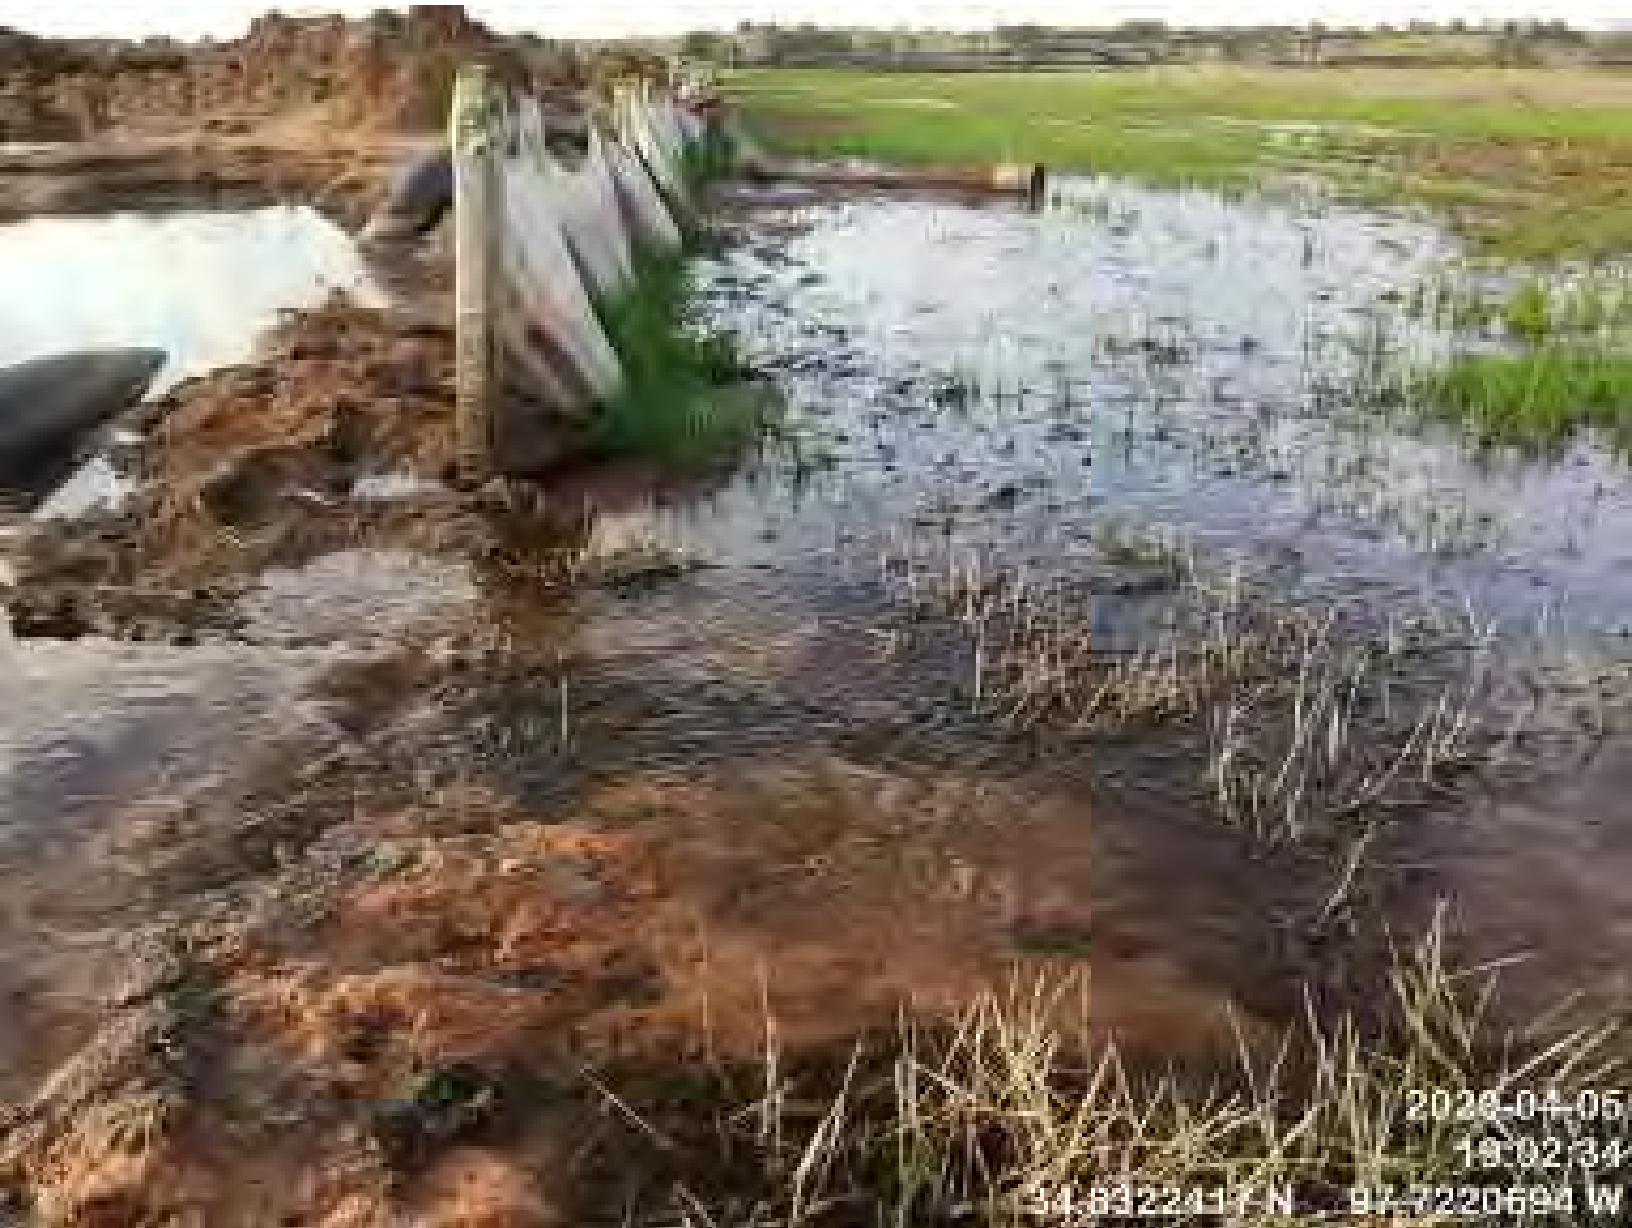
Photo Section 6

Continual Sediment and Erosion Control Violations

Off Right-of-Way

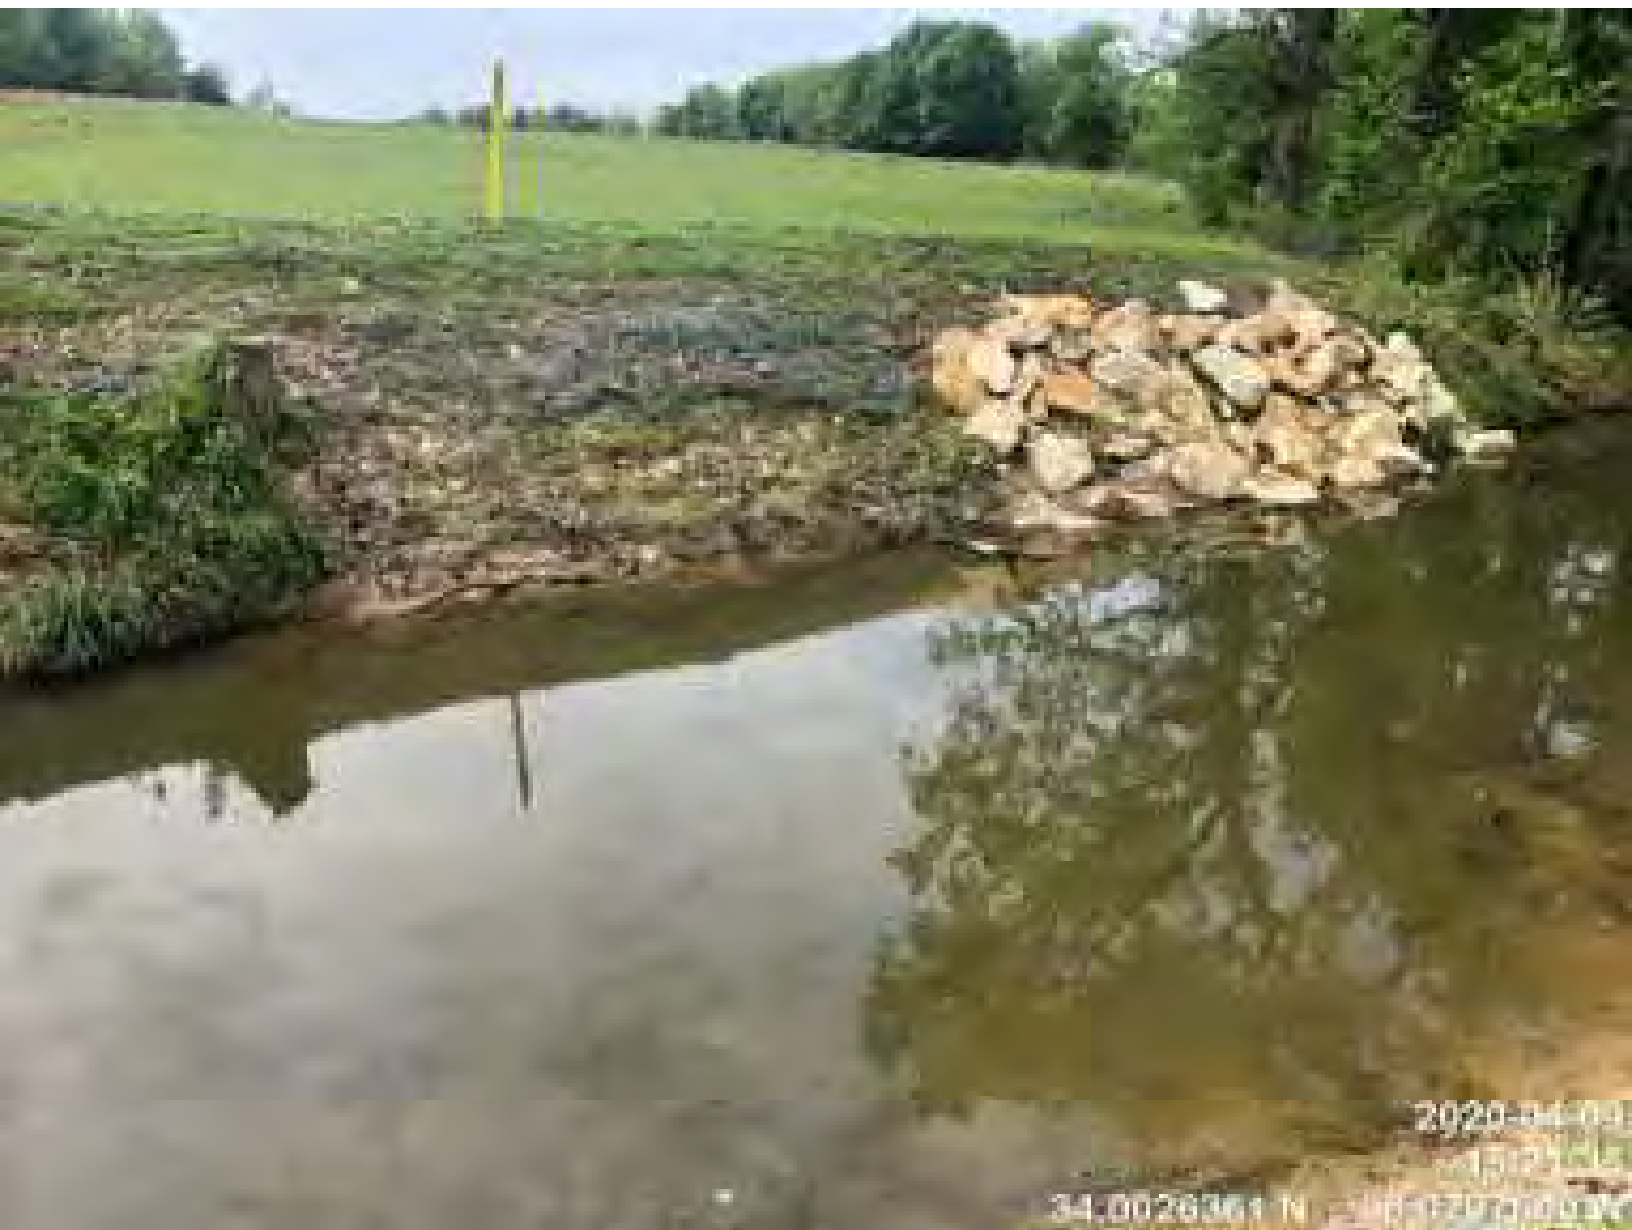
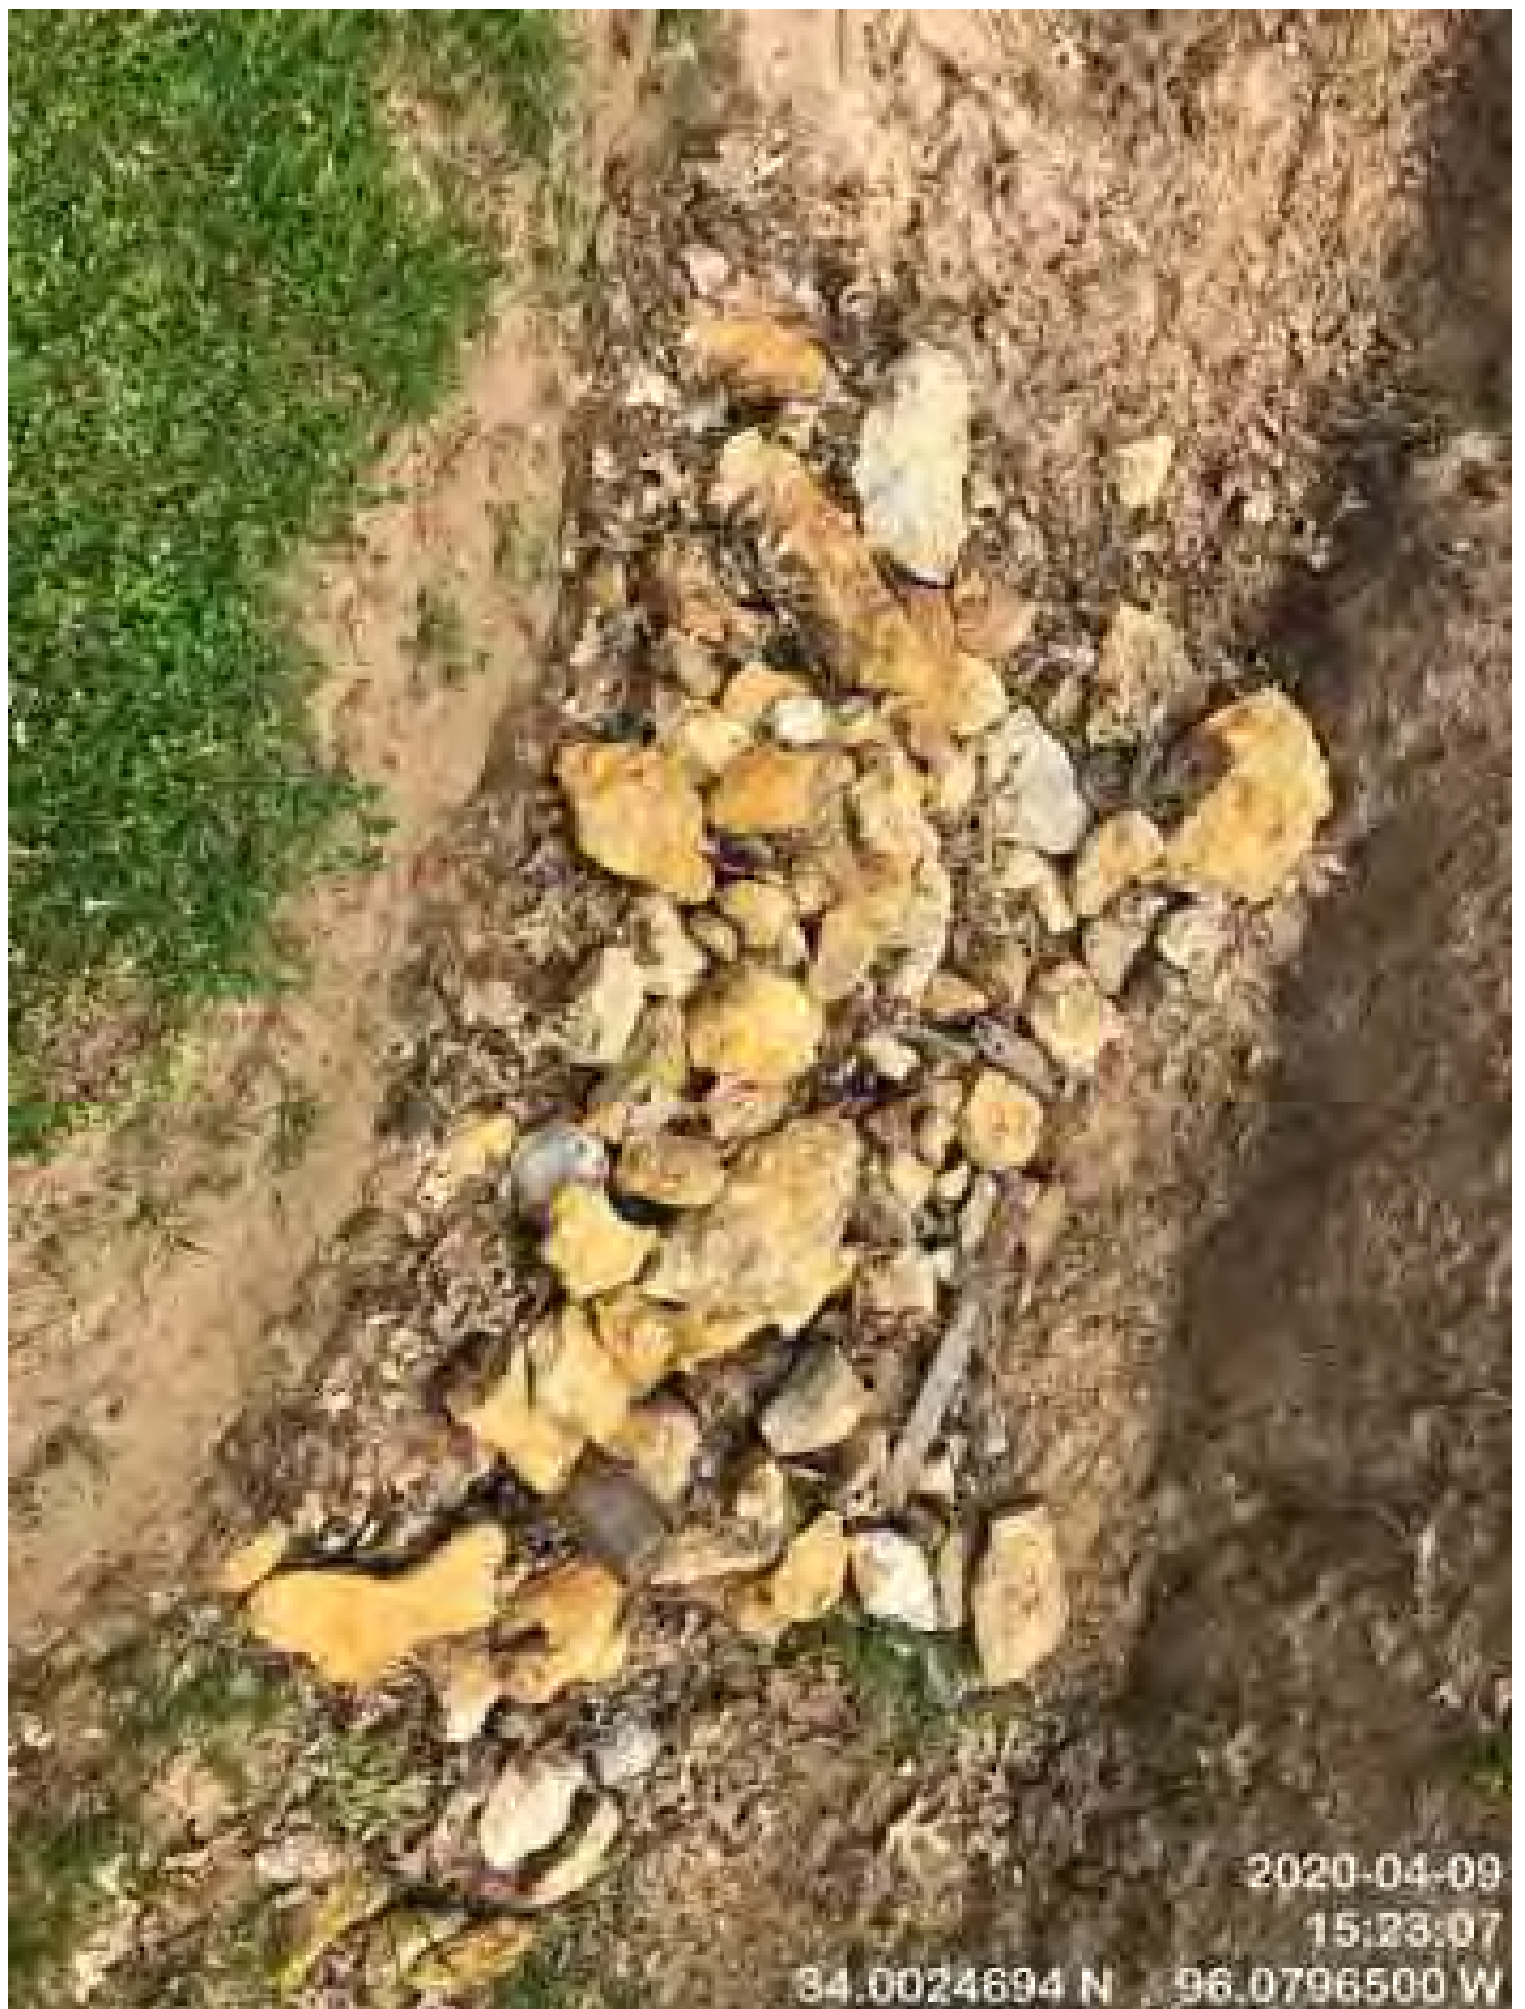
Site Inspection Findings:

- 1.) High levels of rock and blasting material mixed into soil. (FERC Plan: V. A. 3-6.)
 - a. Affected areas naturally have less than 1% rock fragments with a maximum size of 74 mm (NRCS).
- 2.) Importation of approx. 31,000 cubic yards of topsoil for 16.69 acres of ROW. (FERC Plan: IV. B. 1-6.)
 - a. Off-ROW topsoil: 14" (verified by existing NRCS soil surveys)
 - b. In-ROW topsoil: 0" found in multiple locations.
- 3.) Soil Compaction (FERC Plan: V. C. 1-3.)
 - a. Off-ROW Penetrometer reading: Around 180 psi in multiple locations.
 - b. In-ROW Penetrometer reading: 300 psi limit exceeded in every off-ROW location.

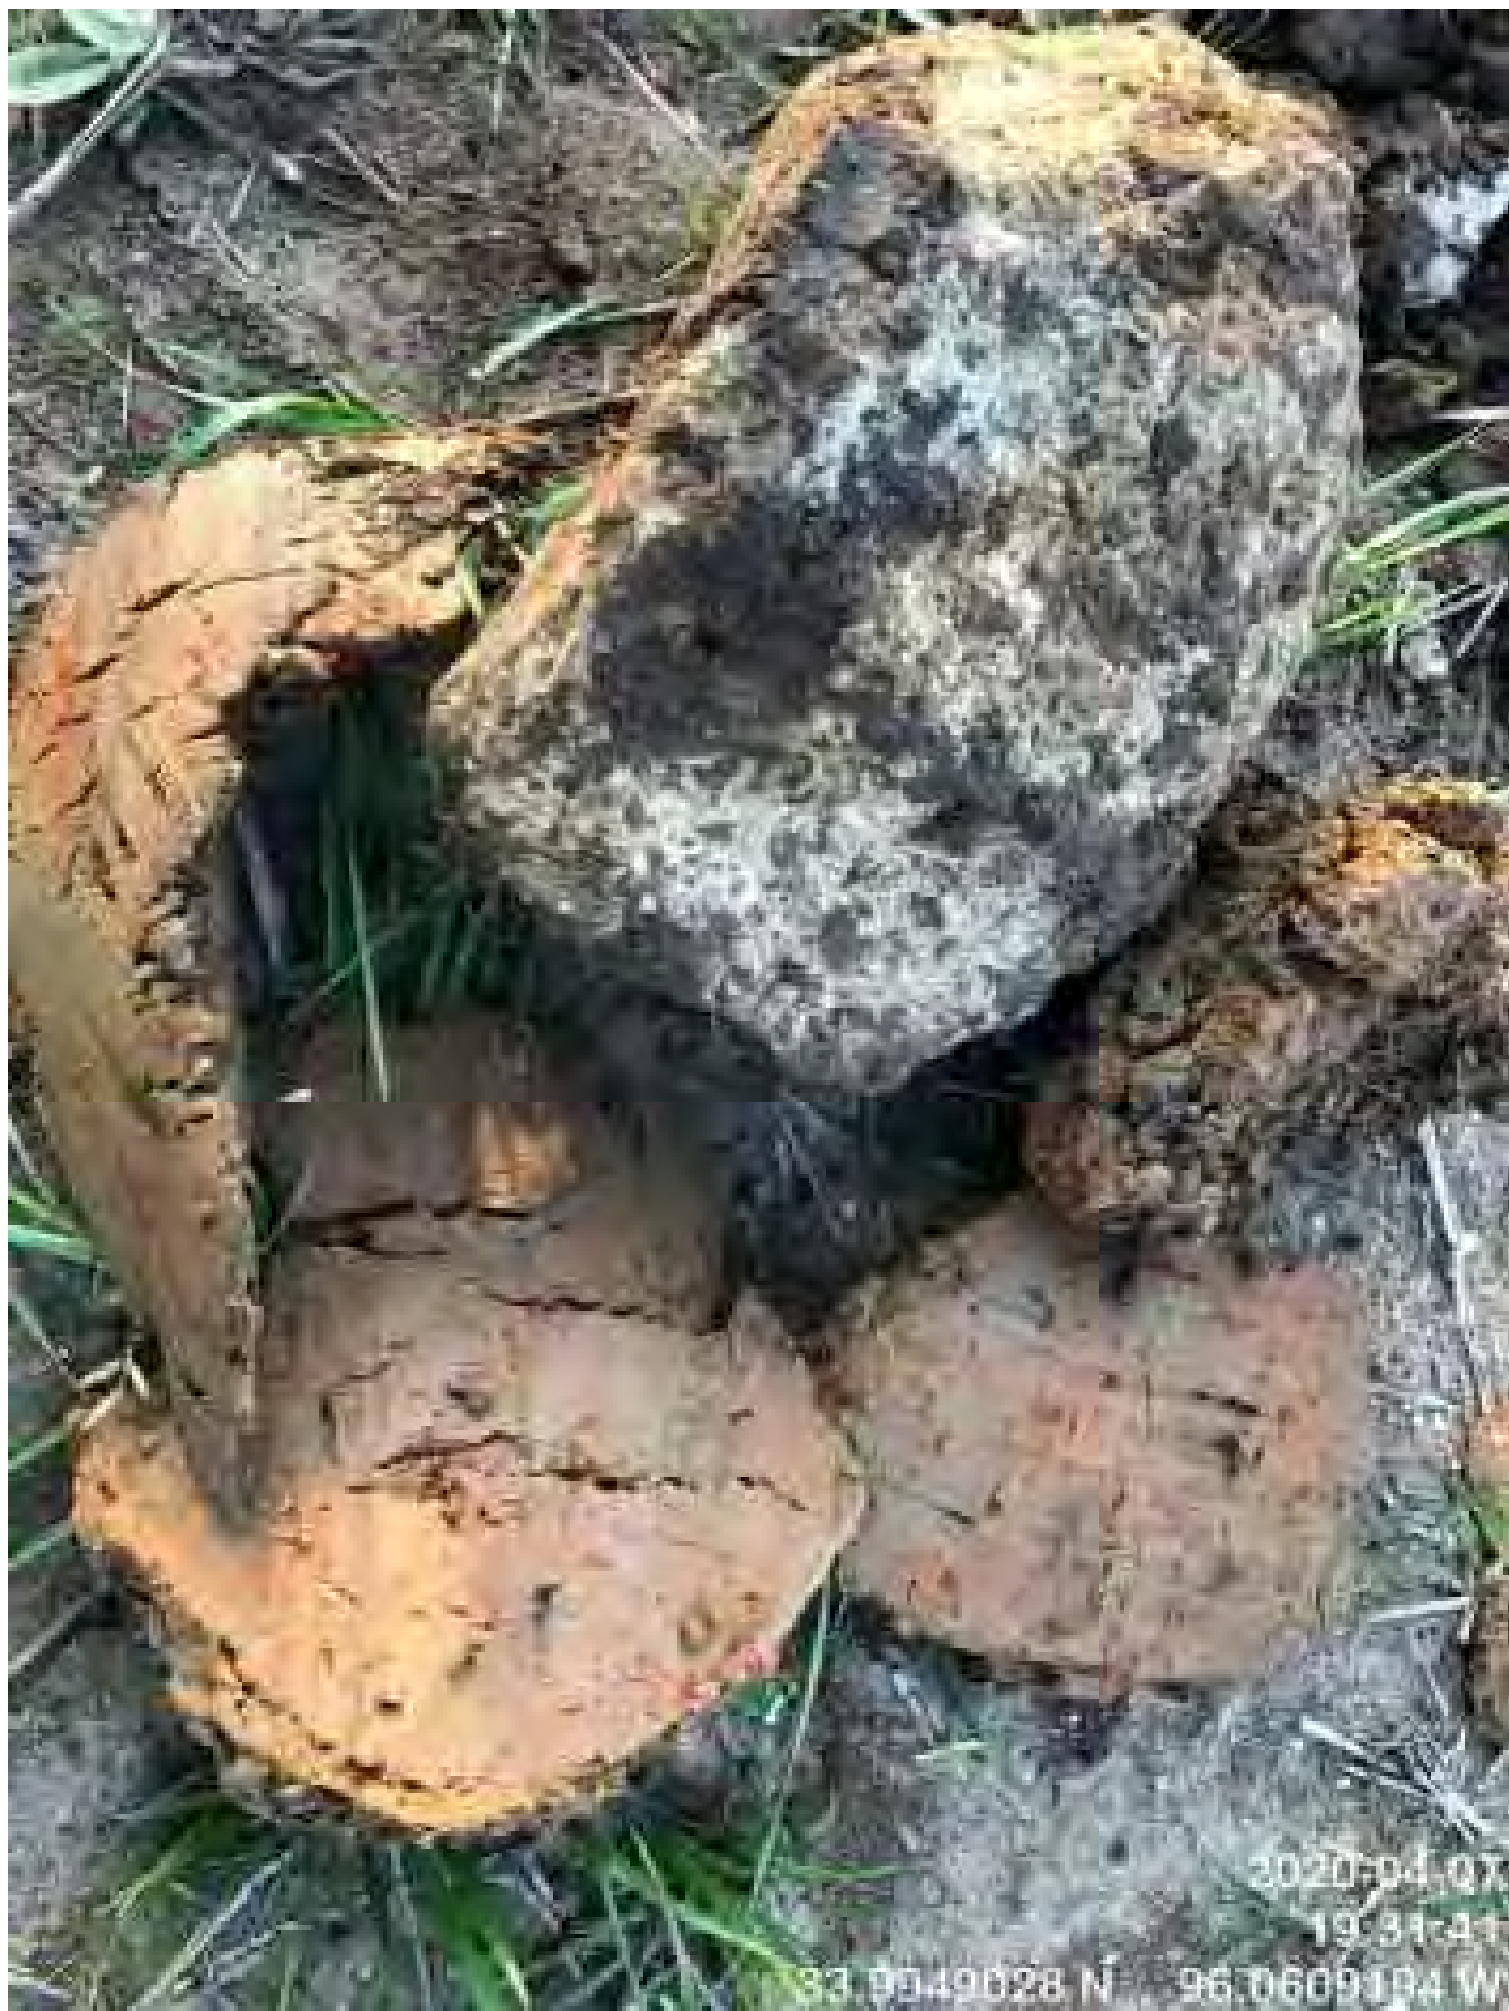
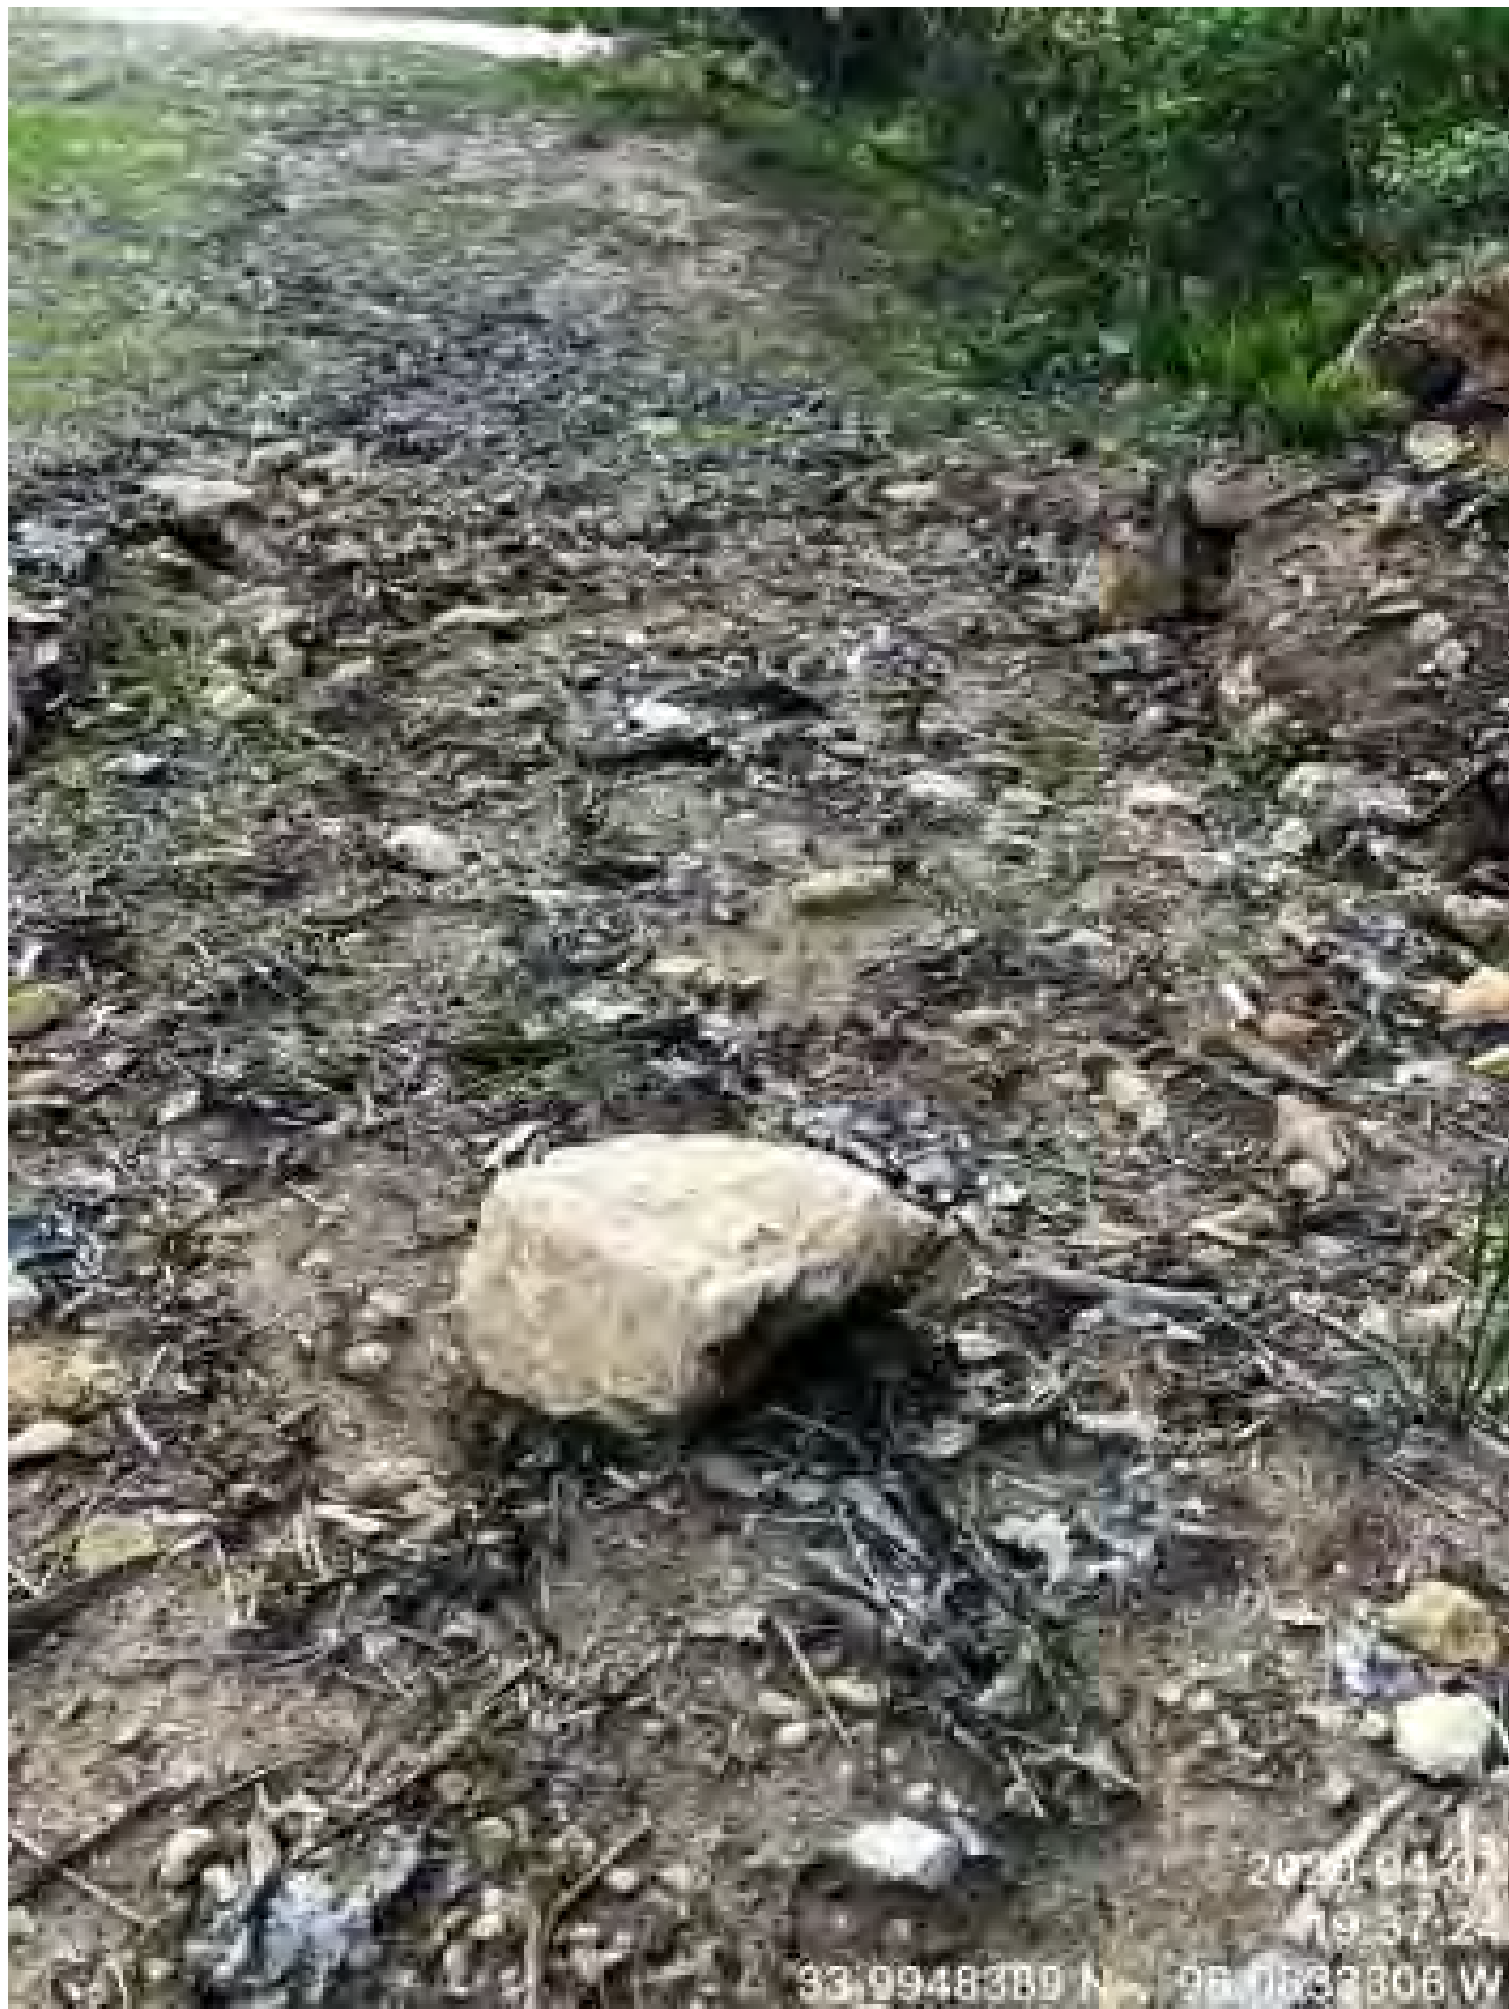
Site Inspection Findings:

- 1.) High levels of rock and blasting material mixed into soil. (FERC Plan: V. A. 3-6.)
 - a. Affected areas naturally have less than 1% rock fragments with a maximum size of 74 mm (NRCS).
- 2.) Importation of approx. 27.860 cubic yards of topsoil for 12.19 acres of ROW. (FERC Plan: IV. B. 1-6.)
 - a. Off-ROW topsoil: 17" (verified by existing NRCS soil surveys)
 - b. In-ROW topsoil: 0" found in multiple locations.
- 3.) Soil Compaction (FERC Plan: V. C. 1-3.)
 - a. Off-ROW Penetrometer reading: Around 150-180 psi in multiple locations.
 - b. In-ROW Penetrometer reading: 300 psi limit exceeded in every off-ROW location.
- 4.) Construction debris used for creek lining without landowner permission. (FERC Plan: V. A. 3.)

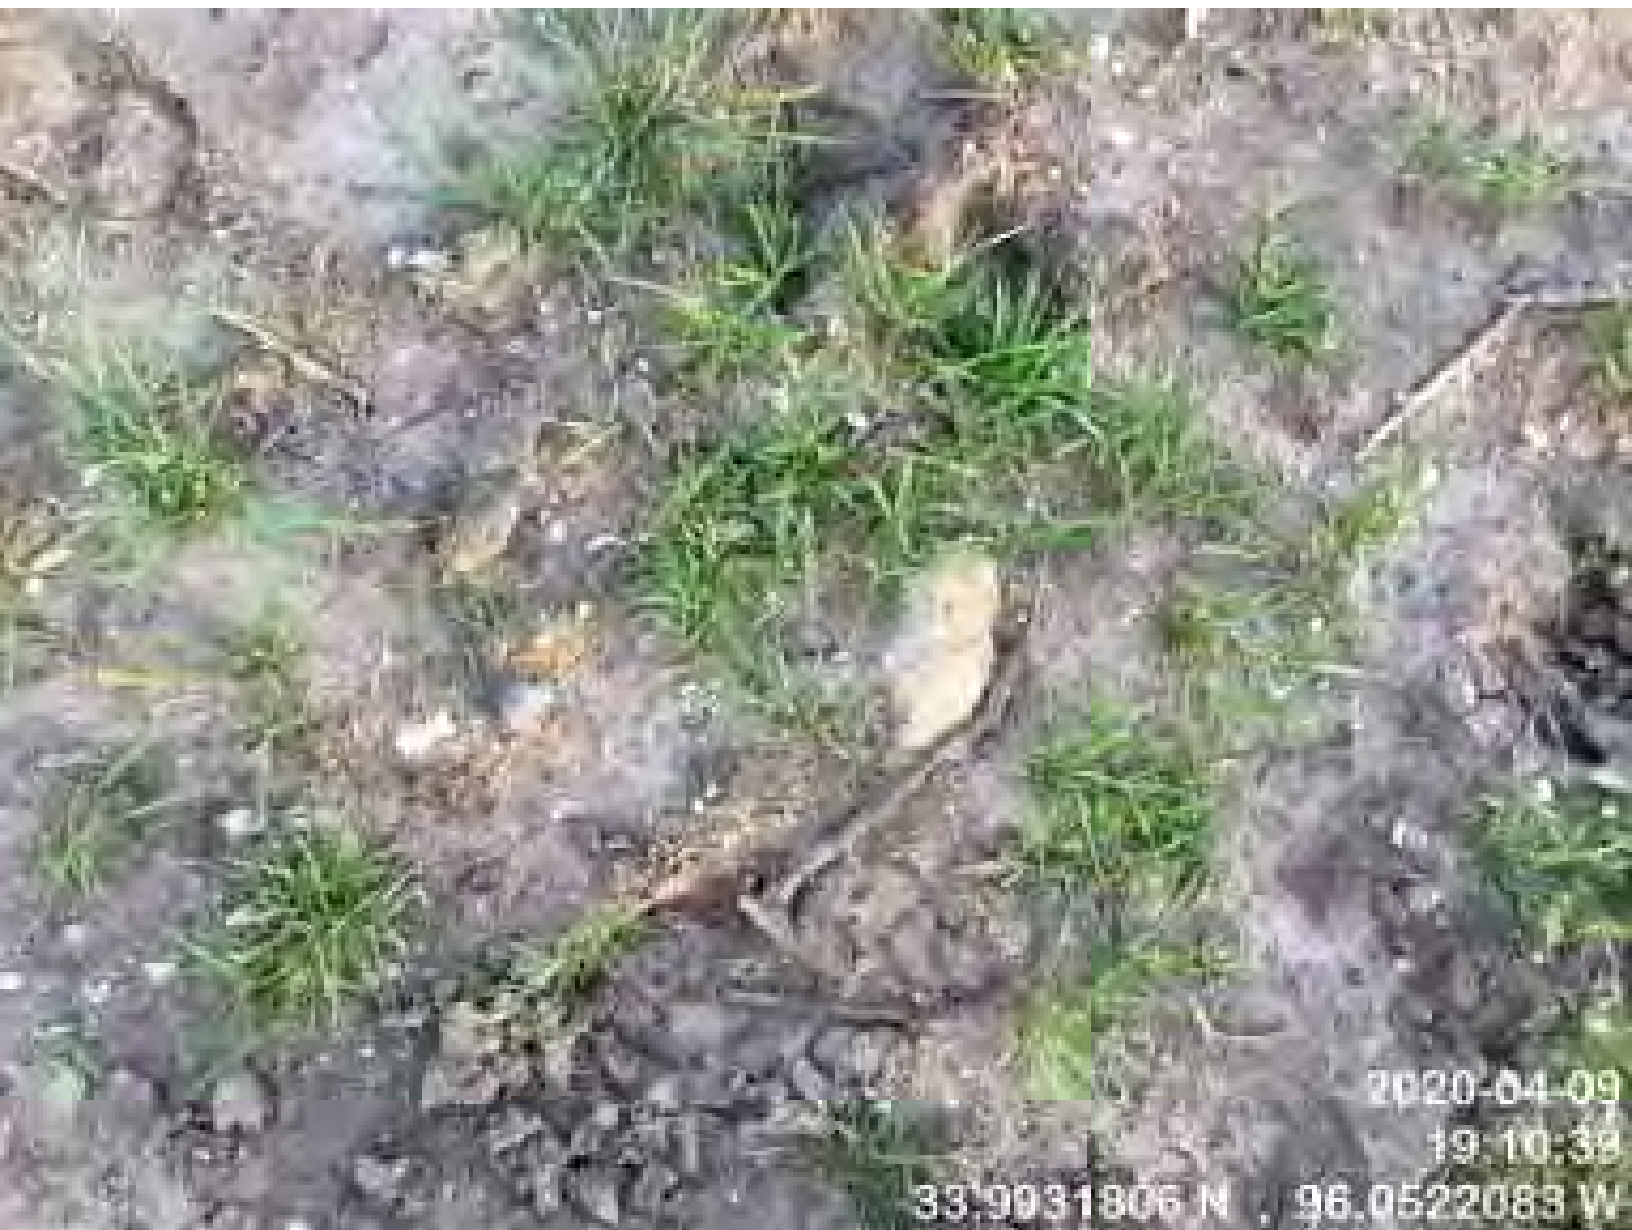
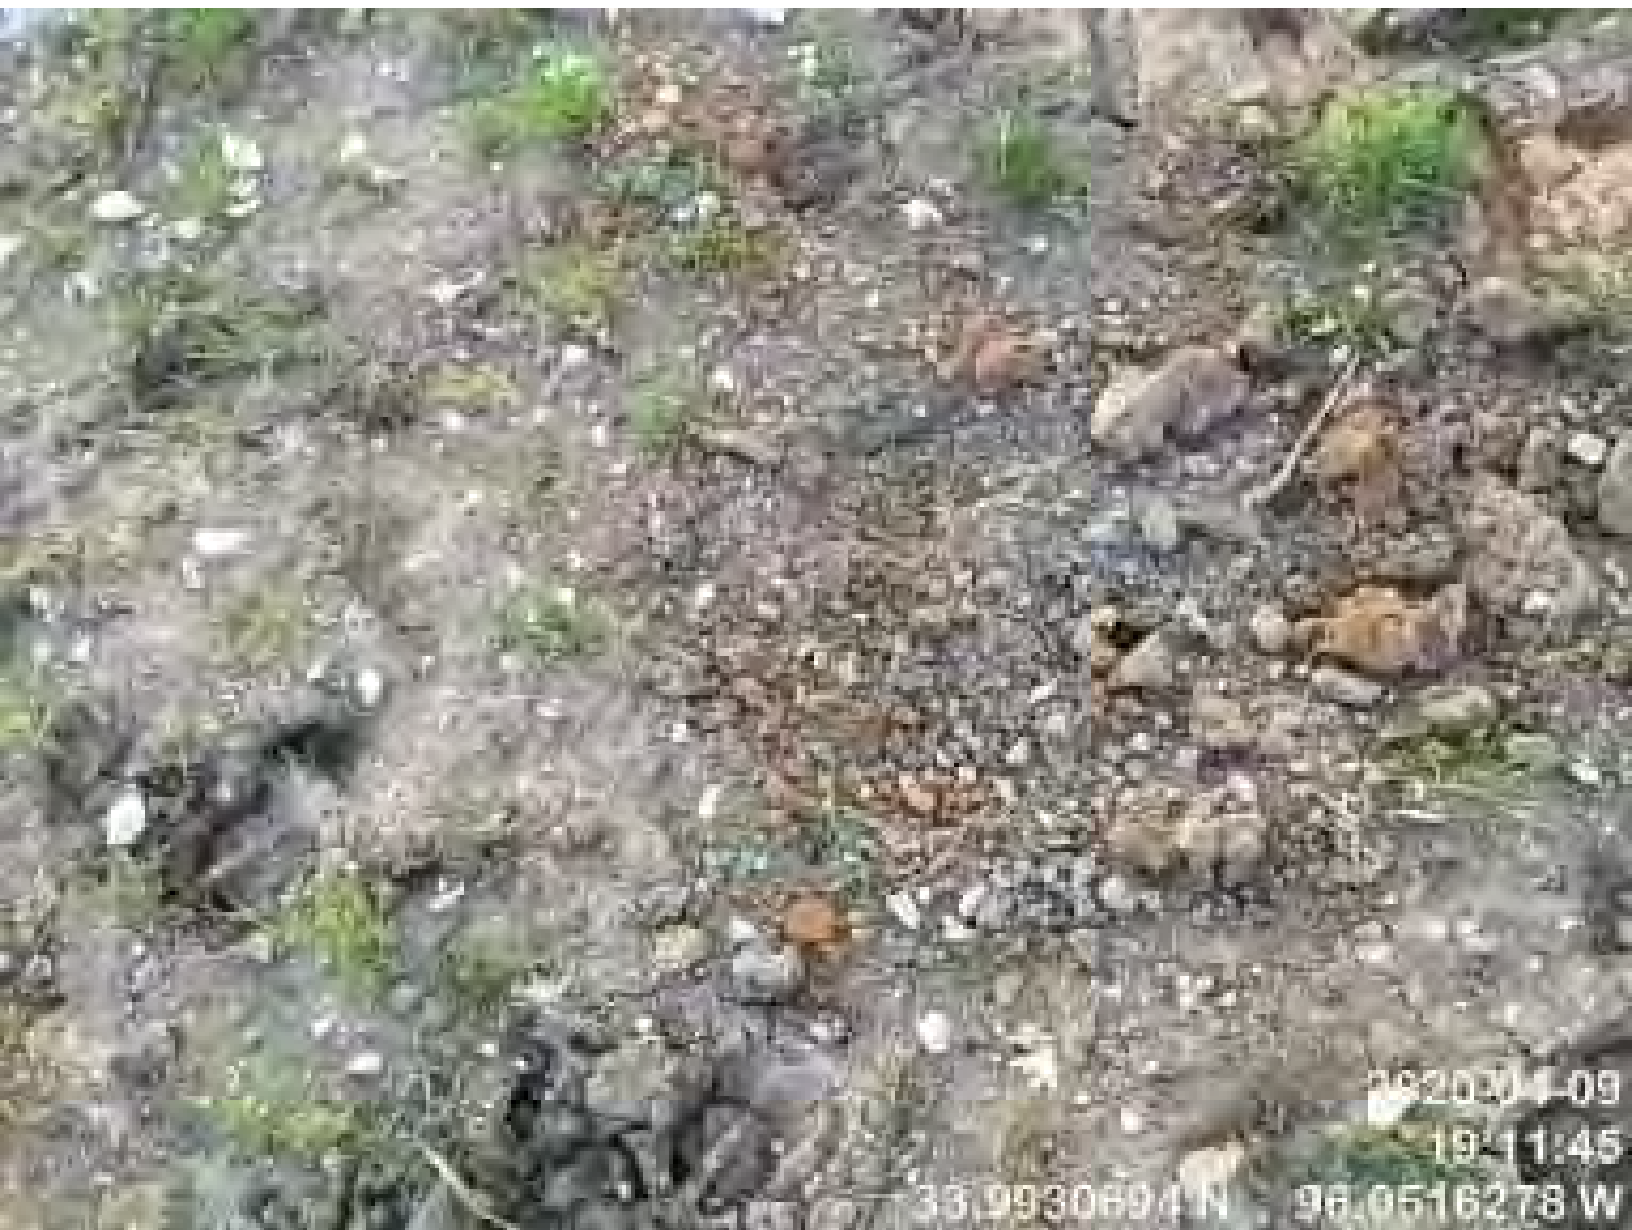
Site Inspection Findings:

- 1.) High levels of rock and blasting material mixed into soil. (FERC Plan: V. A. 3-6.)
 - a. Affected areas naturally have around 1% rock fragments with a maximum size of 74 mm (NRCS)
- 2.) Importation of approx. 3,256 cubic yards of topsoil for 1.73 acres of ROW. (FERC Plan: IV. B. 1-6.)
 - a. Off-ROW topsoil: 14" (verified by existing NRCS soil surveys)
 - b. In-ROW topsoil: 0" found in multiple locations.
- 3.) Soil Compaction (FERC Plan: V. C. 1-3.)
 - a. Off-ROW Penetrometer reading: Around 150 psi in multiple locations.
 - b. In-ROW Penetrometer reading: 300 psi limit exceeded in every off-ROW location.

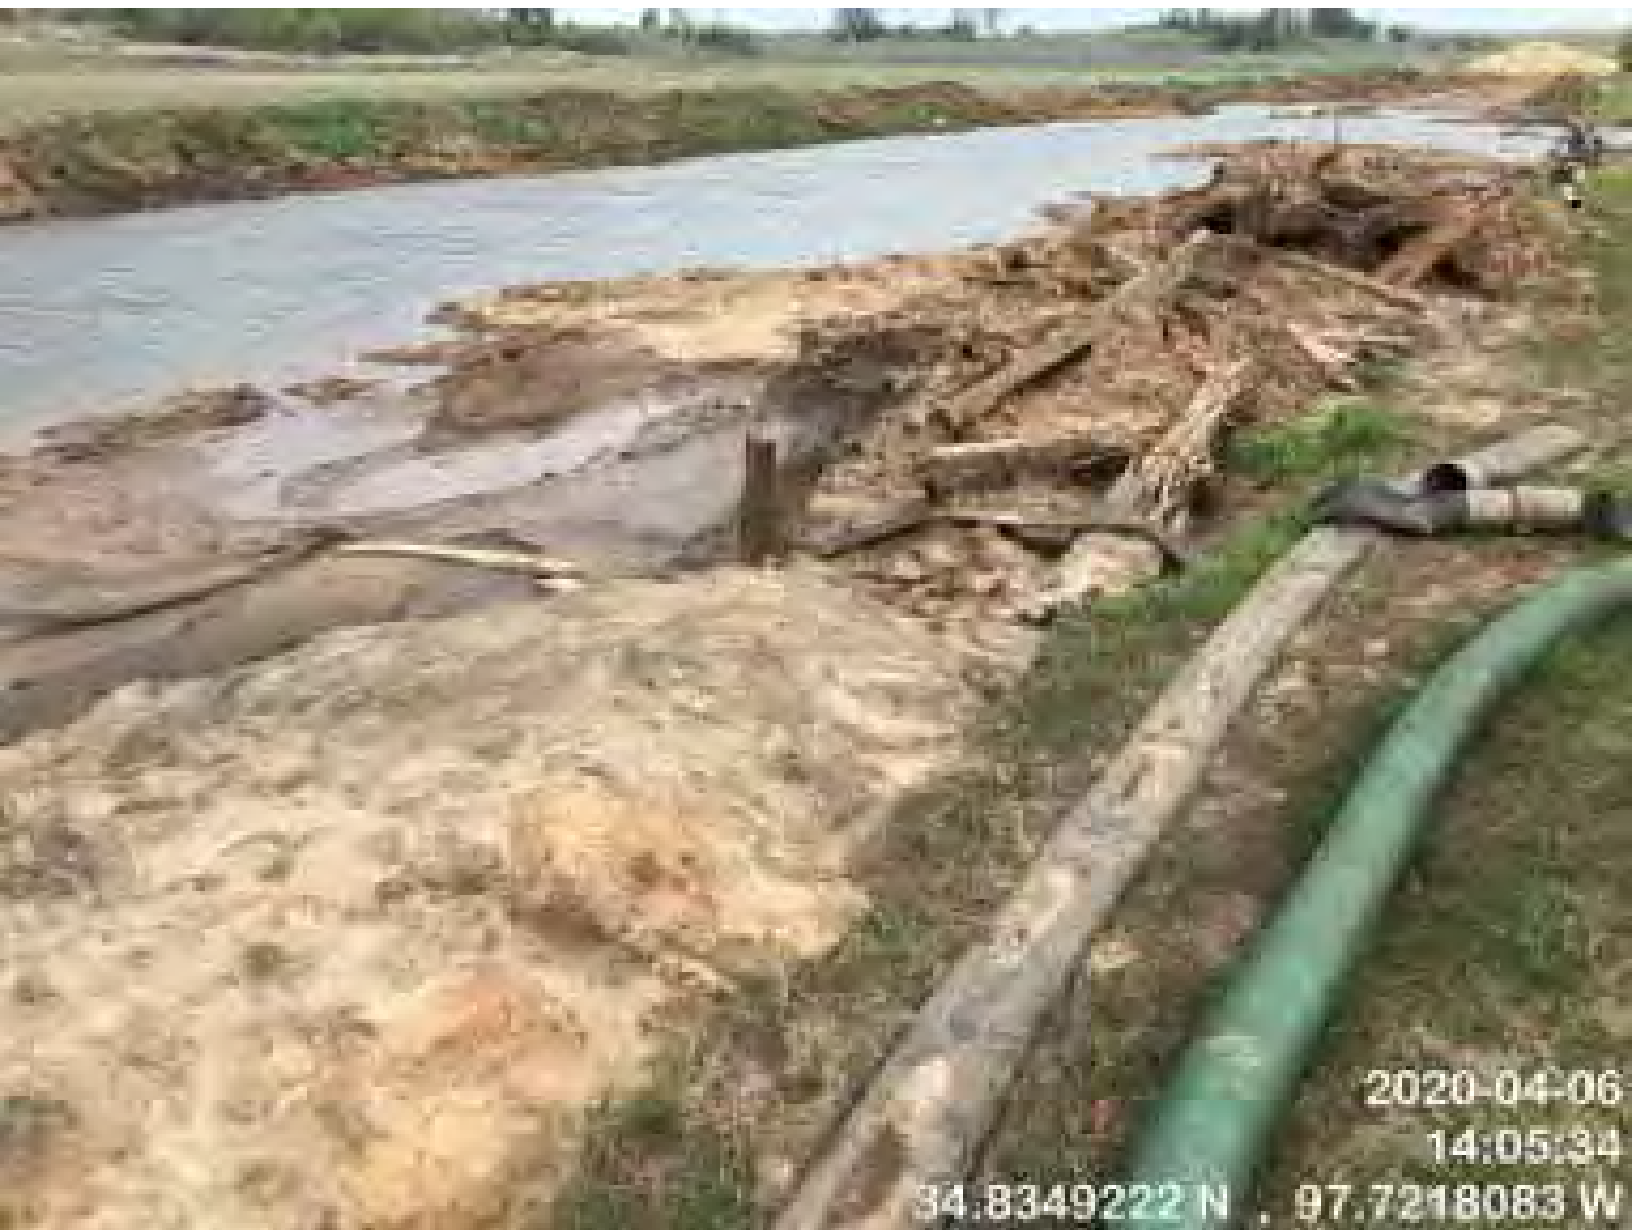
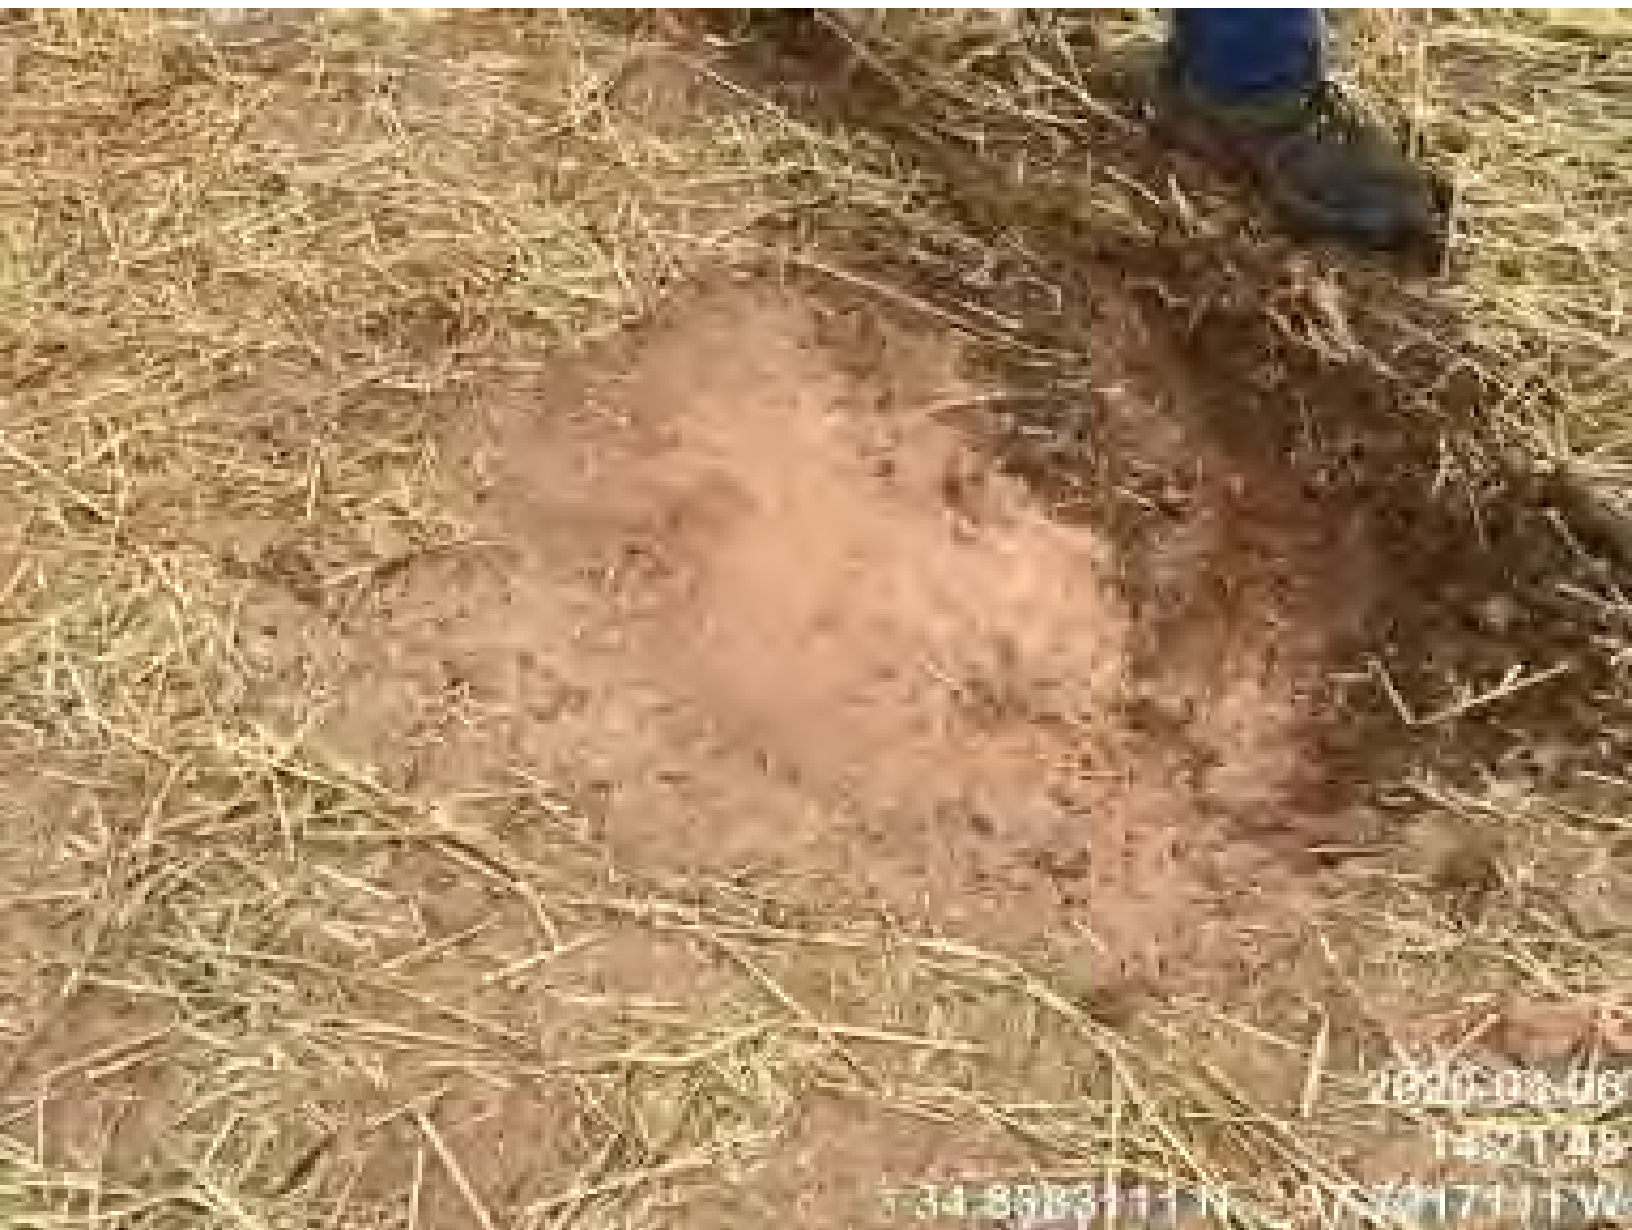
- 1.) Trenches remain open and full of water on tract GR-0338. No catch basins found on property.
- 2.) Sandy Creek (SGR-008)
 - a. Unfiltered trench water continues to be pumped directly into Sandy Creek. (FERC Procedures: V. B. 11.)
 - b. Banks are unstable and slipping into stream. (FERC Procedures: V. C. 2-3.)
 - c. Sediment deposited into stream have partially dammed stream impeding natural flow. (FERC Procedures: V. B. 10-11.)
- 3.) Importation of 50,000 - 100,000 cubic yards of topsoil for 26.27 acres of ROW (FERC Plan: IV. B. 1-6.)

- a. Off-ROW topsoil: 16-29" (verified by existing NRCS soil surveys)
- b. In-ROW topsoil: 0" found in multiple locations.
- 4.) Soil Compaction (FERC Plan: V. C. 1-3.)
 - a. Off-ROW Penetrometer reading: Around 150 psi in multiple locations.
 - b. In-ROW Penetrometer reading: 300 psi limit exceeded in every off-ROW location.
- 5.) Large rocks and debris mixed into soil and scattered throughout entire property. (FERC Plan: V. A. 3-6.)
 - a. NRCS indicates very little natural rock throughout soils in this area.
 - 1. Affected cropland areas naturally have 0% rock fragments on GR-0338.
