Robert Squires - Squires Consulting LLC
Landowner Advocate

Opening Statement for May 5, 2021 Subcommittee on Civil Rights and Civil Liberties Hearing:
“Pipelines Over People (Part II): Midship Pipeline’s Disregard for Landowners in Its Pathway”

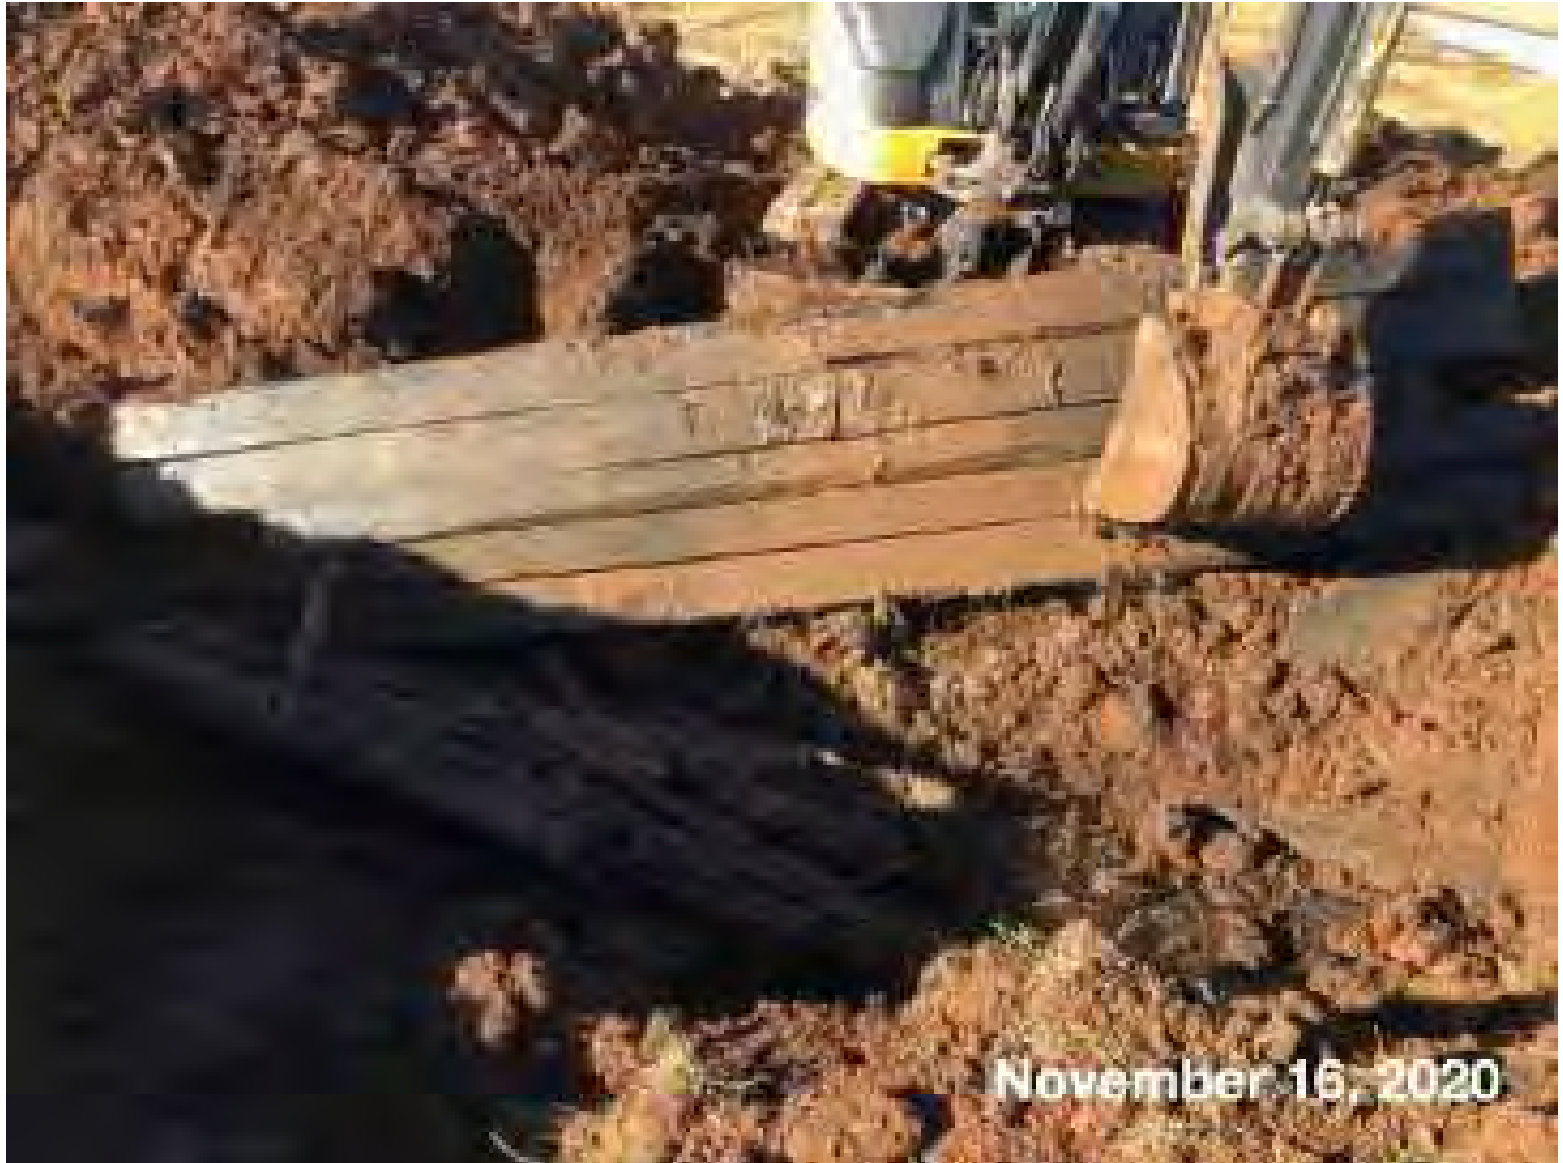
On November 16, 2020 the Landowners Verified Several Large Sections of Matting Were Found in the Topsoil and as Deep as 60"

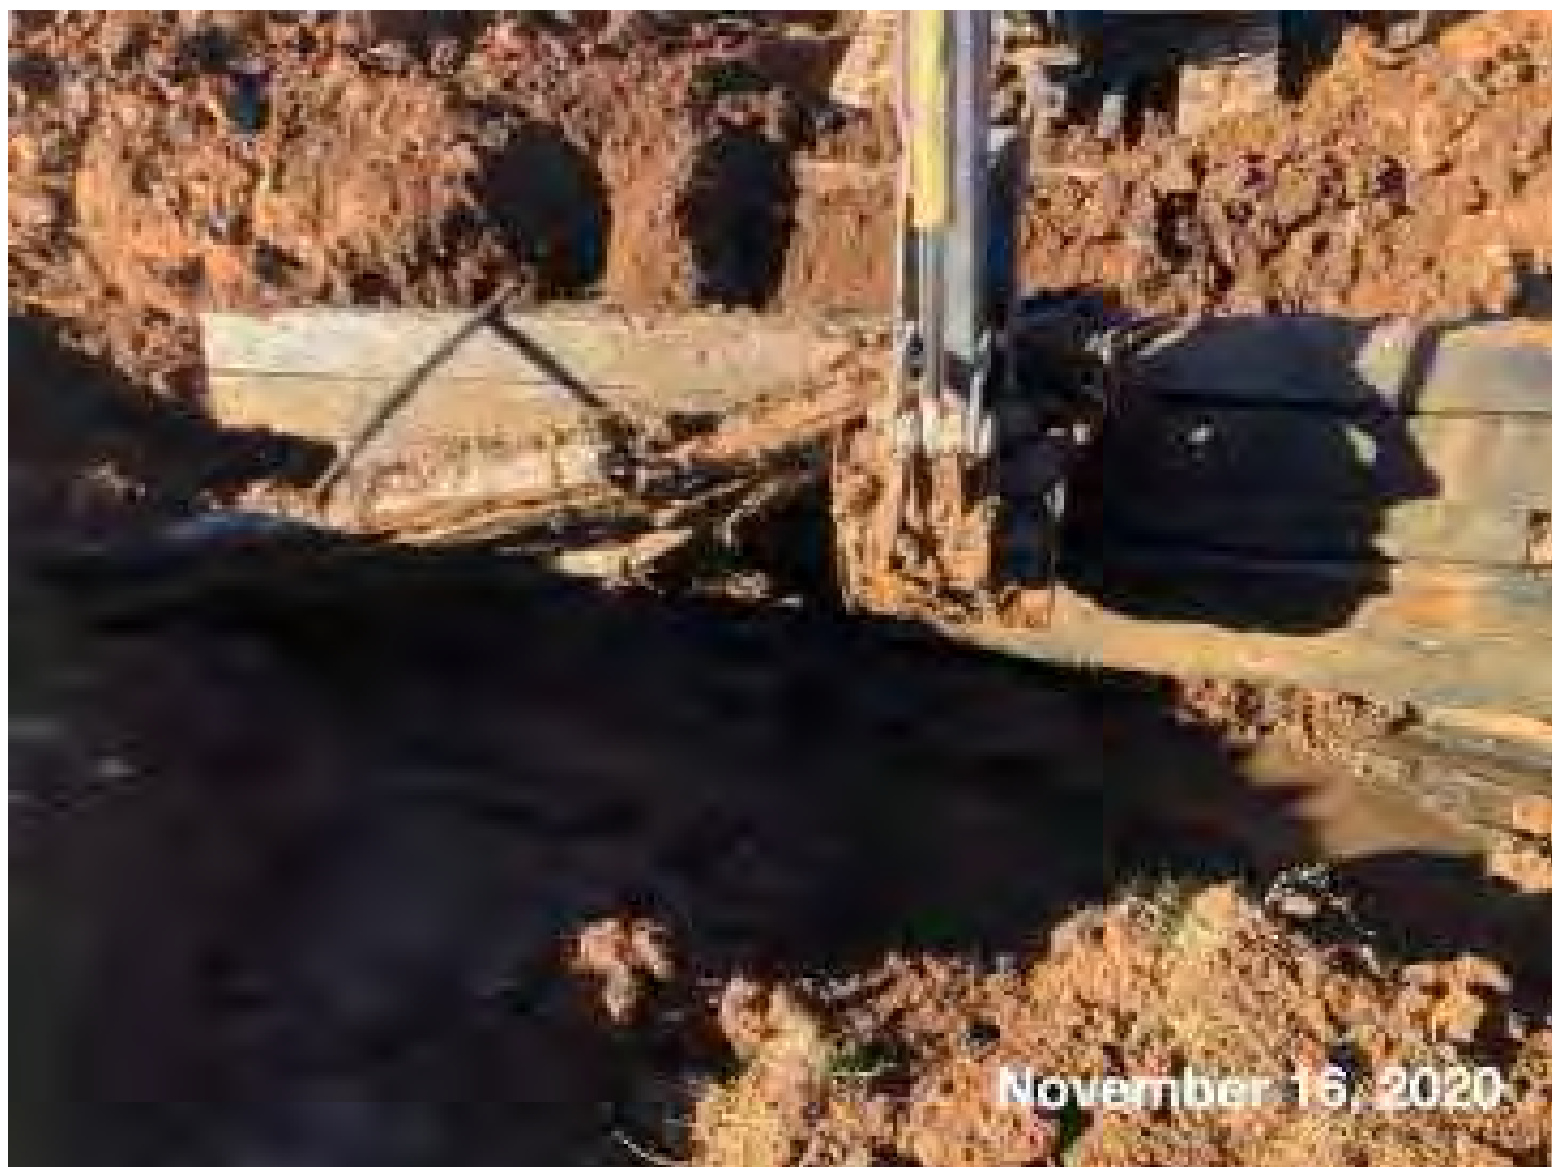
Large Sections of Matting Were Found in Several Locations North and South on Tract # GR-0338

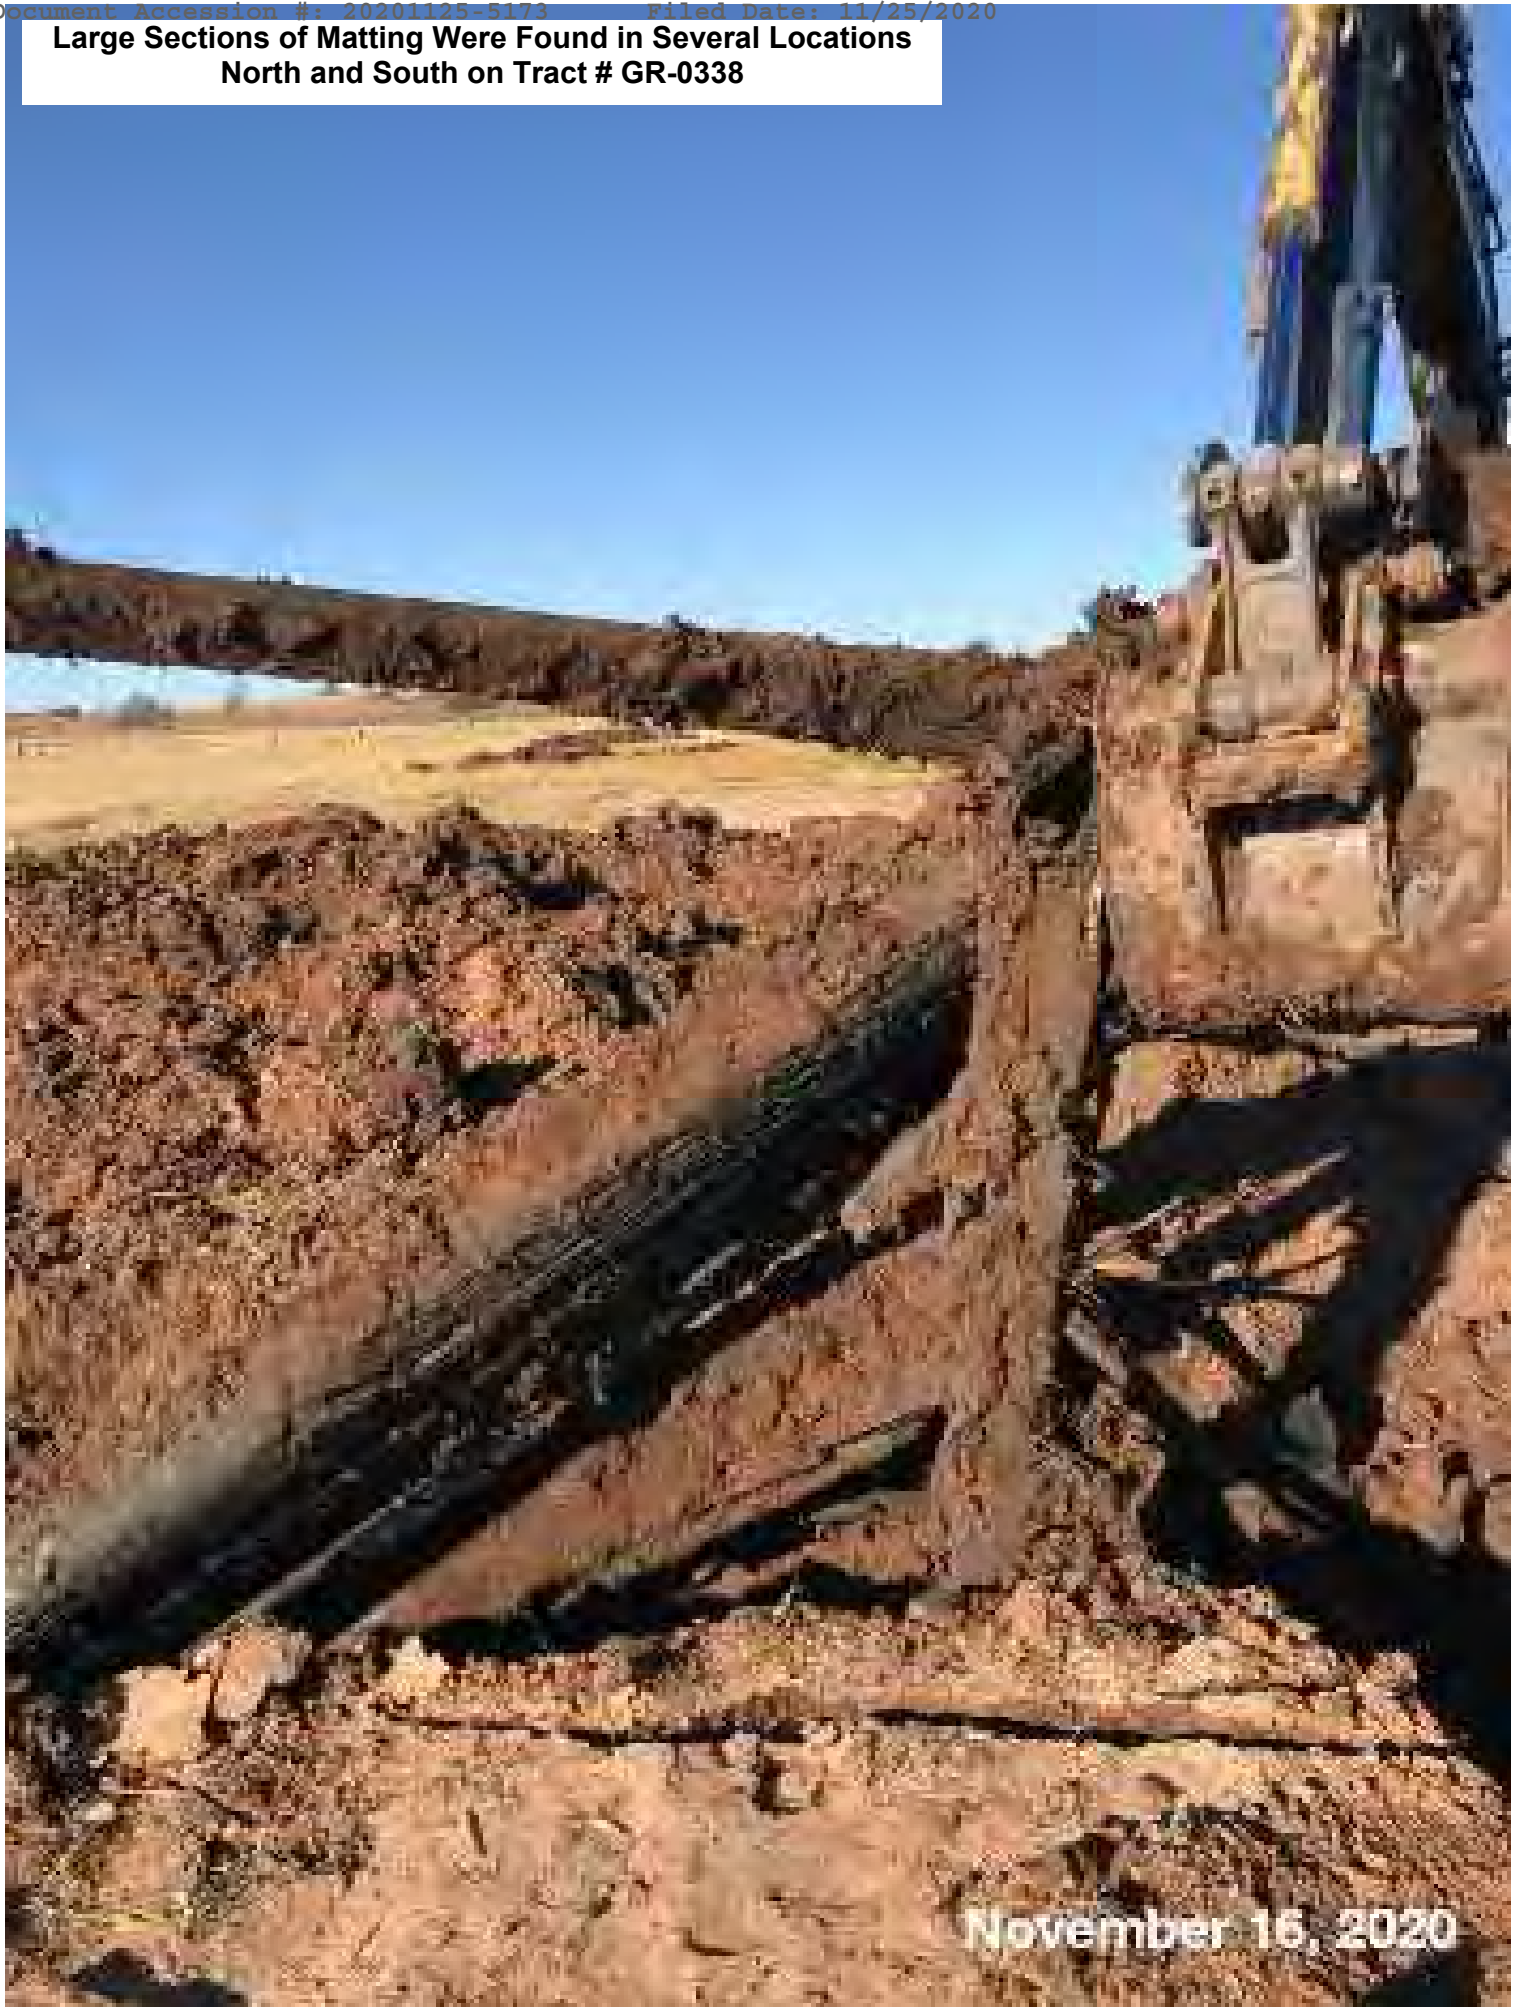
**Large Sections of Matting Were Found in Several Locations
North and South on Tract # GR-0338**

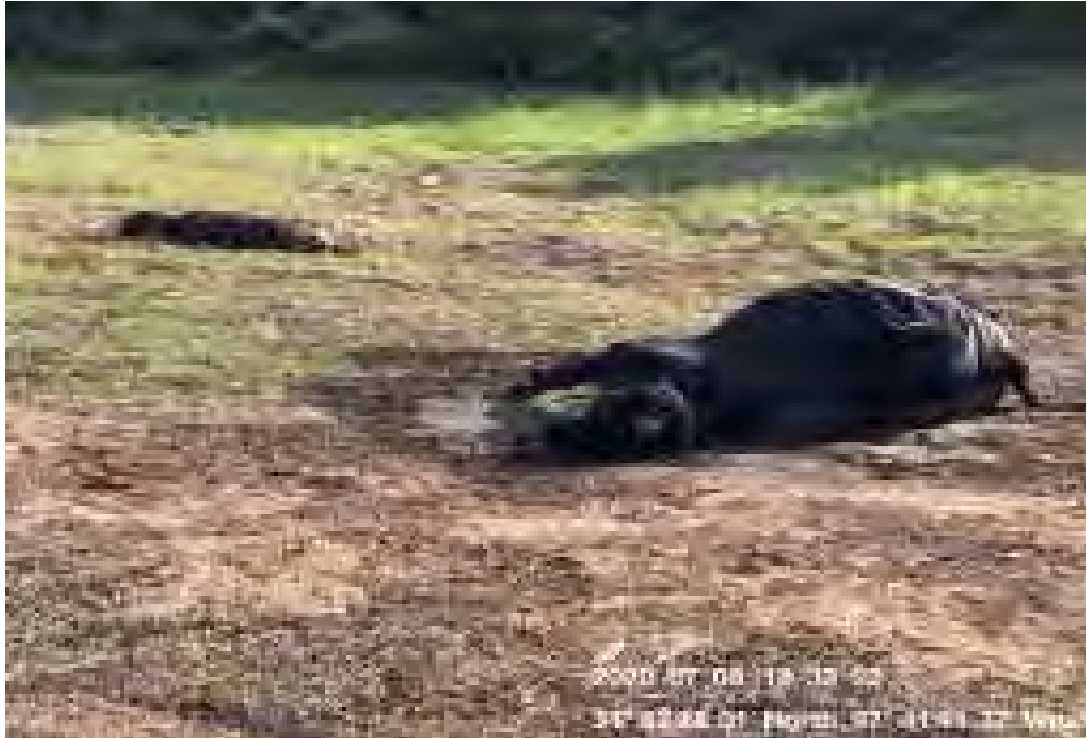
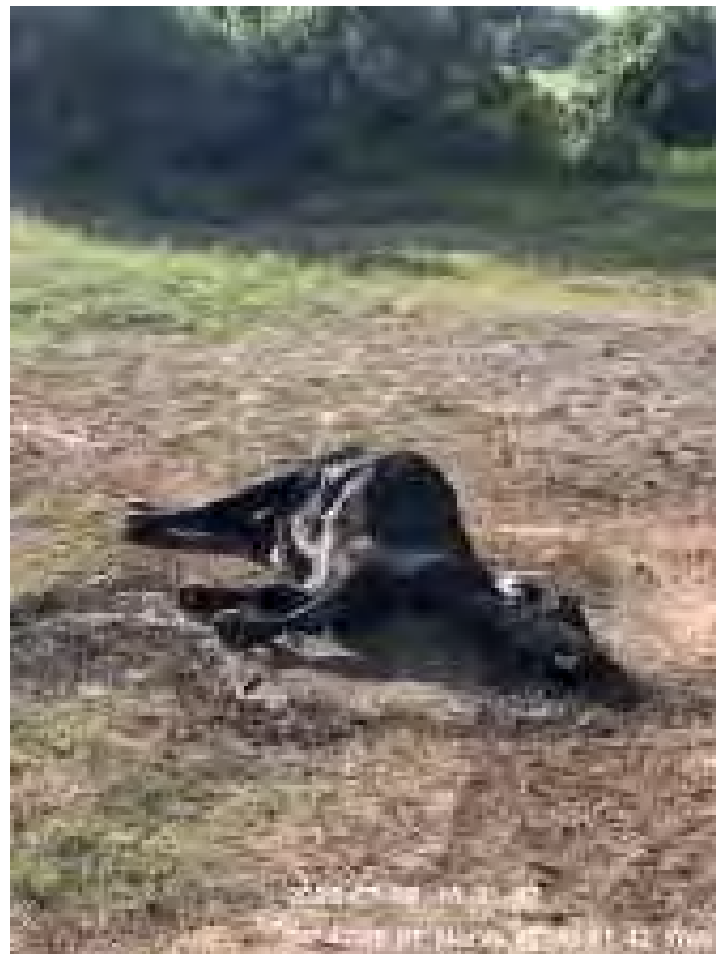
Section 3.1

Cattle Found Dead in Easement

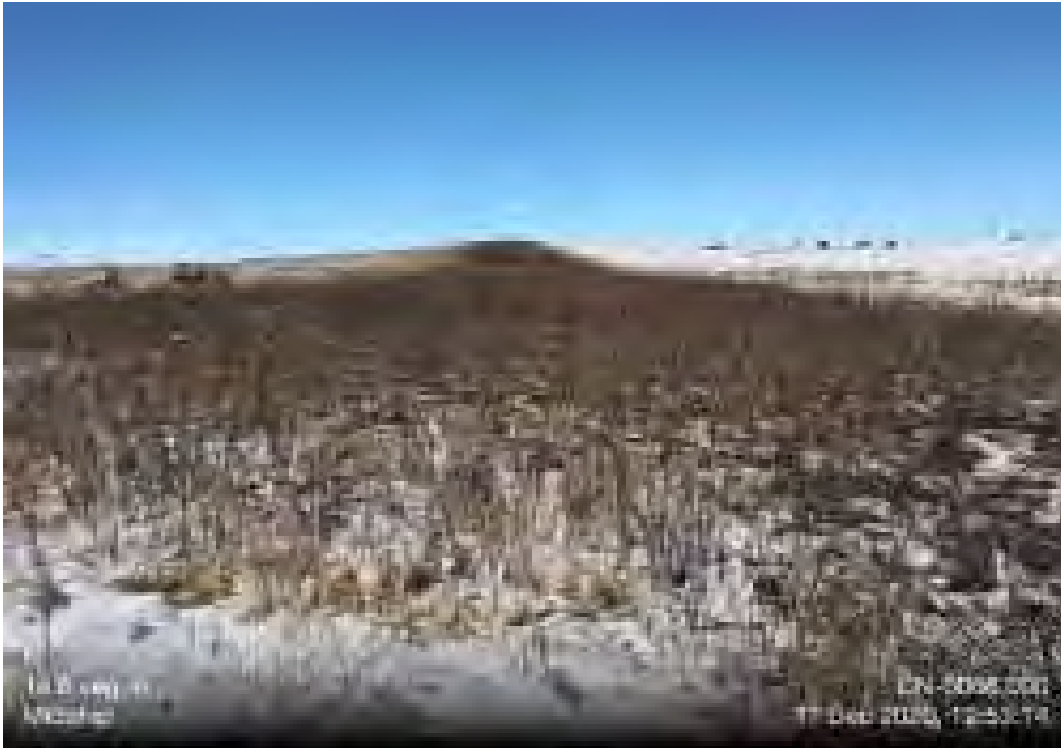
Photo 1: View of mature vegetation on tract CN-0066.000, North Spread, MP 14.8 (see EV-8931 issued on 12/17/2020).

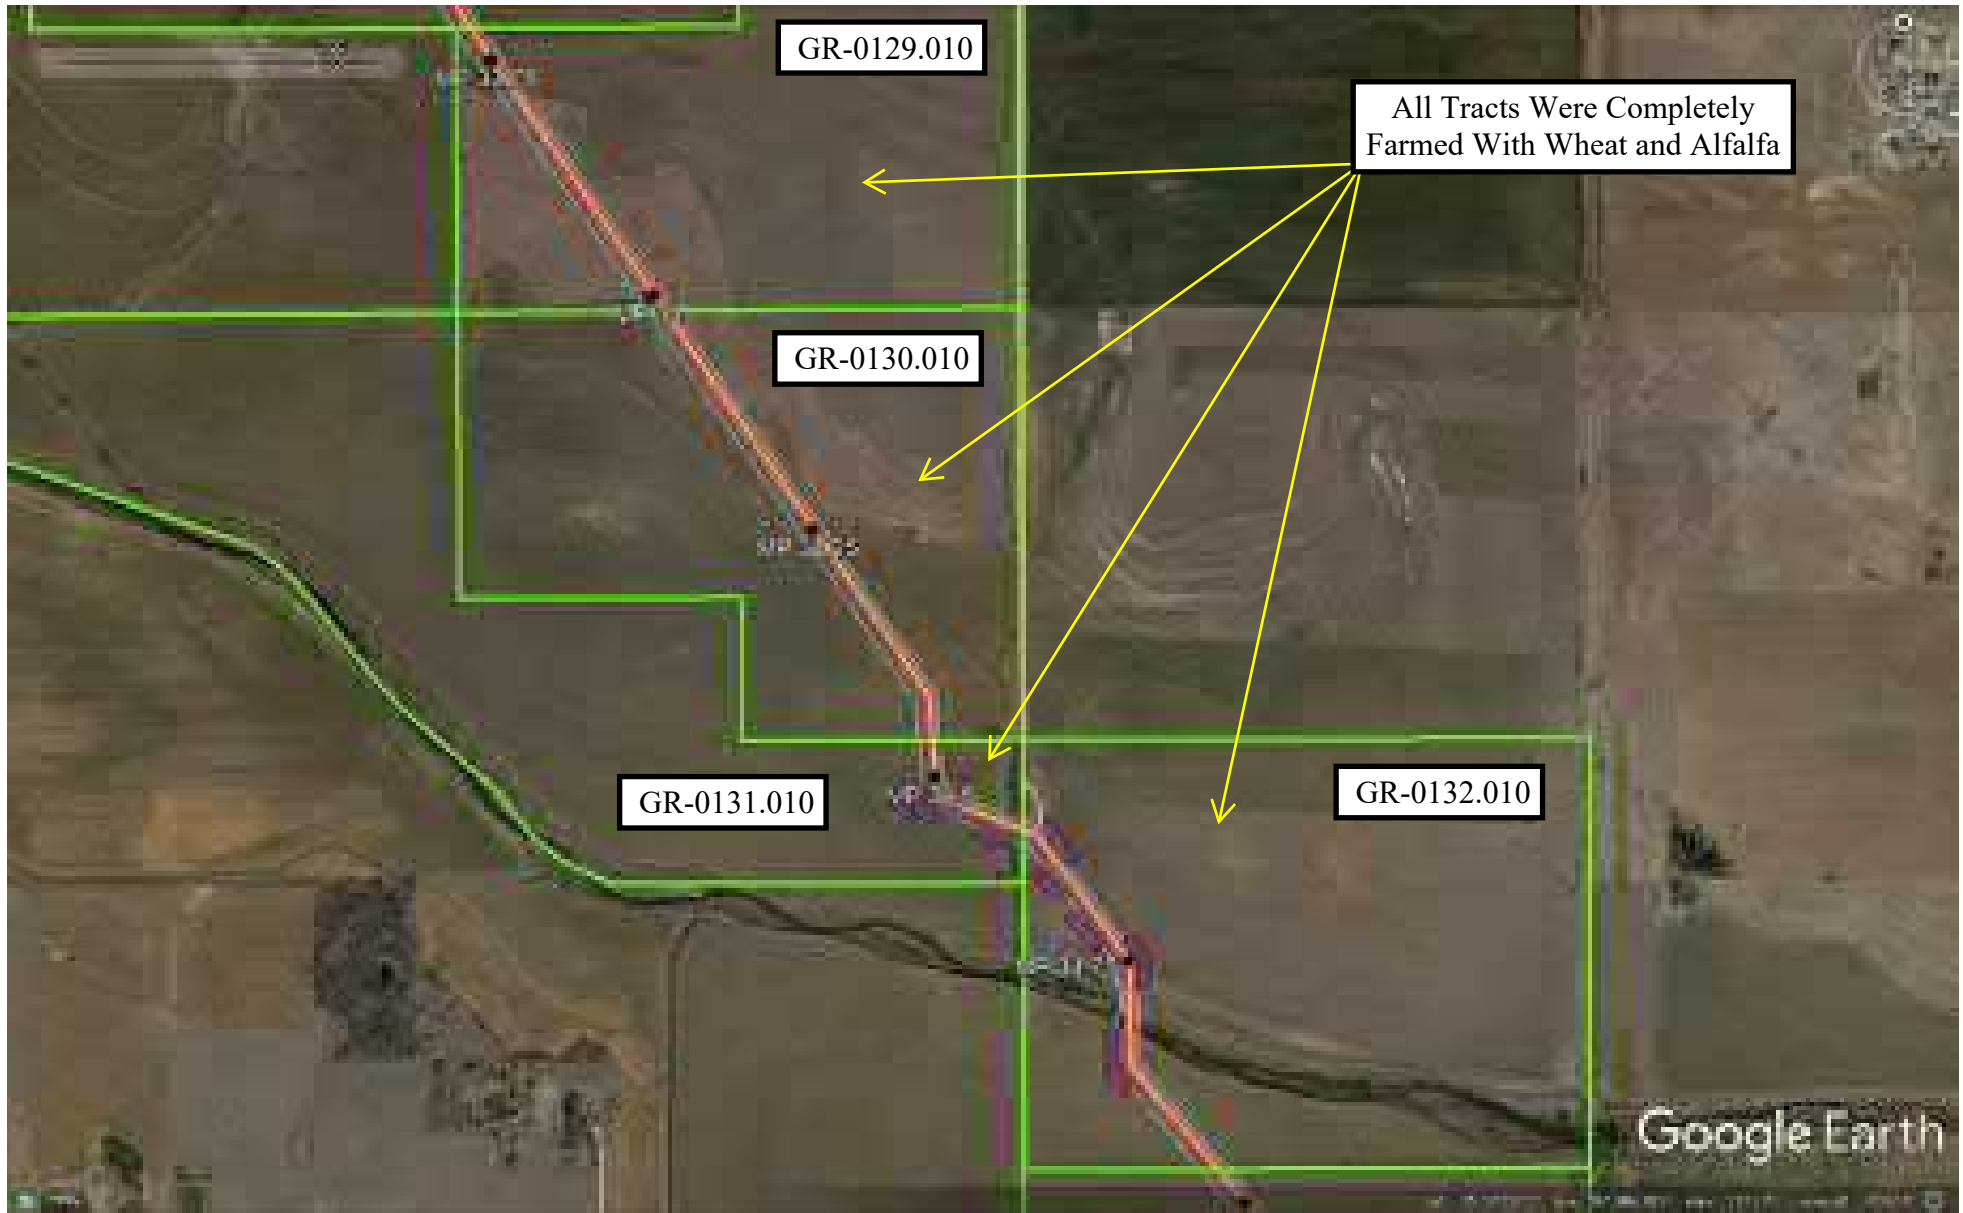
McComas Tracts GR-0129.010, GR-0130.010, GR-0131.010, & GR-0132.010 Indicating No Ponding or Deficiencies Near the Easement.
Compared to Current Condition, This Shows That the Tract Has Not Been Restored Near It's Pre-Construction Condition.

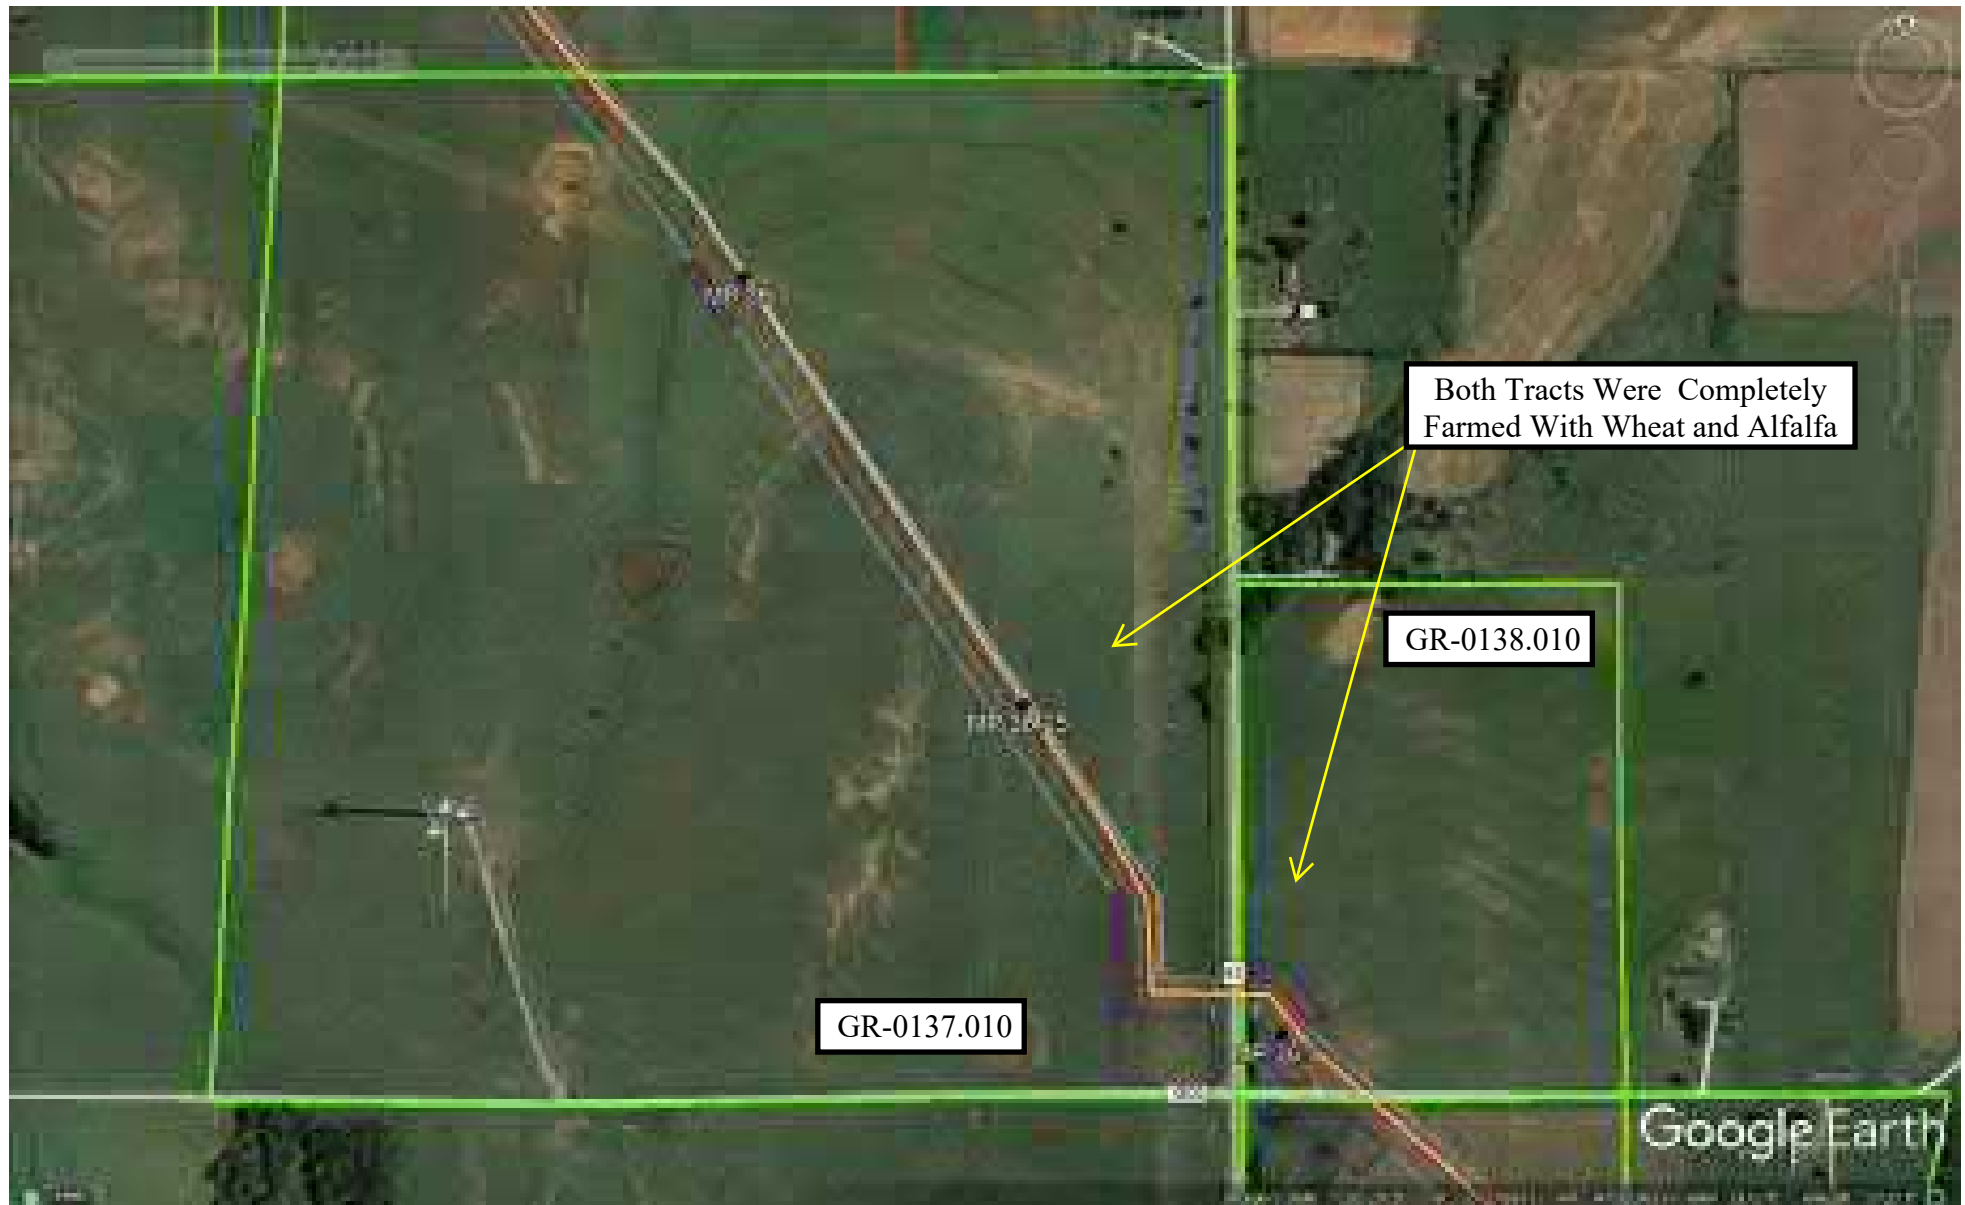
McComas Tracts GR-0137.010 & GR-0138.010 Indicating No Ponding or Deficiencies Near the Easement.
Compared to Current Condition, This Shows That the Tract Has Not Been Restored Near It's Pre-Construction Condition.

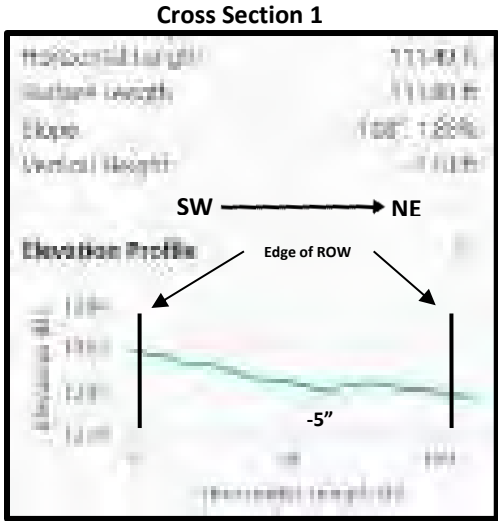
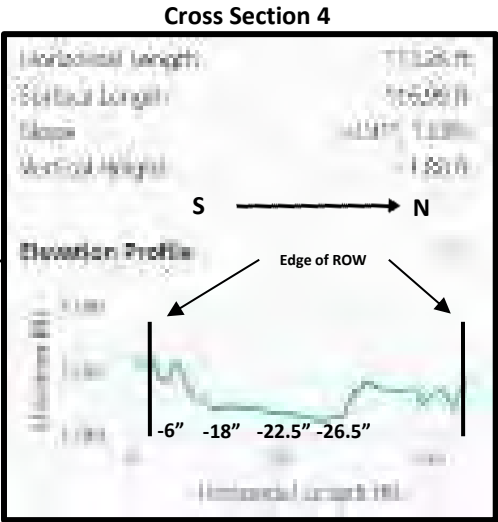
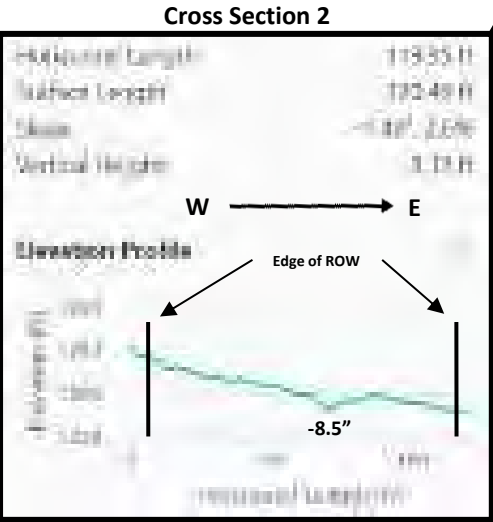
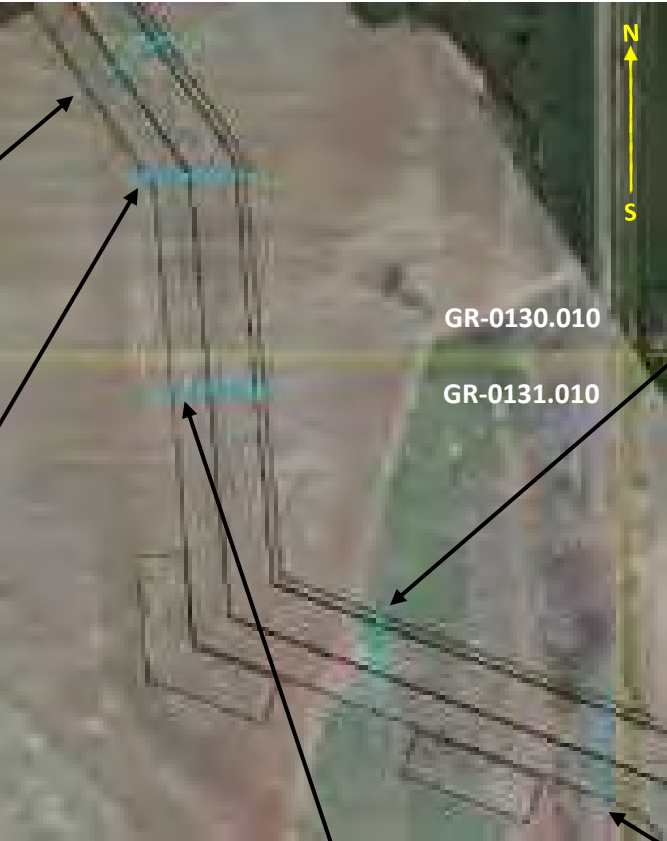
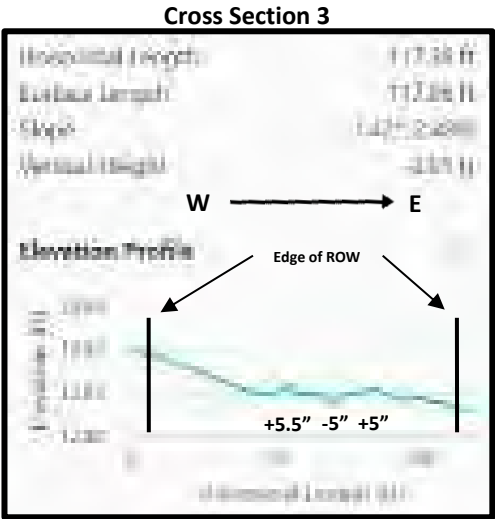
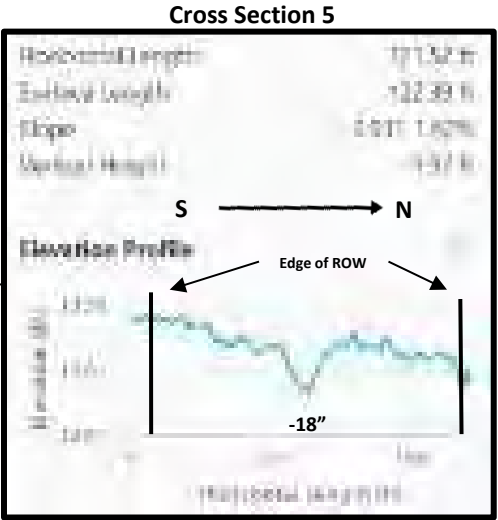
Cross Sectional Grade Evaluation for The McComas Family Pertaining to Tracts GR-0130.010 & GR-0131.010.
Data Collected November 21, 2020.

V.A.5: “Grade the construction right-of-way to restore pre-construction contours and leave the soil in the proper condition for planting.”

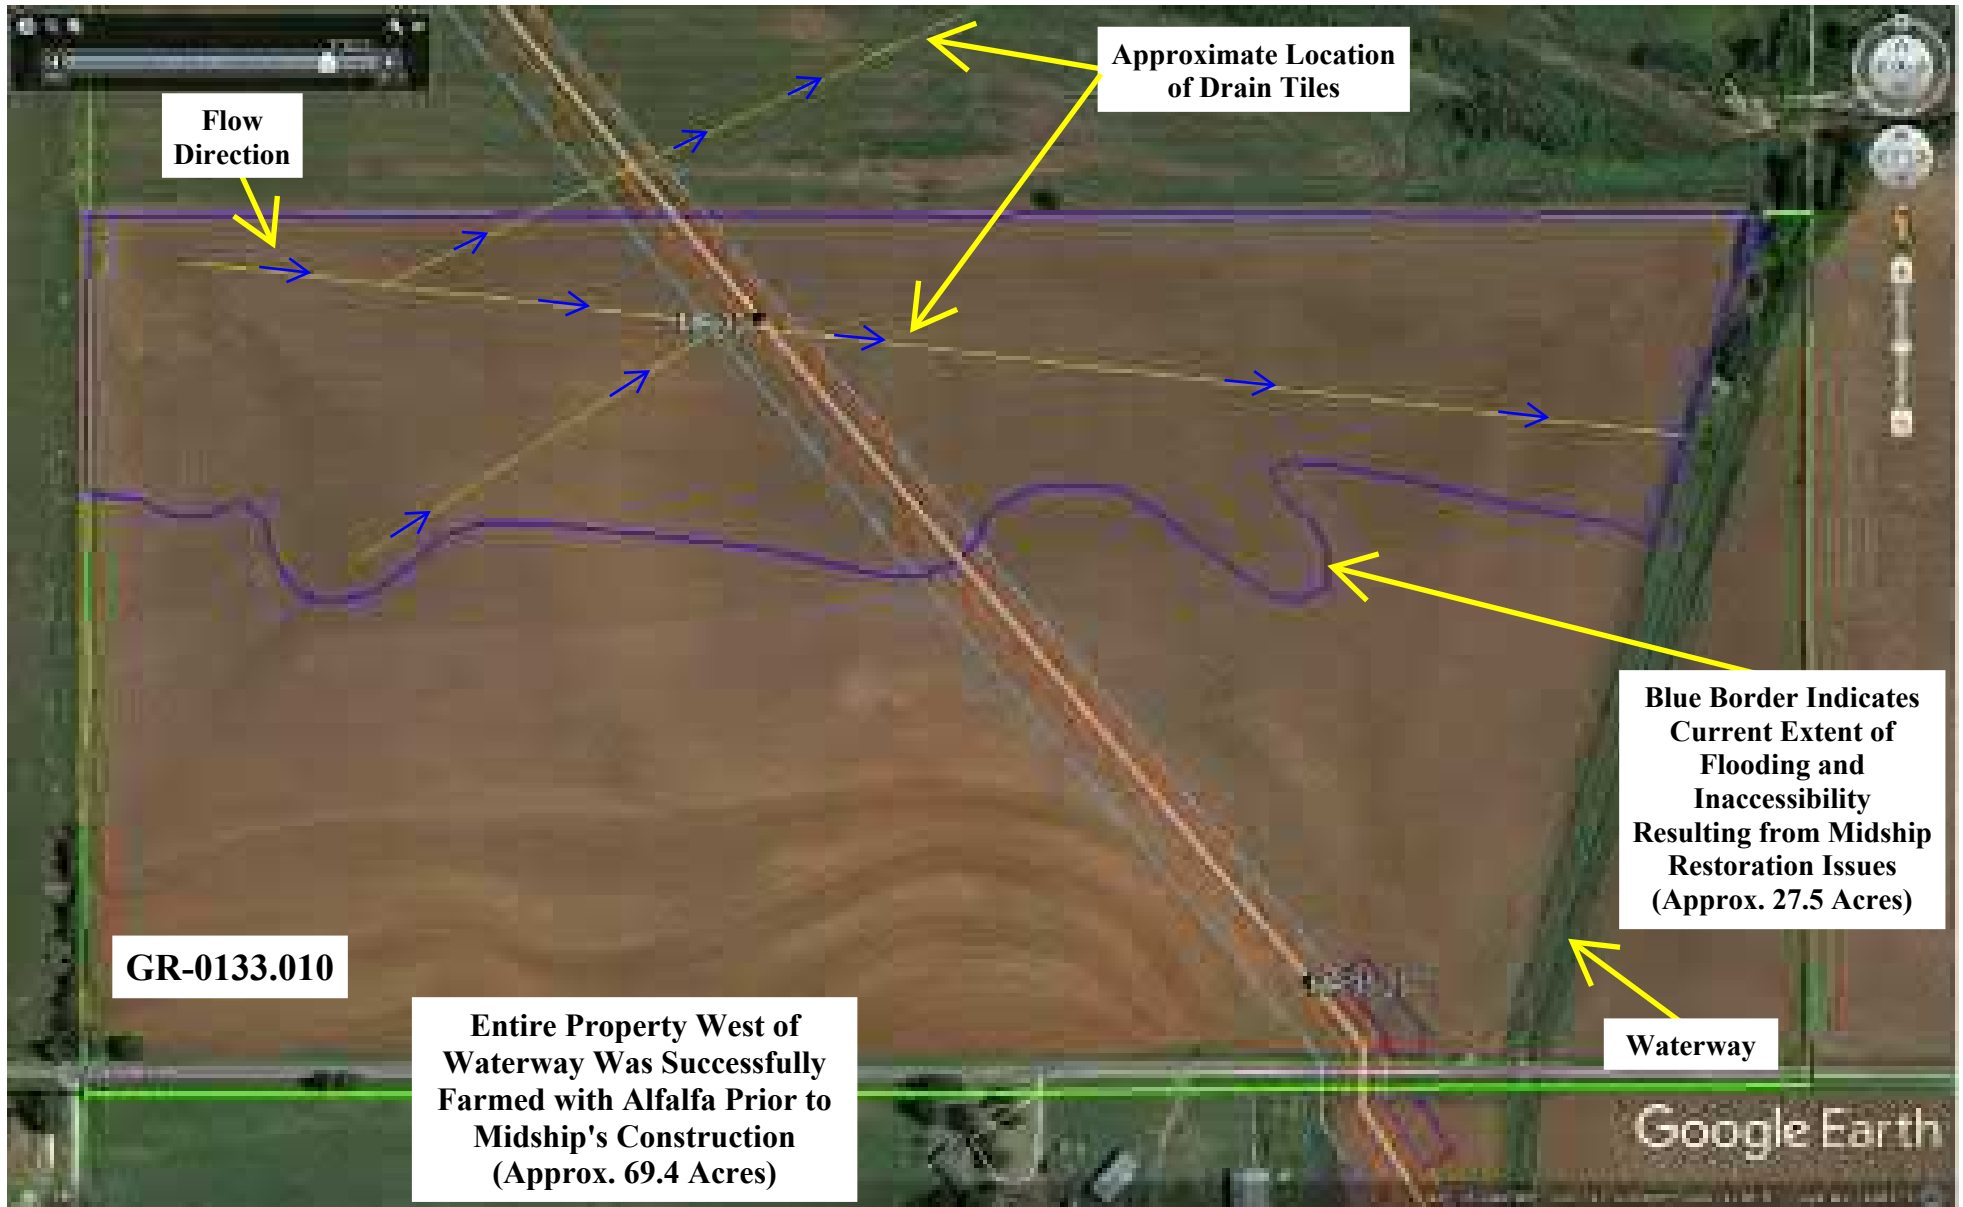
Google Earth Screenshot from 2015 of Burchfield Tract GR-0133.010. No Signs of Flooding or Drainage Issues.

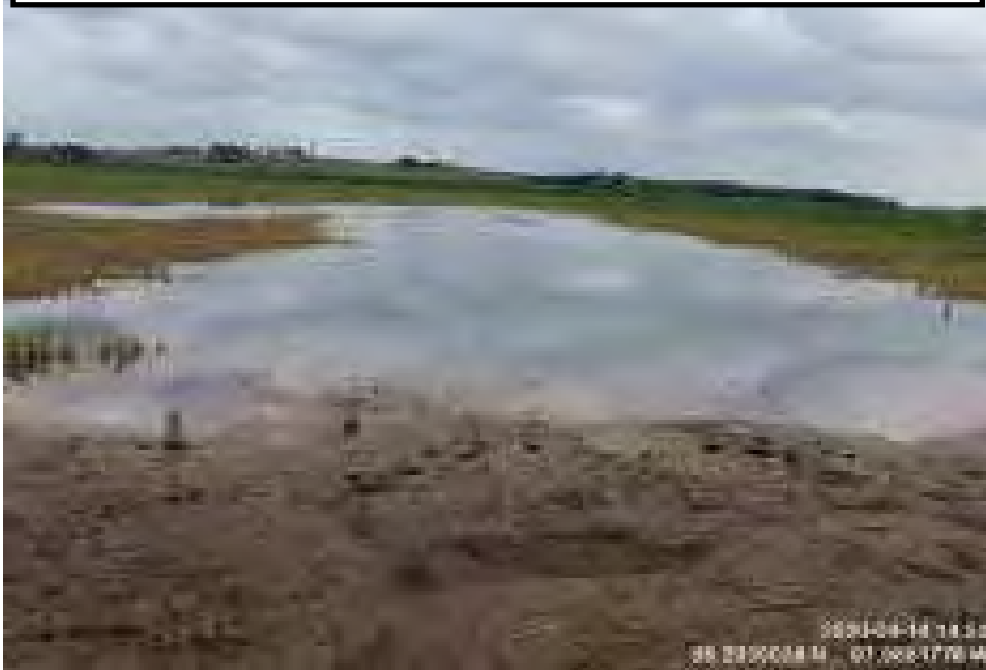
Large Area of Off-ROW Ponding Due to Impacted Drainage

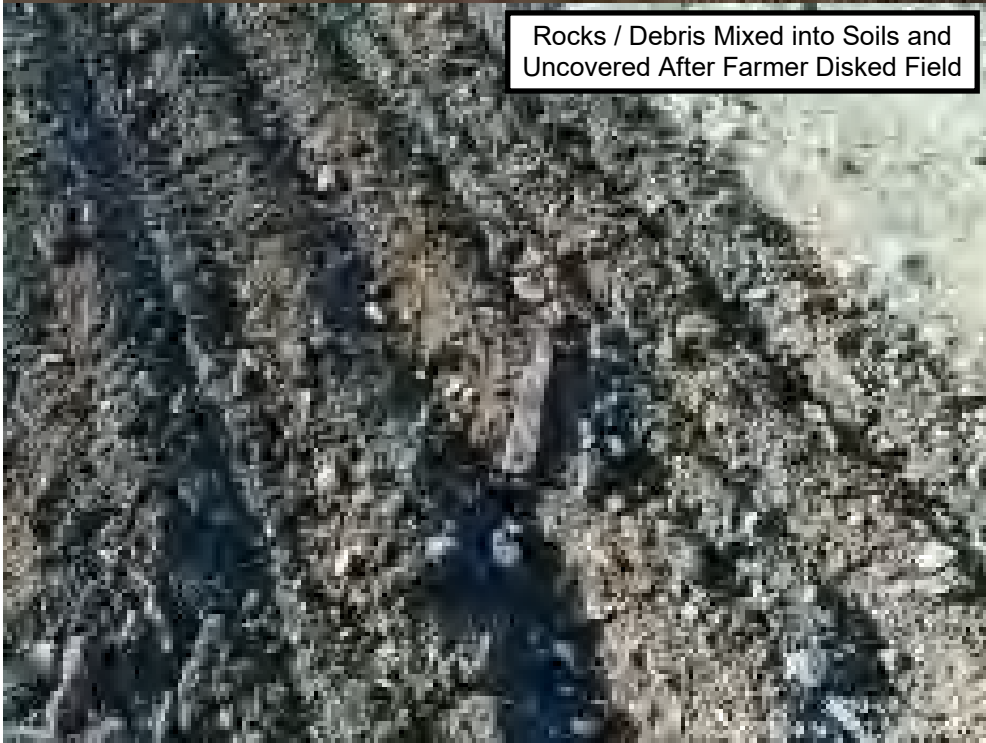
Rocks / Debris Mixed into Soils and Uncovered After Farmer Disked Field

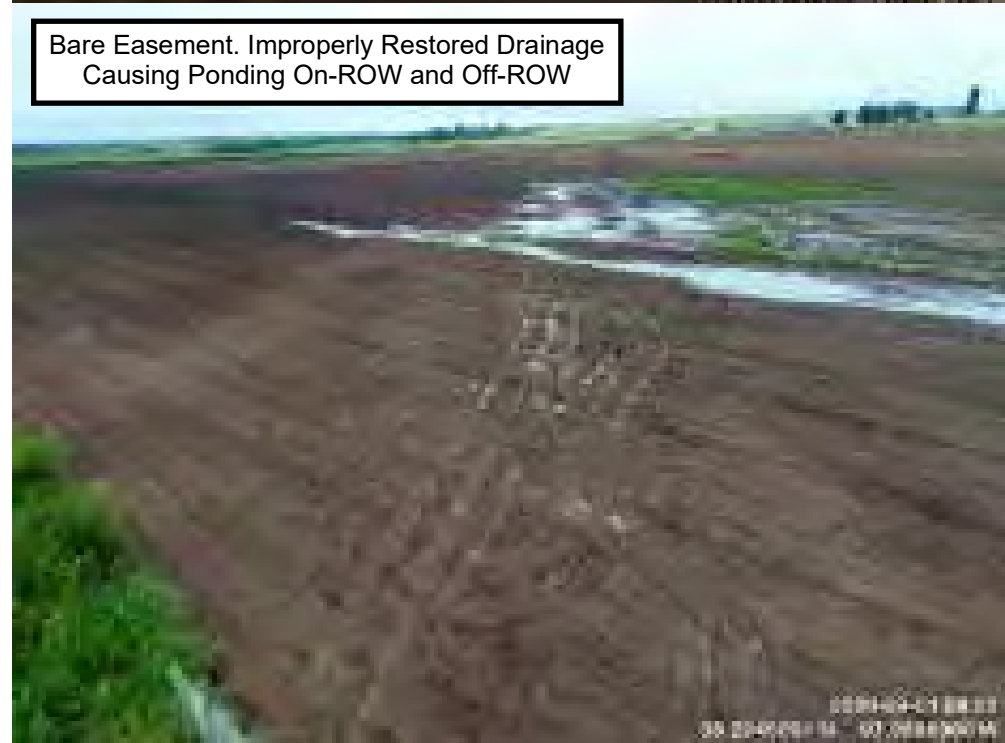
Bare Easement. Improperly Restored Drainage Causing Ponding On-ROW and Off-ROW

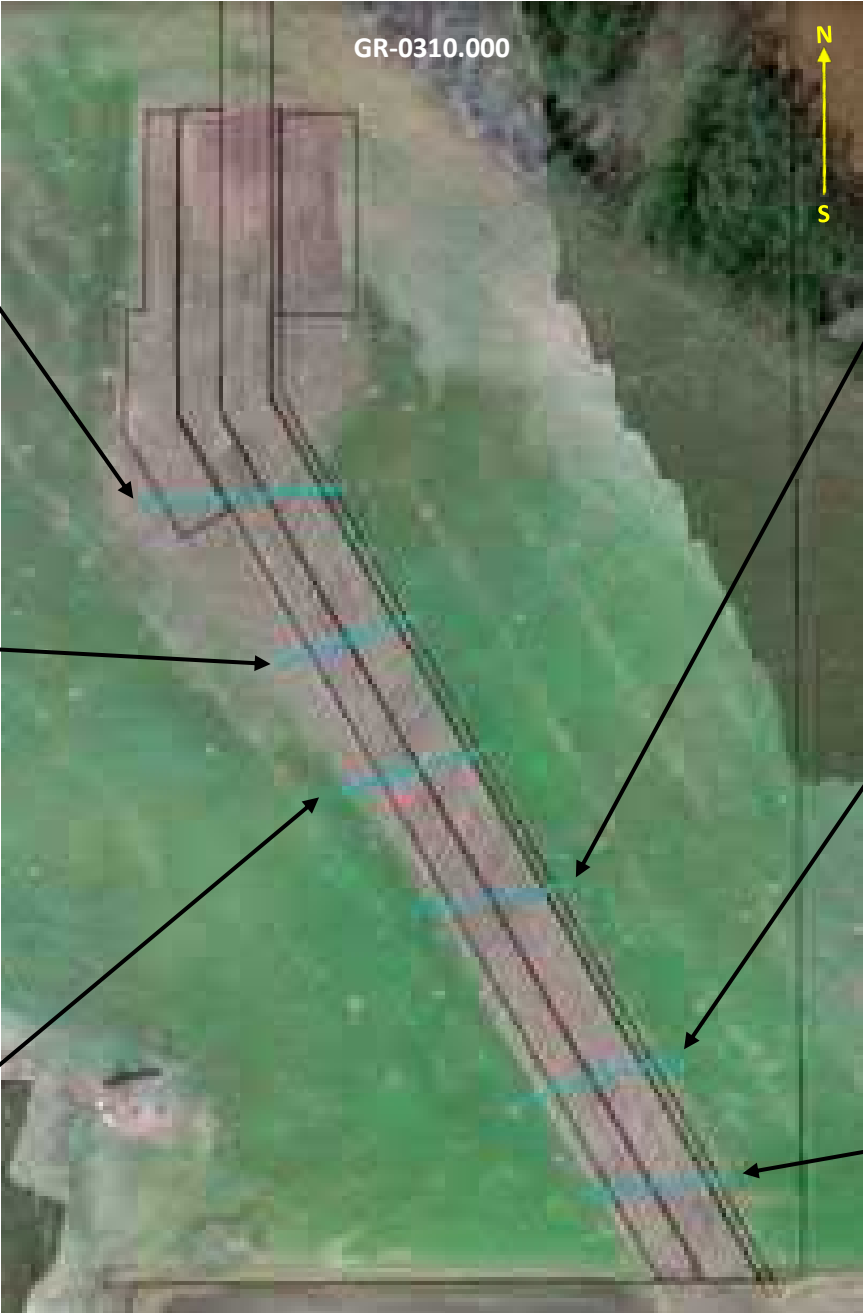
Cross Sectional Grade Evaluation for James McElvany Pertaining to Tract GR-0310.000.
Data Collected November 23, 2020.

V.A.5: “Grade the construction right-of-way to restore pre-construction contours and leave the soil in the proper condition for planting.”

**Easement is Mostly Bare.
Approximately 8% of the Easement is Vegetated.
Easement Appears Sunken Compared to Off-ROW.
Easement is Extremely Saturated and Muddy.**
