Robert Squires - Squires Consulting LLC
Landowner Advocate

Opening Statement for May 5, 2021 Subcommittee on Civil Rights and Civil Liberties Hearing:
“Pipelines Over People (Part II): Midship Pipeline’s Disregard for Landowners in Its Pathway”

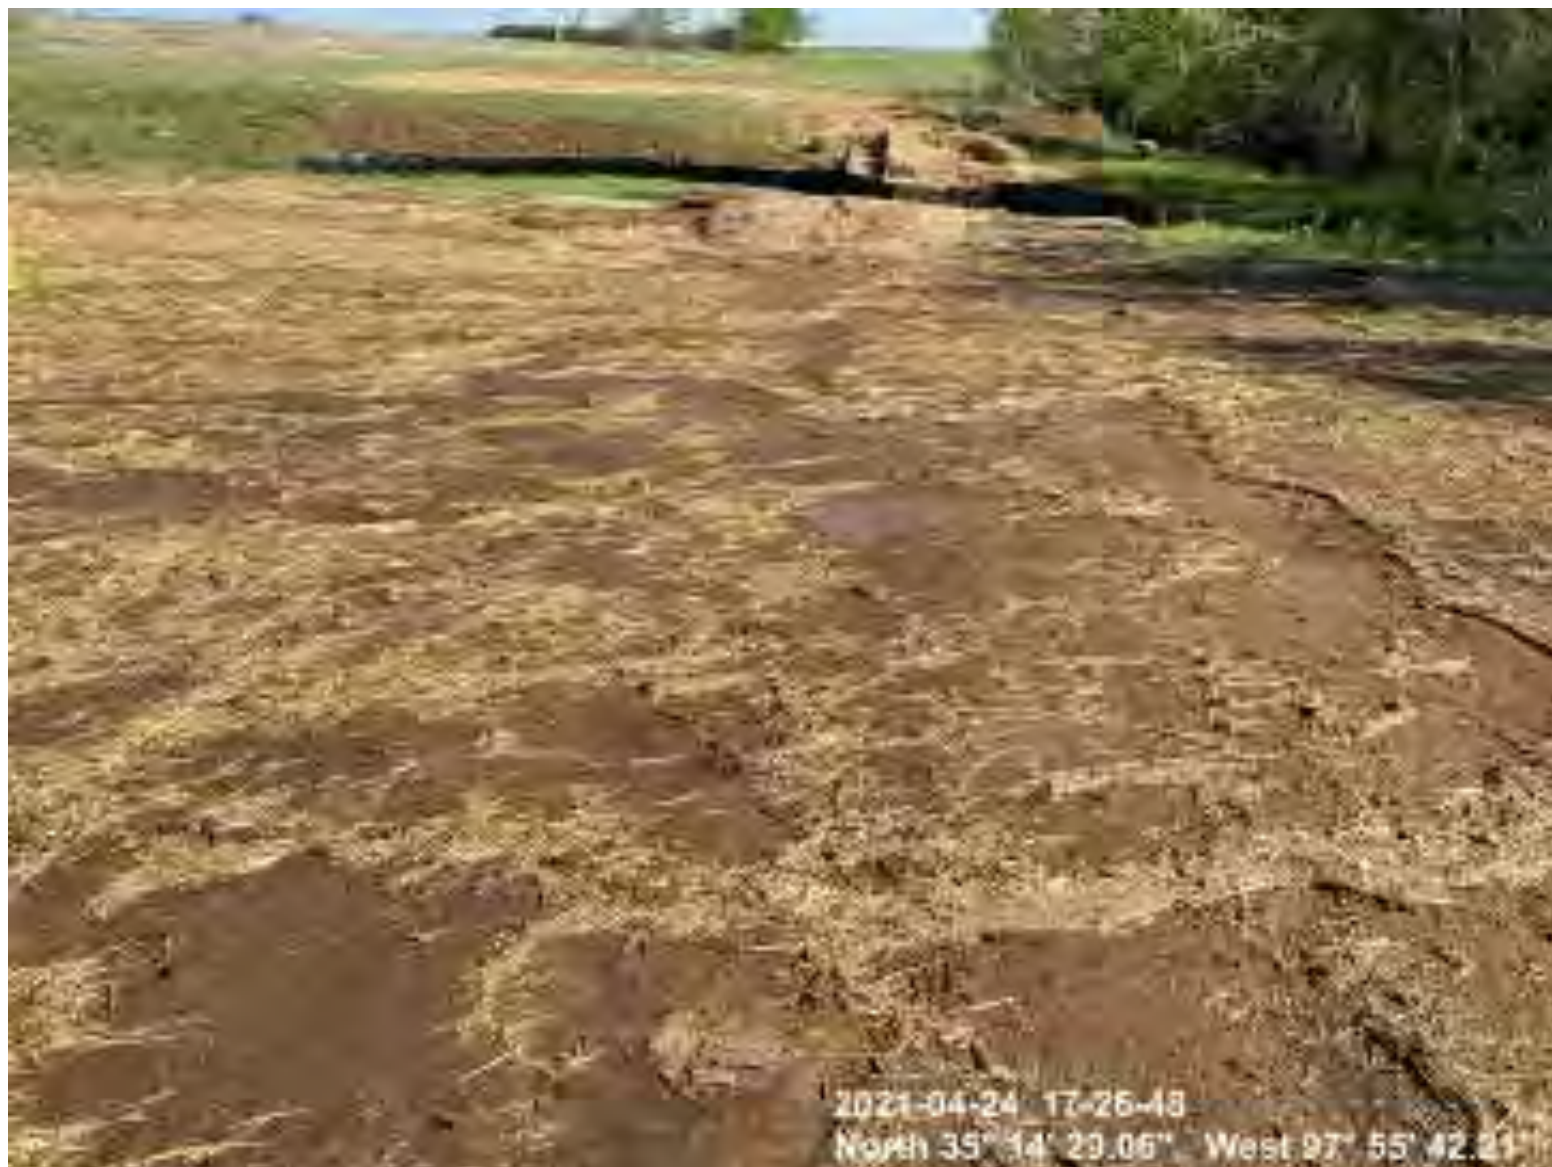
Byron Hardesty
Tract # GR-0147.010
Current Restoration Conditions

Erosion and Runoff Towards the Creek
