Robert Squires - Squires Consulting LLC
Landowner Advocate

Opening Statement for May 5, 2021 Subcommittee on Civil Rights and Civil Liberties Hearing:
“Pipelines Over People (Part II): Midship Pipeline’s Disregard for Landowners in Its Pathway”

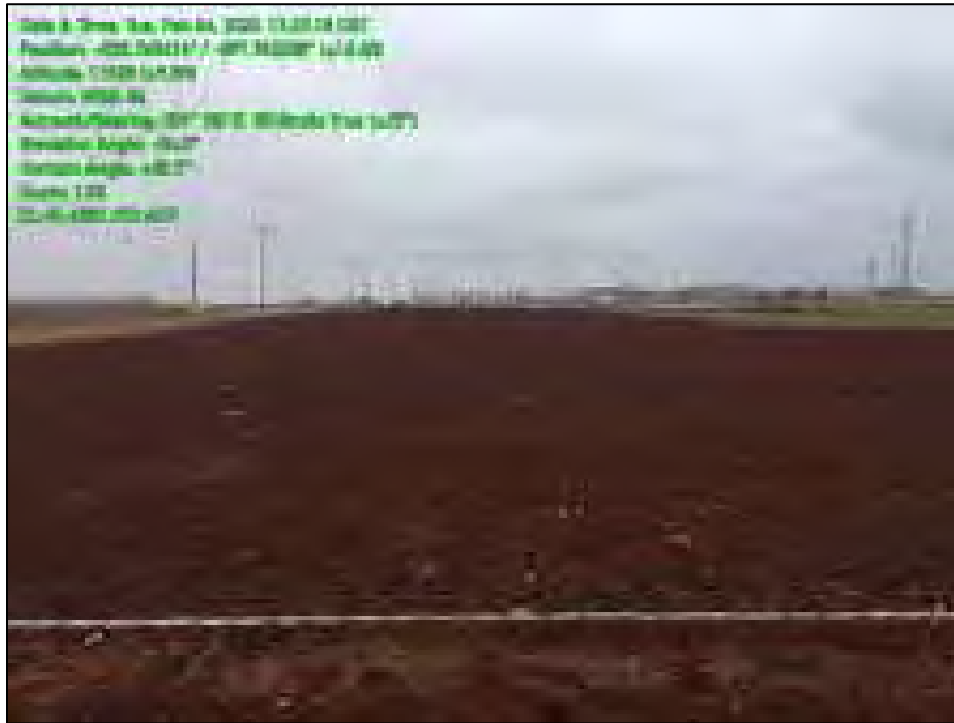
Facing north on Tract CL-KI-0001.010 (actively cultivated field ["ACF"]) on 02/04/20.

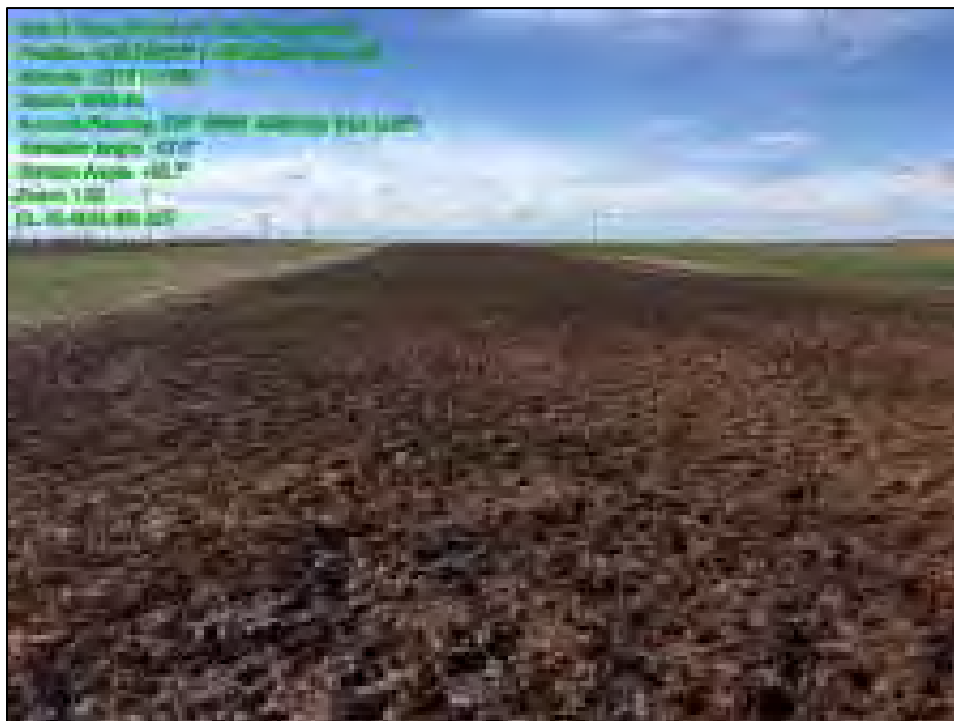
Facing west on Tract CL-KI-0026.000 (ACF) on 02/07/20.

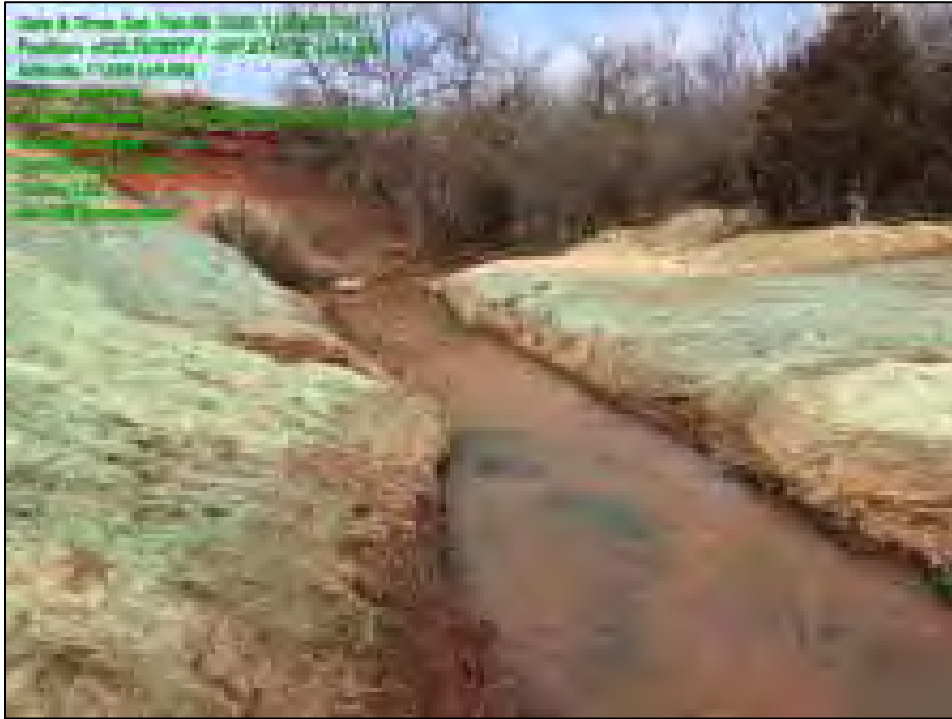
Downstream of Waterbody SKI-025 (S-KI-WCR-17/01/17-01) near MP CH7.6 on 02/08/20 (Tract CL-KI-0039.000).

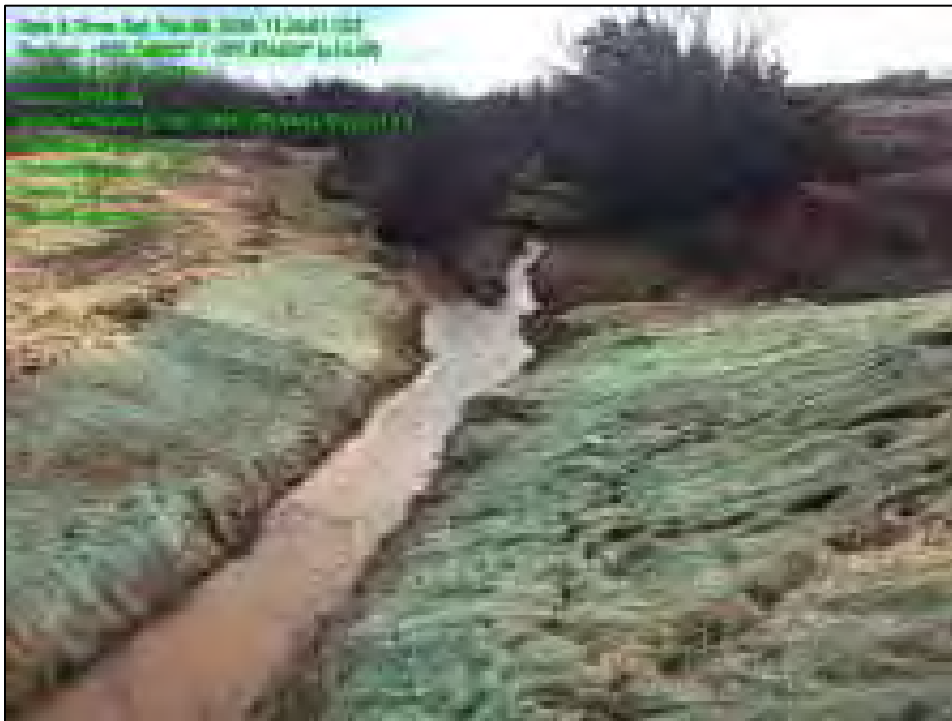
Upstream of Waterbody SKI-025 (S-KI-WCR-17/01/17-01) near MP CH7.6 on 02/08/20 (Tract CL-KI-0039.000).

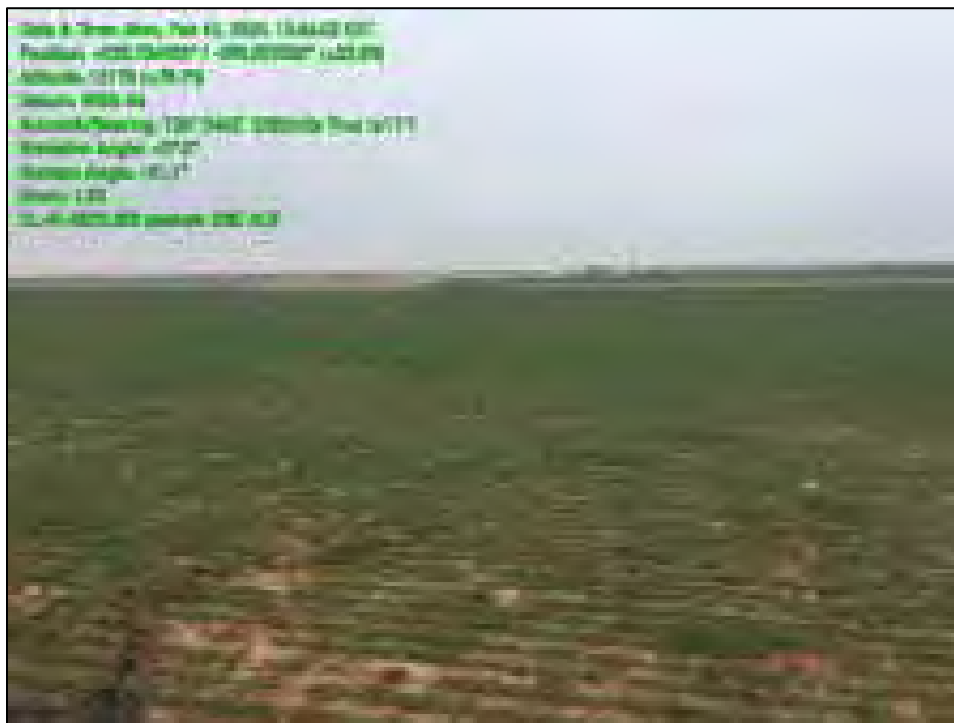
Facing east on Tract CL-KI-0076.000 (ACF) on 02/10/20.

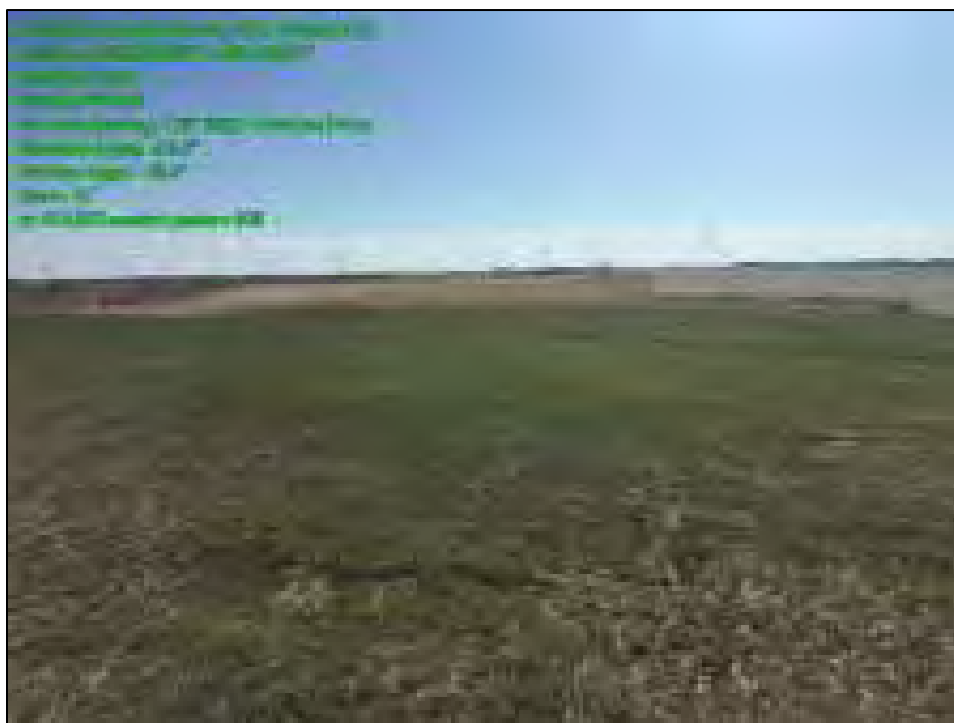
Facing south on Tract CN-0014.000 on 11/04/19.

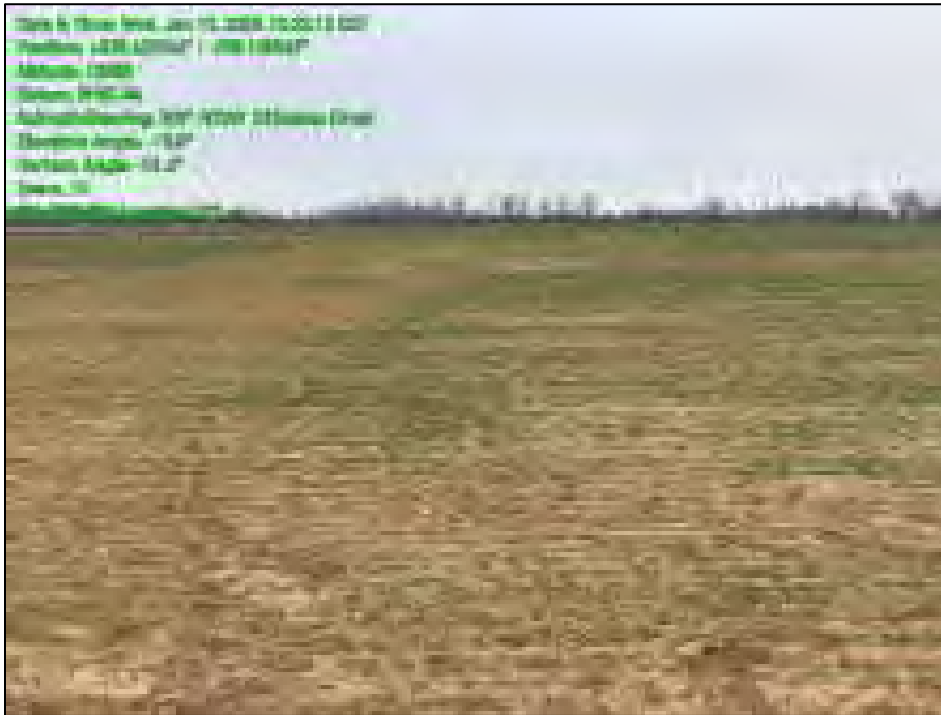
Facing north on Tract CN-0035.000 on 01/15/20.

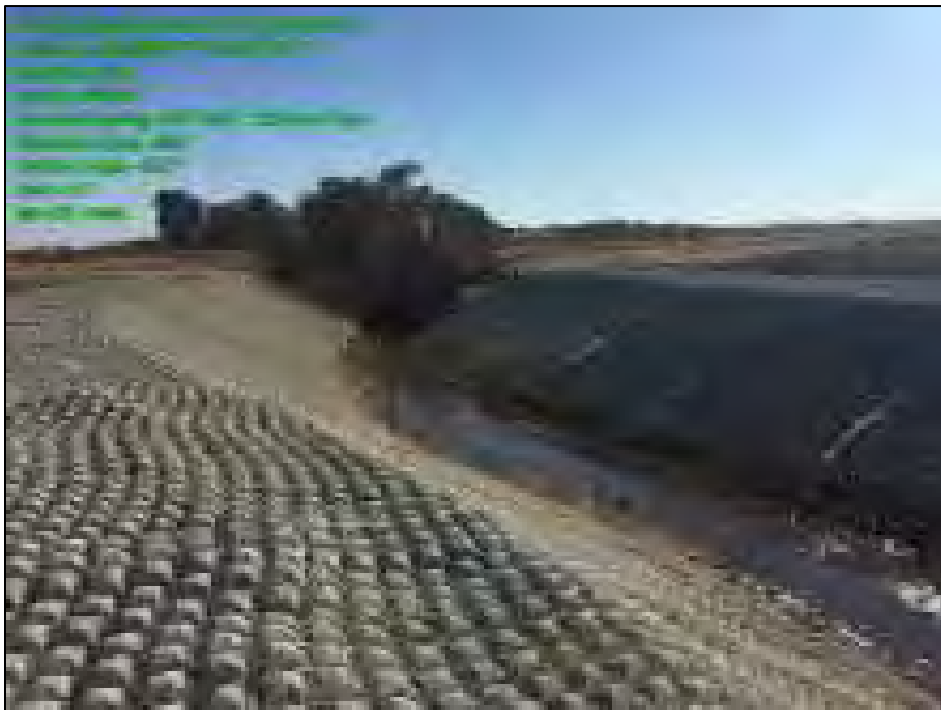
Downstream of Waterbody SCN-021 (S-CN-WCR-17/01/18-02) near MP 12.2 on 11/05/19 (Tract CN-0055.000).

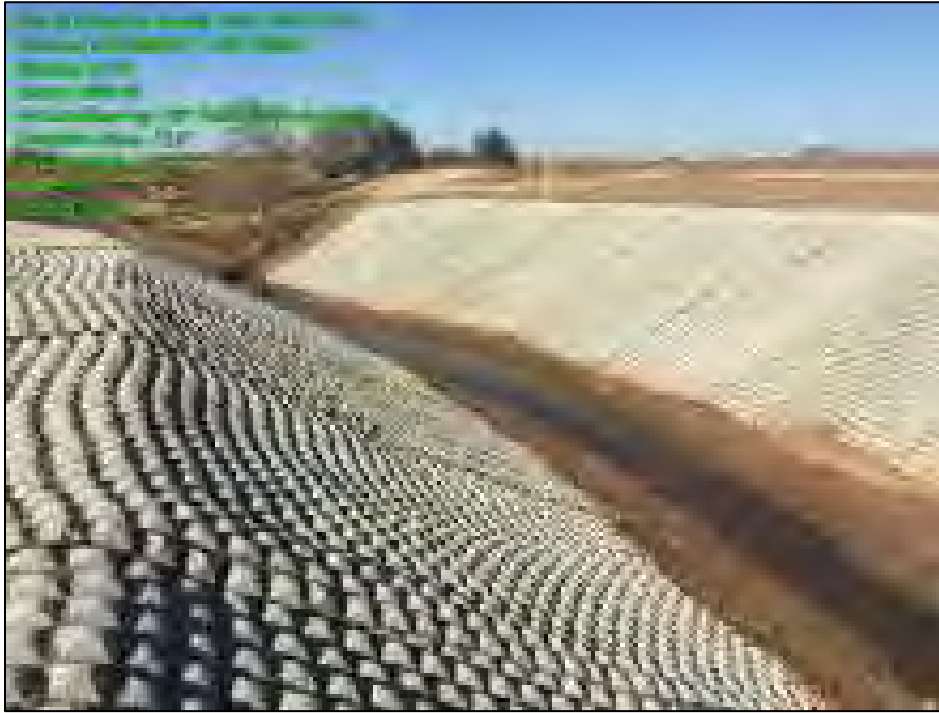
Upstream of Waterbody SCN-021 (S-CN-WCR-17/01/18-02) near MP 12.2 on 11/05/19 (Tract CN-0055.000).

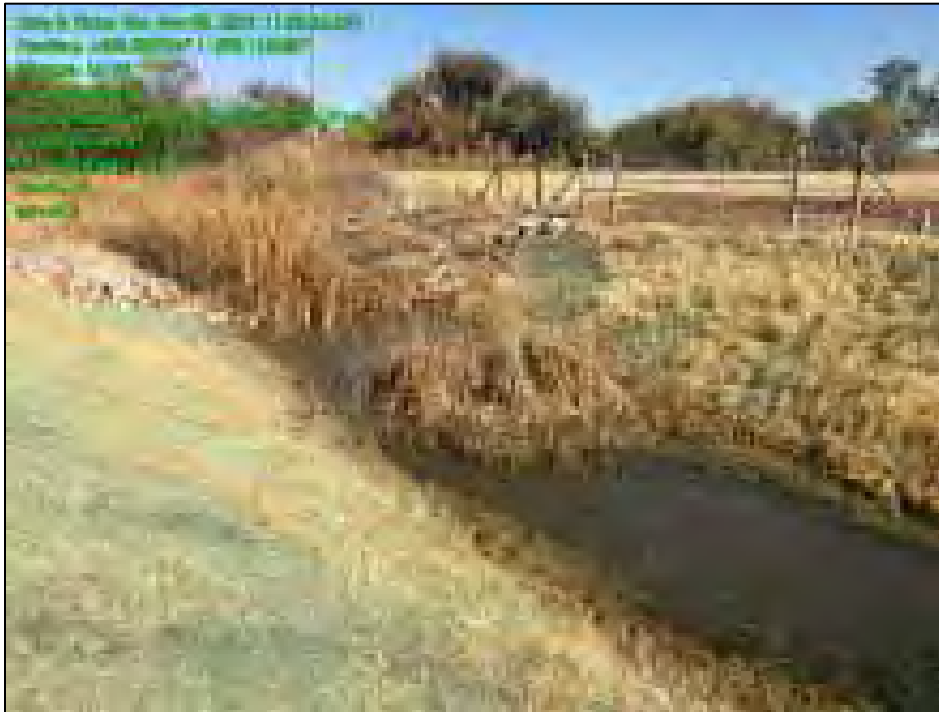
Downstream of Waterbody SCN-015 (S-CN-WCR-16/12/07-03) near MP 13.3 on 11/05/19 (Tract CN-0059.000).

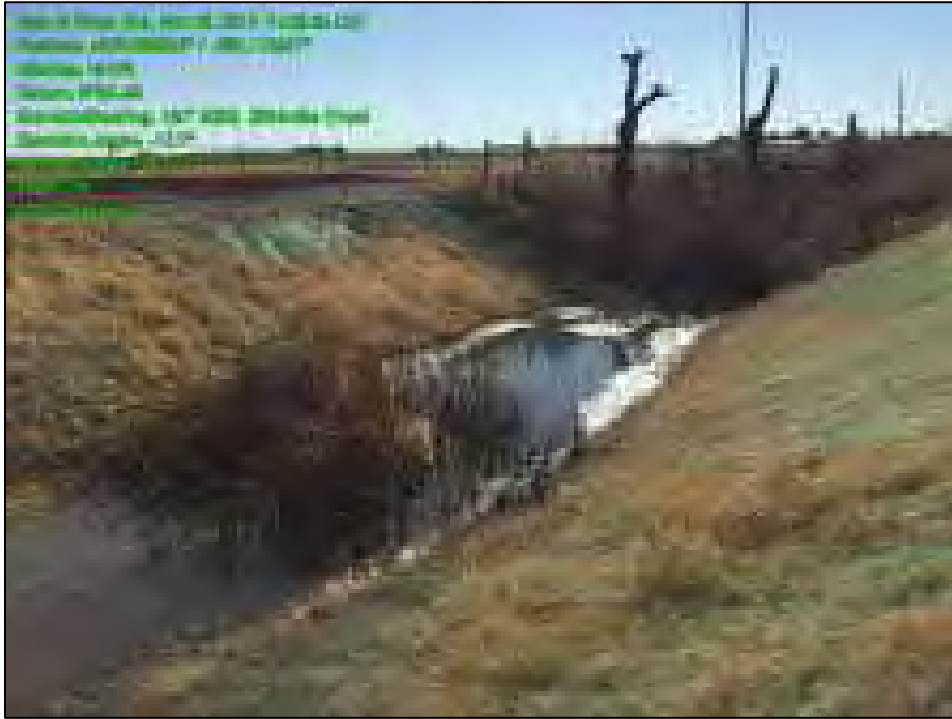
Upstream of Waterbody SCN-015 (S-CN-WCR-16/12/07-03) near MP 13.3 on 11/05/19 (Tract CN-0059.000).

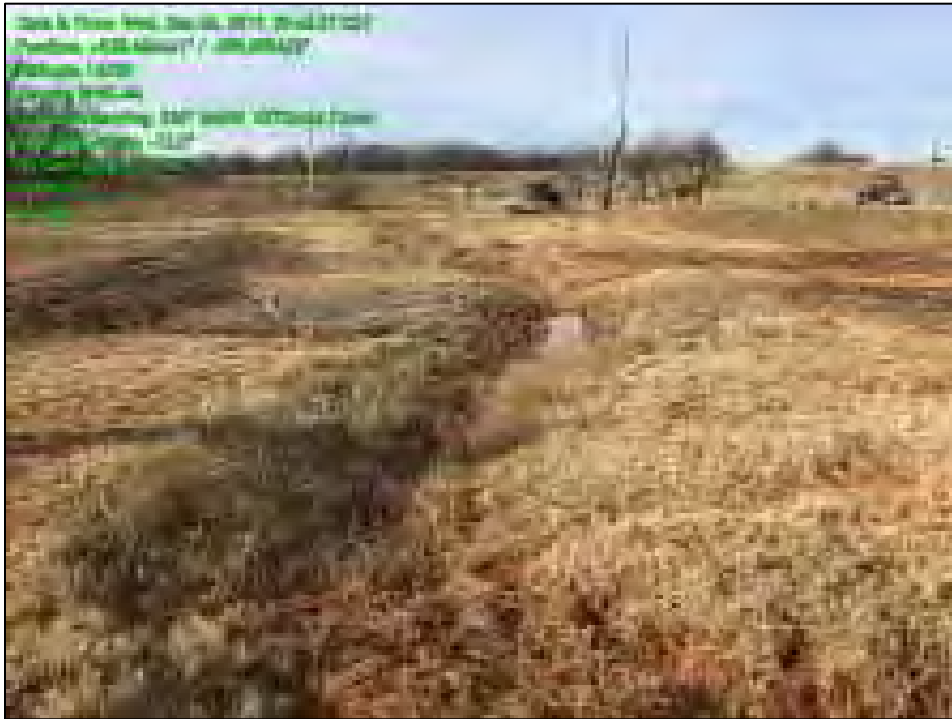
Downstream of Waterbody SCN-002 (S-CN-AAL-17/01/18-03) near MP 19.3 on 12/04/19 (Tract CN-0083.010).

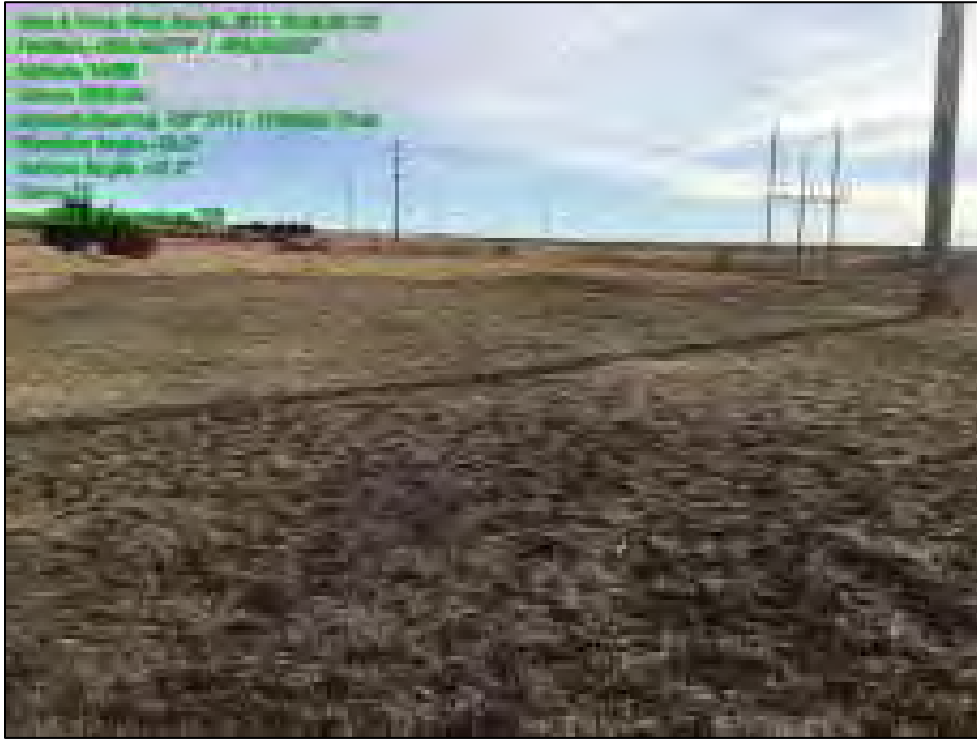
Facing south on Tract CN-0083.010 on 12/04/19.

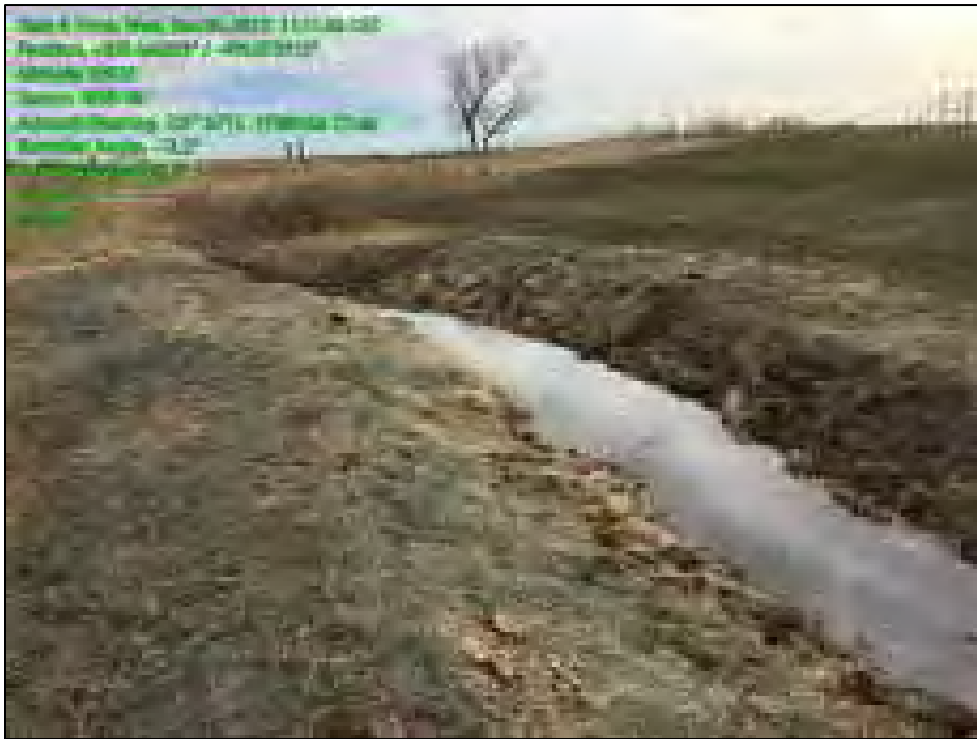
Downstream of Waterbody SCN-012 (S-CN-TAS-17/01/19-01) near MP 21.3 on 12/04/19 (Tract CN-0092.010).

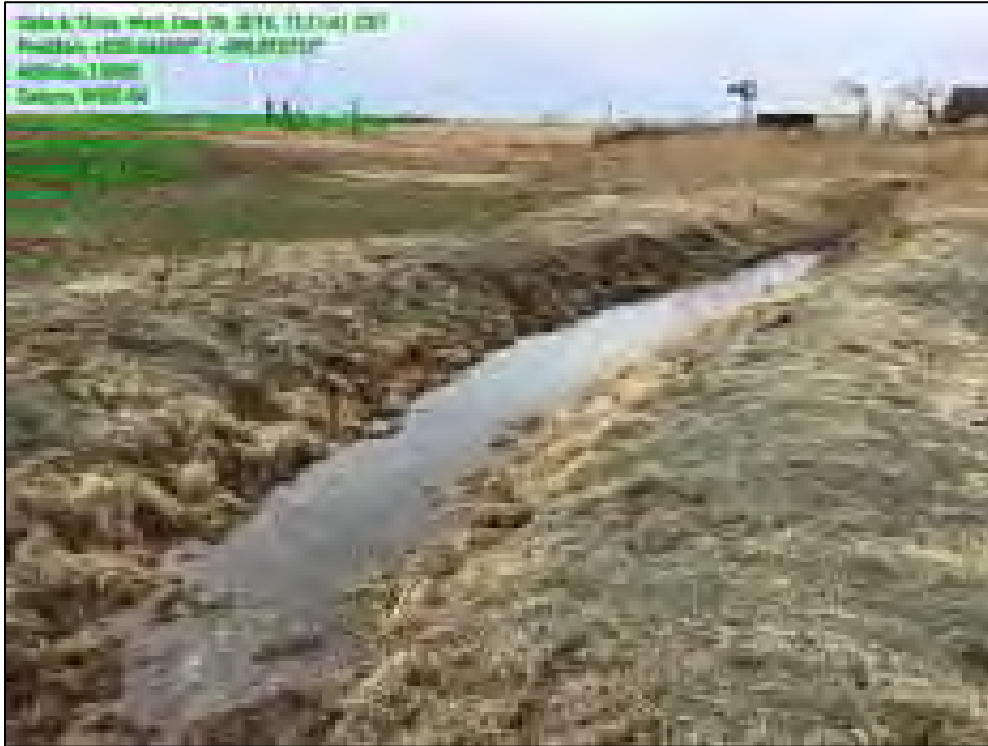
Upstream of Waterbody SCN-012 (S-CN-TAS-17/01/19-01) near MP 21.3 on 12/04/19 (Tract CN-0092.010).

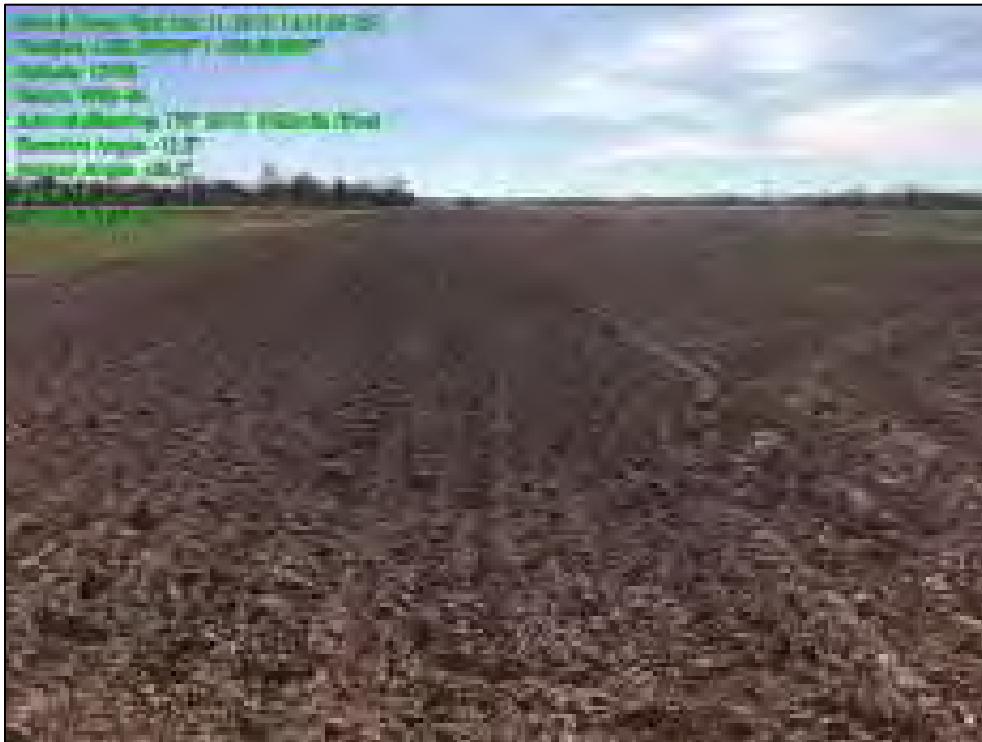
Facing south on Tract CN-0106.020 (ACF) on 12/11/19.

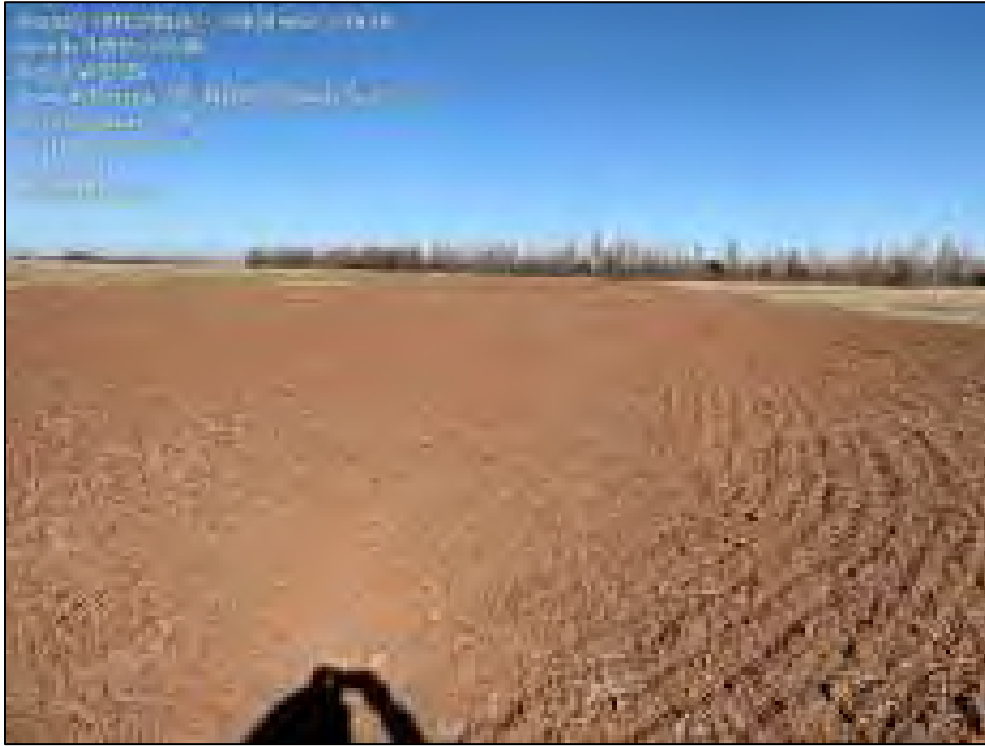
Facing north on Tract GR-0109.010 (ACF) on 12/12/19.

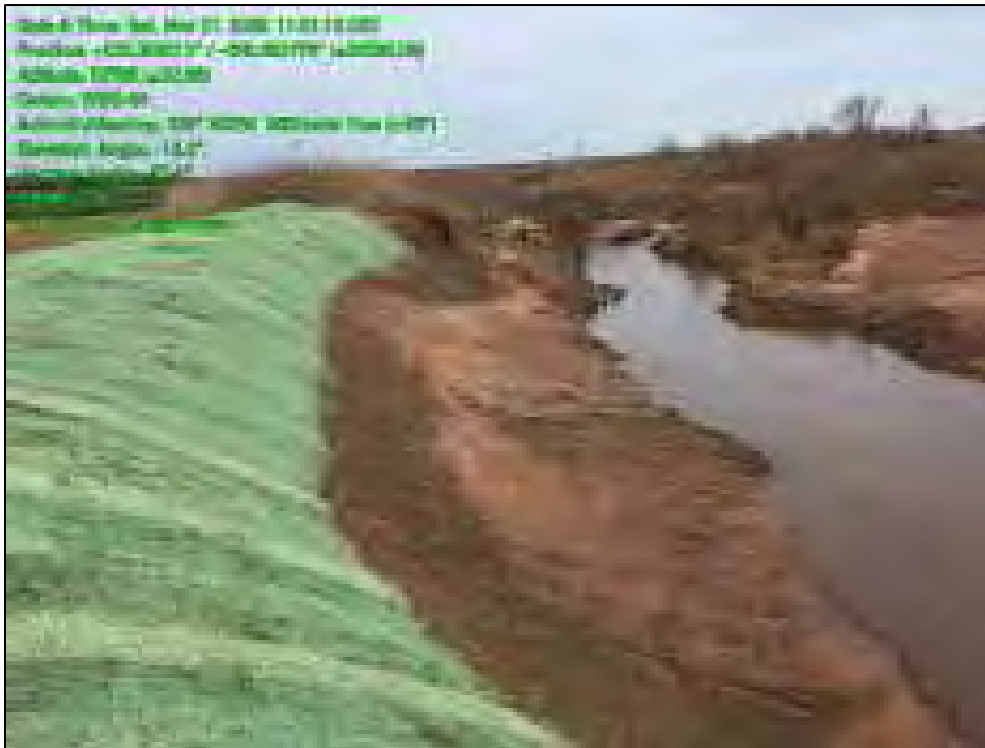
Upstream of Waterbody SCR-013 Buggy Creek (S-GR-RFT-16/12/10-1) near MP 34.8 on 03/21/20 (Tract GR-0132.010).

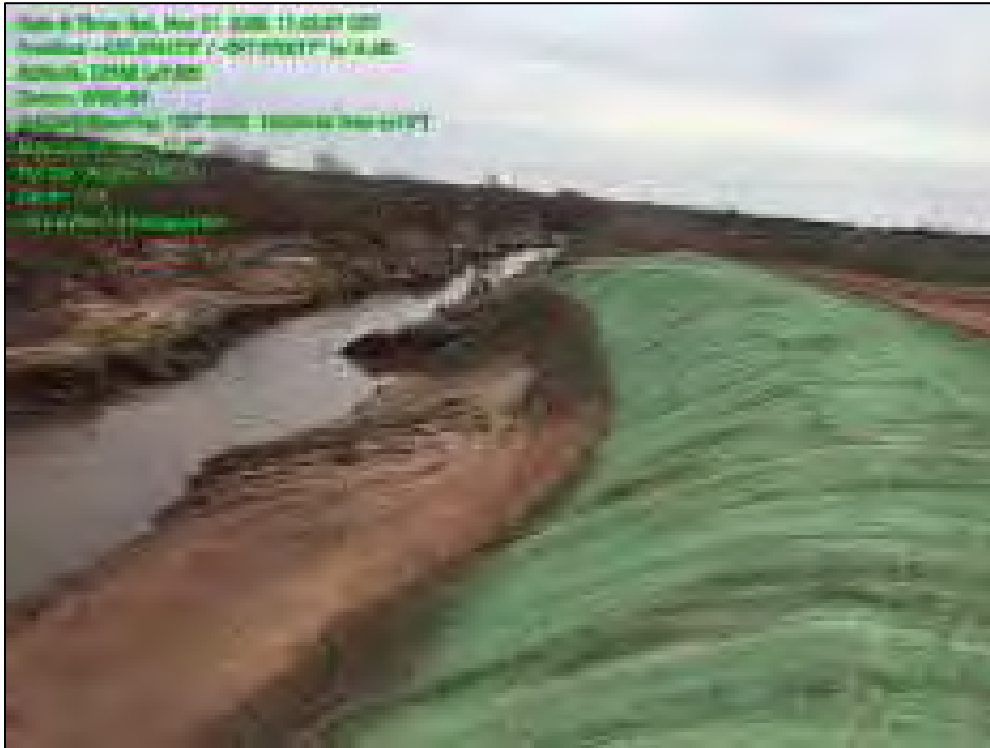
Downstream of Waterbody SCR-013 Buggy Creek (S-GR-RFT-16/12/10-1) near MP 34.8 on 03/21/20
(Tract GR-0132.010).

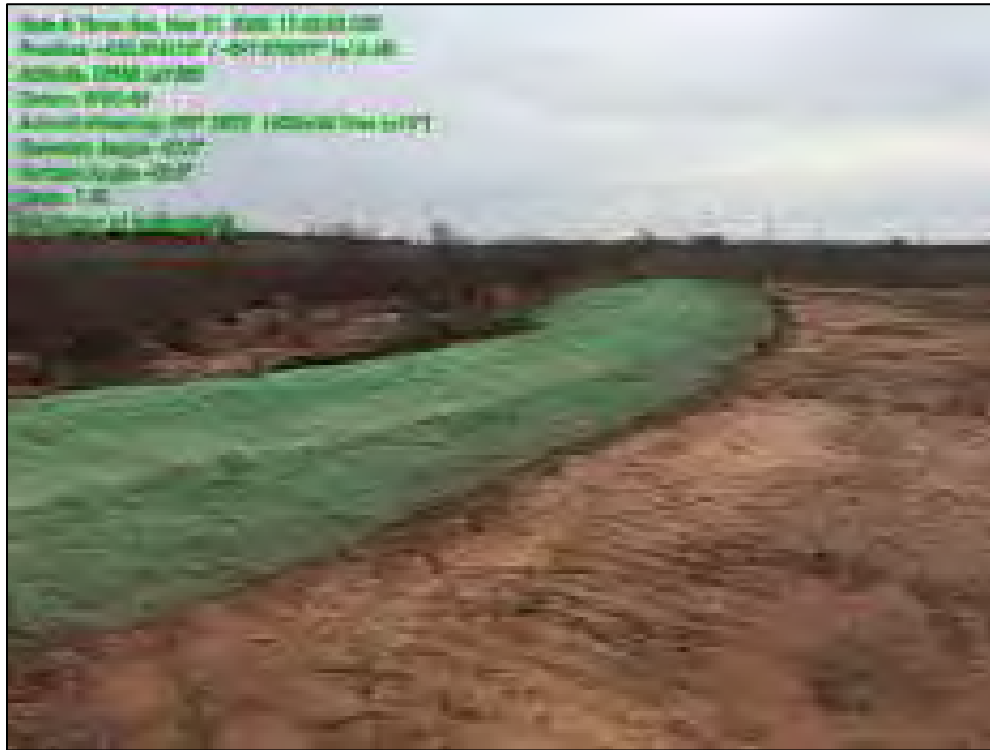
South top of bank at Waterbody SCR-013 Buggy Creek (S-GR-RFT-16/12/10-1) near MP 34.8 on 03/21/20 (Tract GR-0132.010).

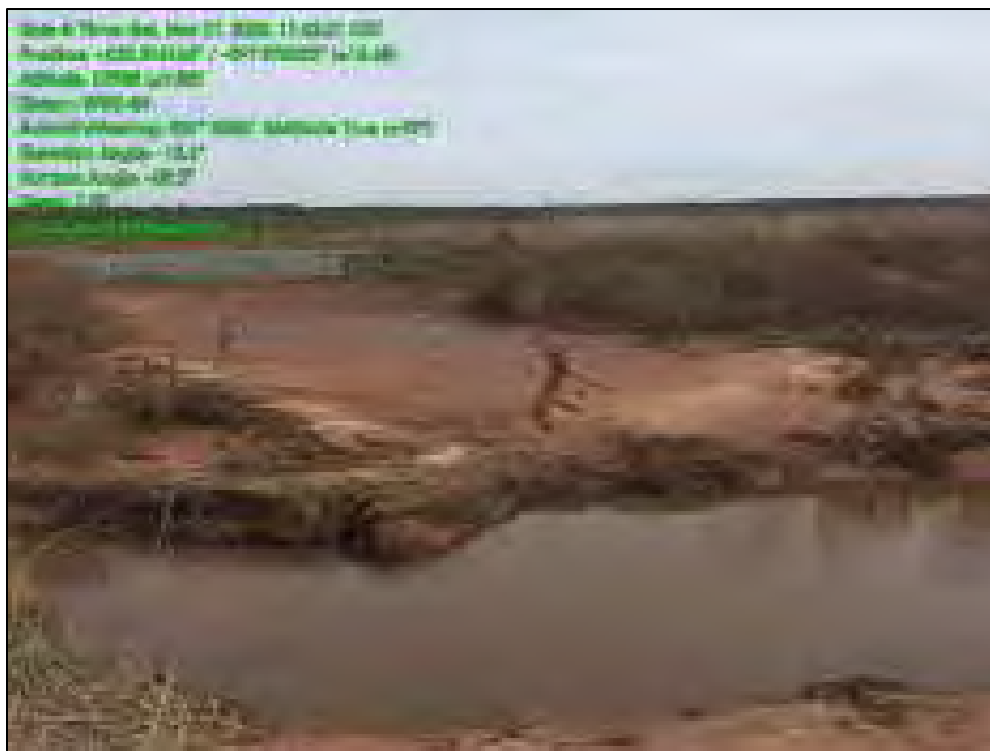
View across Waterbody SCR-013 Buggy Creek (S-GR-RFT-16/12/10-1) near MP 34.8 on 03/21/20 (Tract GR-0132.010).

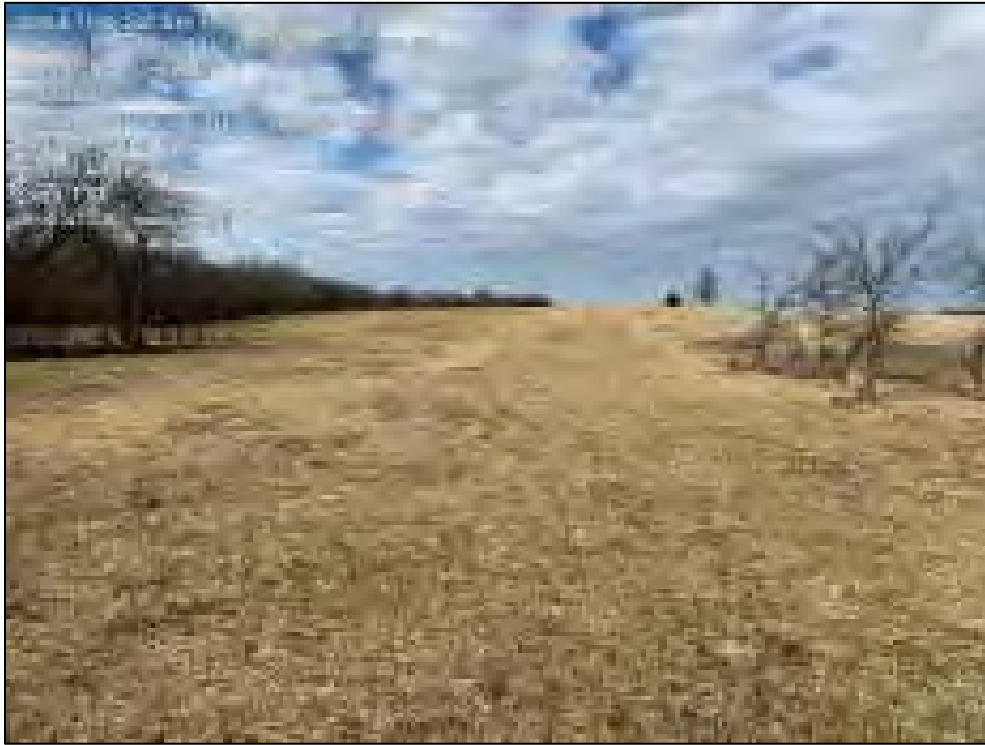
Facing north on Tract GR-0147.010 on 12/14/19.

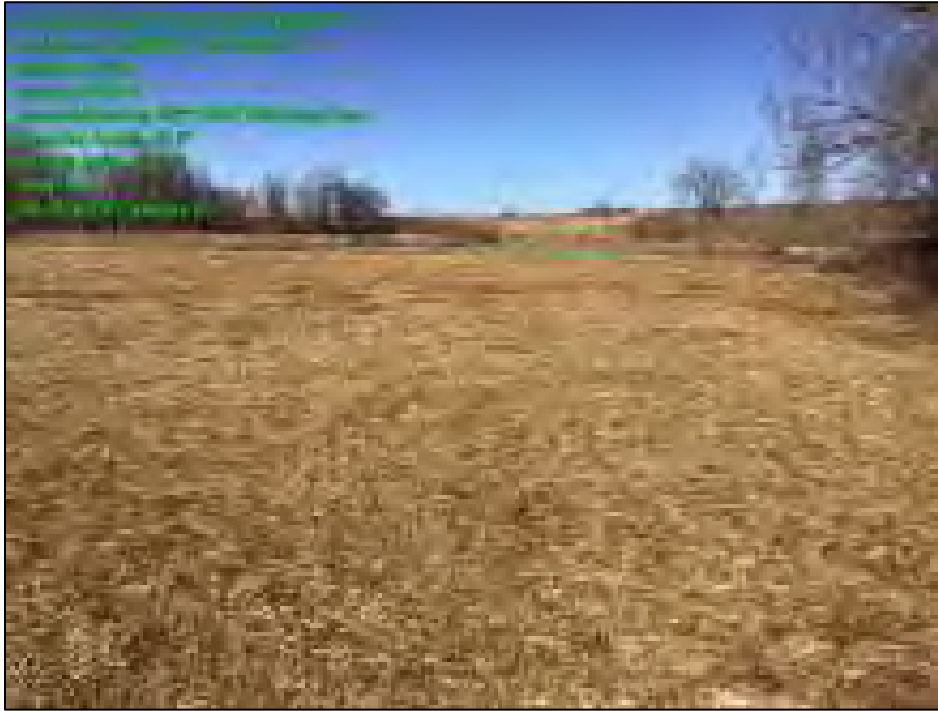
Facing north on Tract GR-0178.010 on 01/07/20.

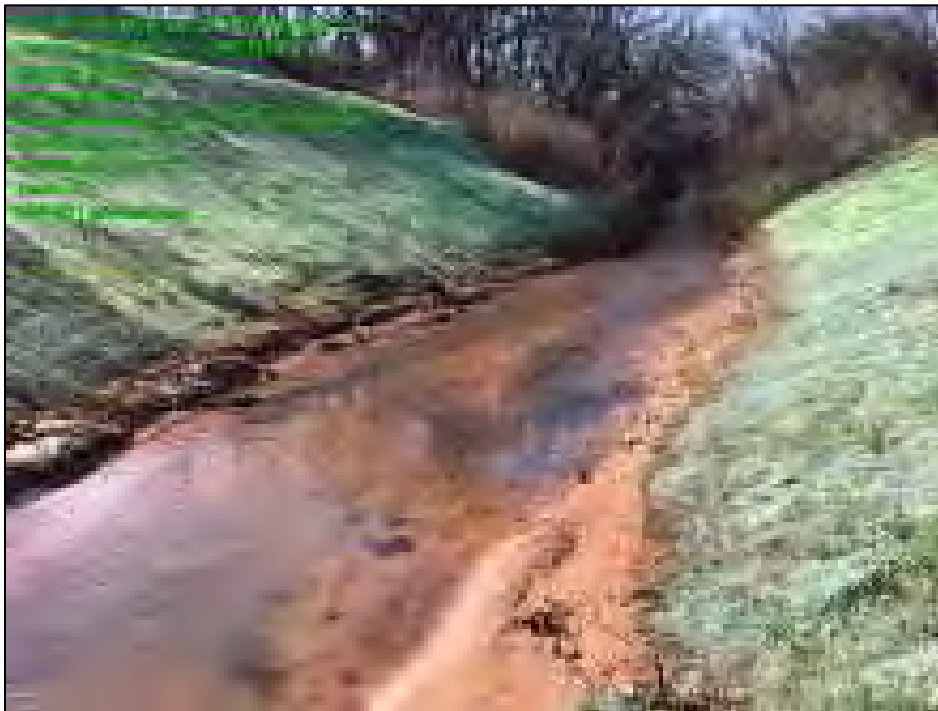
Downstream of Waterbody SGR-031 (S-GR-RKT-16/12/10-10) near MP 54.5 on 01/27/20 (Tract GR-0204.010).

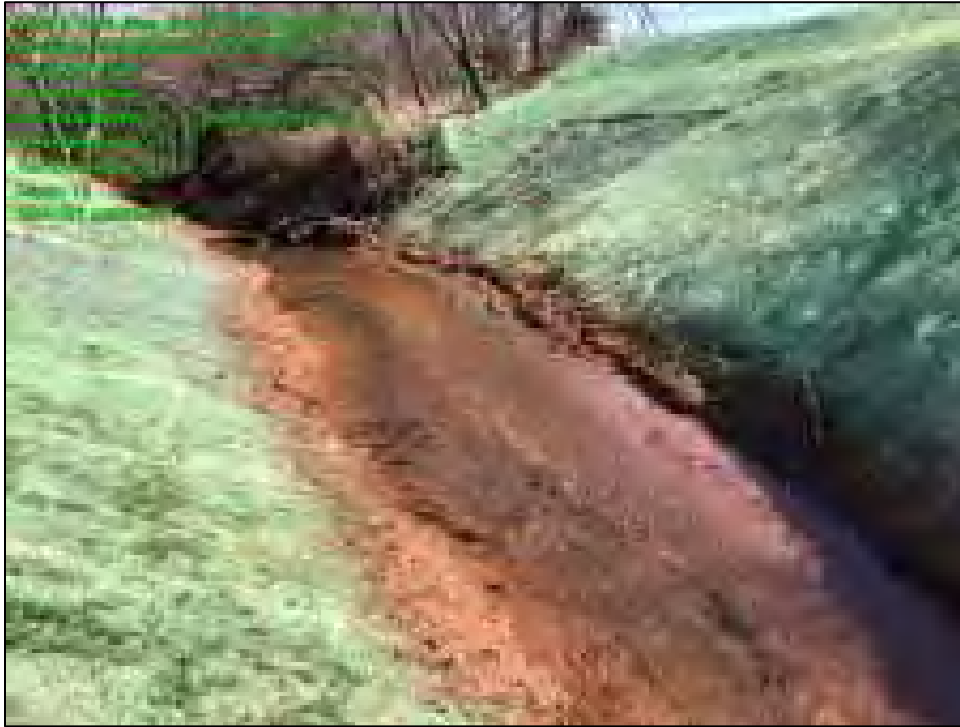
Upstream of Waterbody SGR-031 (S-GR-RKT-16/12/10-10) near MP 54.5 on 01/27/20 (Tract GR-0204.010).

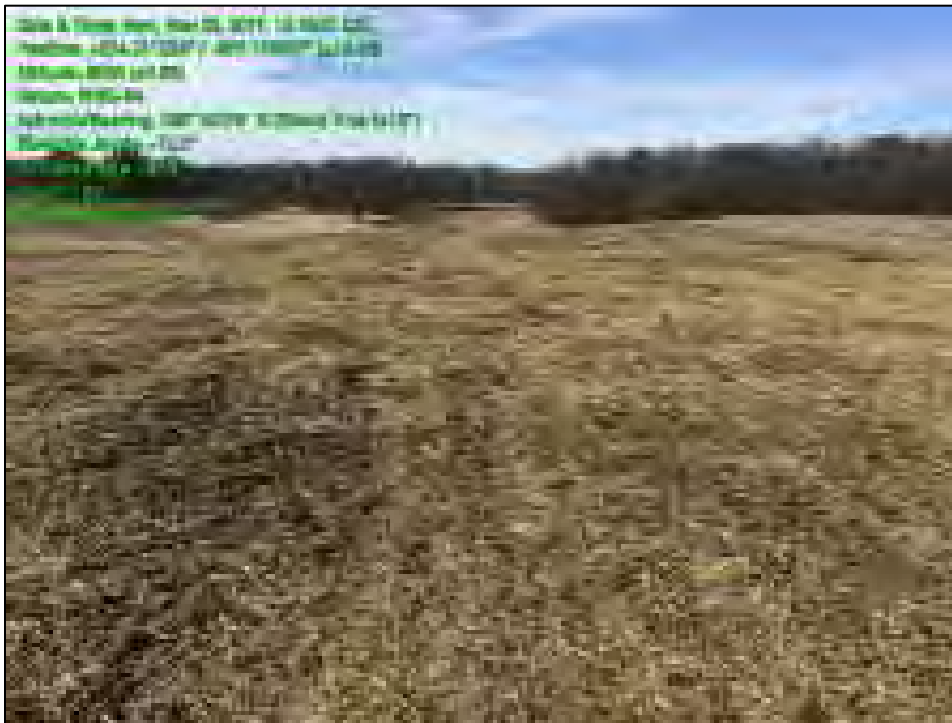
Facing west on Tract CR-0627.000 on 11/25/19.

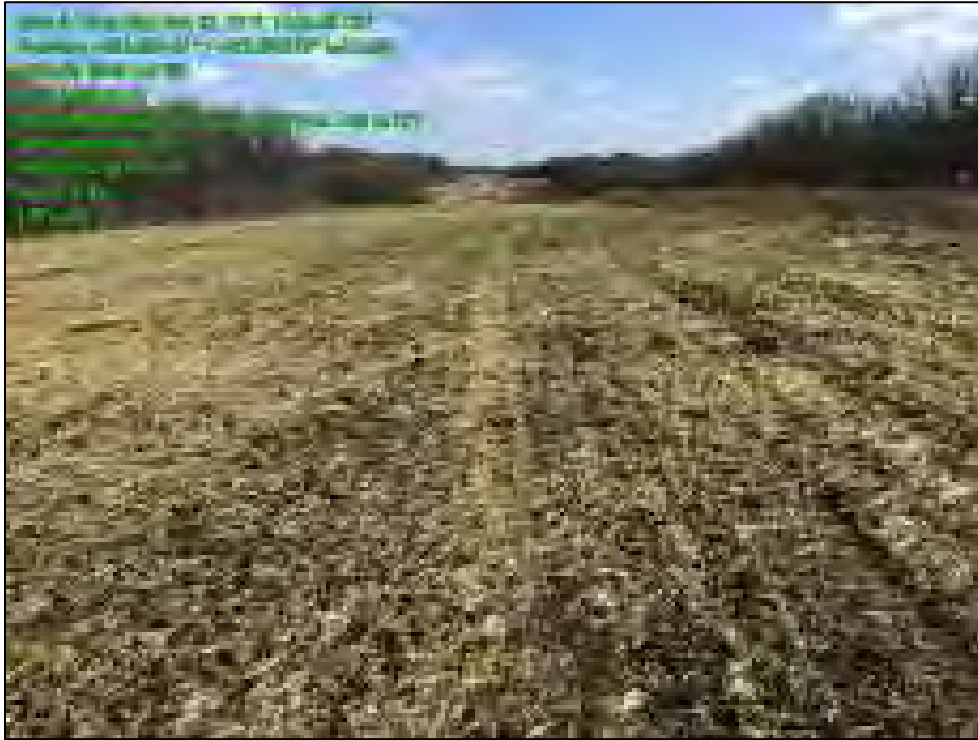
Facing west on Tract CR-0661.000 on 11/23/19.

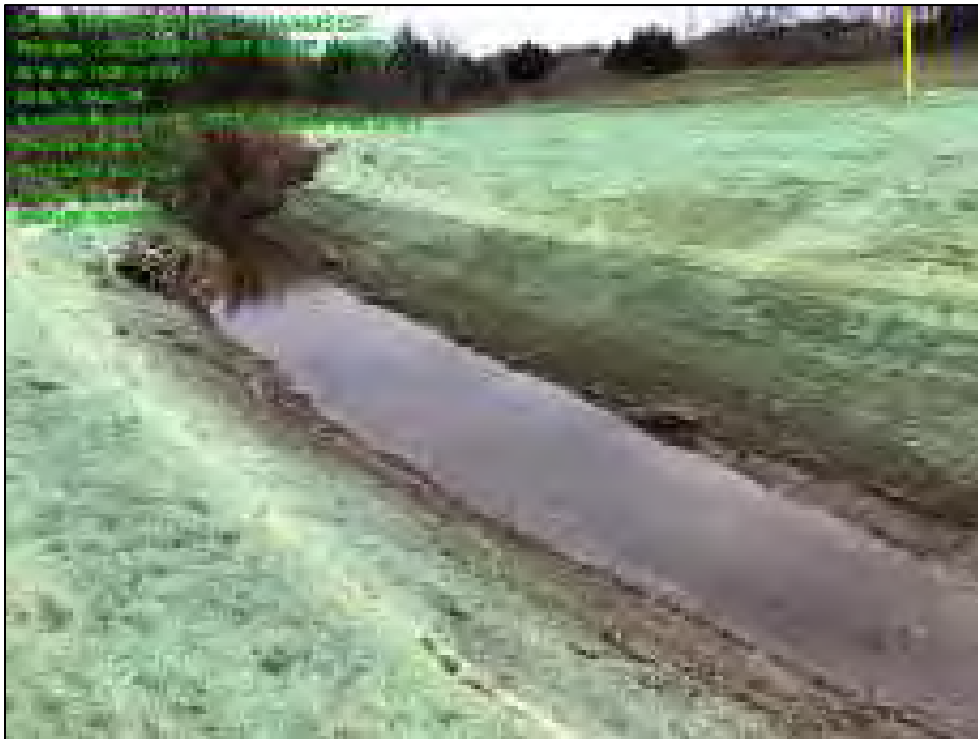
Downstream of Waterbody SCR-067 (S-CR-LAG-17/01/09-08) near MP 131.6 on 11/22/19 (Tract CR-0676.000).

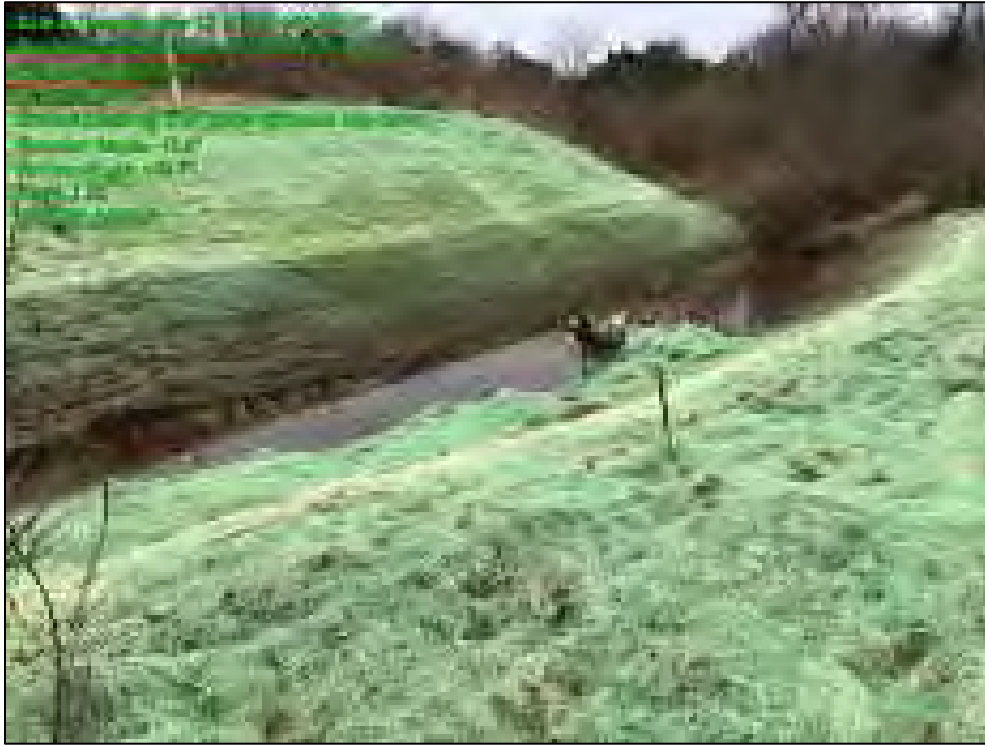
Upstream of Waterbody SCR-067 (S-CR-LAG-17/01/09-08) near MP 131.6 on 11/22/19 (Tract CR-0676.000).

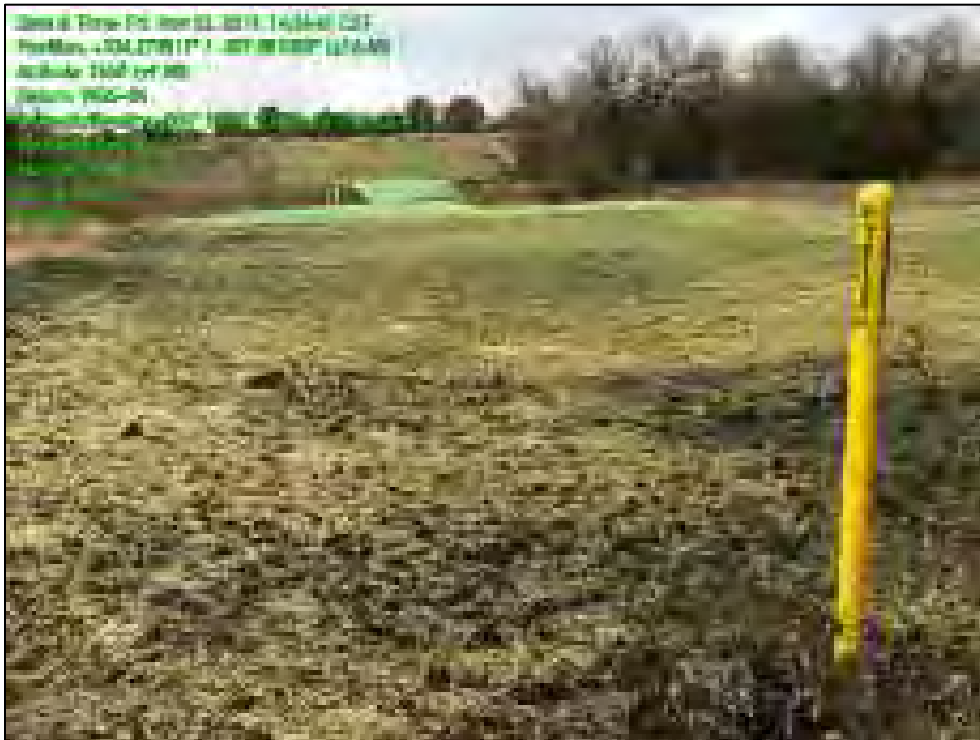
Facing west on Tract CR-0679.000 on 11/22/19.

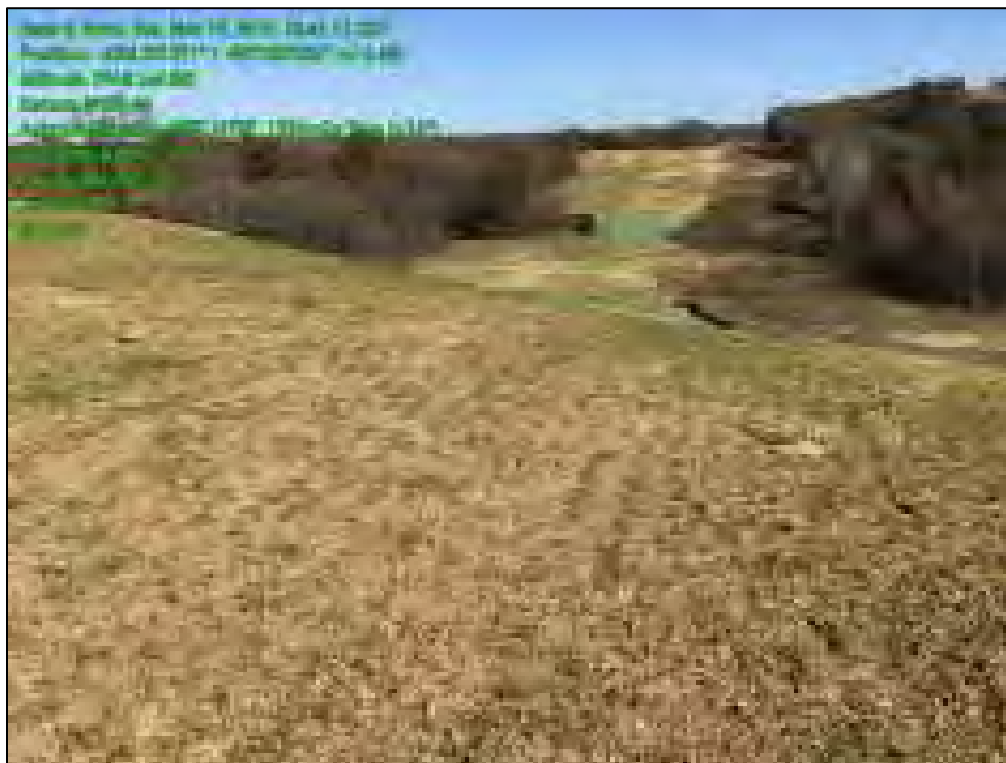
Facing east on Tract CR-0692.000 on 11/19/19.
