Robert Squires - Squires Consulting LLC
Landowner Advocate

Opening Statement for May 5, 2021 Subcommittee on Civil Rights and Civil Liberties Hearing:
“Pipelines Over People (Part II): Midship Pipeline’s Disregard for Landowners in Its Pathway”

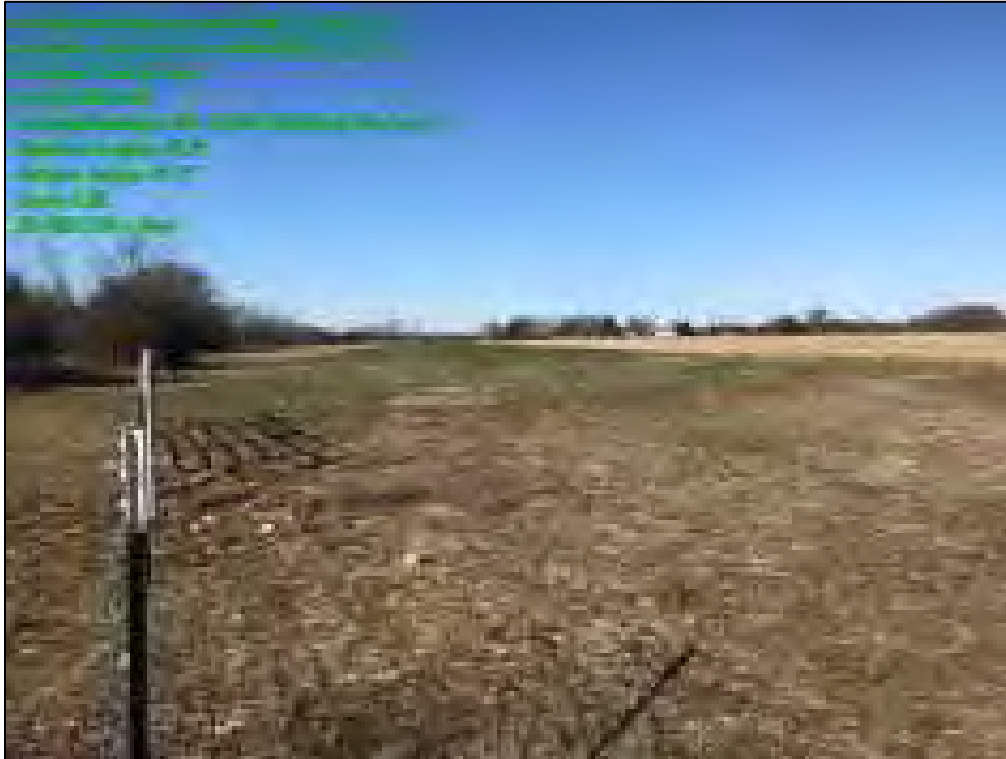
Facing west on Tract JO-0839.000 on 01/06/20.

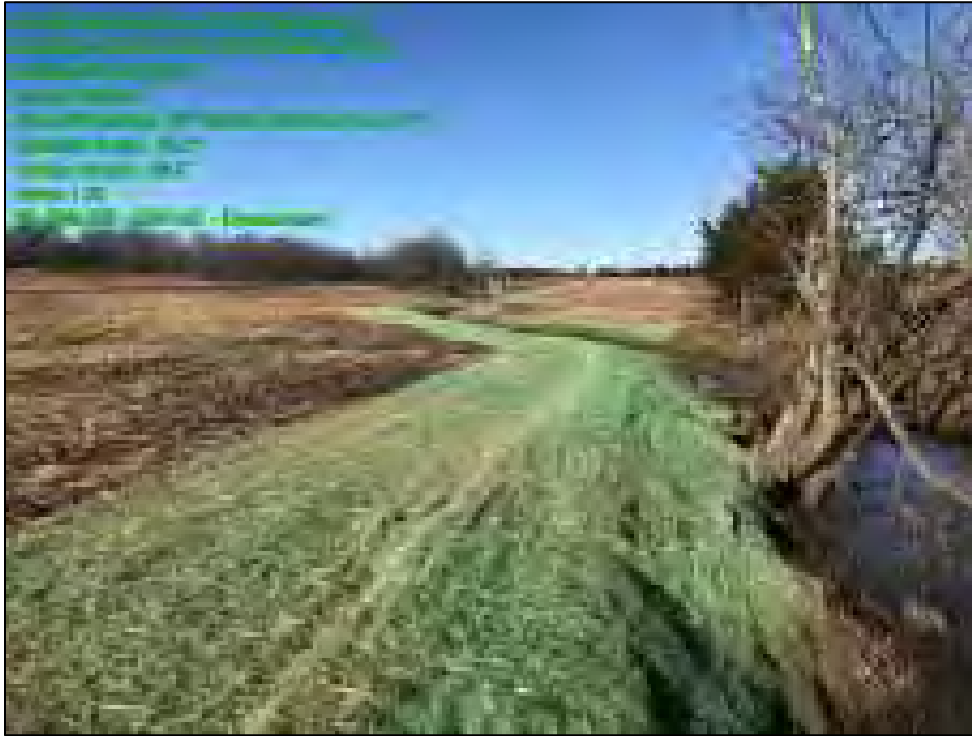
Downstream of Waterbody SBR-061 (S-BR-TAS-17/01/16-01) near MP 174.8 on 01/07/20 (Tract BR-0886.000).

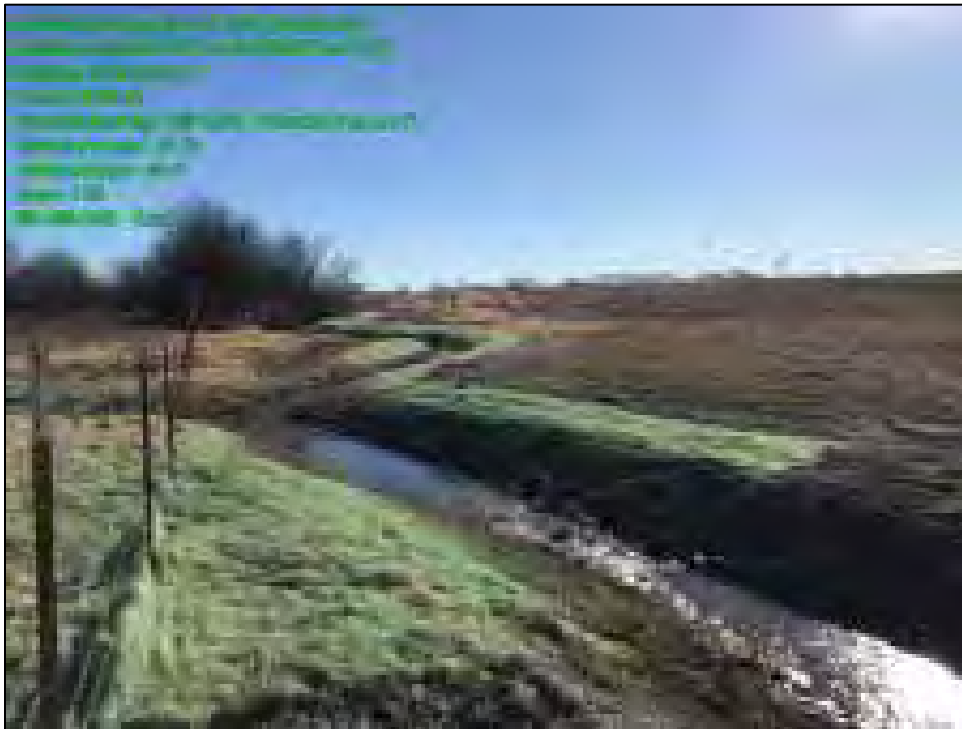
Upstream of Waterbody SBR-061 (S-BR-TAS-17/01/16-01) near MP 174.8 on 01/07/20 (Tract BR-0886.000).

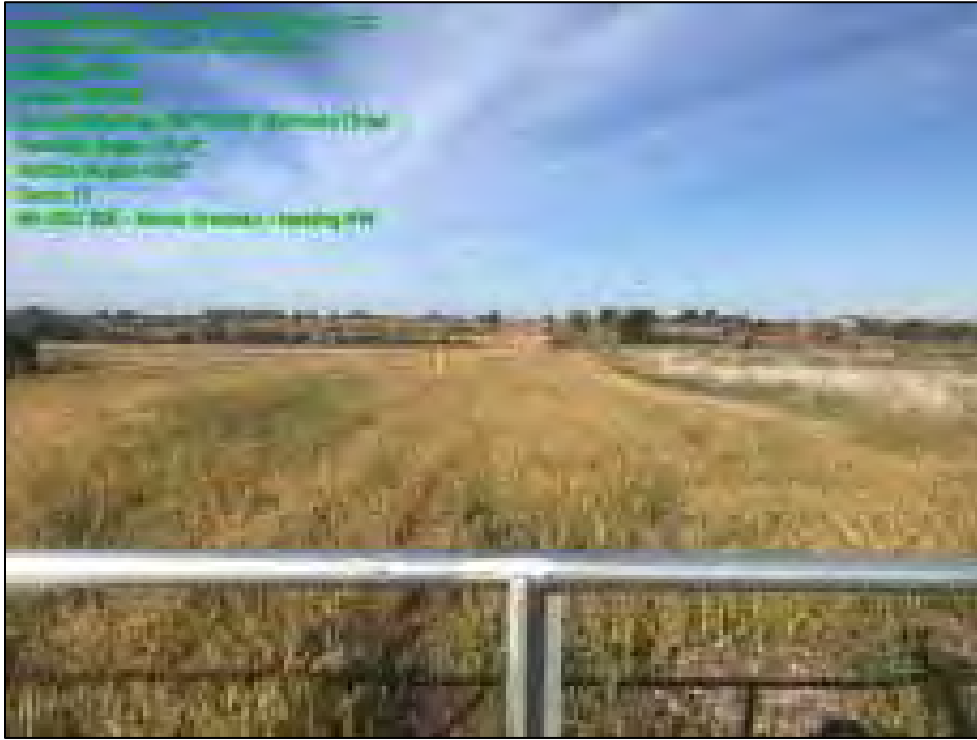
Facing northwest on Tract BR-0901.000 on 10/17/19.

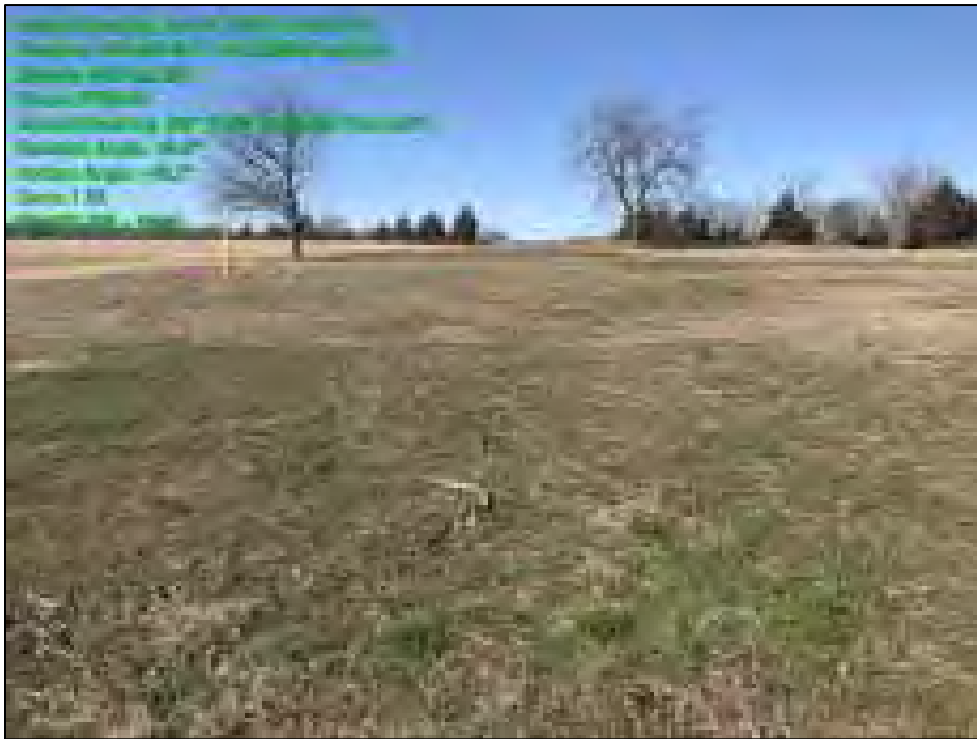
Facing west on Tract BR-0931.000 on 01/07/20.

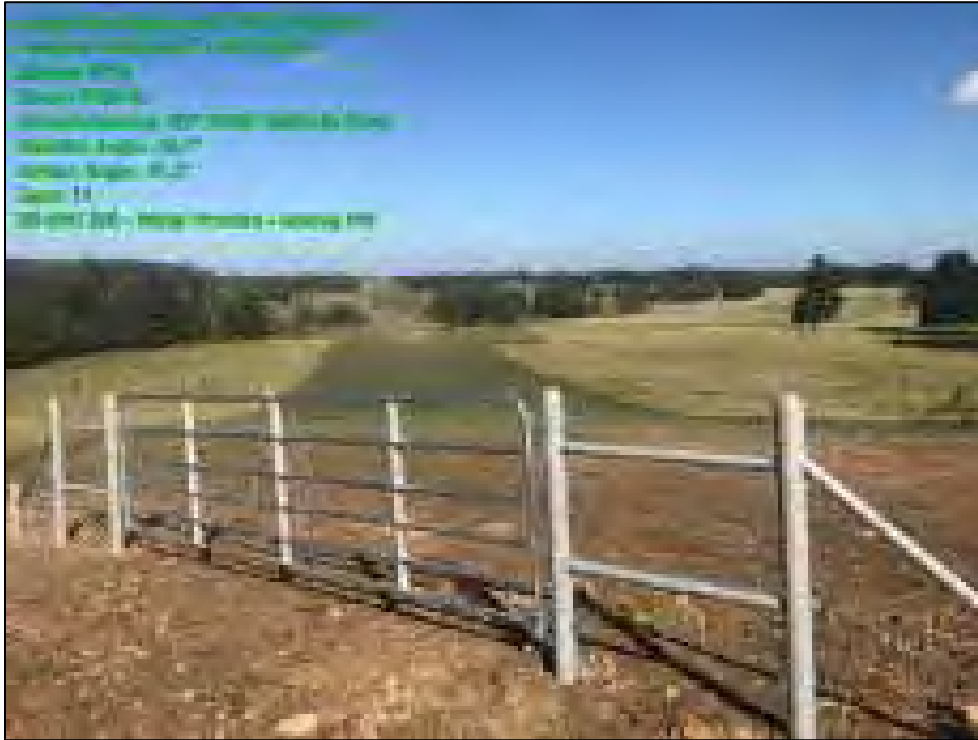
Facing northwest on Tract BR-0941.000 on 10/02/19.

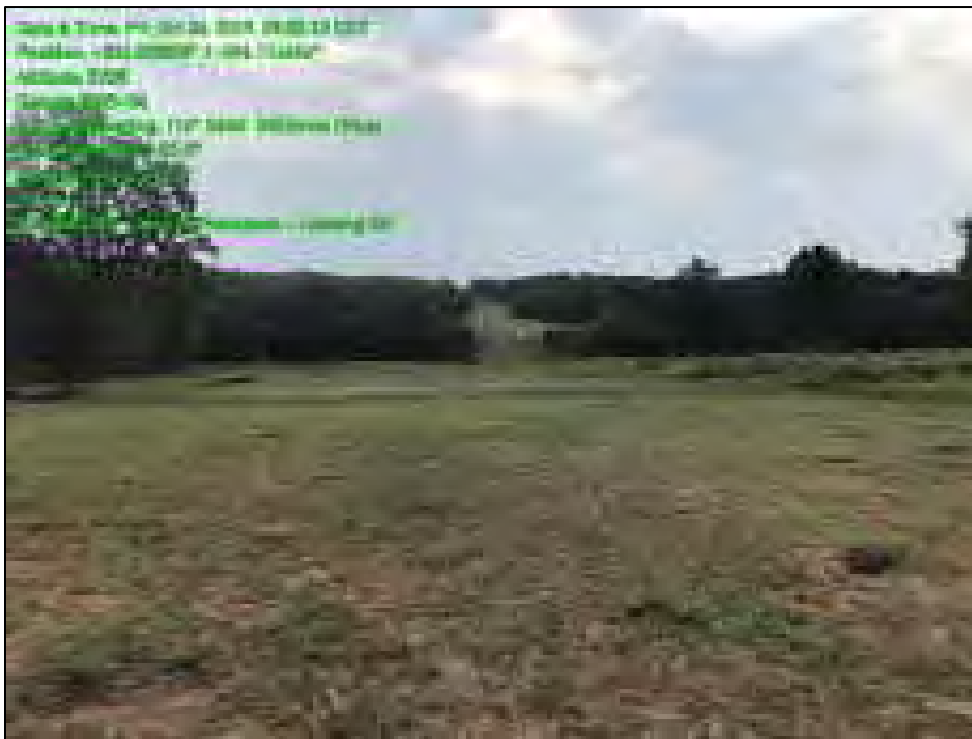
Facing southeast on Tract BR-0980.000 on 10/04/19.

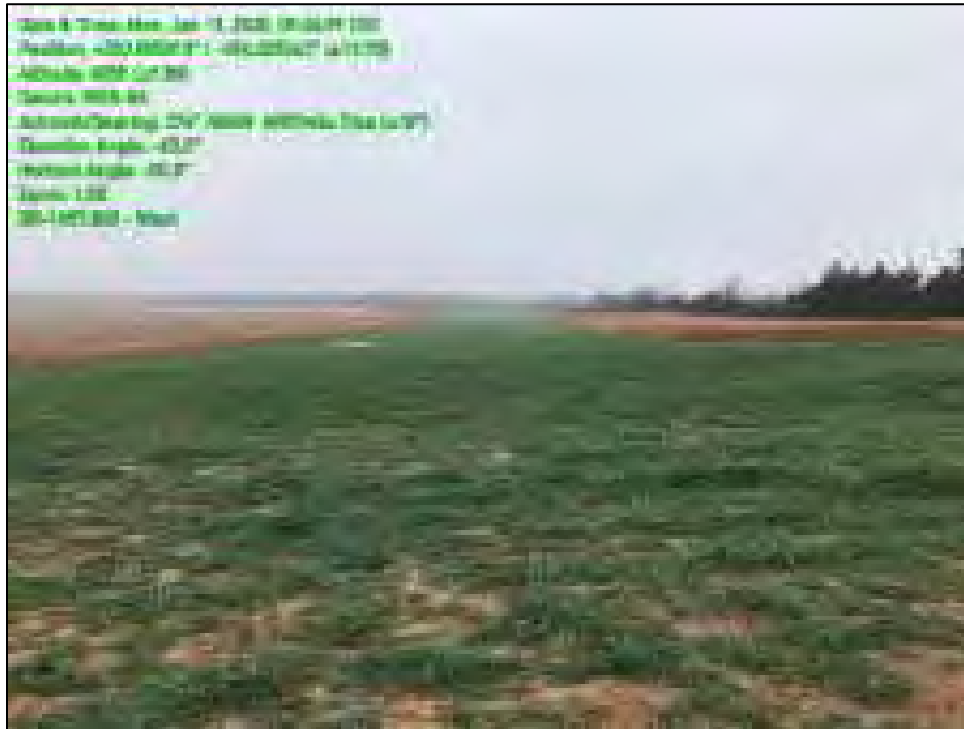
Facing west on Tract BR-1007.000 on 01/13/20.

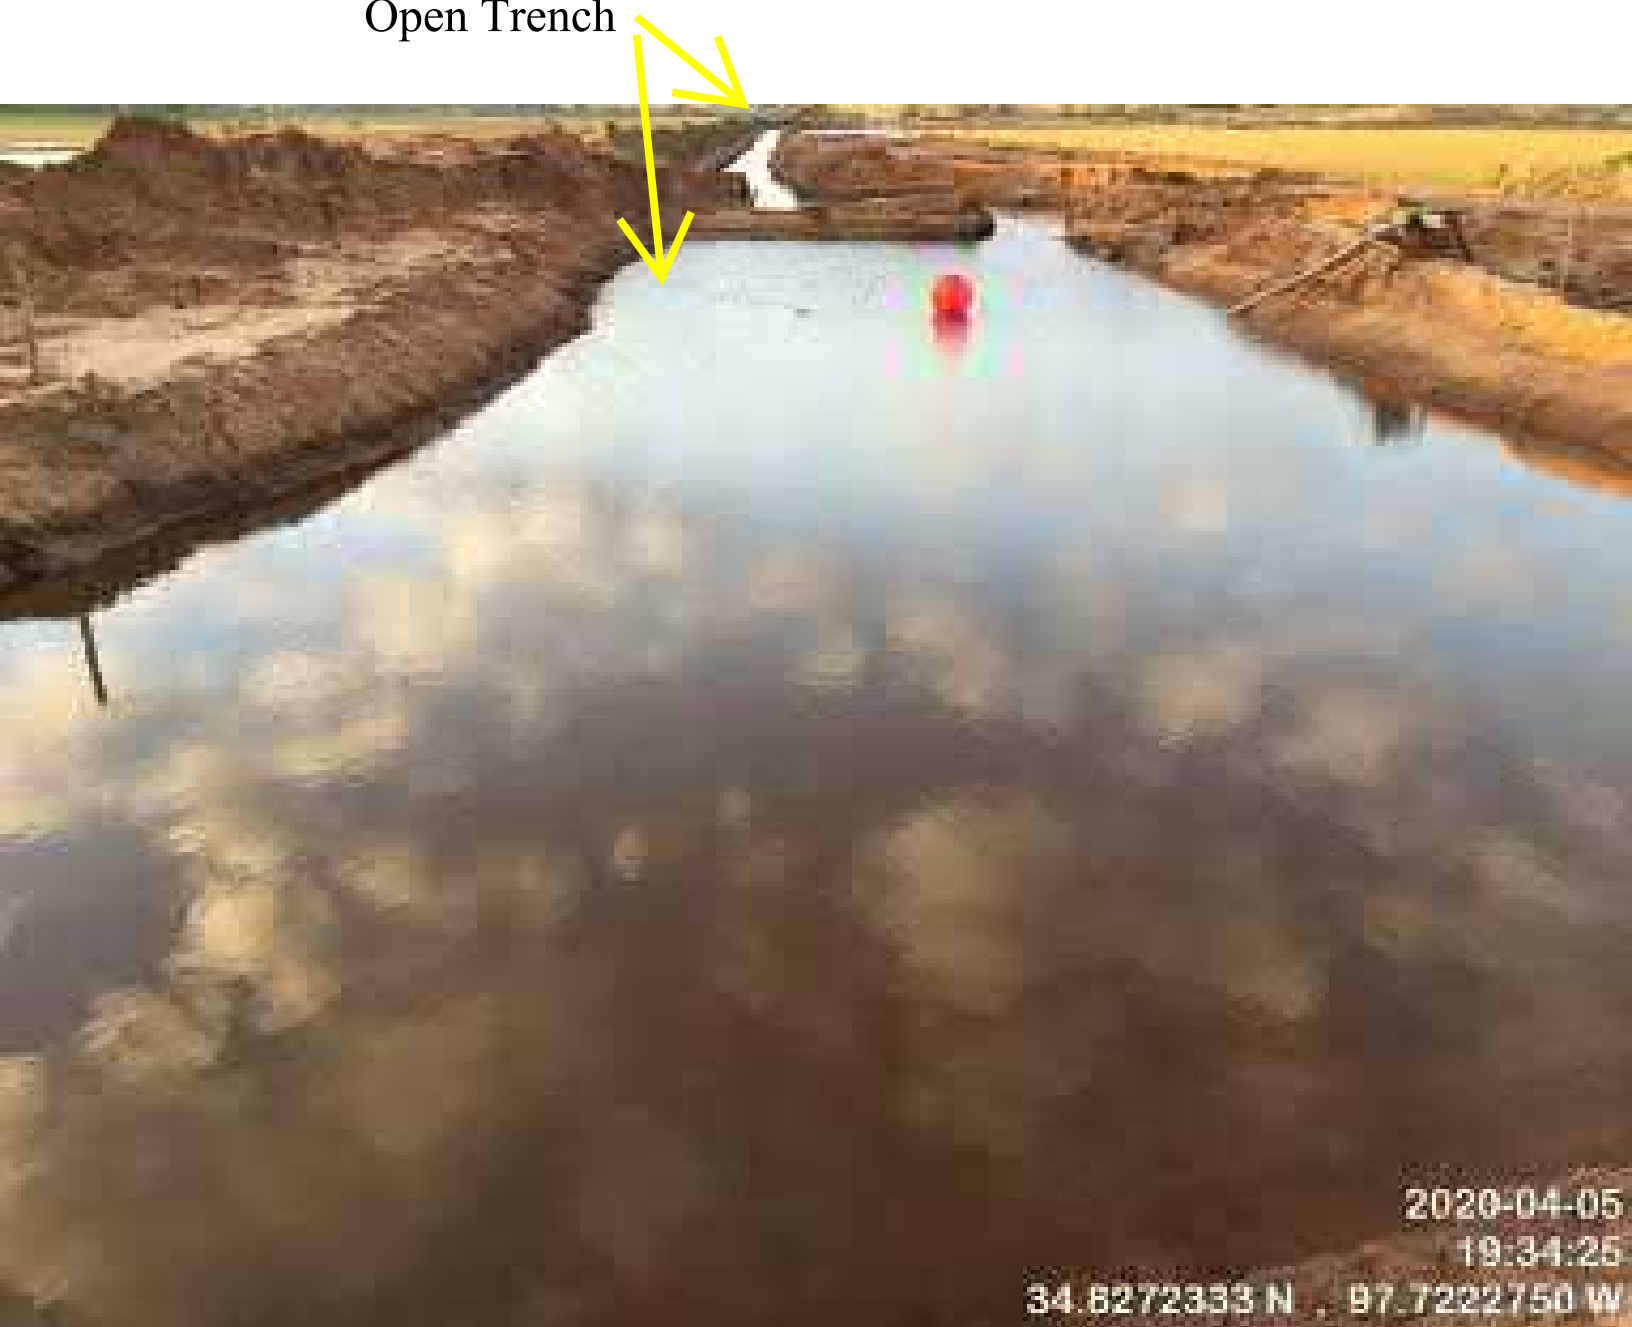
- 1.) At least 3,000 feet of open trenches on tract GR-0338.000.
- 2.) Unfiltered trench water being pumped directly into a stream (SGR-008).
- 3.) Large rocks and construction materials buried beneath 2-4" of soil.
- 4.) Construction debris and matting scattered throughout workspace and across property.
- 5.) Ponding on and off right-of-way seemingly caused by disruption of existing drainage.
- 6.) Evidence of continual sediment and erosion control violations in multiple locations.
- 7.) Presence of an unknown sheeny contaminant in water inside and near right-of-way.
- 8.) Bank erosion and slipping vegetation along multiple streams.

Open Trench

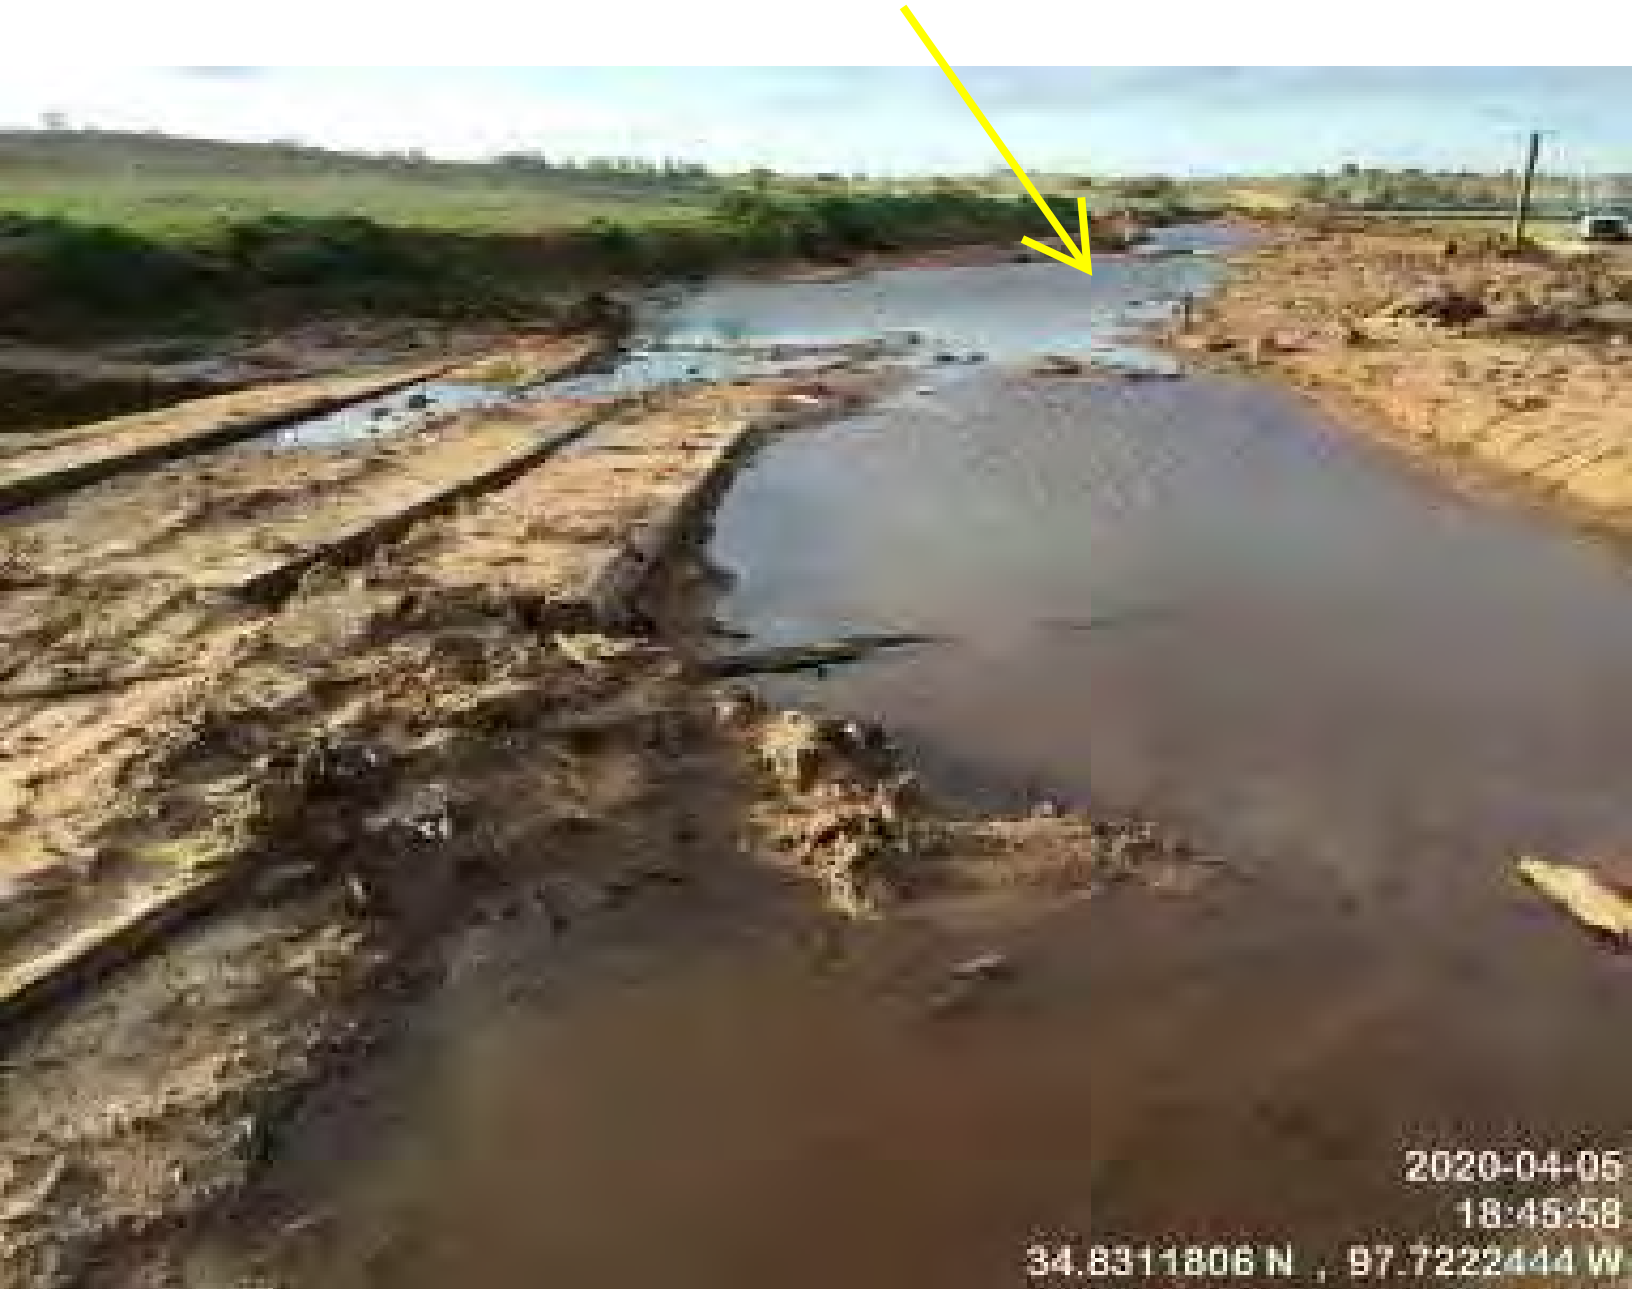
Open Trench

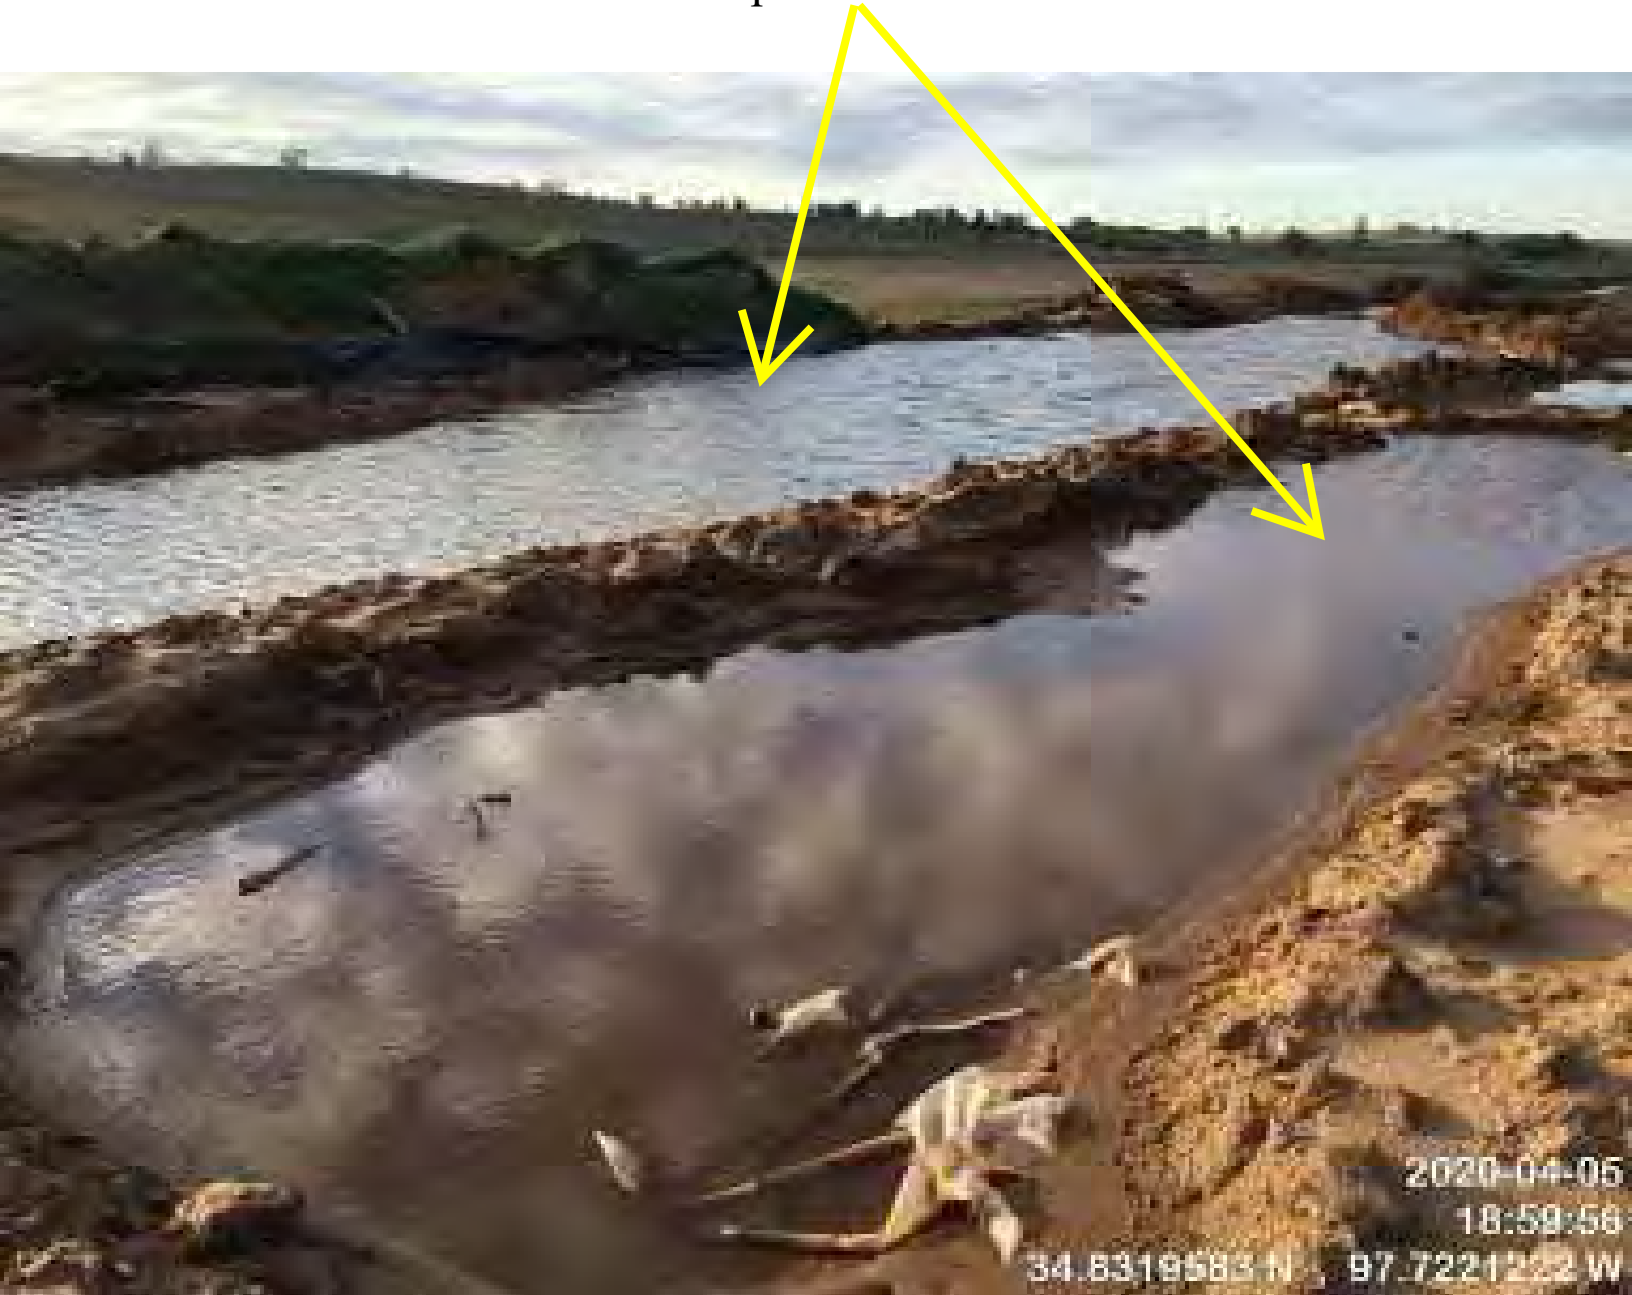
Open Trench

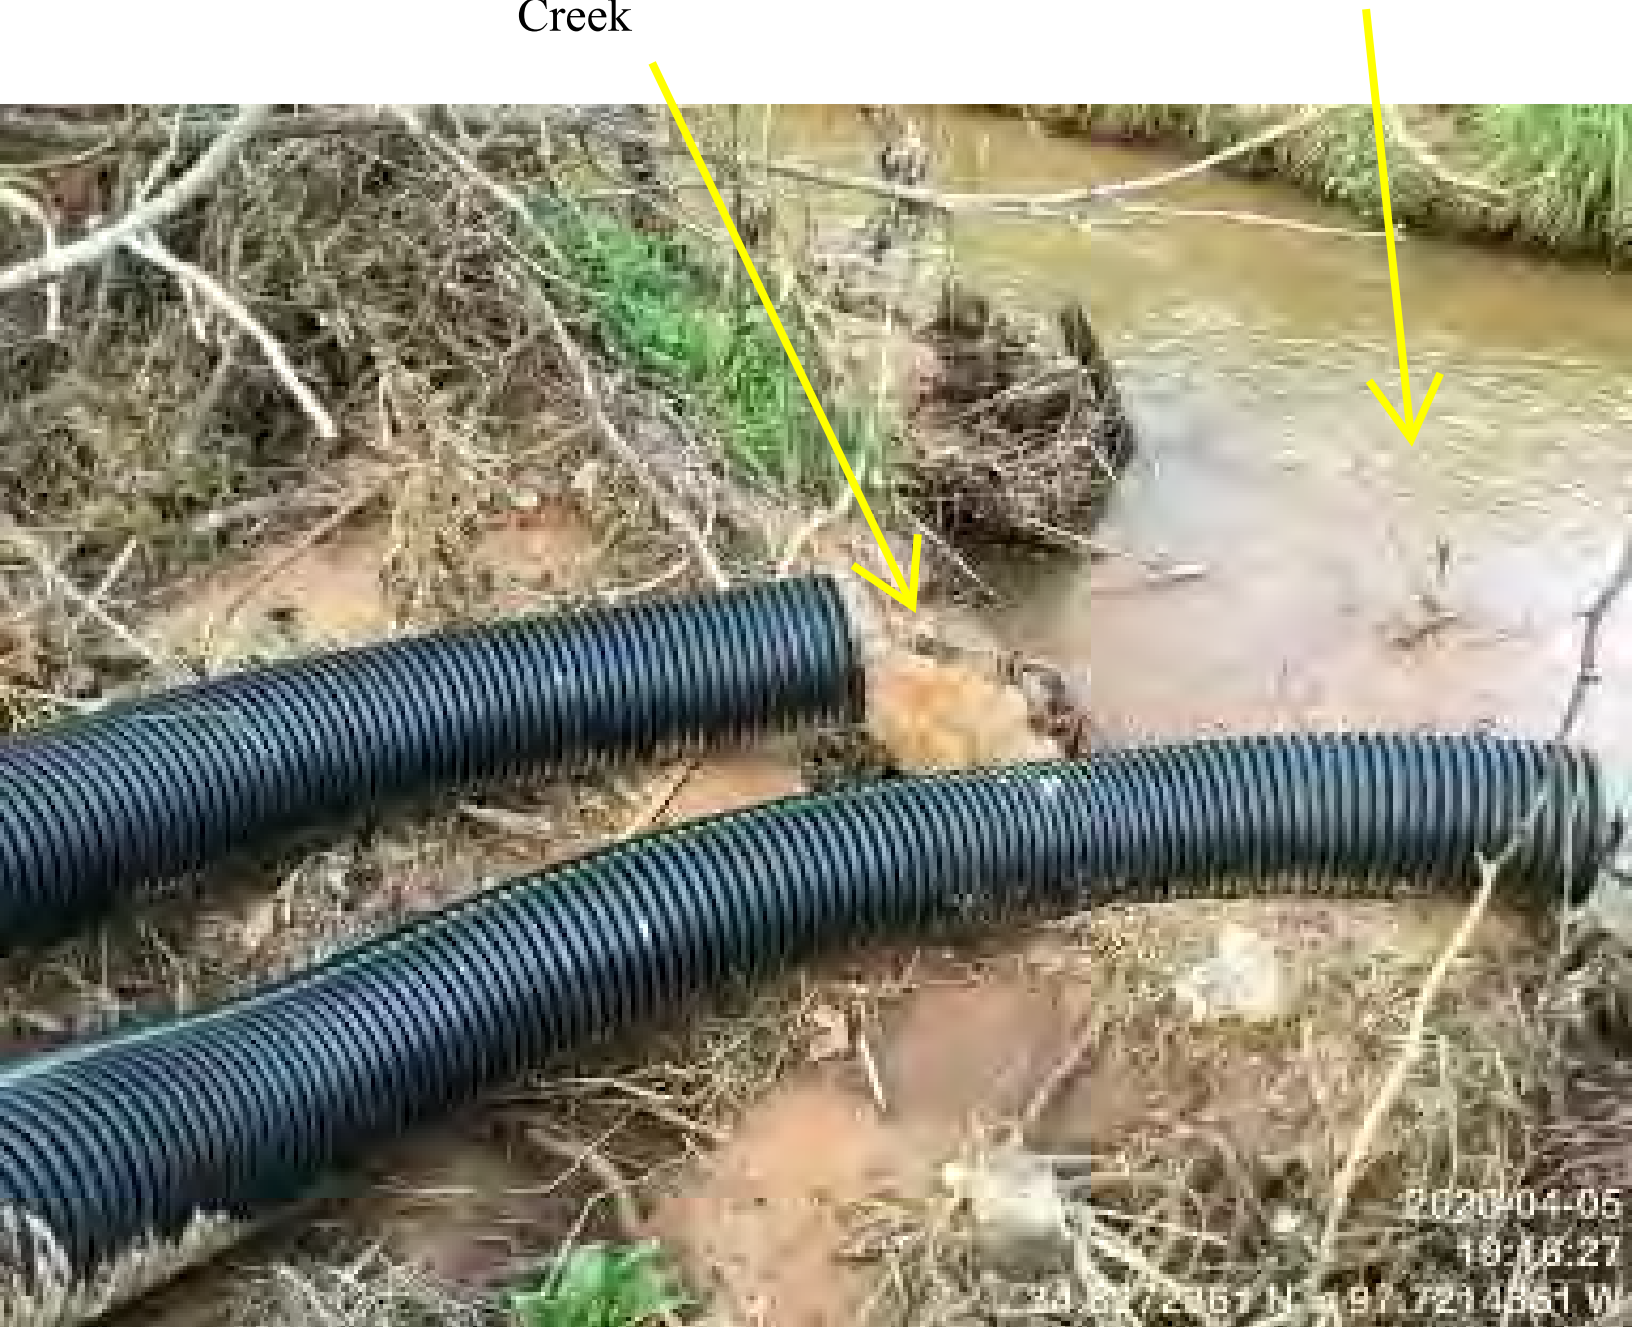
Sandy Creek (SGR-008)

Unfiltered, Silt-Laden
Water Pumped into
Creek

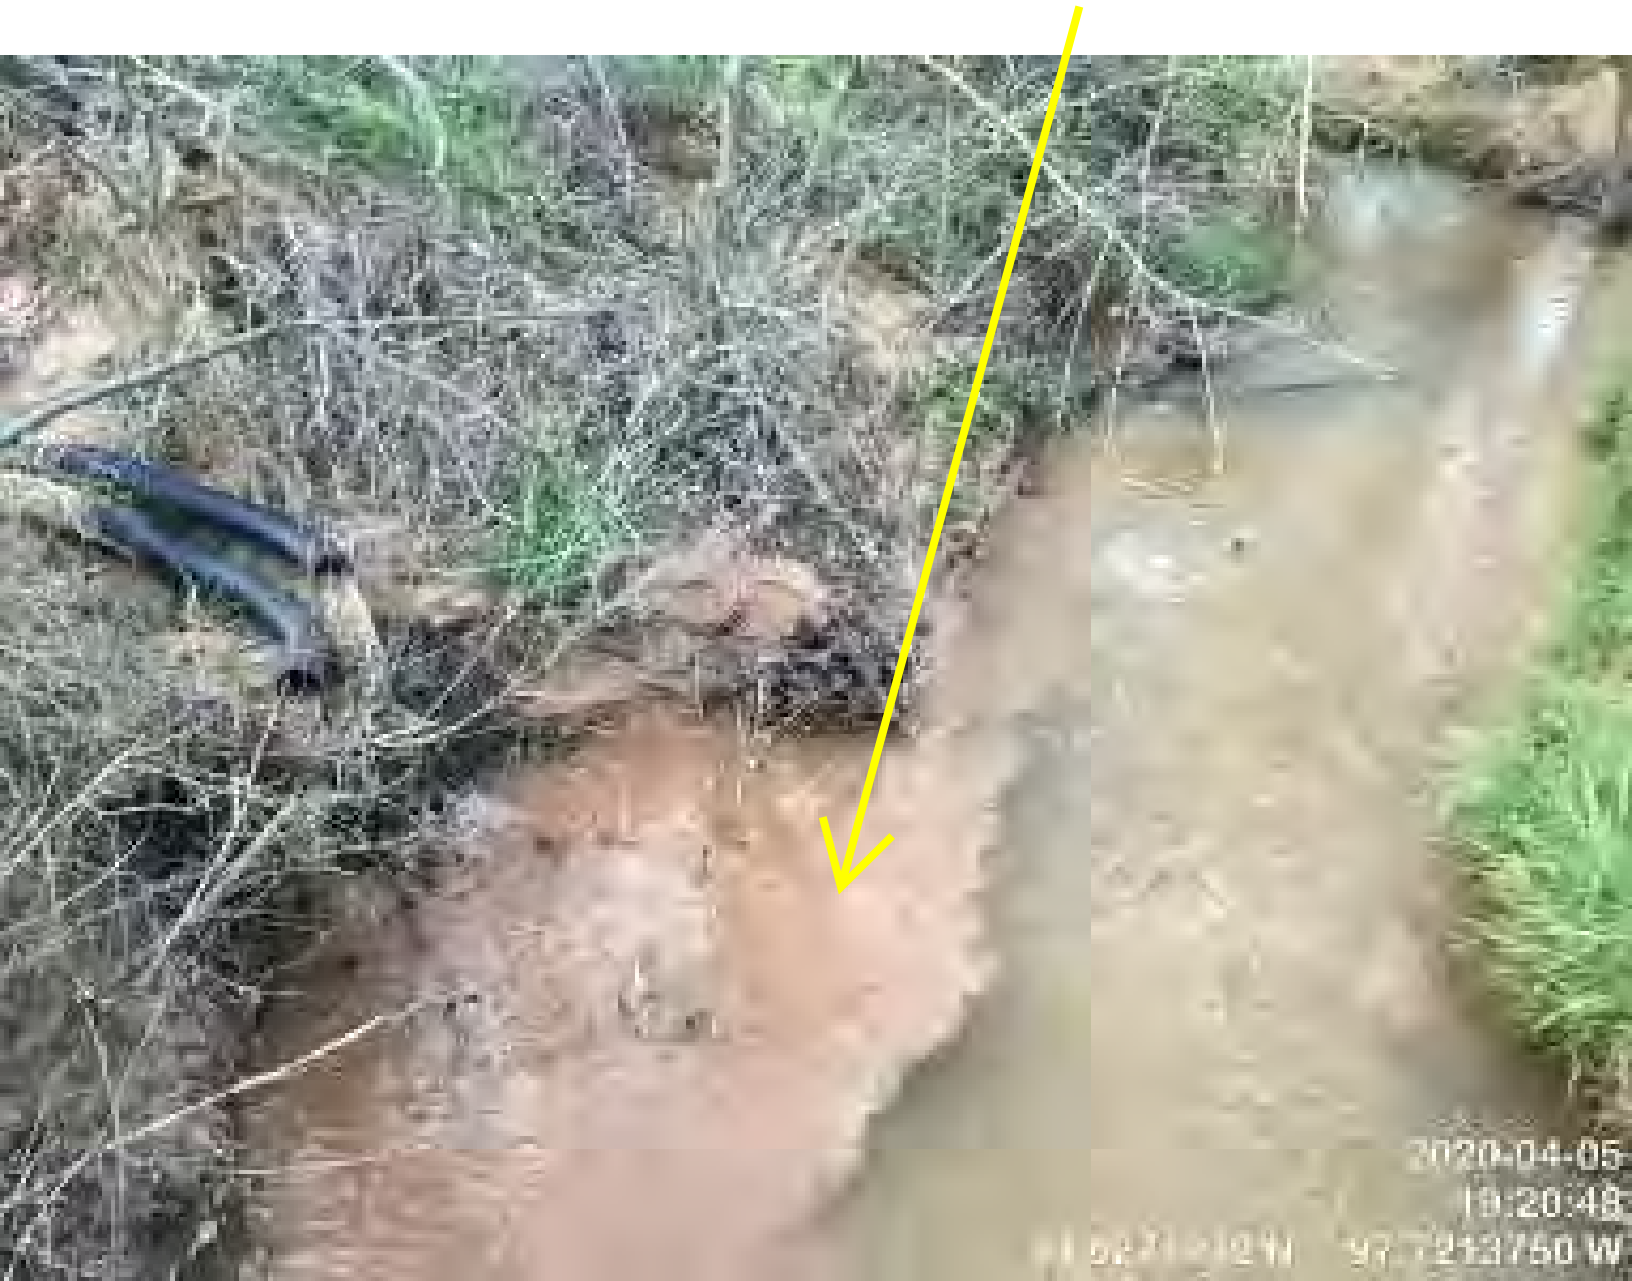
Sediment Plume

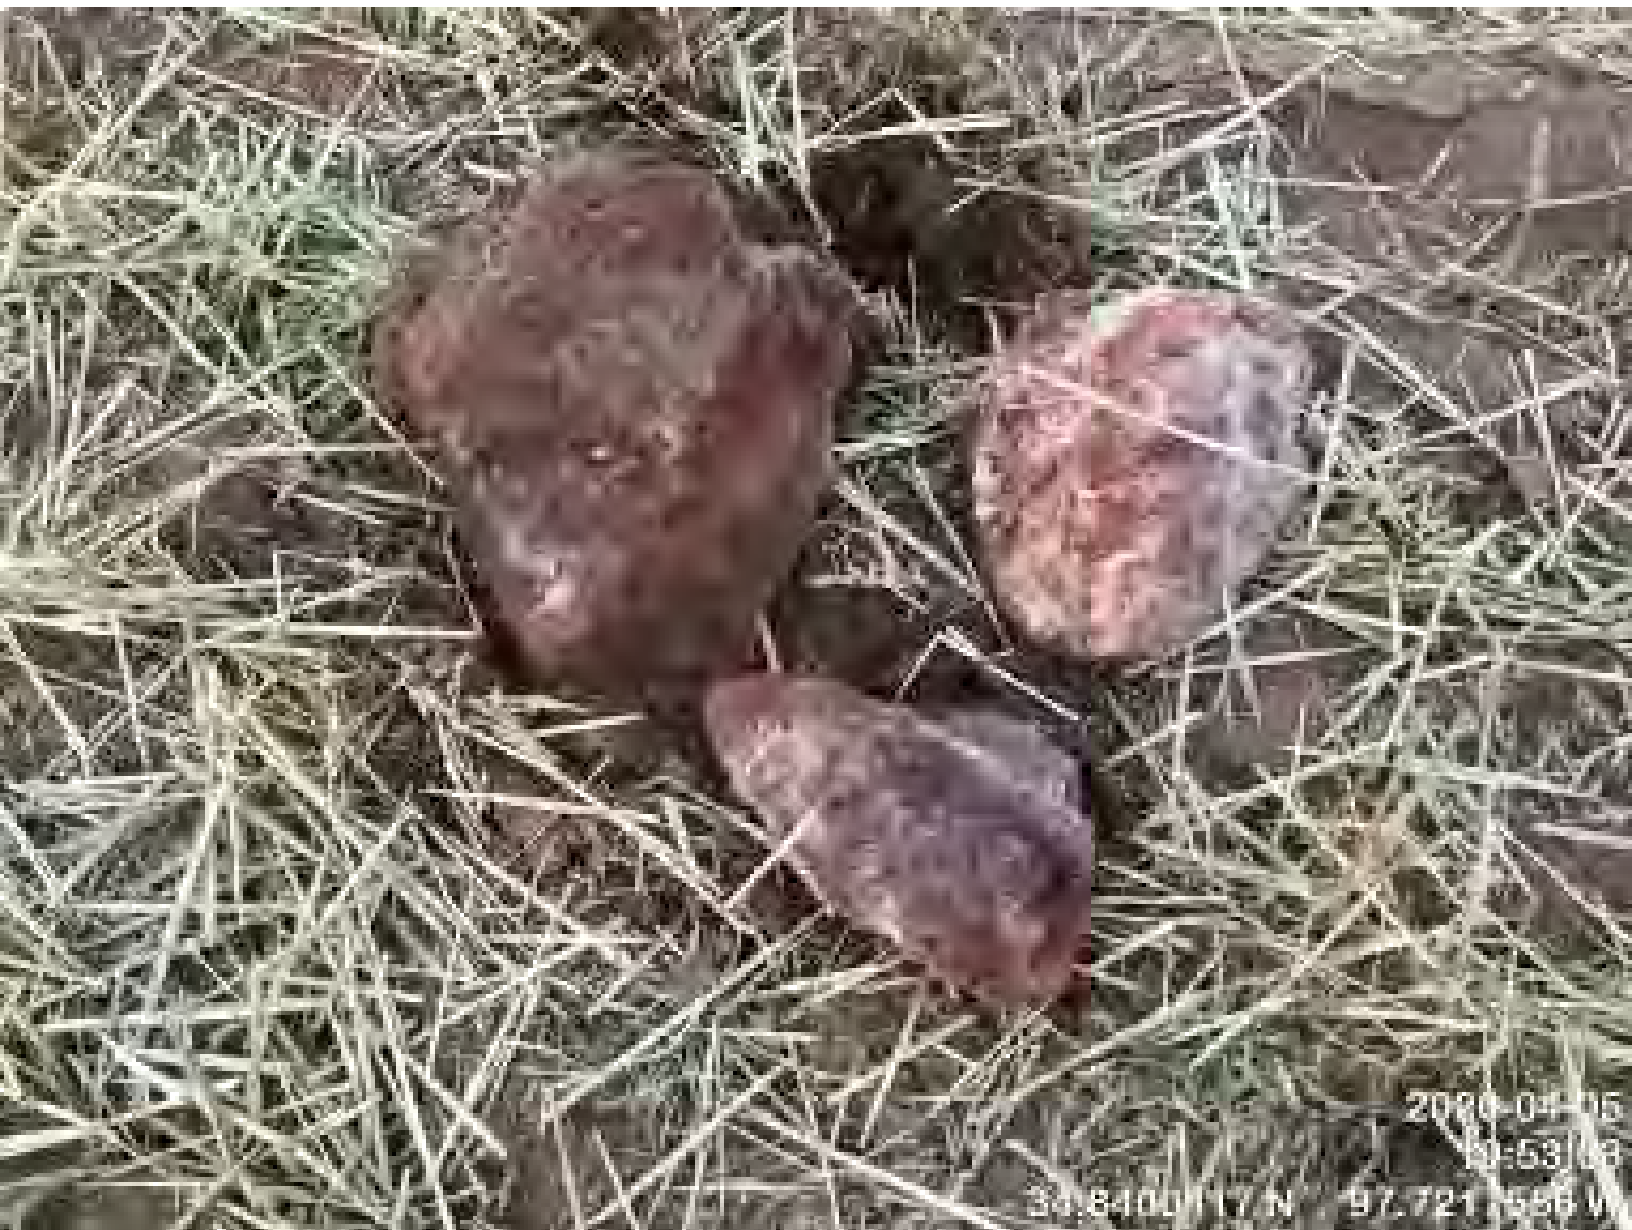
Buried Rocks and Construction Debris

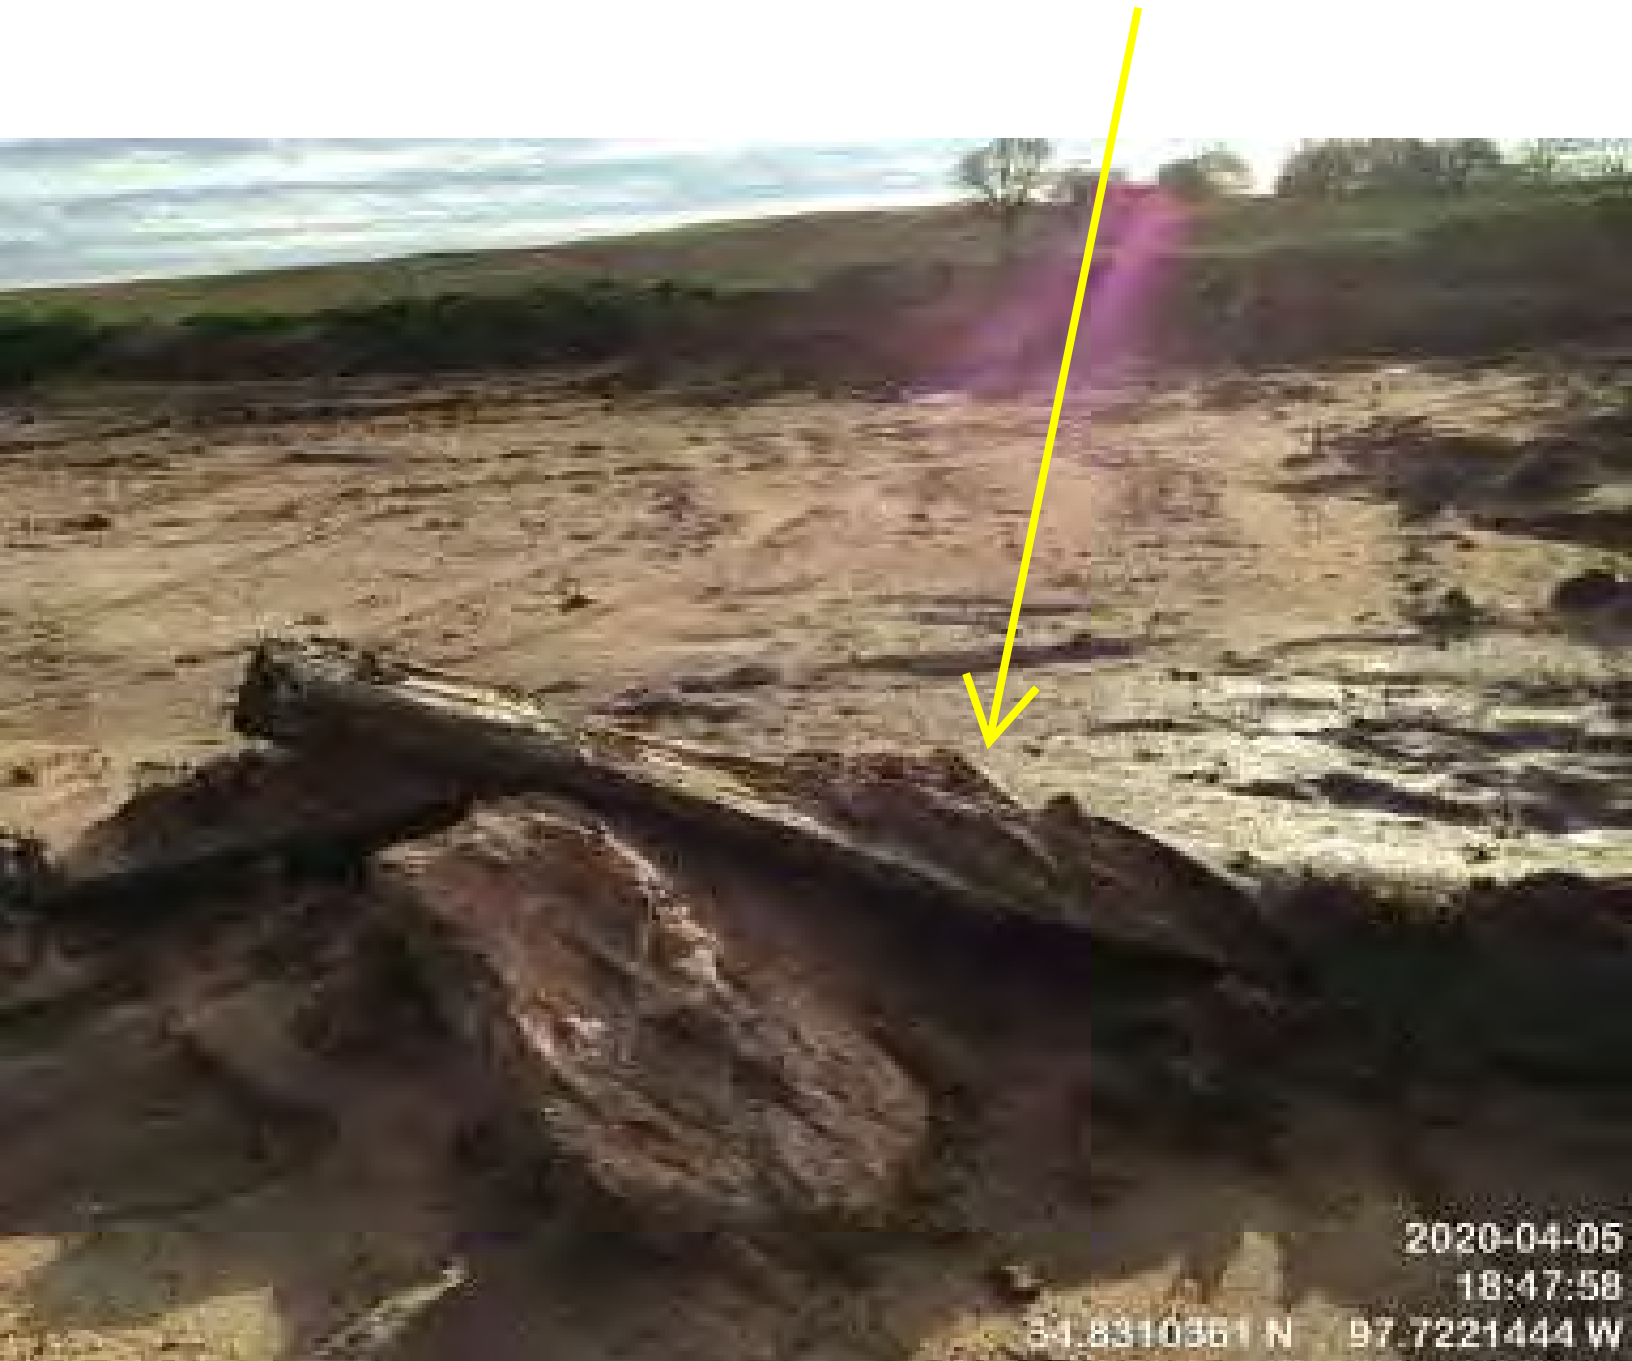
Buried Matting

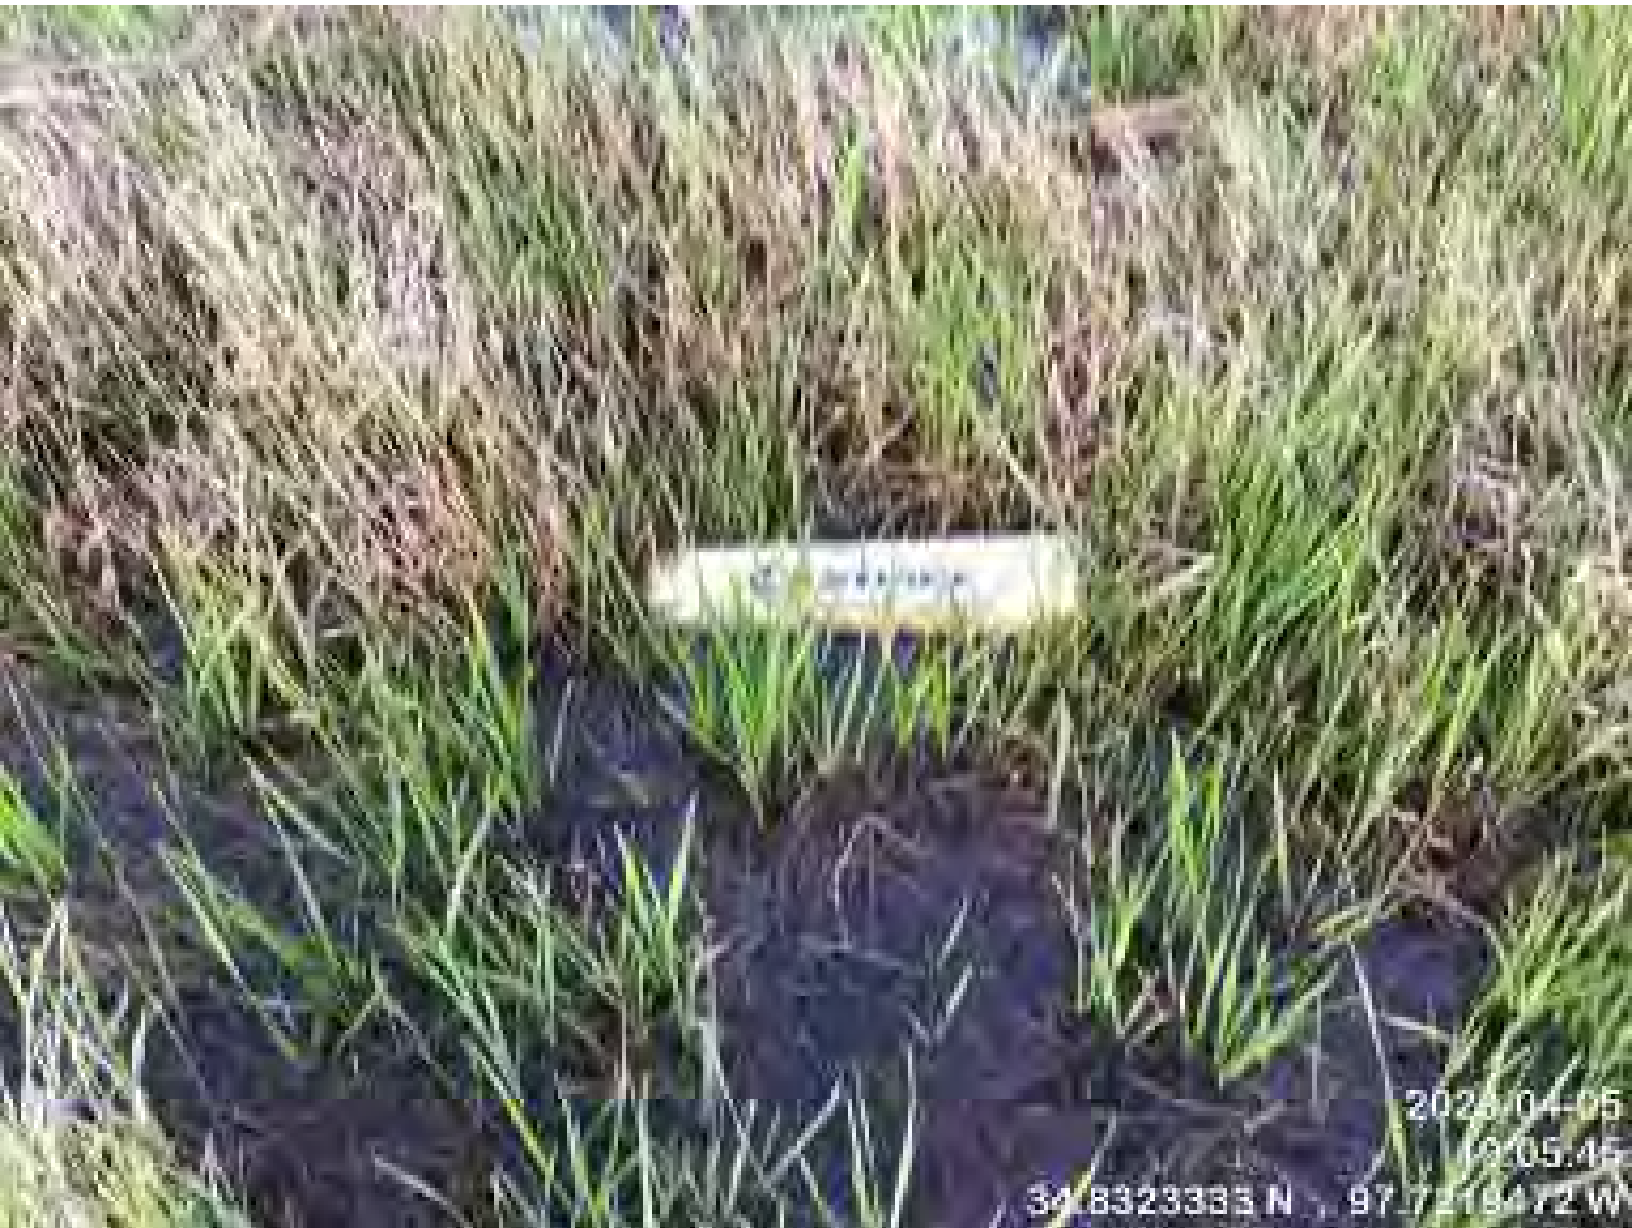
Off Right-of-Way Debris
