Robert Squires - Squires Consulting LLC
Landowner Advocate

Opening Statement for May 5, 2021 Subcommittee on Civil Rights and Civil Liberties Hearing:
“Pipelines Over People (Part II): Midship Pipeline’s Disregard for Landowners in Its Pathway”

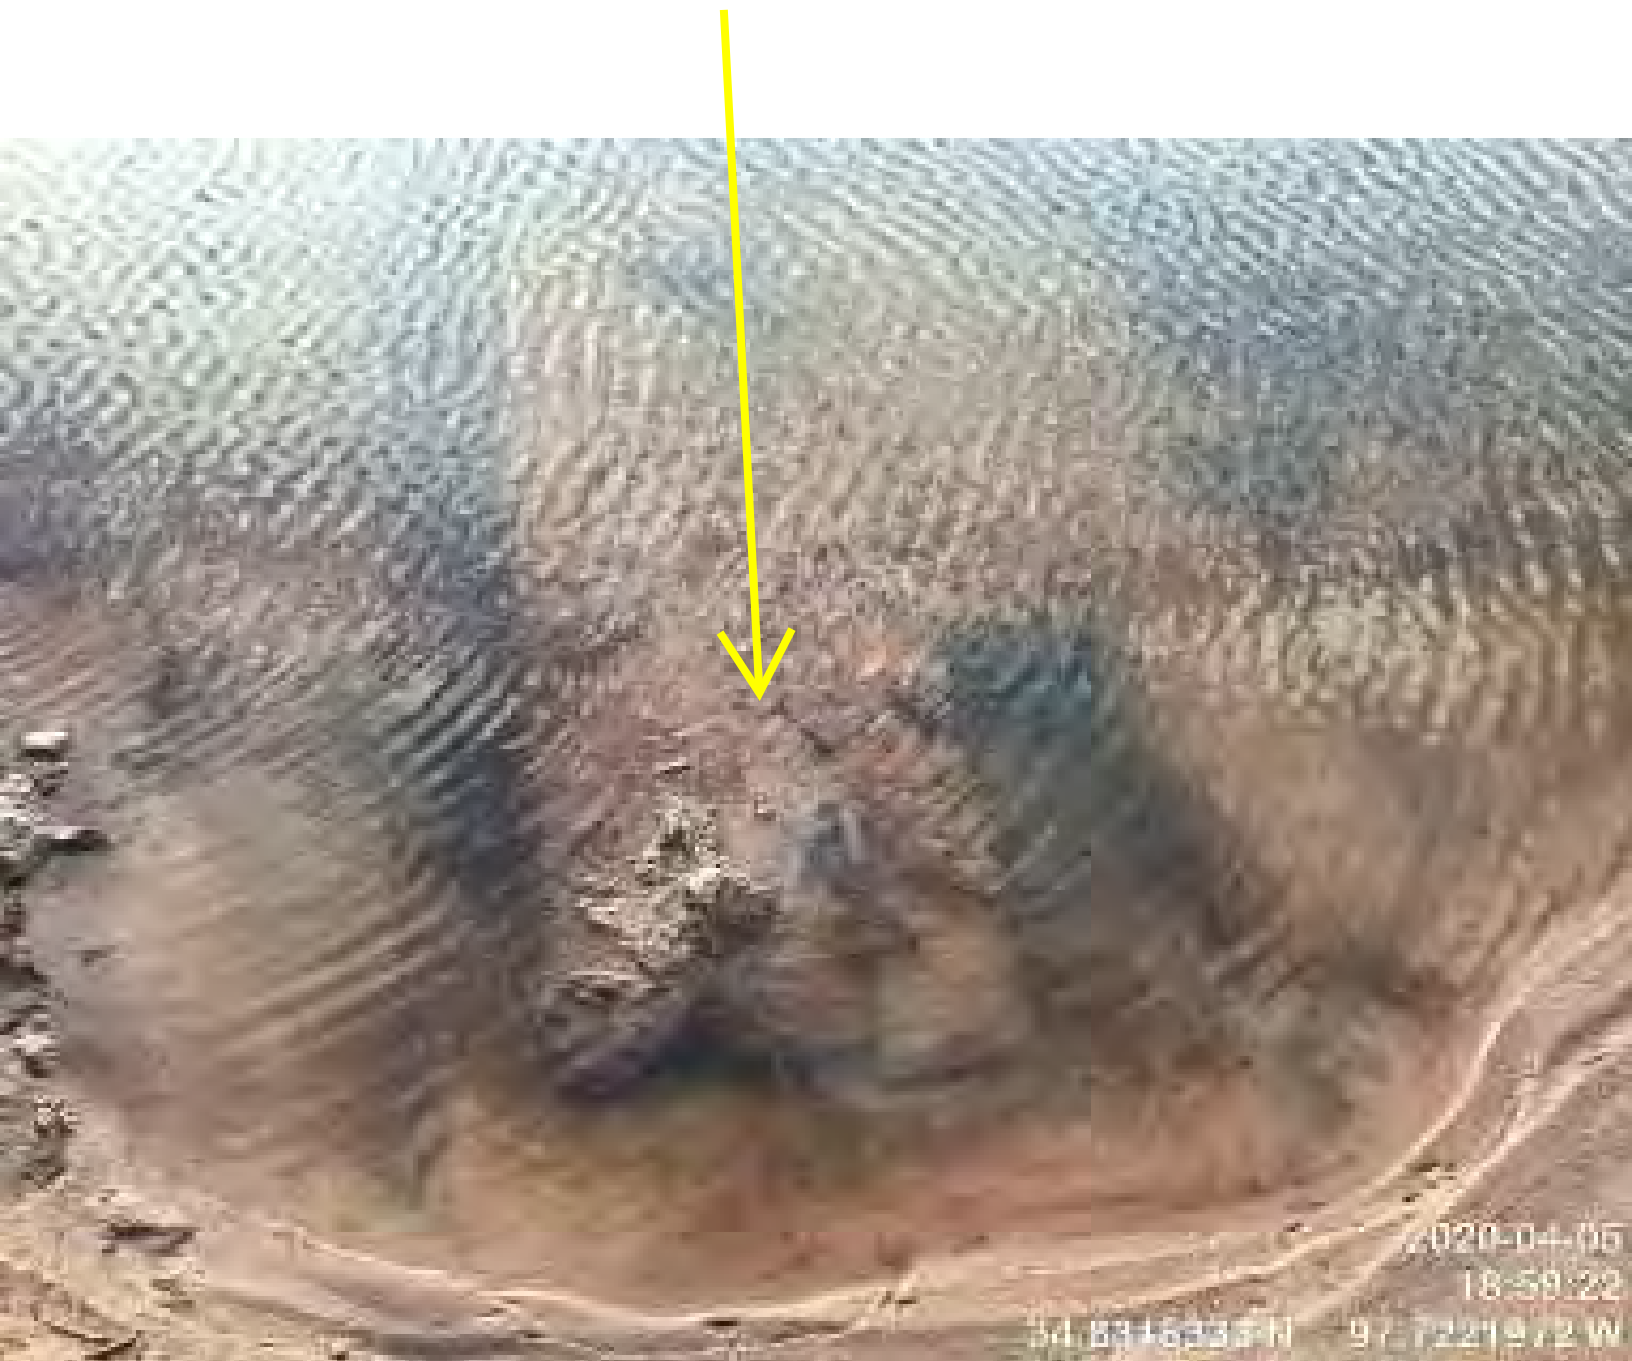
Construction Debris

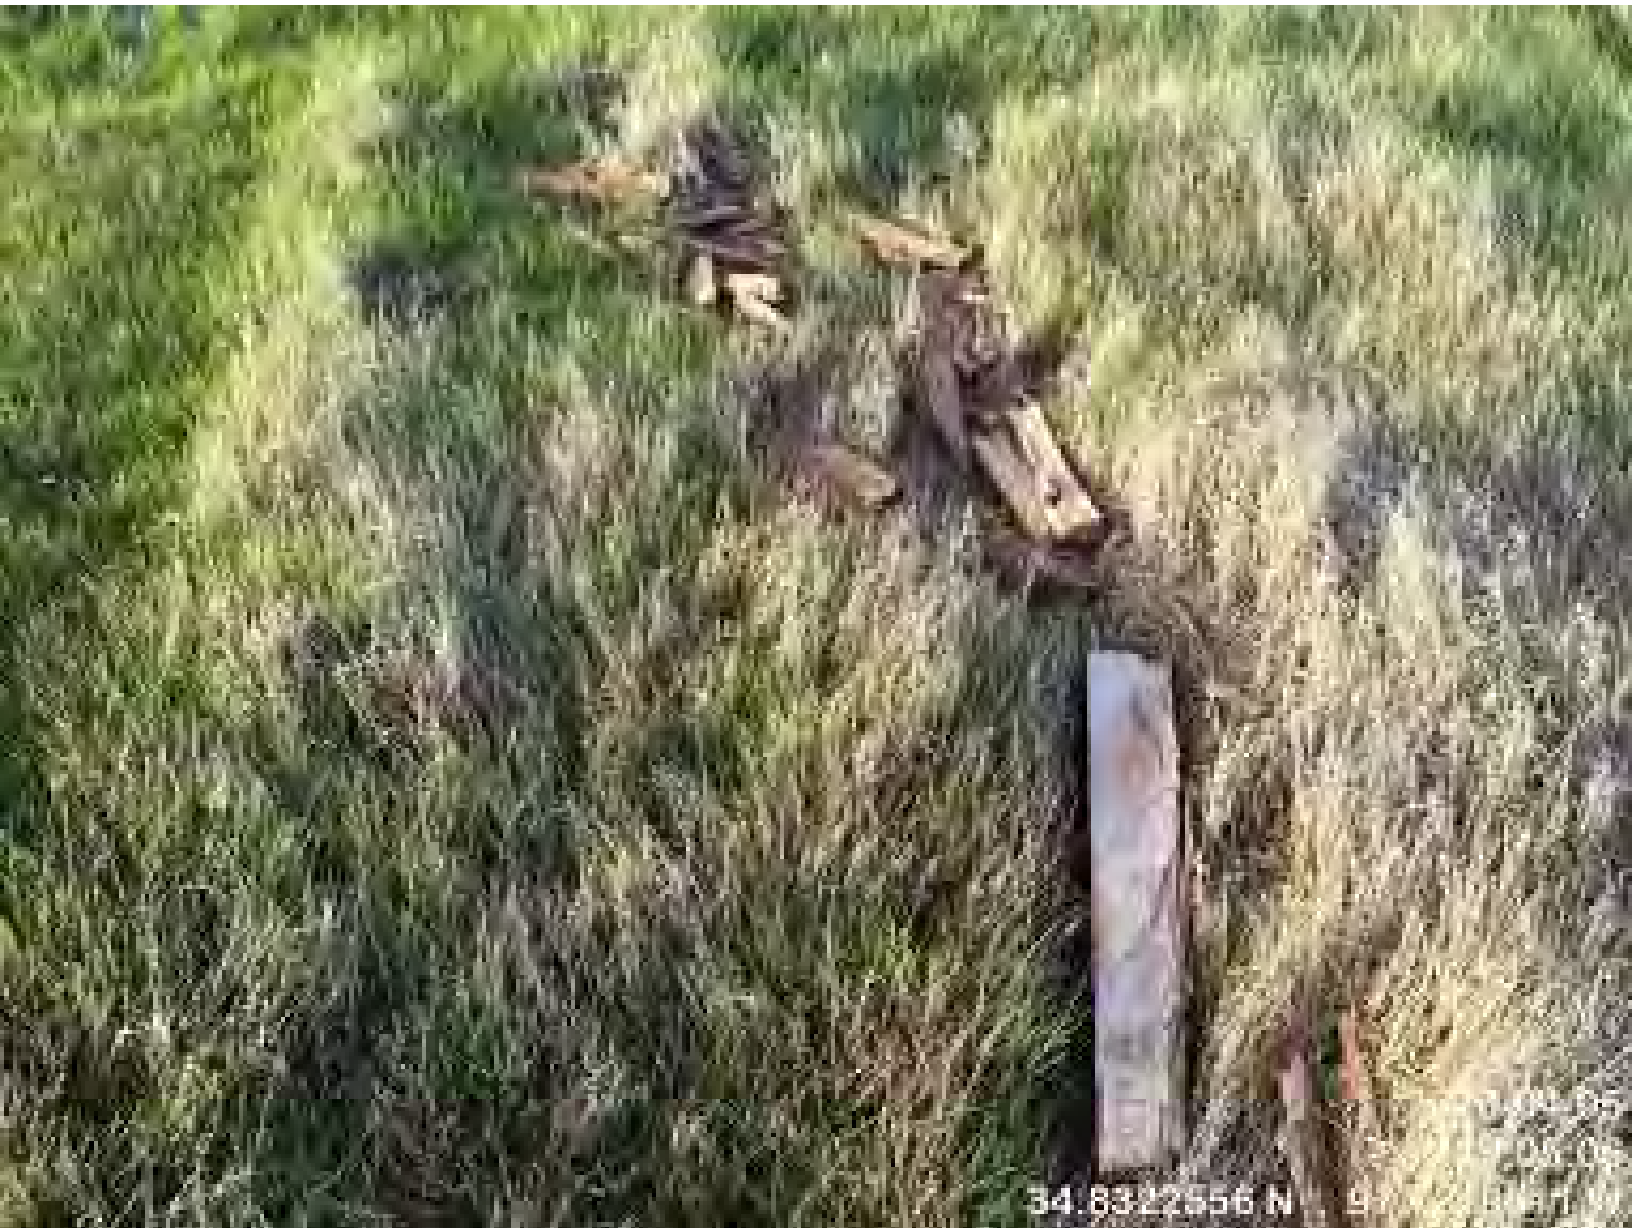
Off Right-of-Way Debris

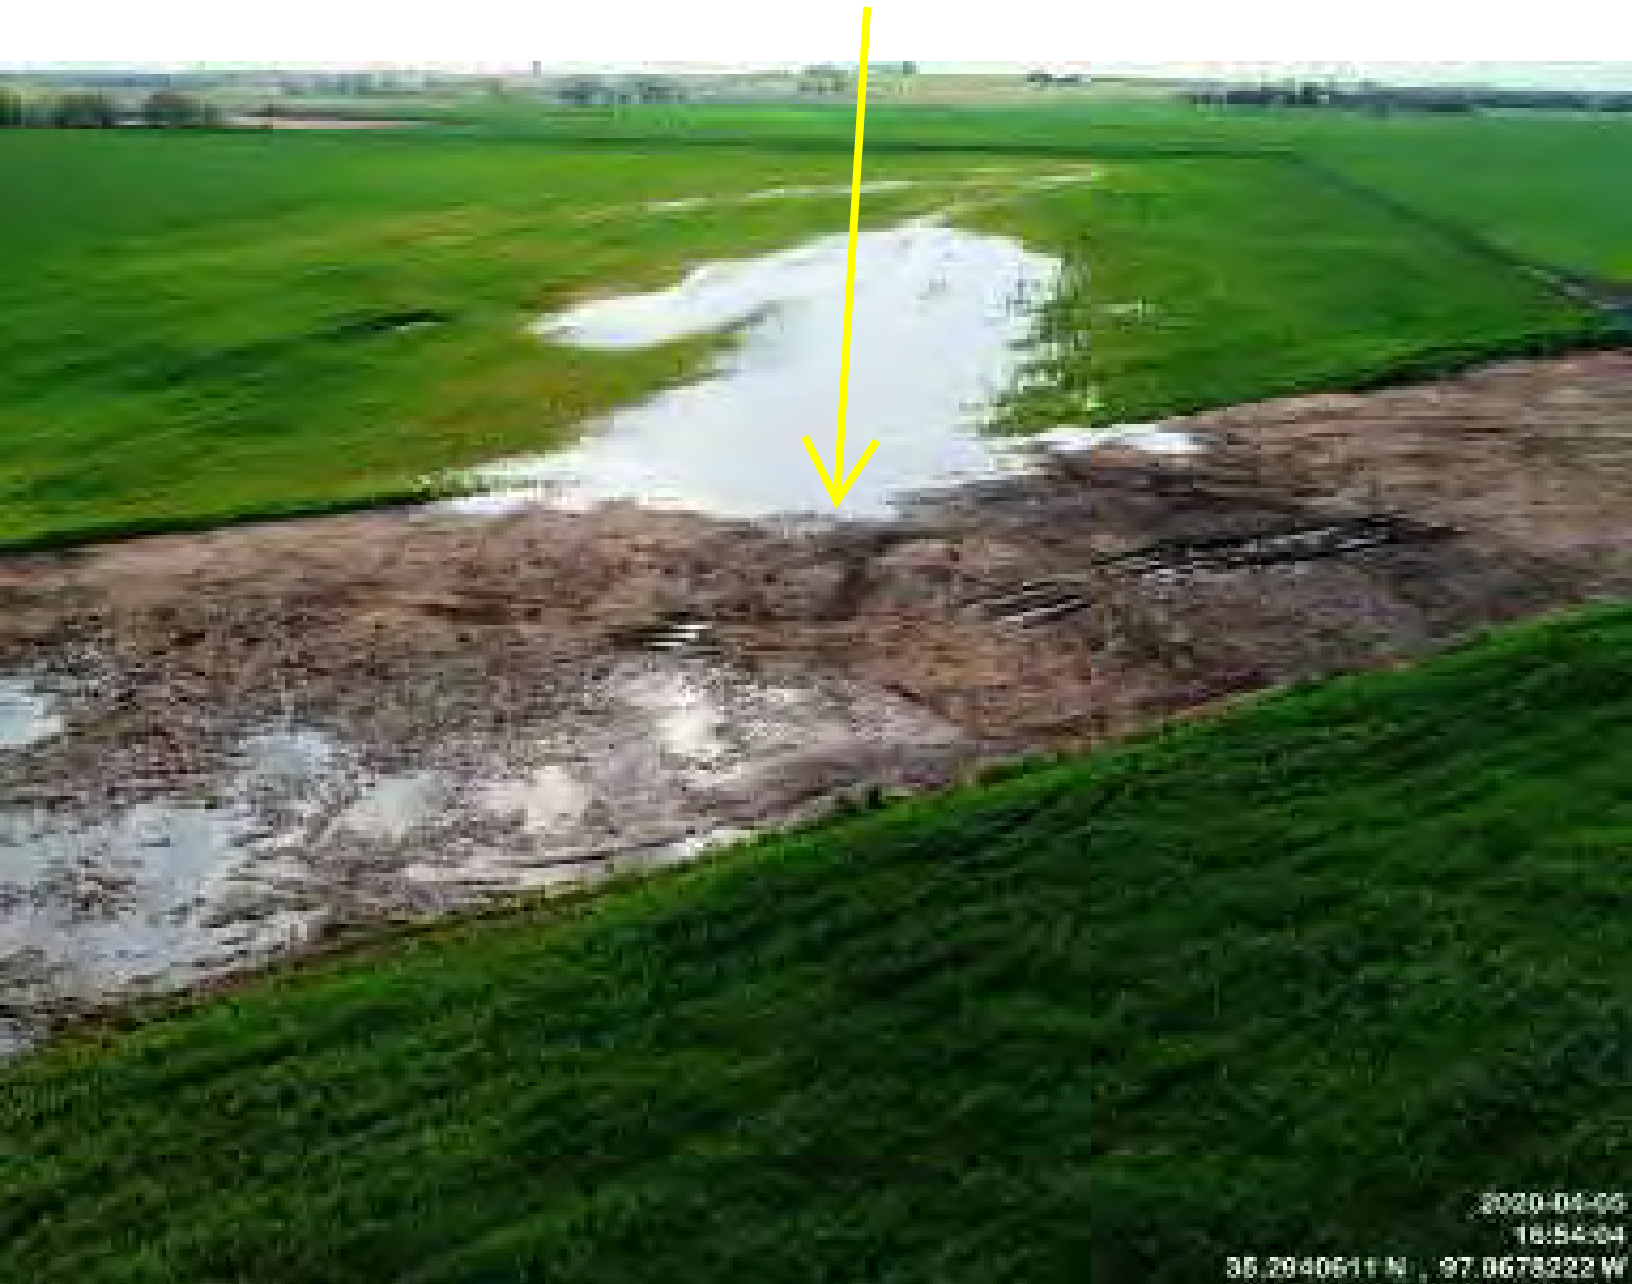
Ponding Due to Blocked Drainage Inside Right-of-Way

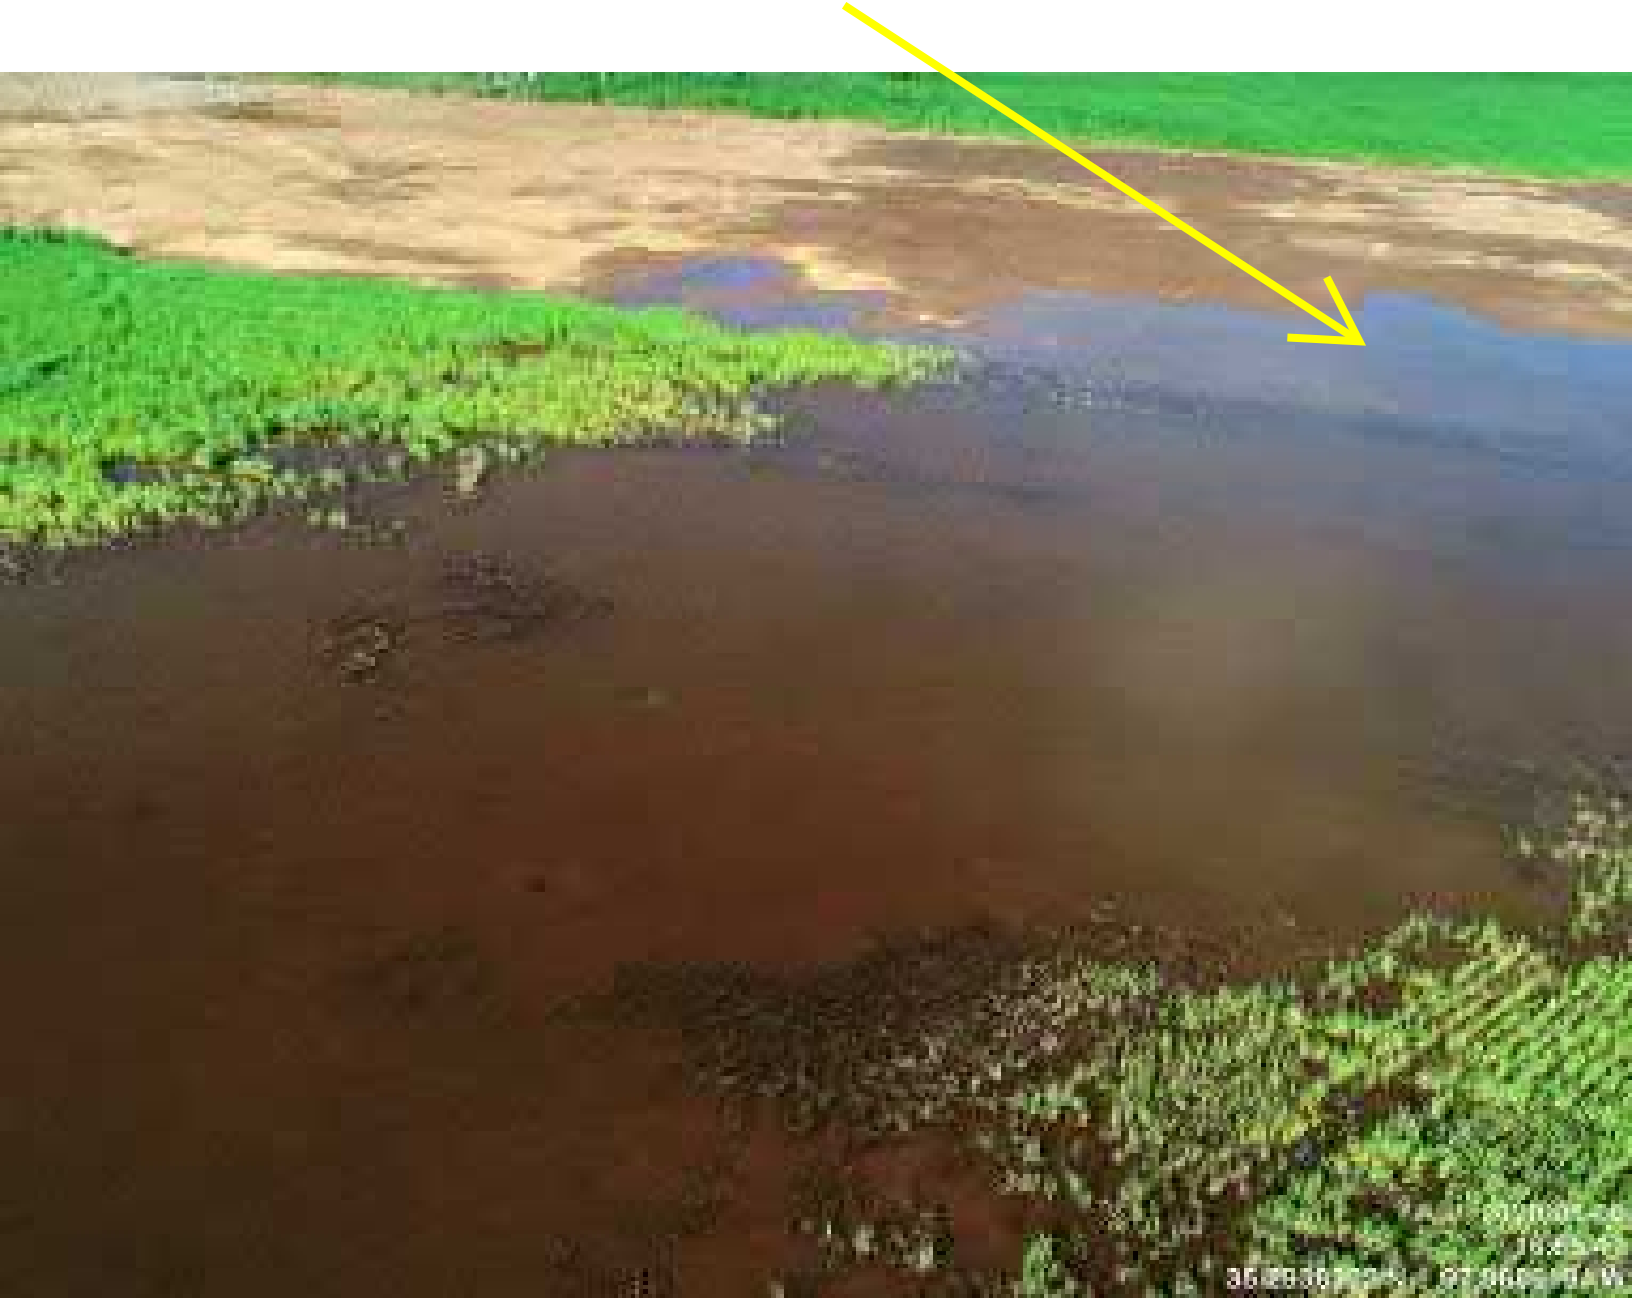
Ponding Due to Blocked Drainage Inside Right-of-Way

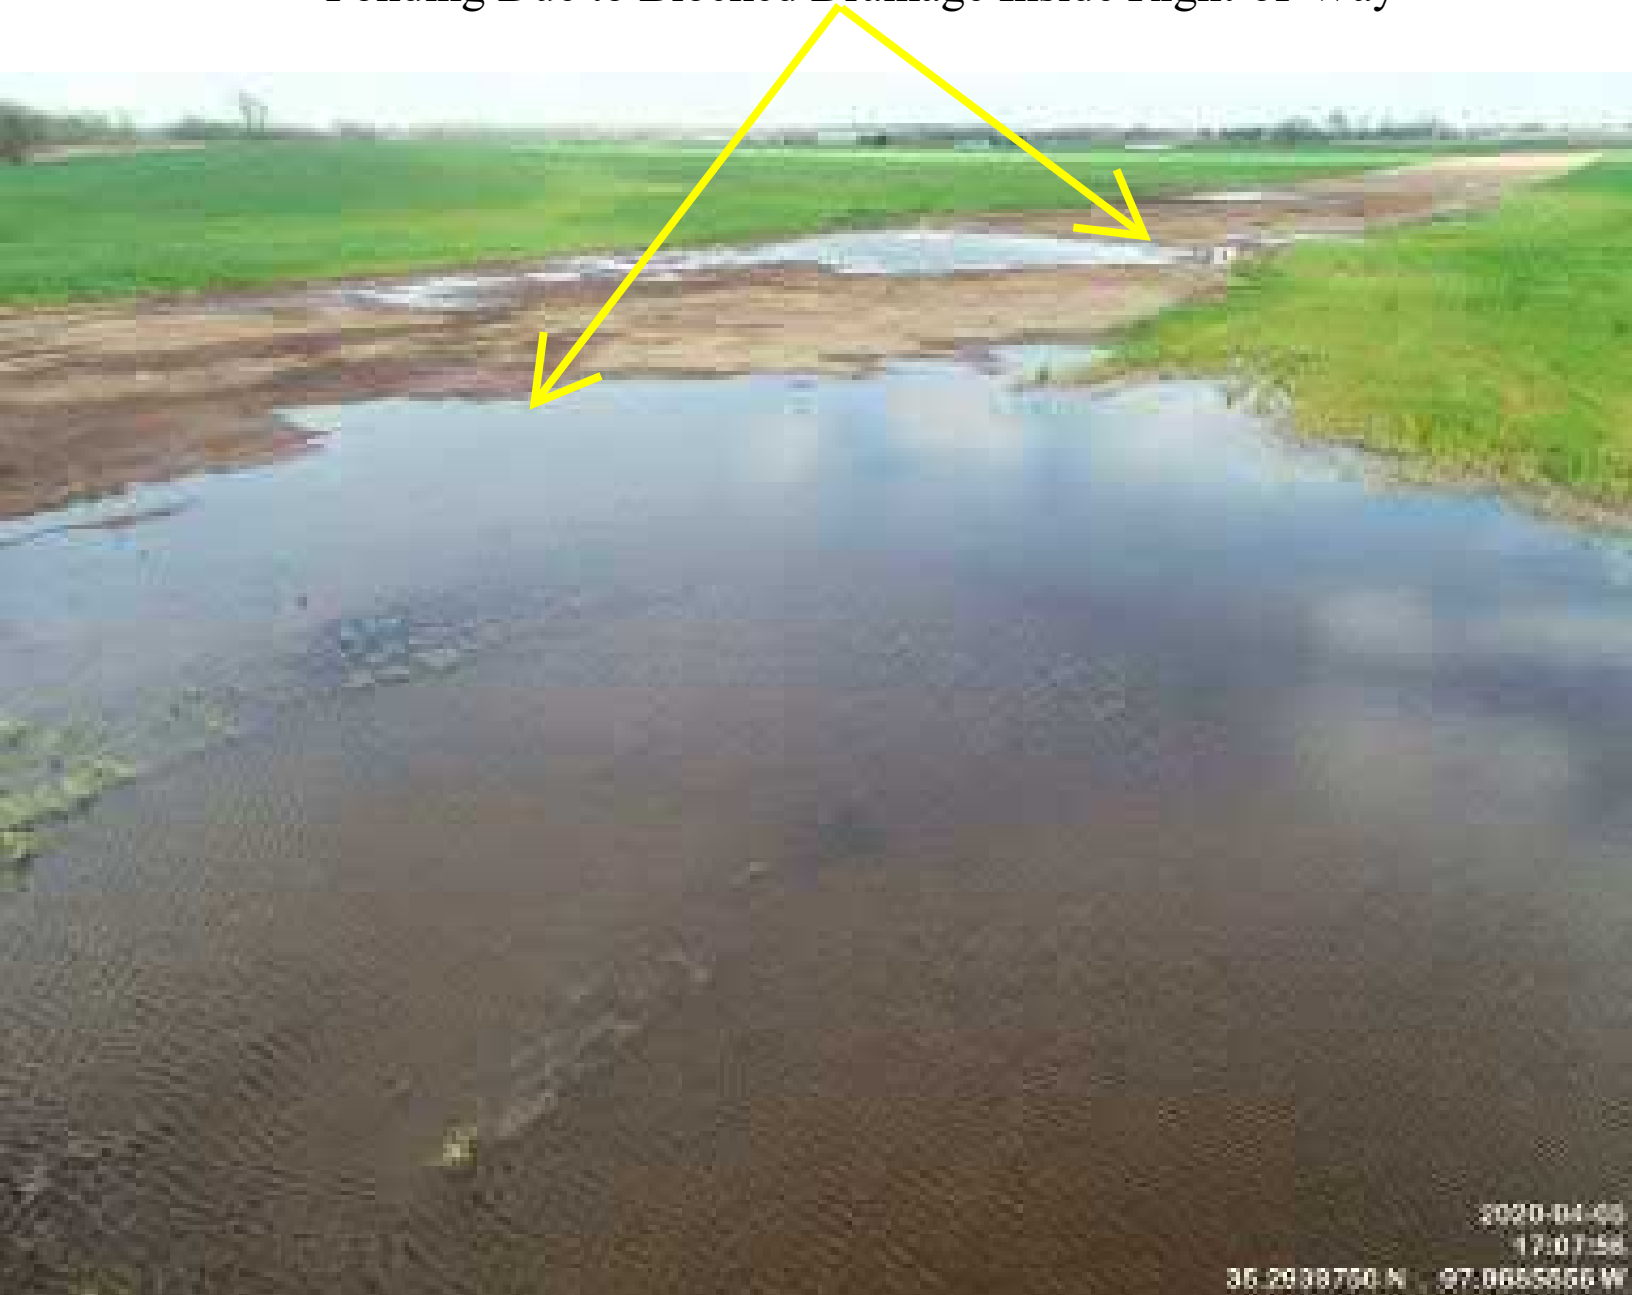
Ponding Due to Blocked Drainage Inside Right-of-Way

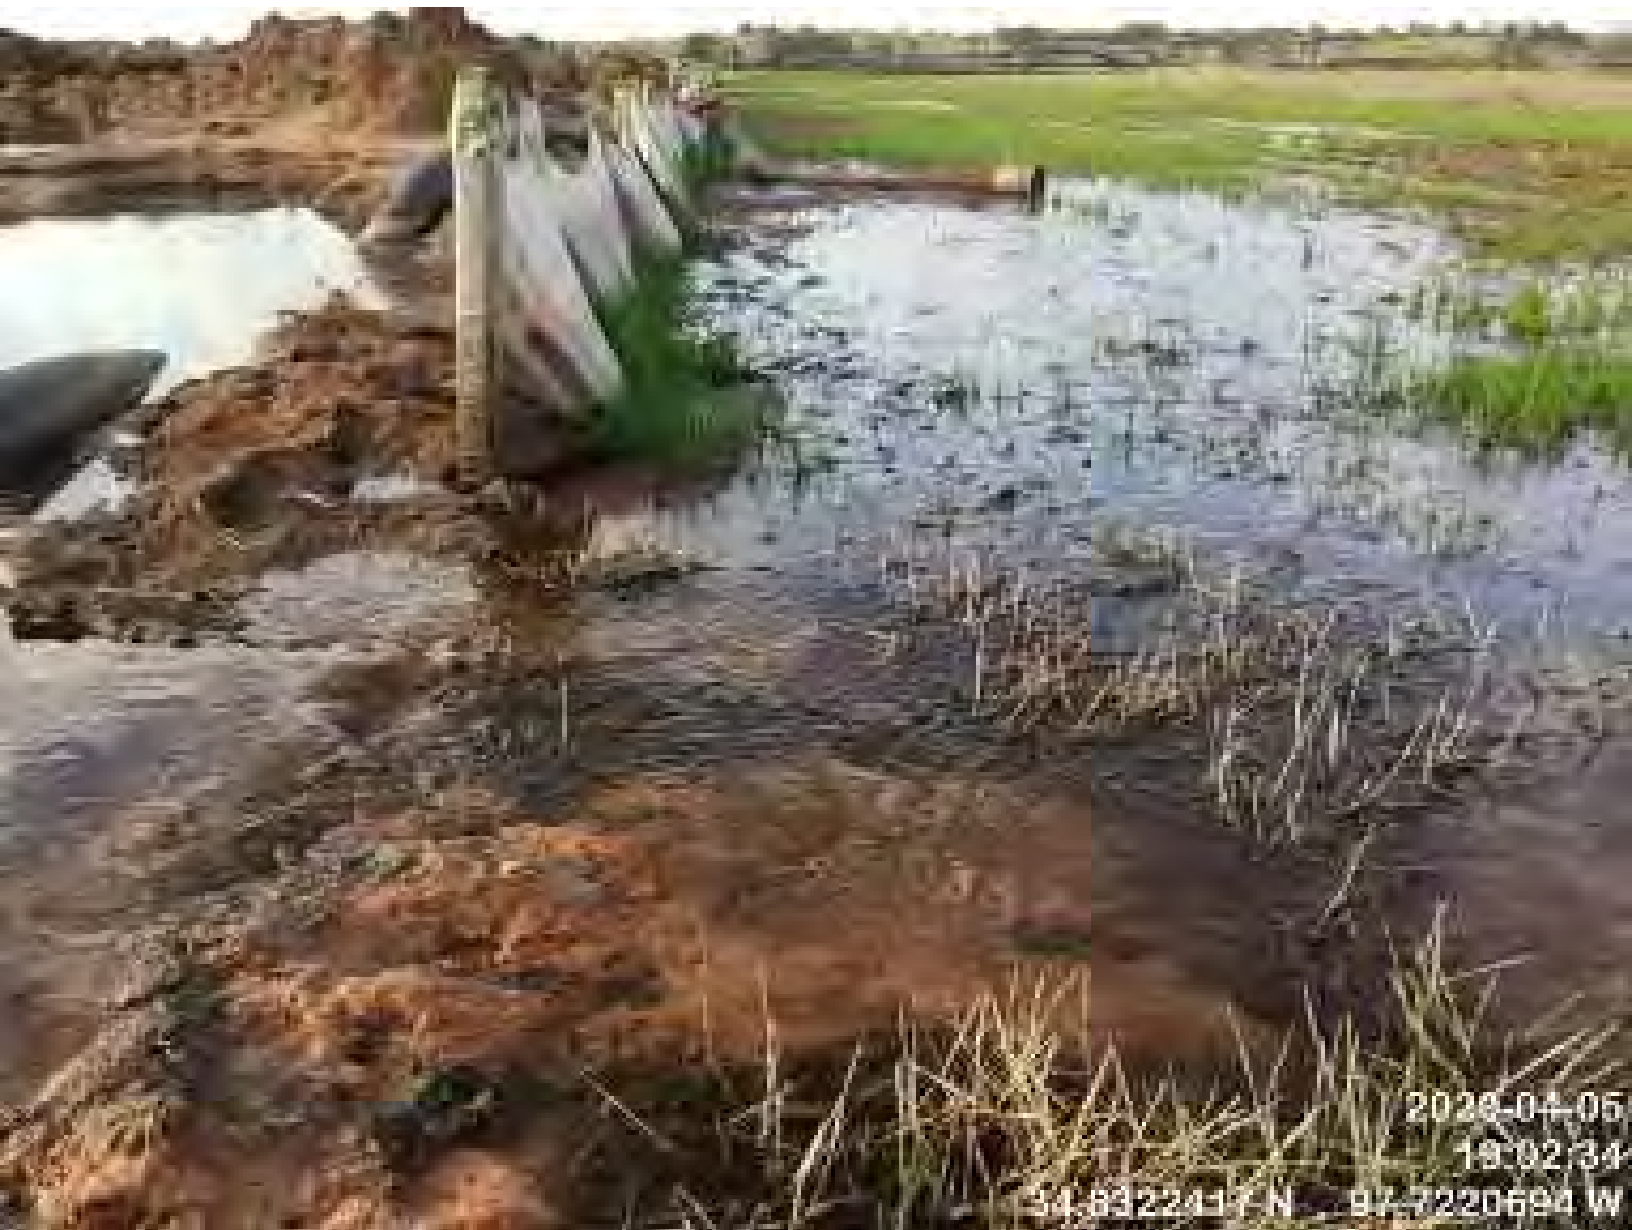
Off Right-of-Way

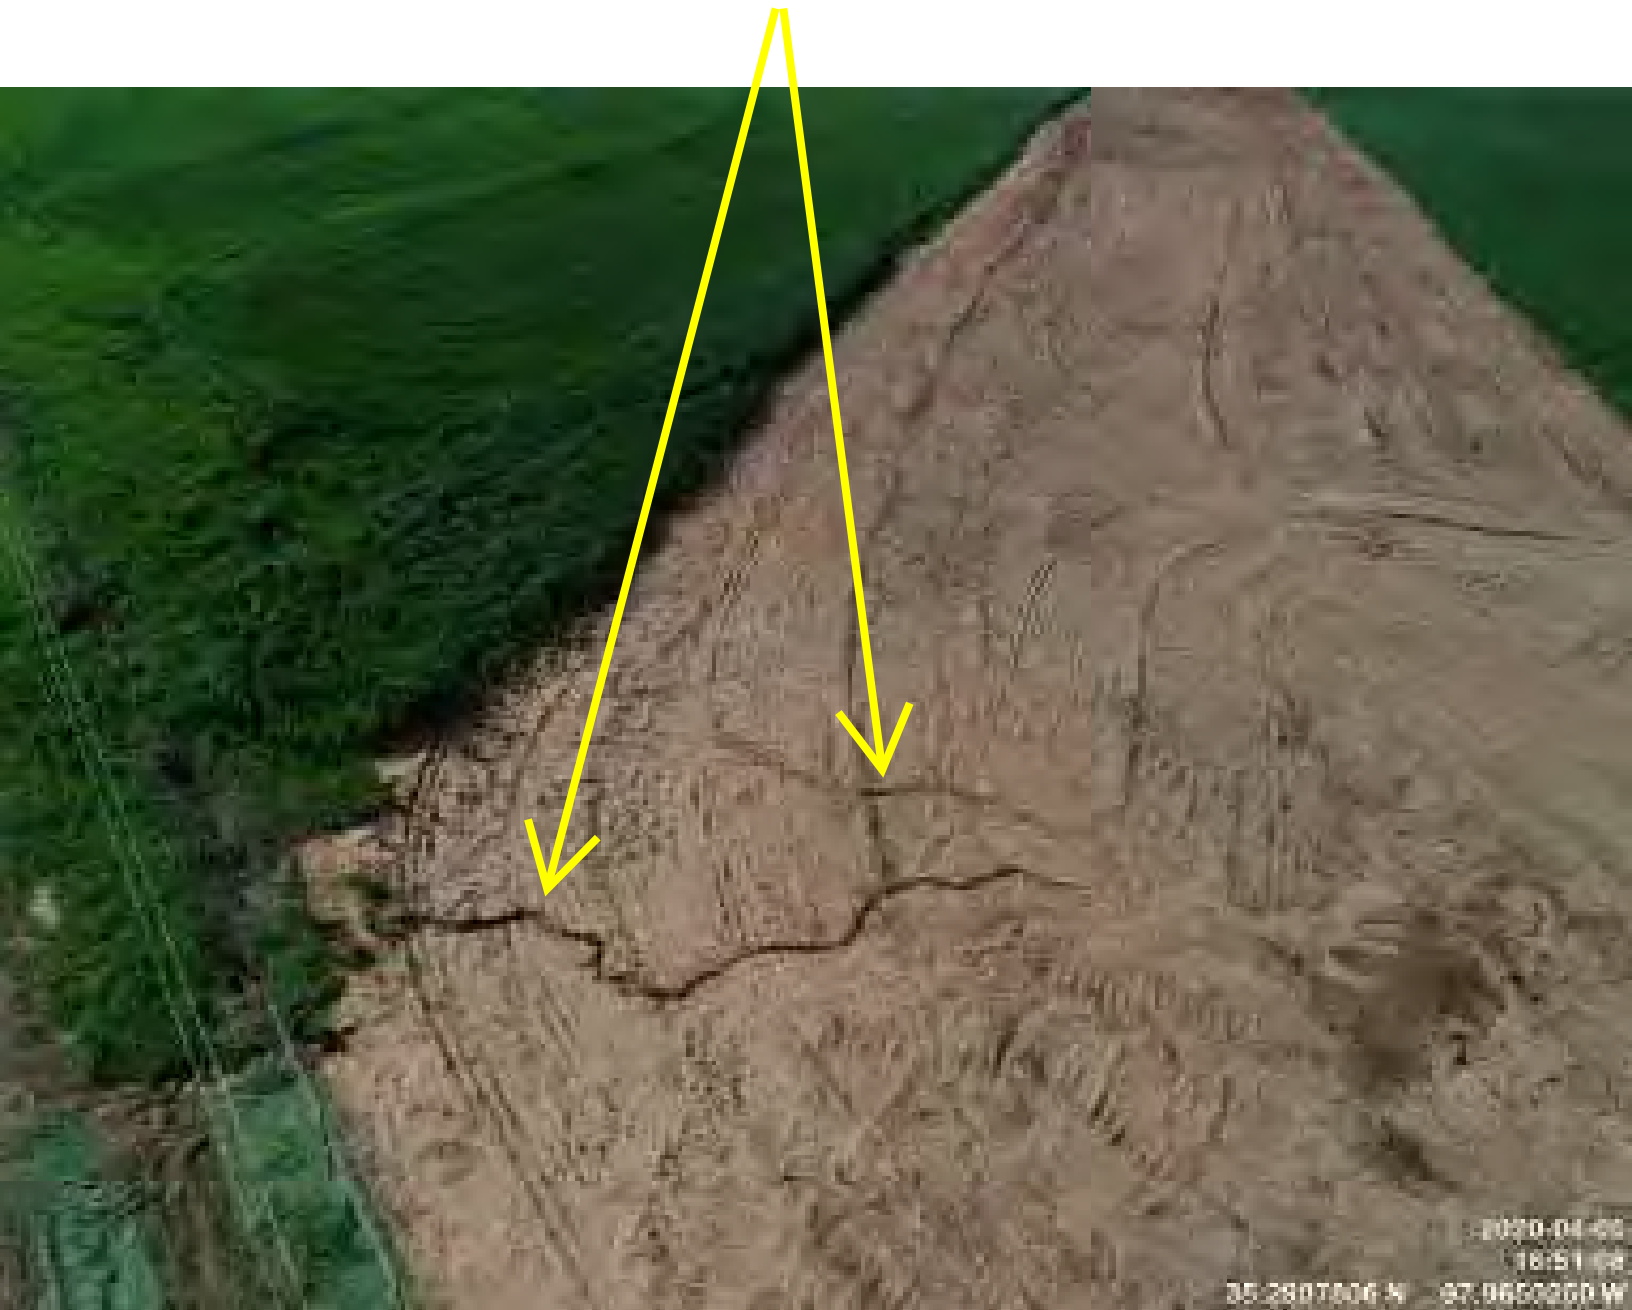
Erosion Rills Due to Lack of Vegetation

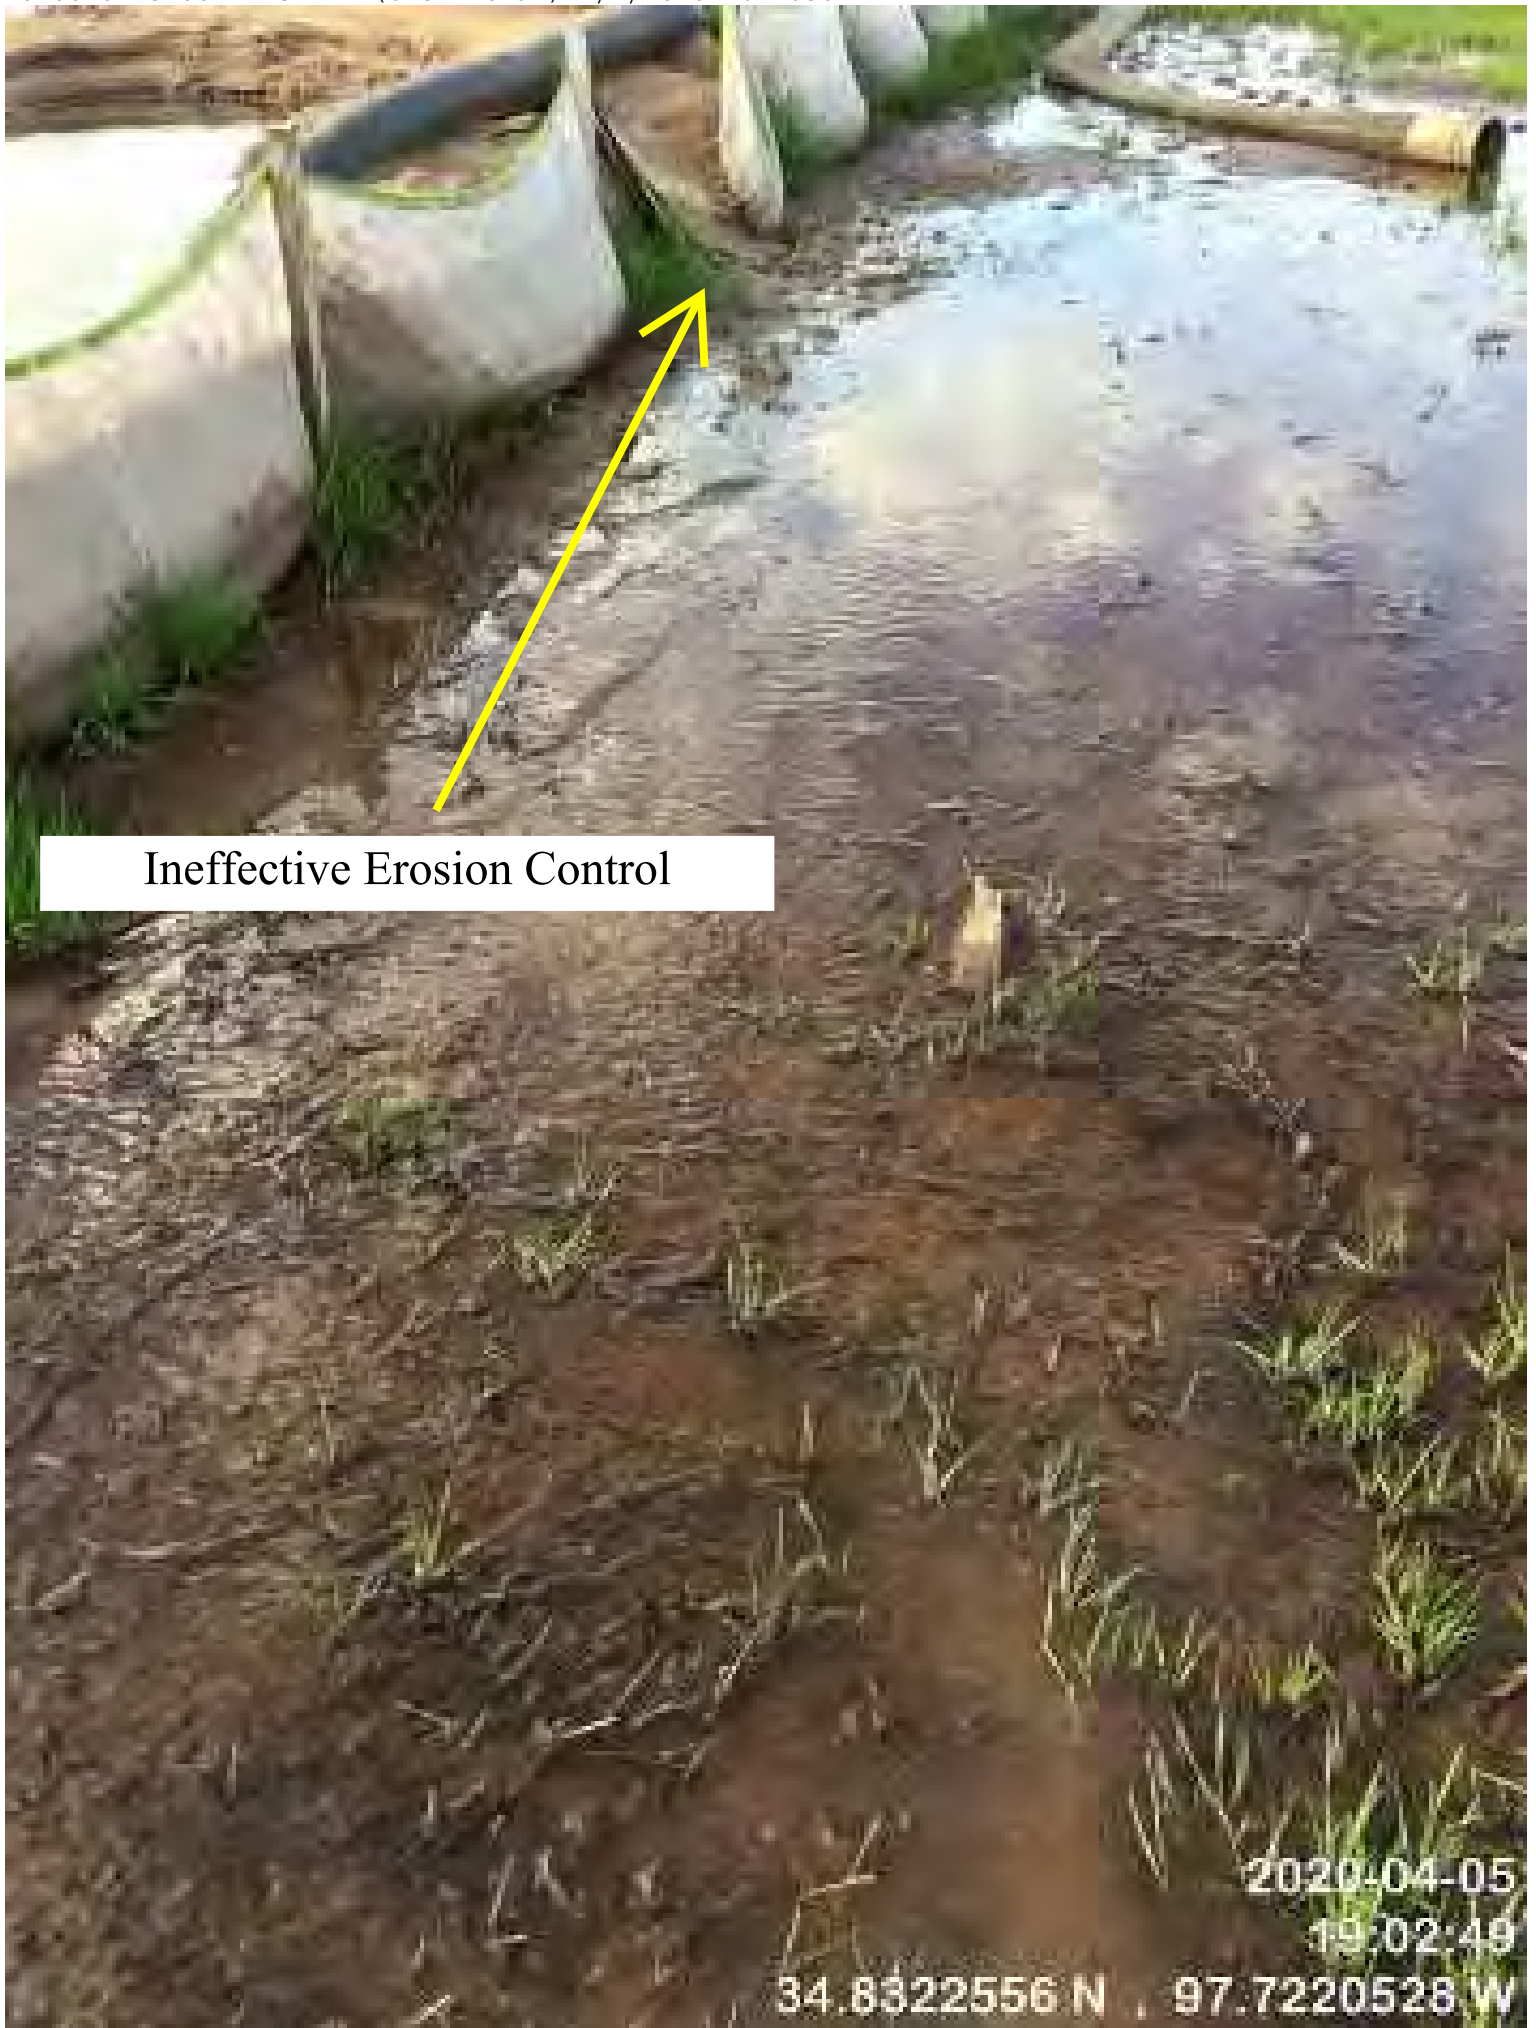
Ineffective Erosion Control

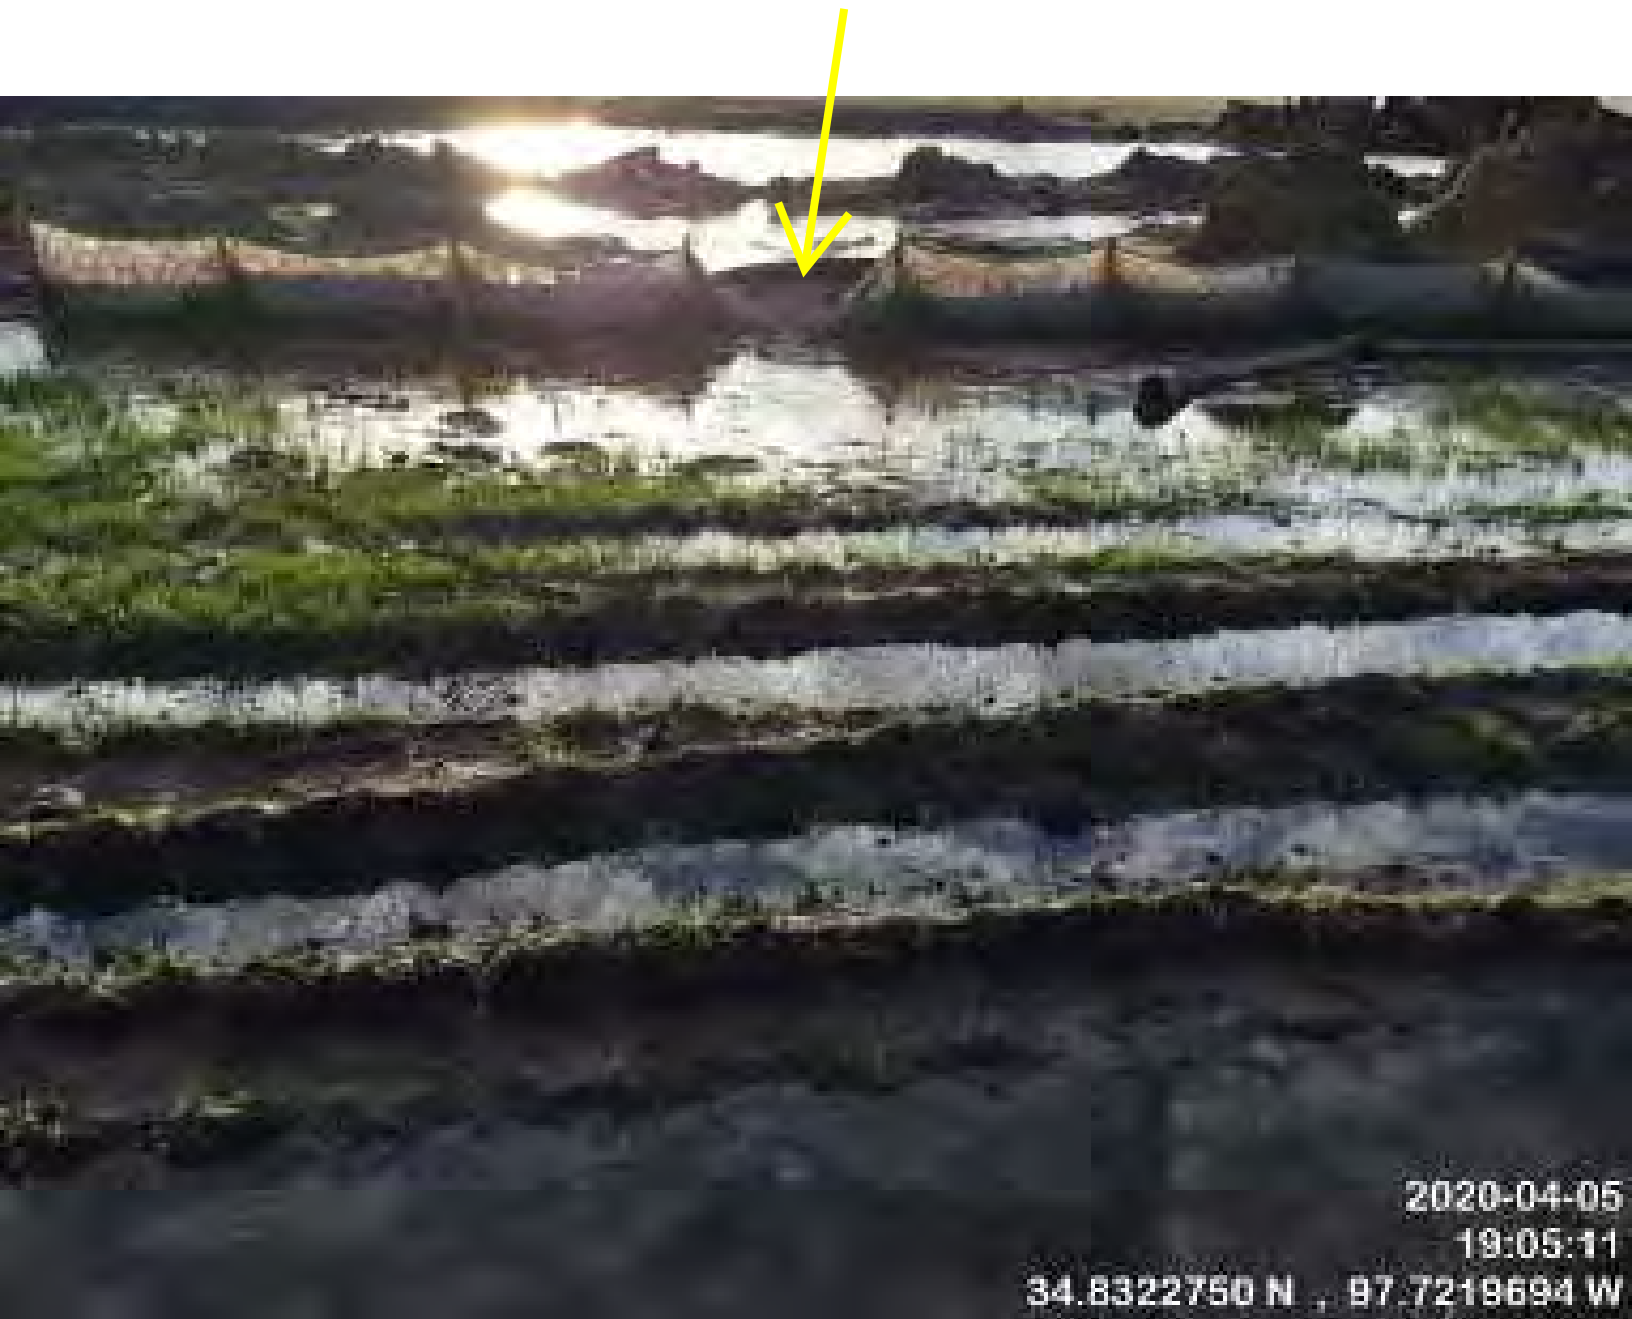
Ineffective Erosion Control

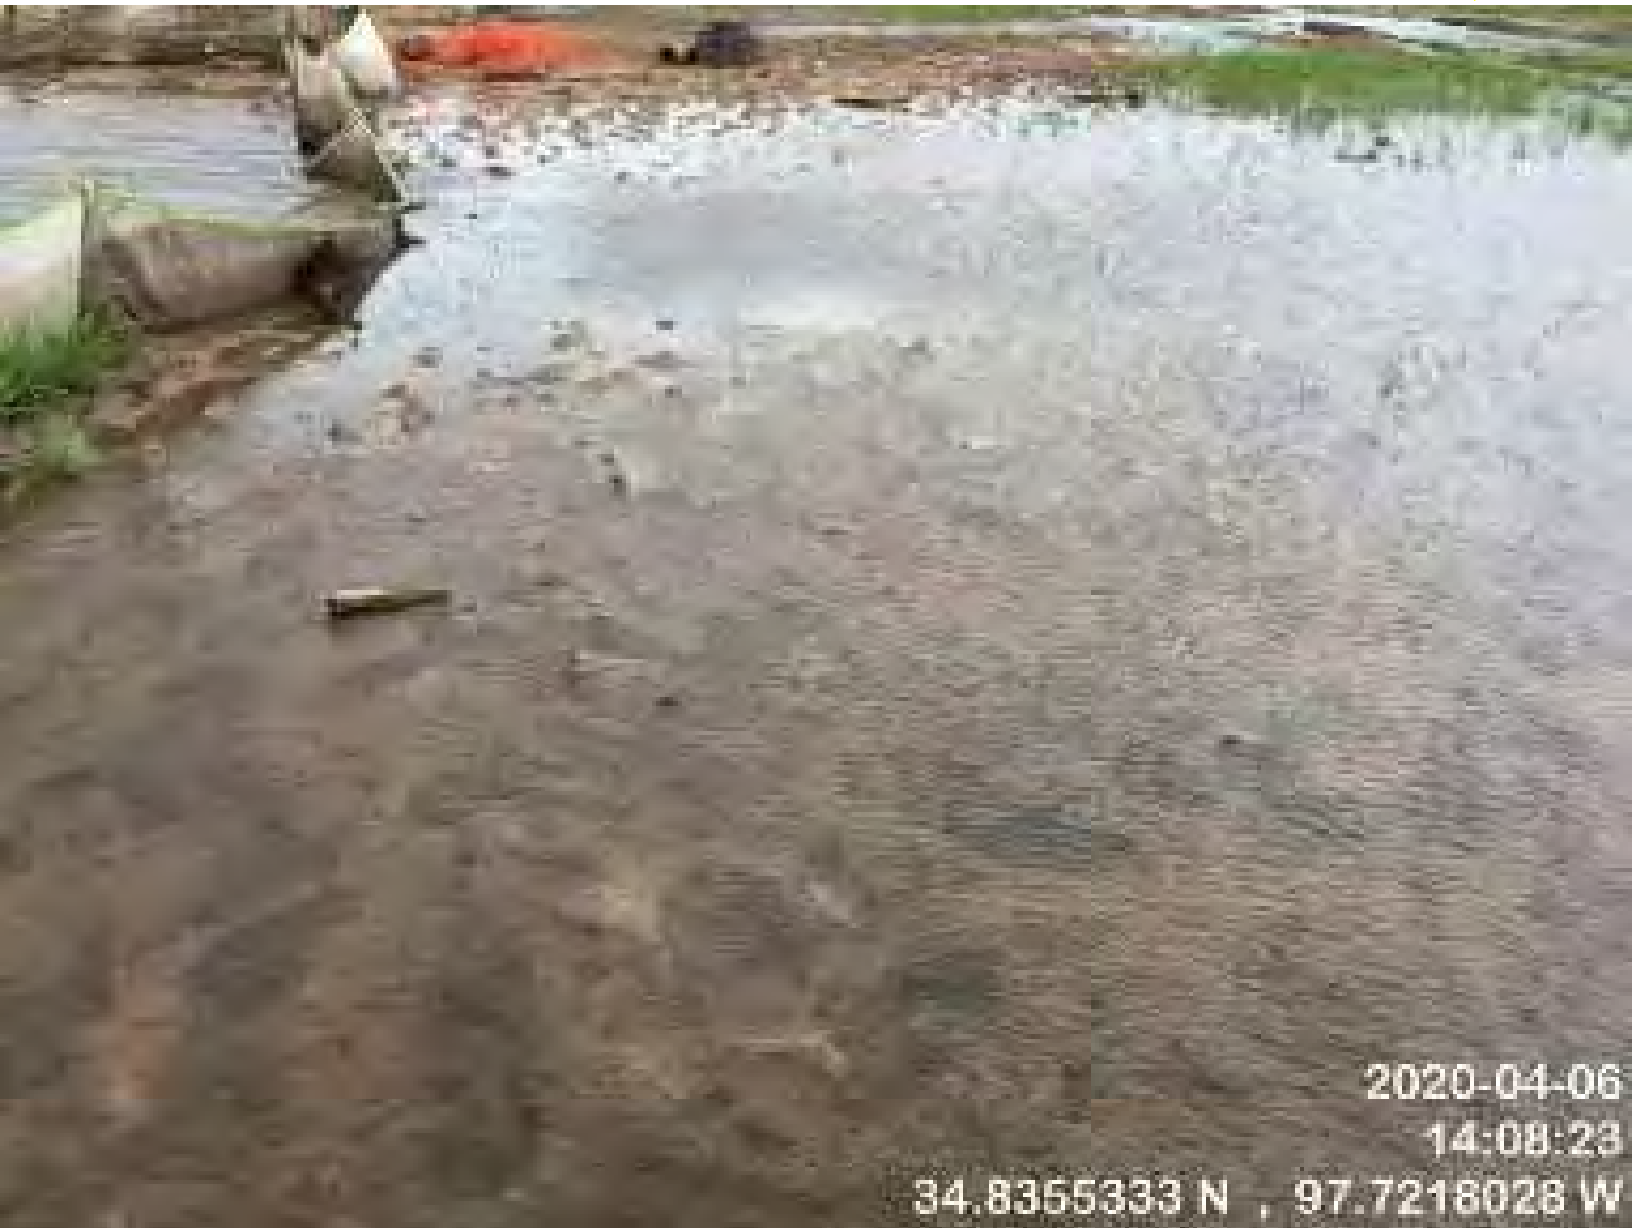
Off Right-of-Way
