Robert Squires - Squires Consulting LLC
Landowner Advocate

Opening Statement for May 5, 2021 Subcommittee on Civil Rights and Civil Liberties Hearing:
“Pipelines Over People (Part II): Midship Pipeline’s Disregard for Landowners in Its Pathway”

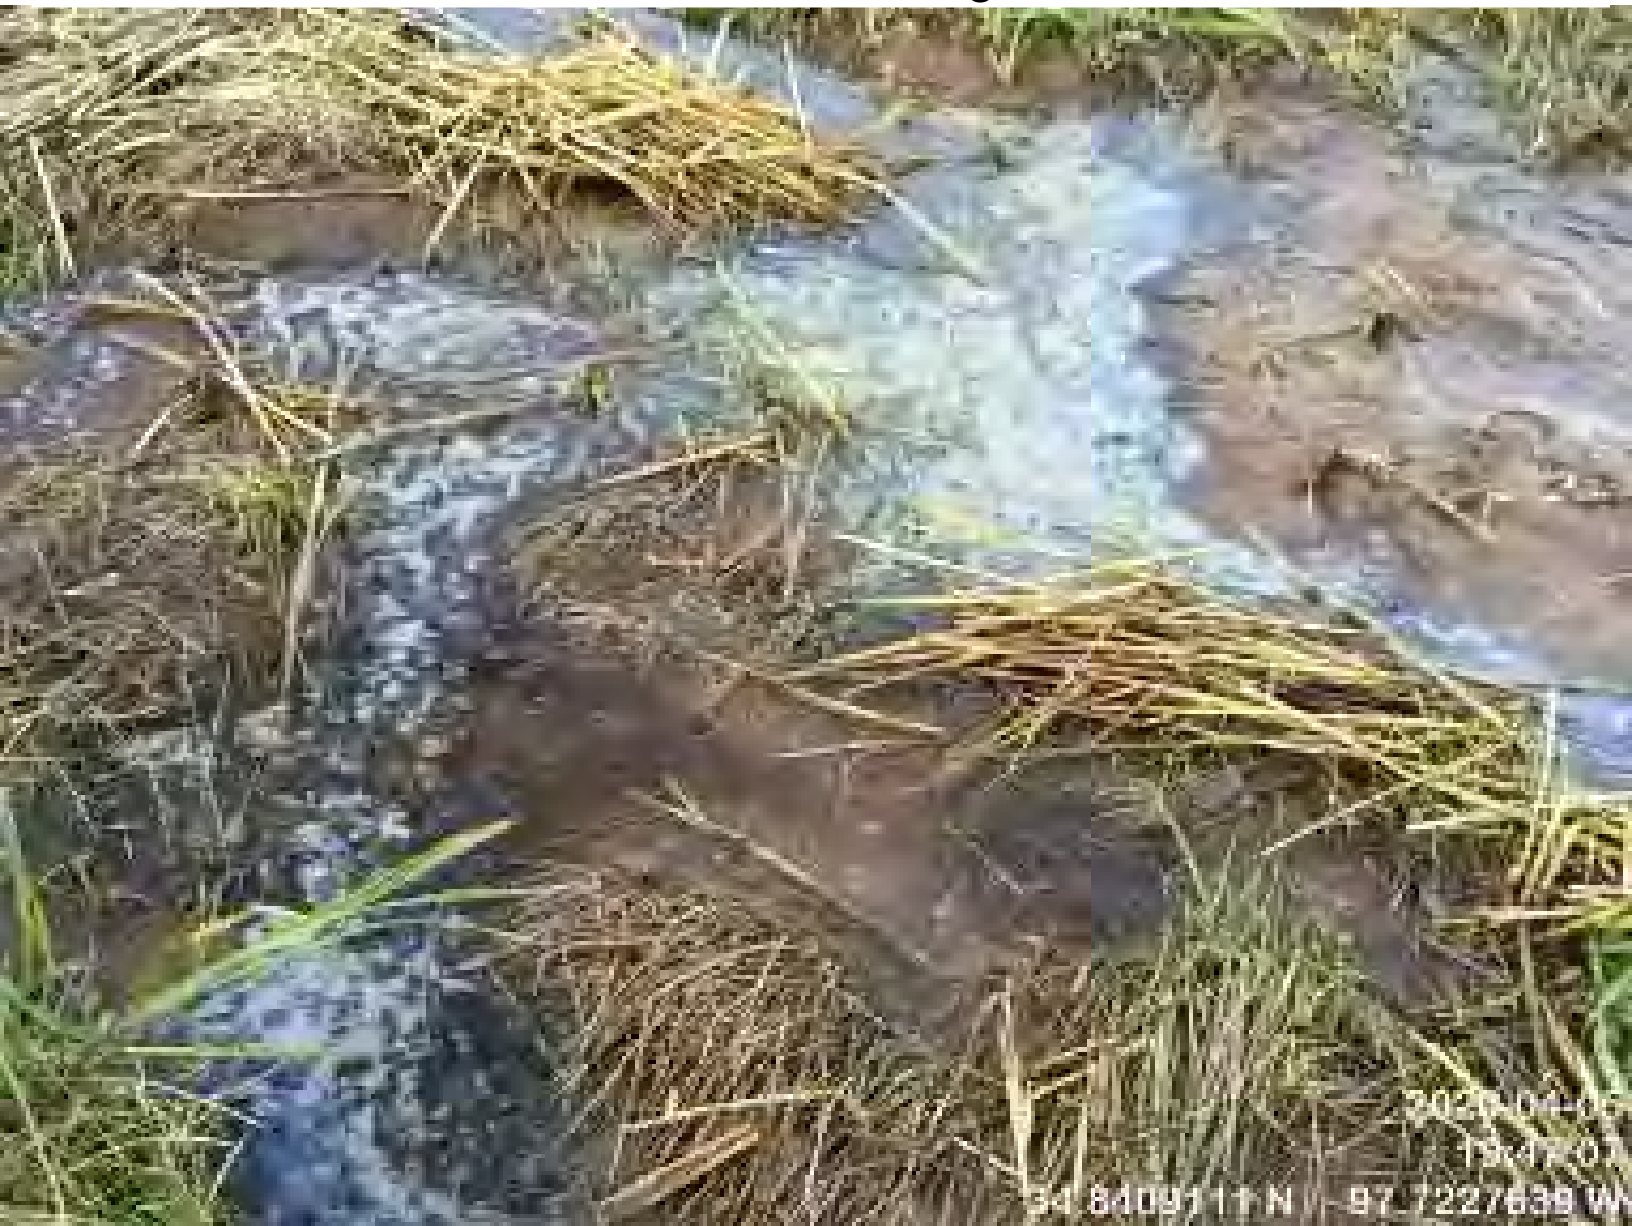
Sheeny Substance Flowing Away from Right-of-Way
Less than 100 feet from Irrigation Pond

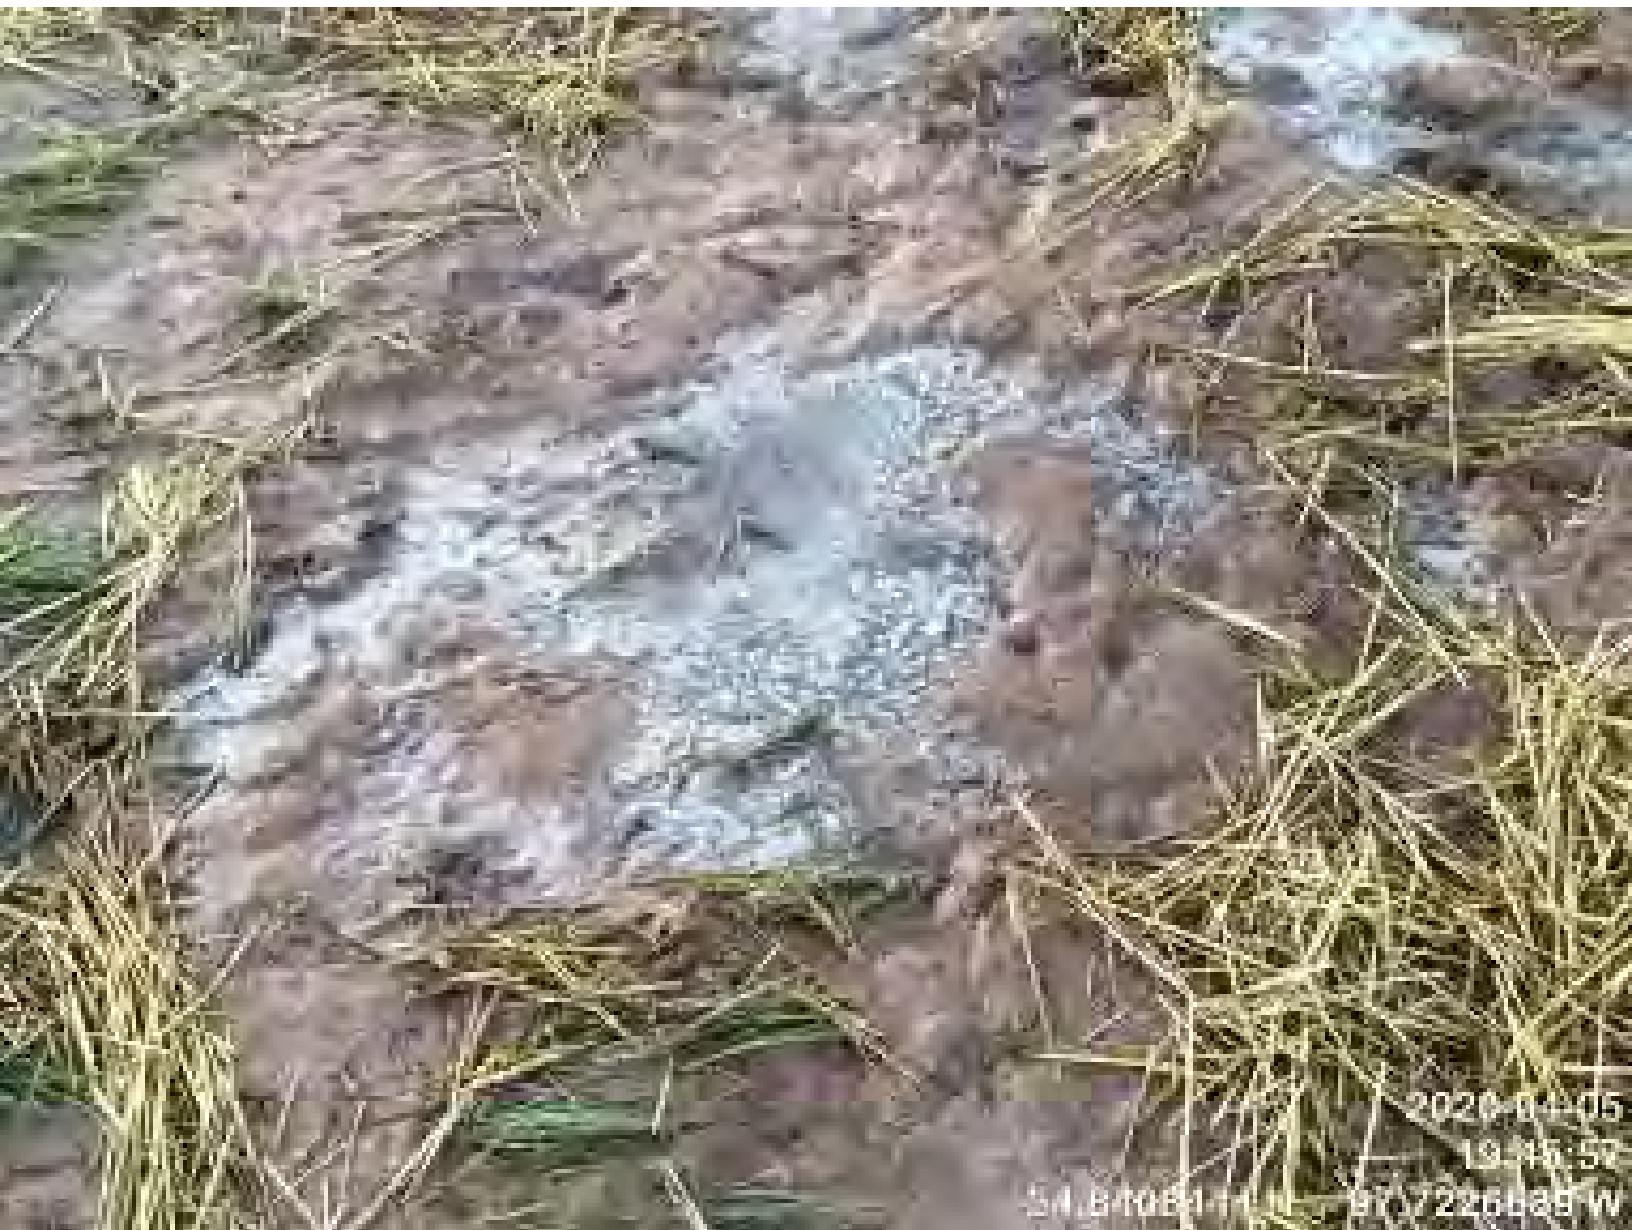
Sheeny Substance at Edge of Right-of-Way
Less than 100 feet from Irrigation Pond

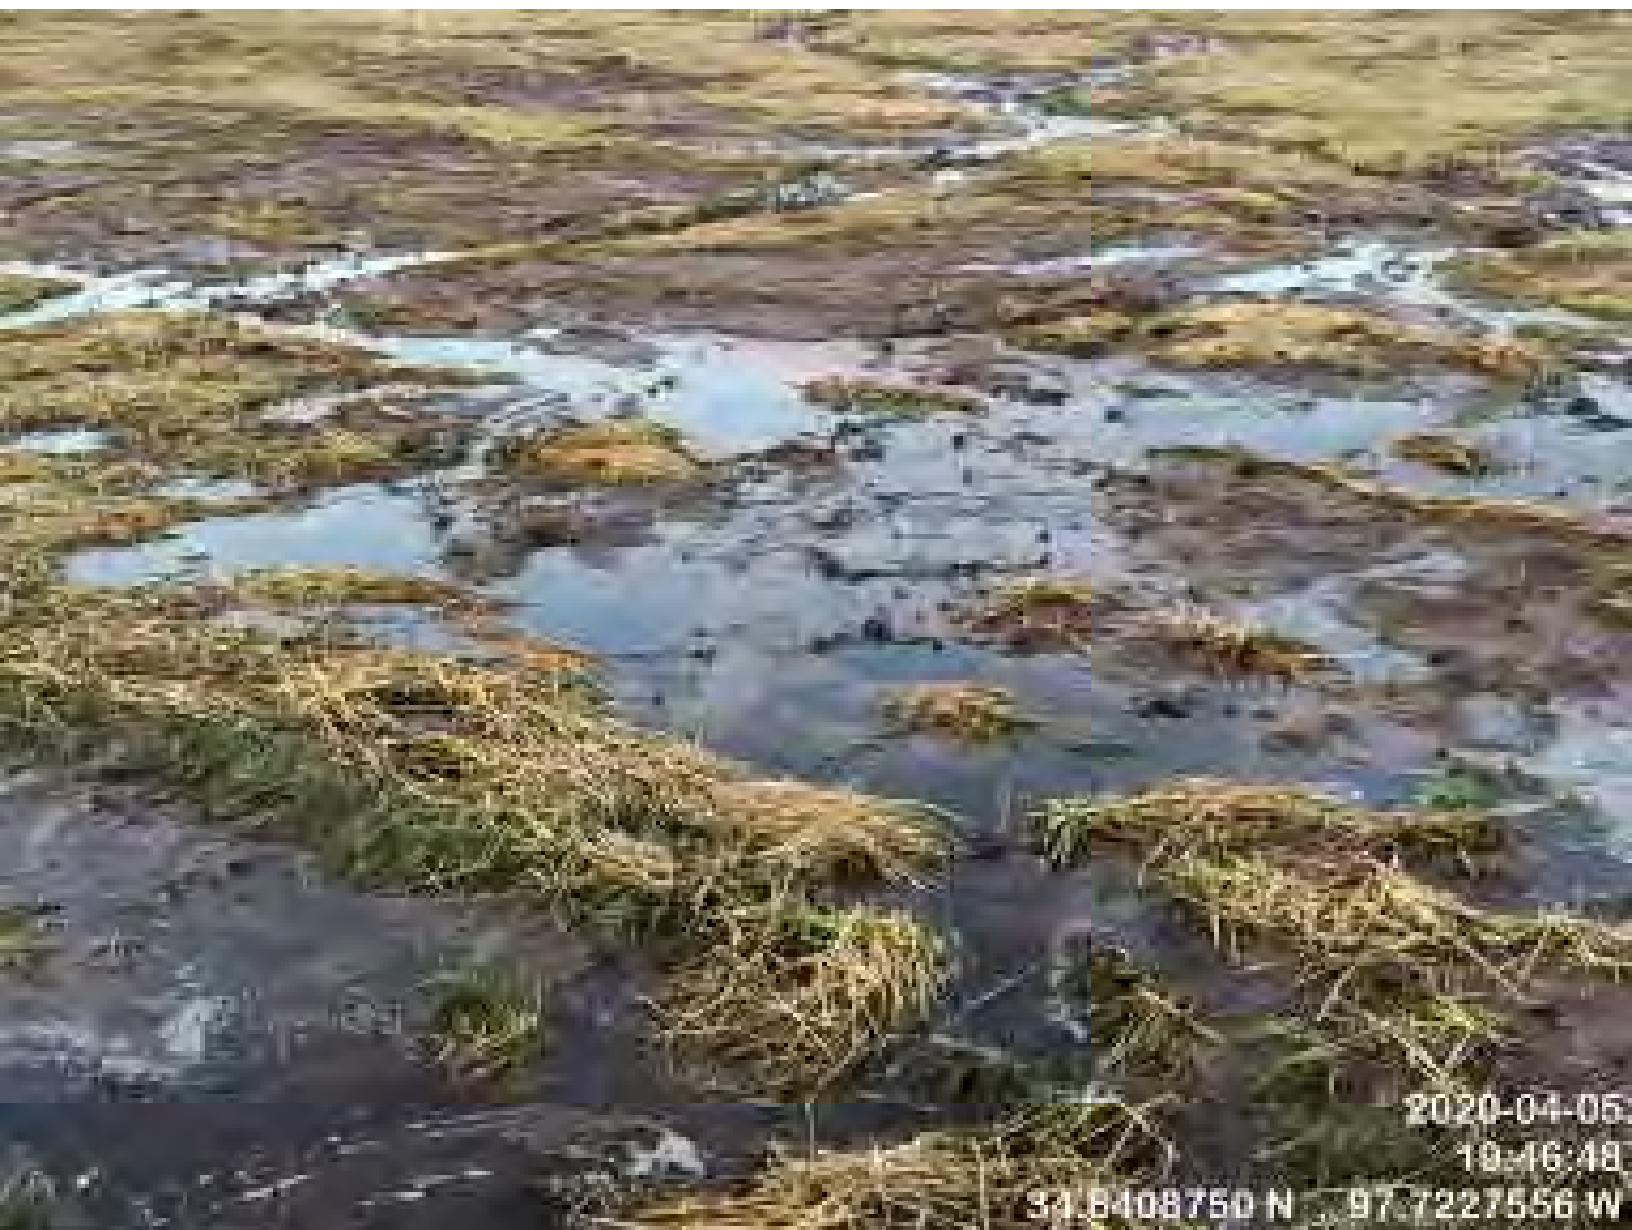
Sheeny Substance Flowing Away from Right-of-Way
Less than 100 feet from Irrigation Pond

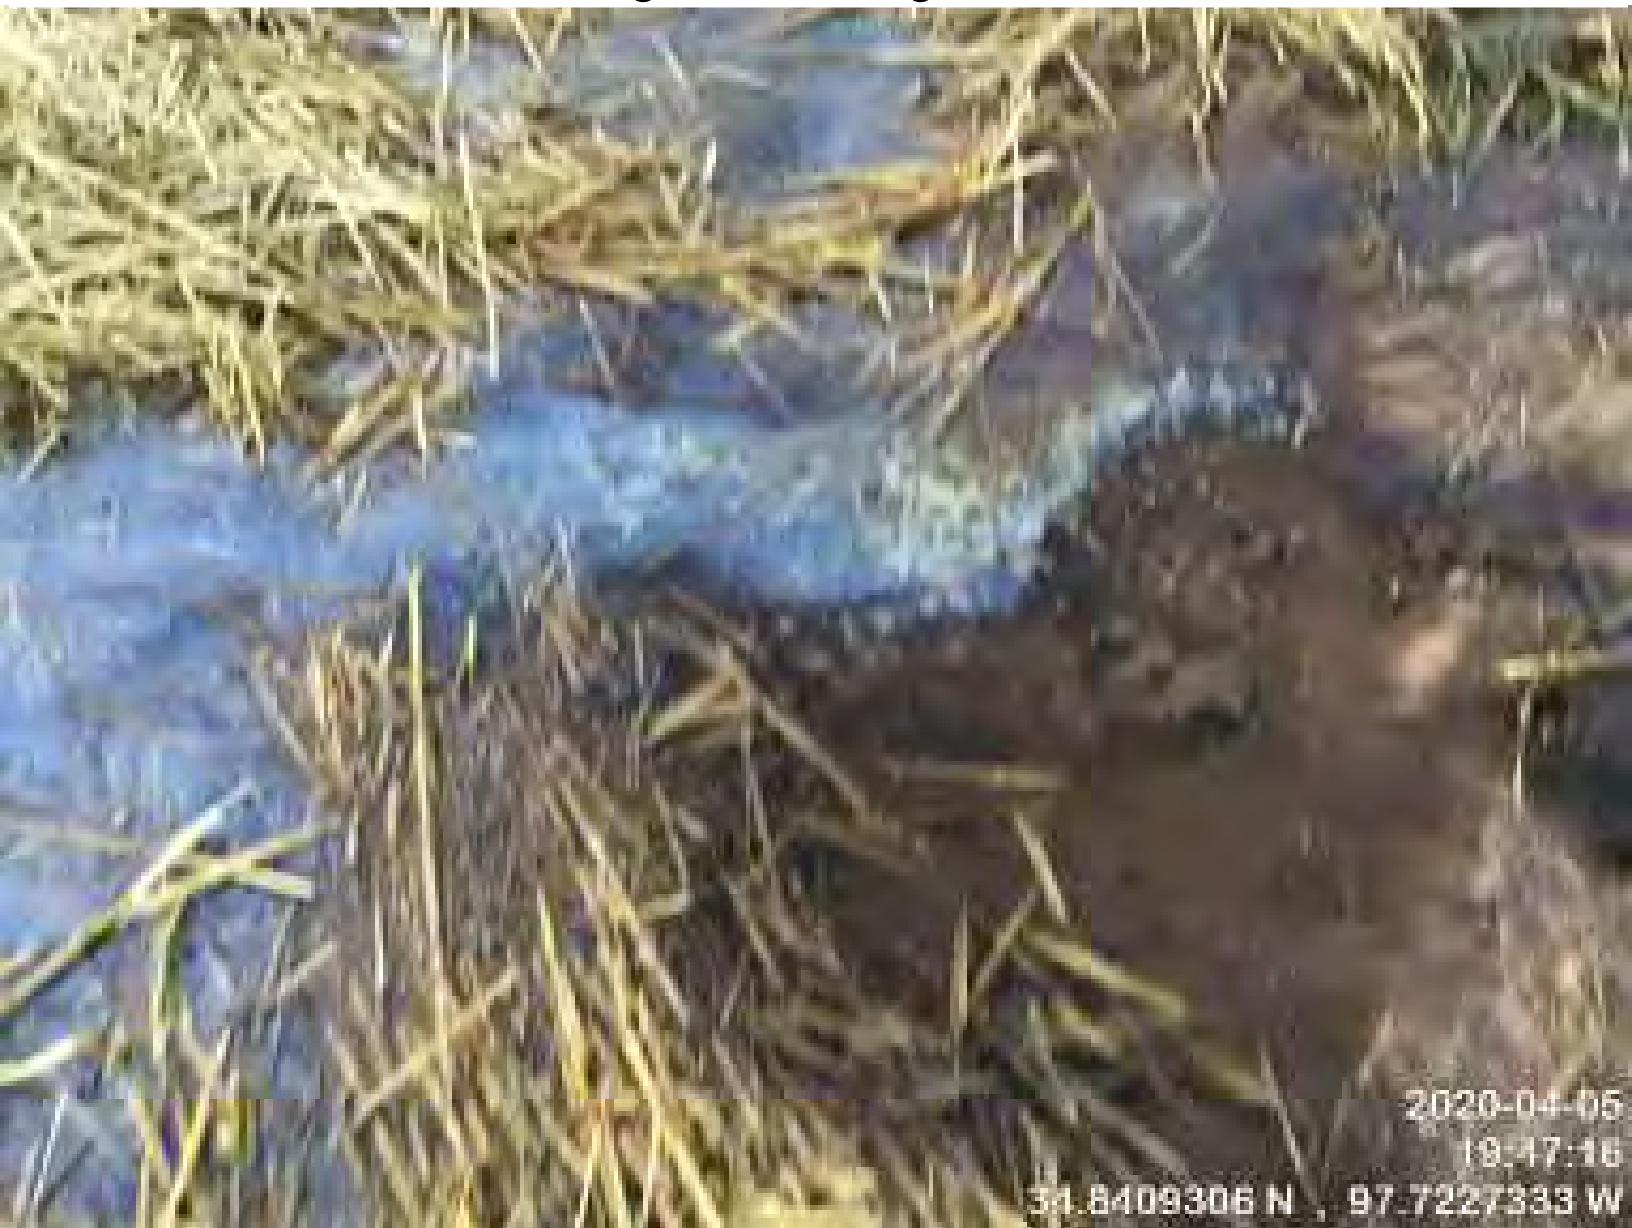
Sheeny Substance at Edge of Right-of-Way
Flowing Towards Irrigation Pond

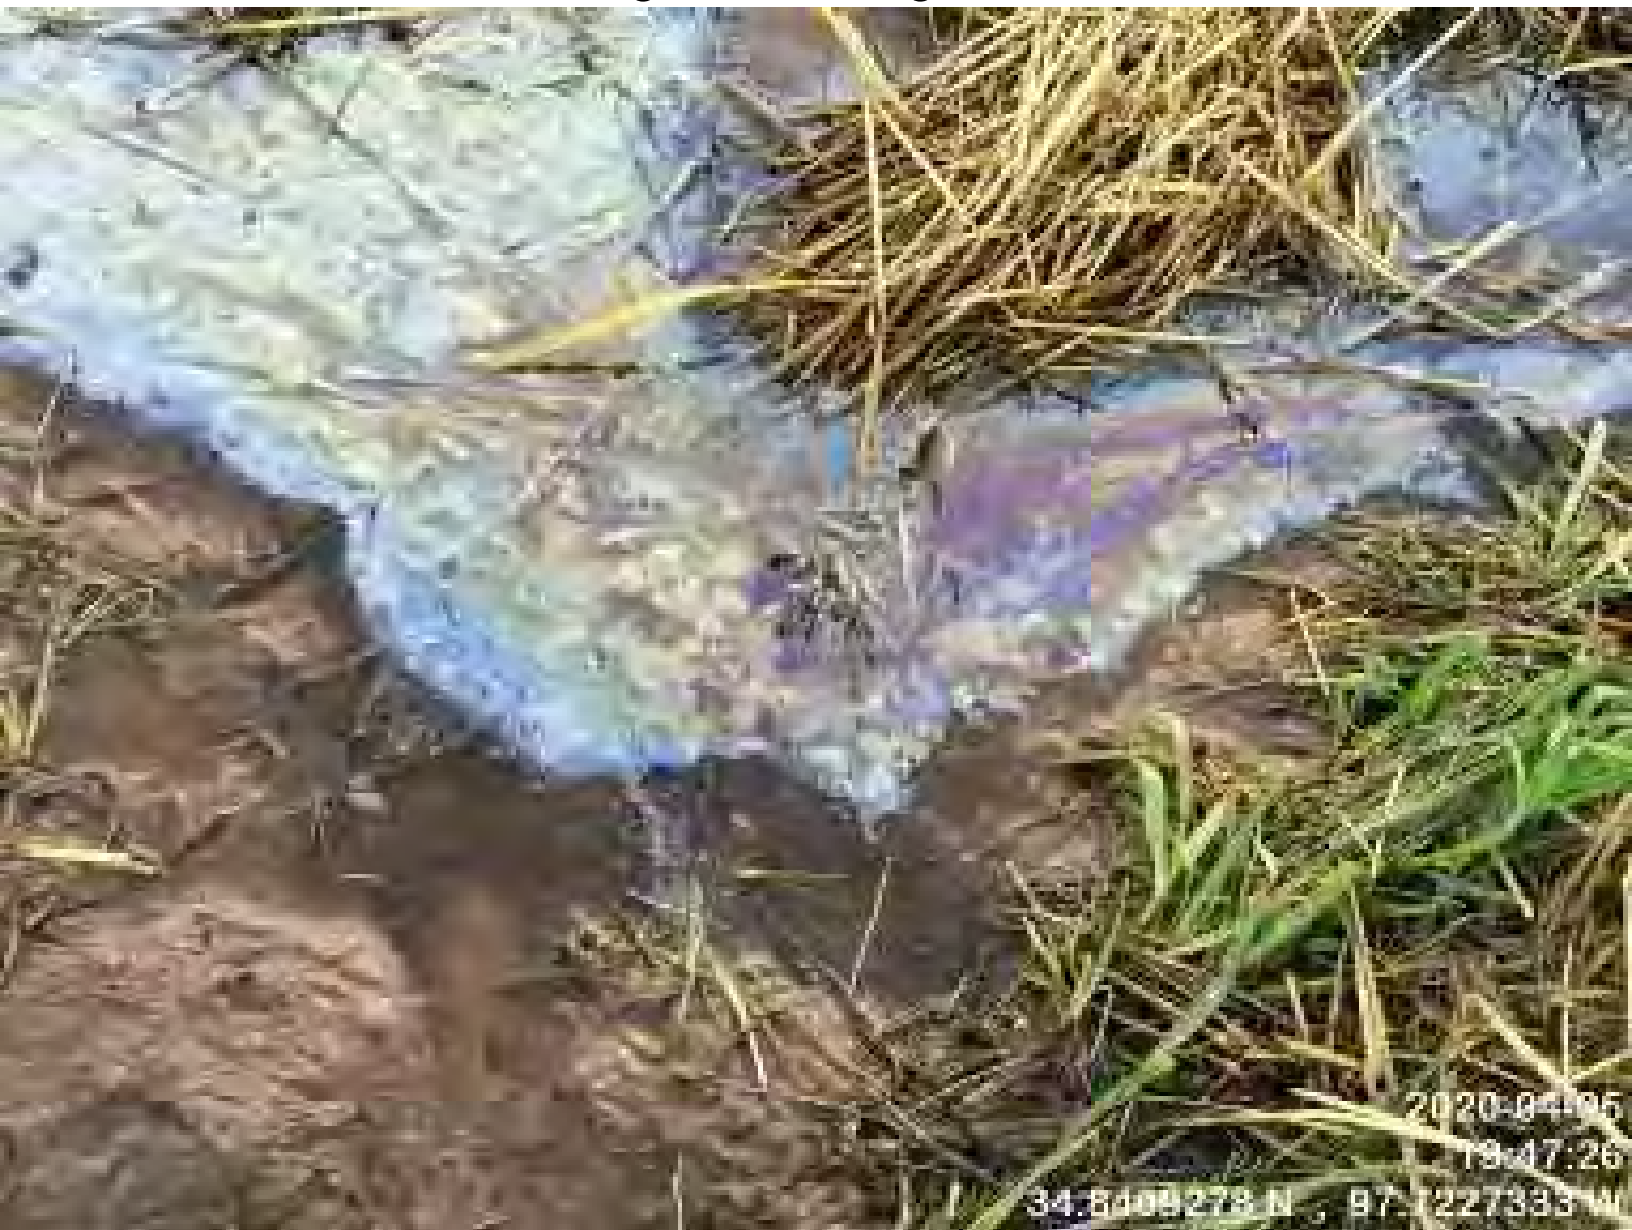
Sheeny Substance at Edge of Right-of-Way
Flowing Towards Irrigation Pond

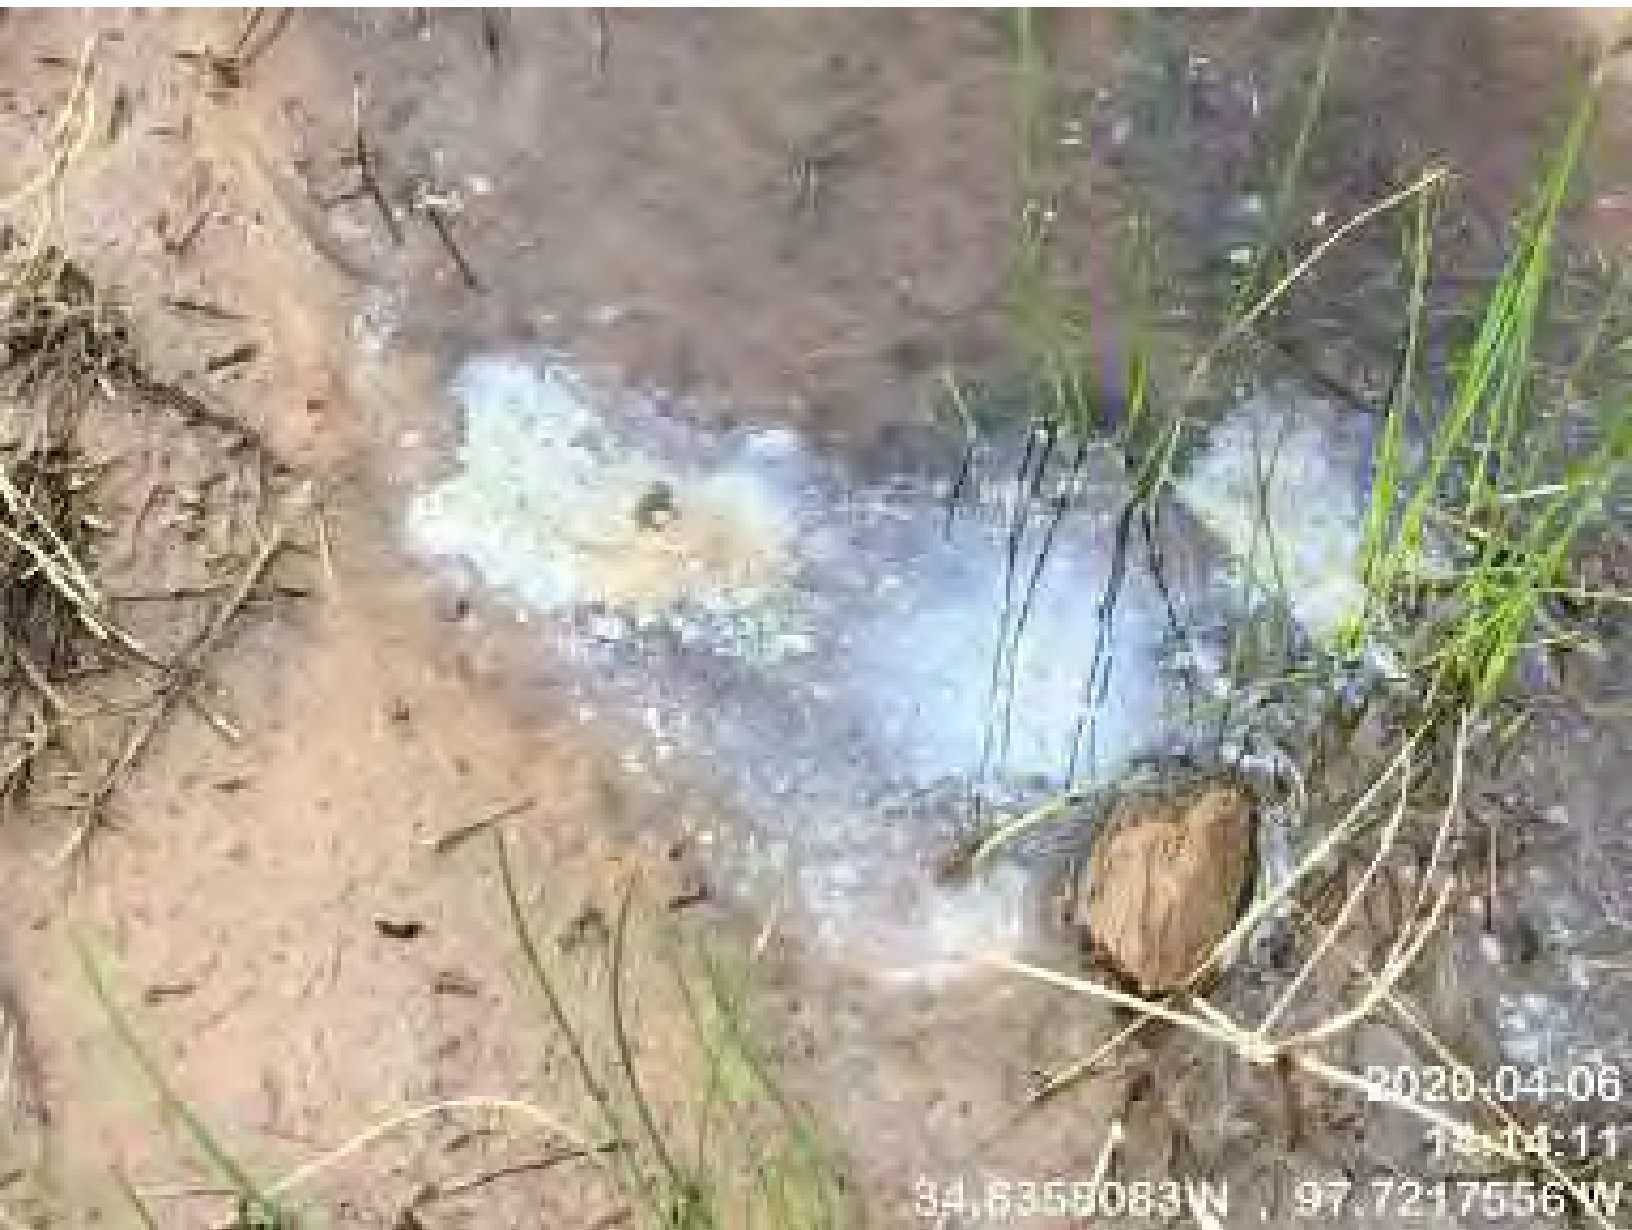
Sheeny Substance Inside Right-of-Way

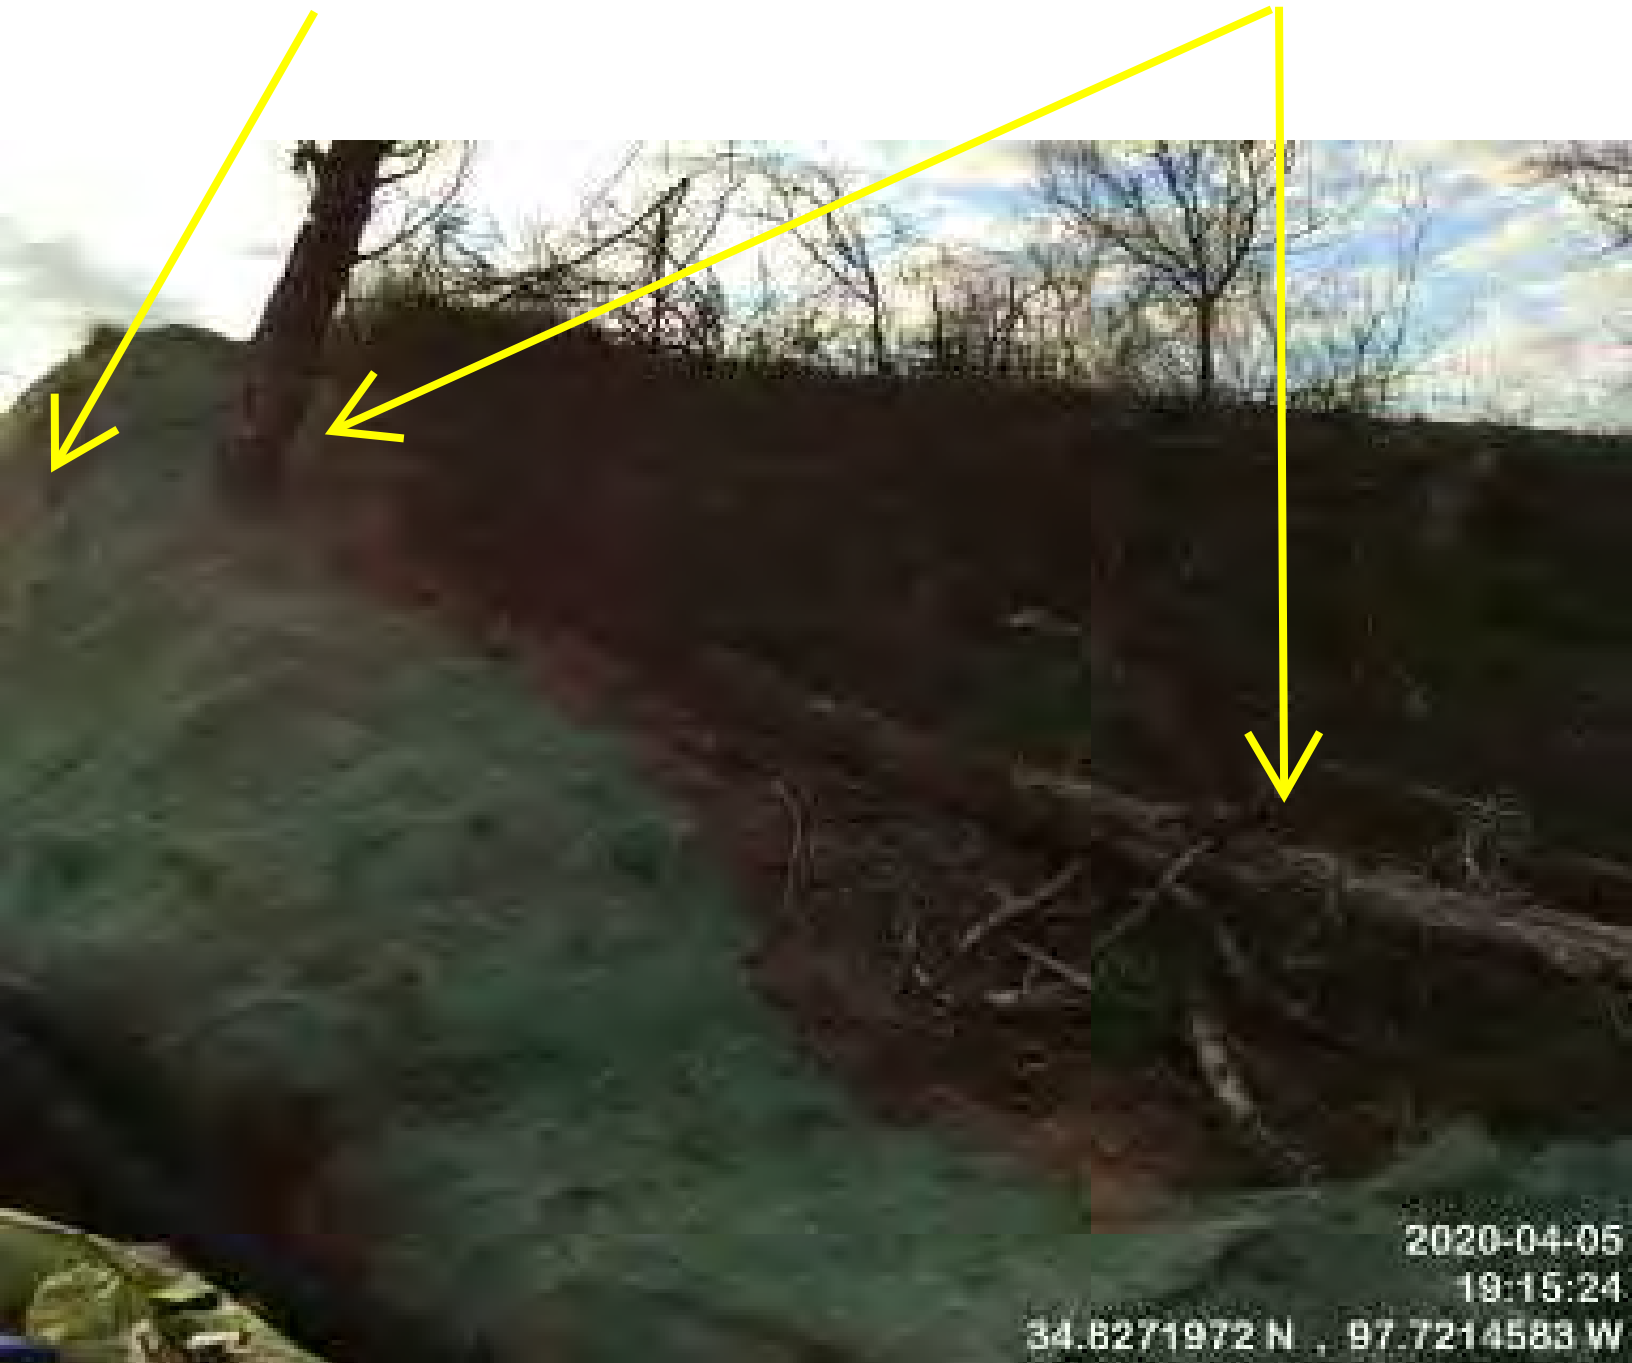
Trees Falling and Slipping
Towards Creek

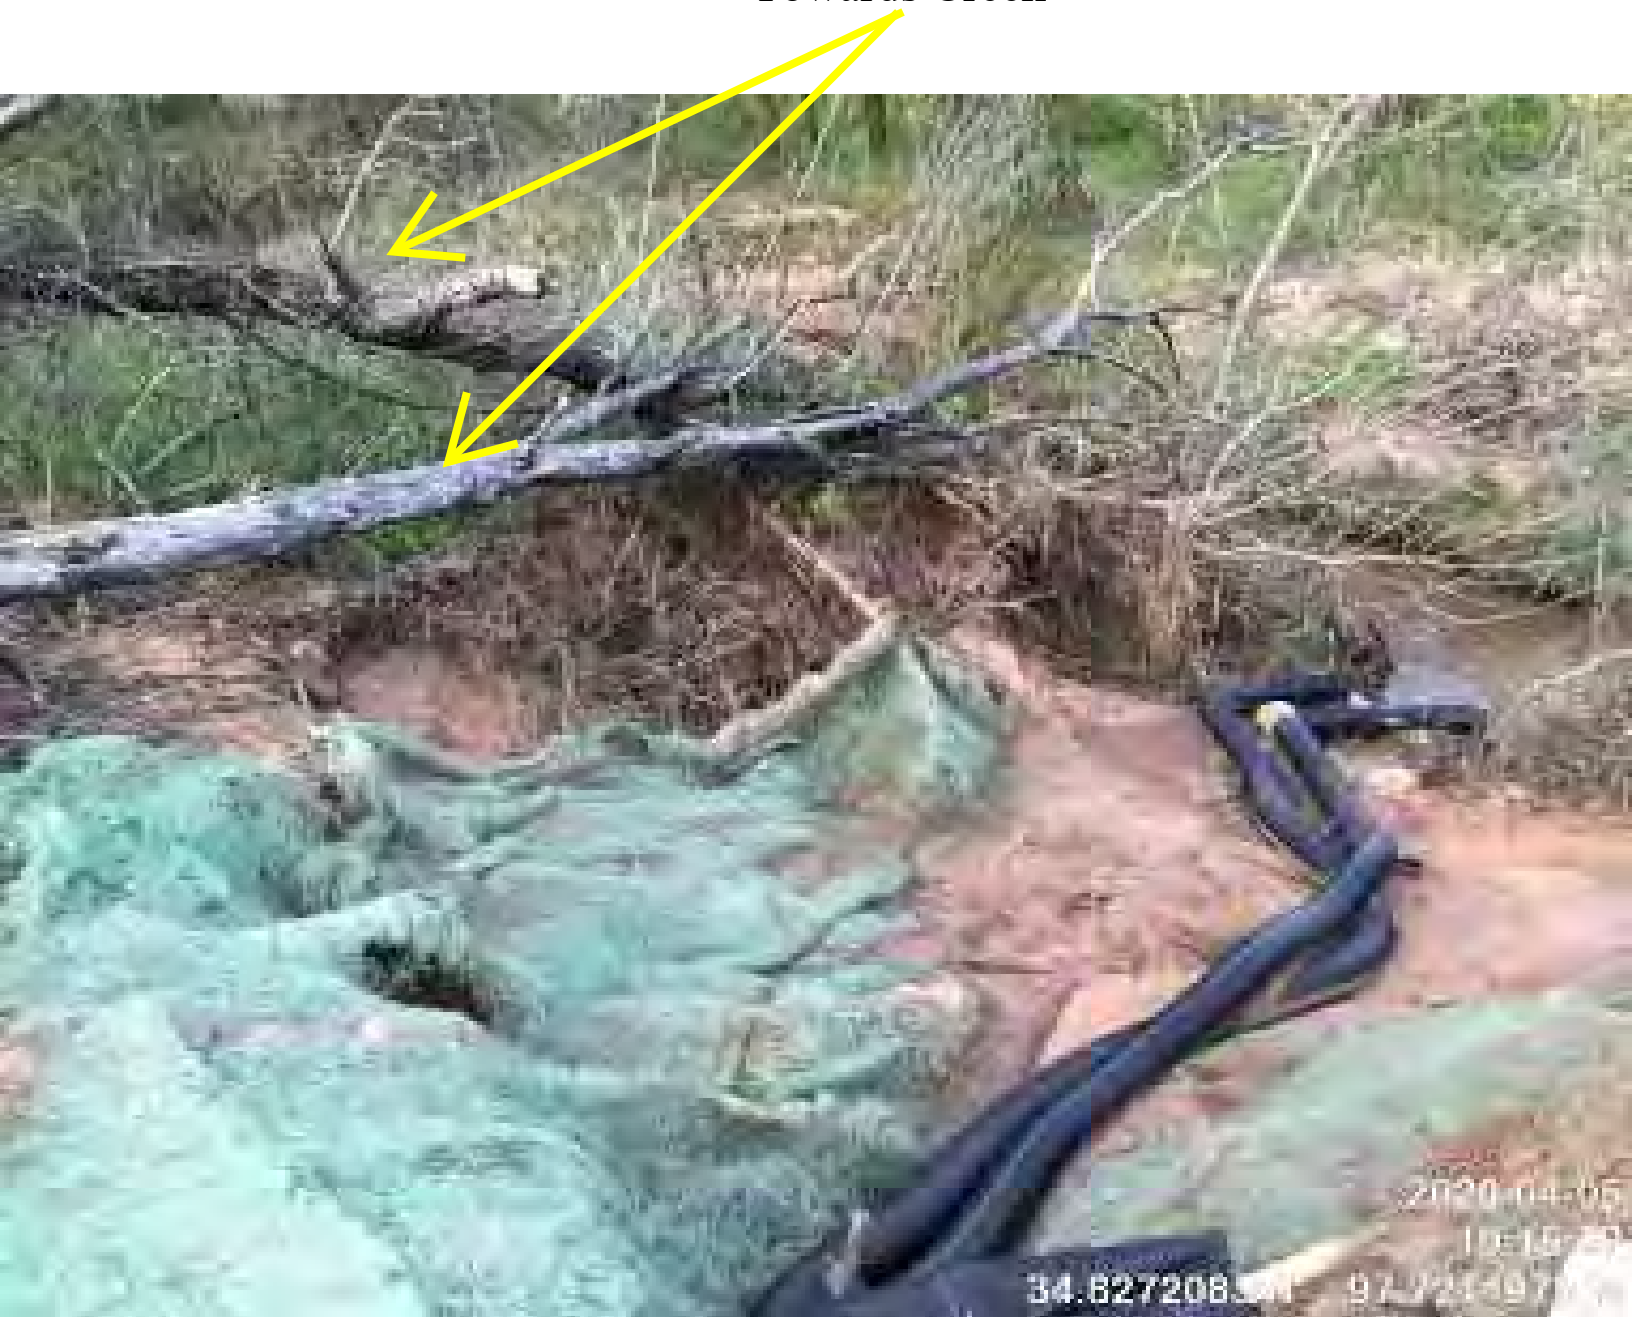
Trees Falling and Slipping
Towards Creek

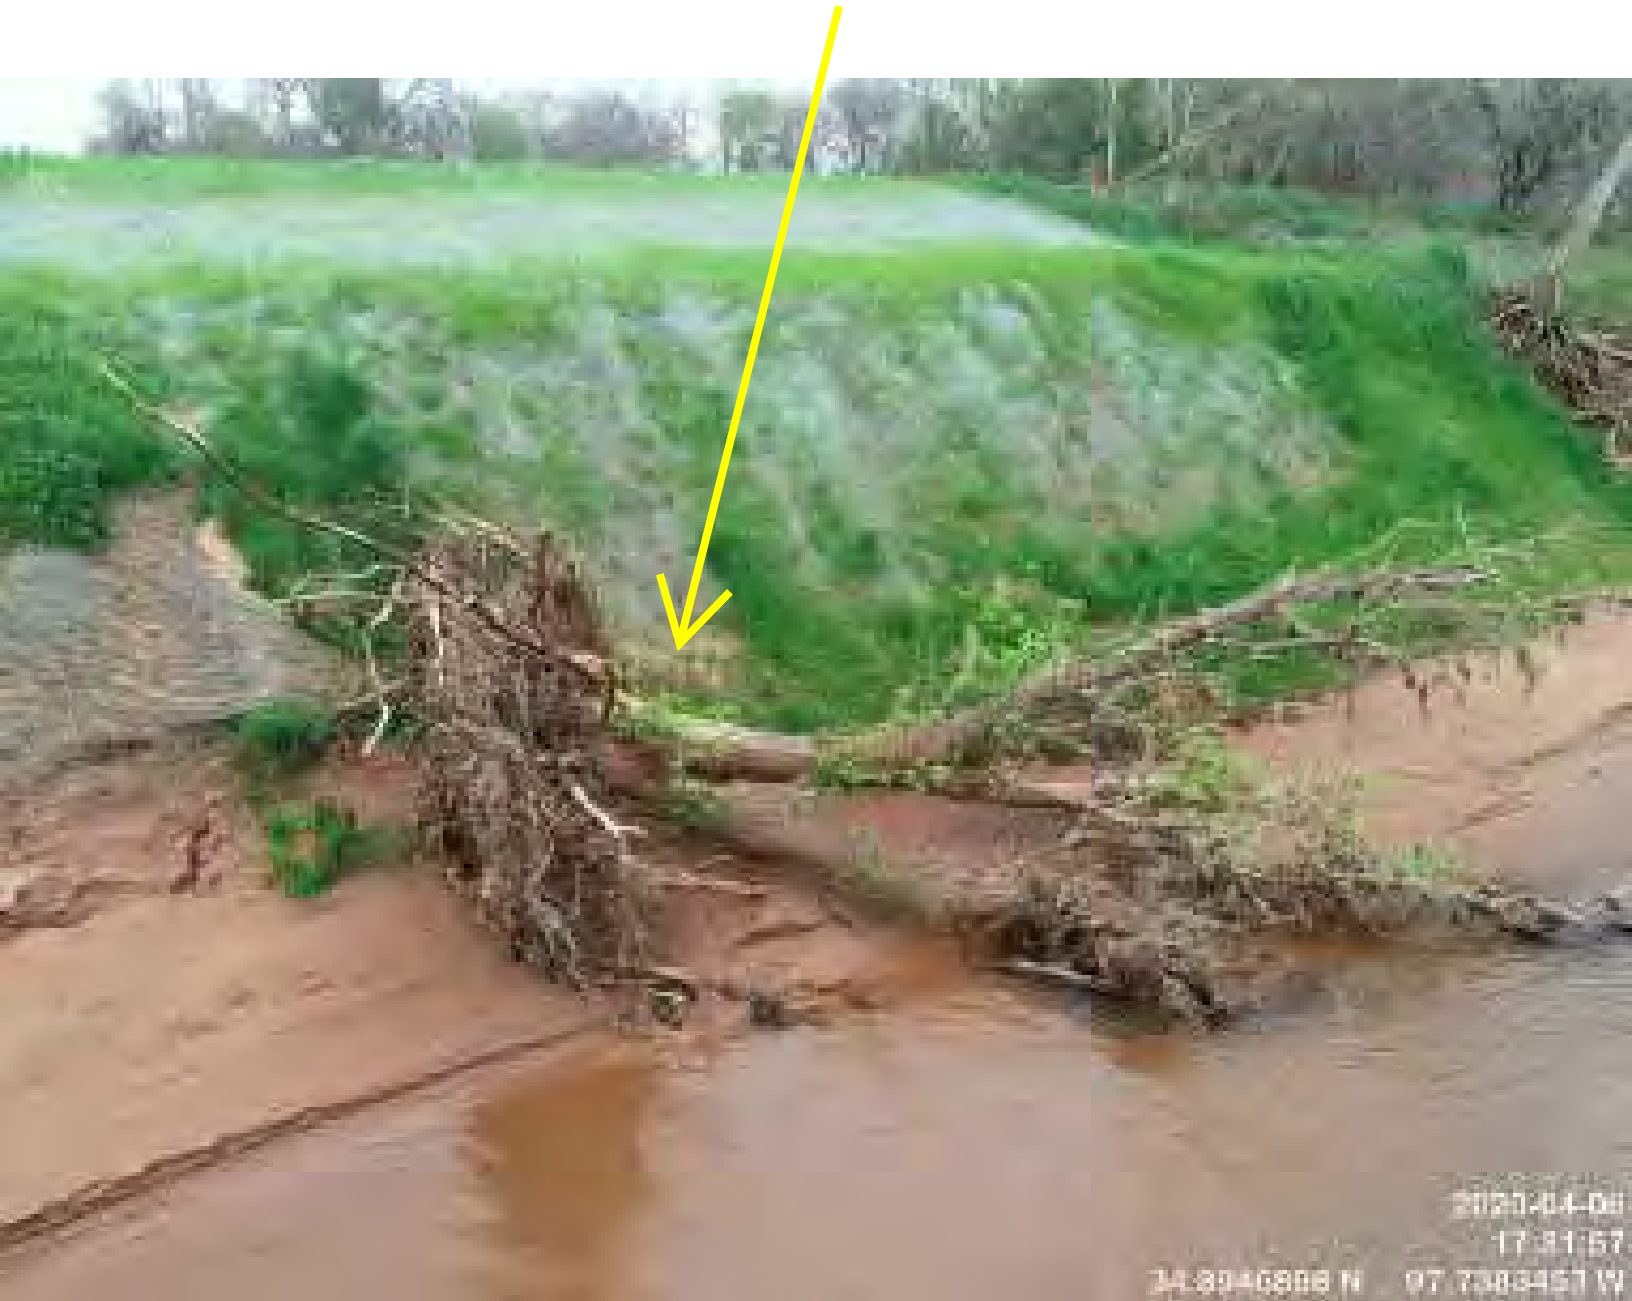
Unstable Creek Bank Causing Trees and Vegetation to Slide into Creek

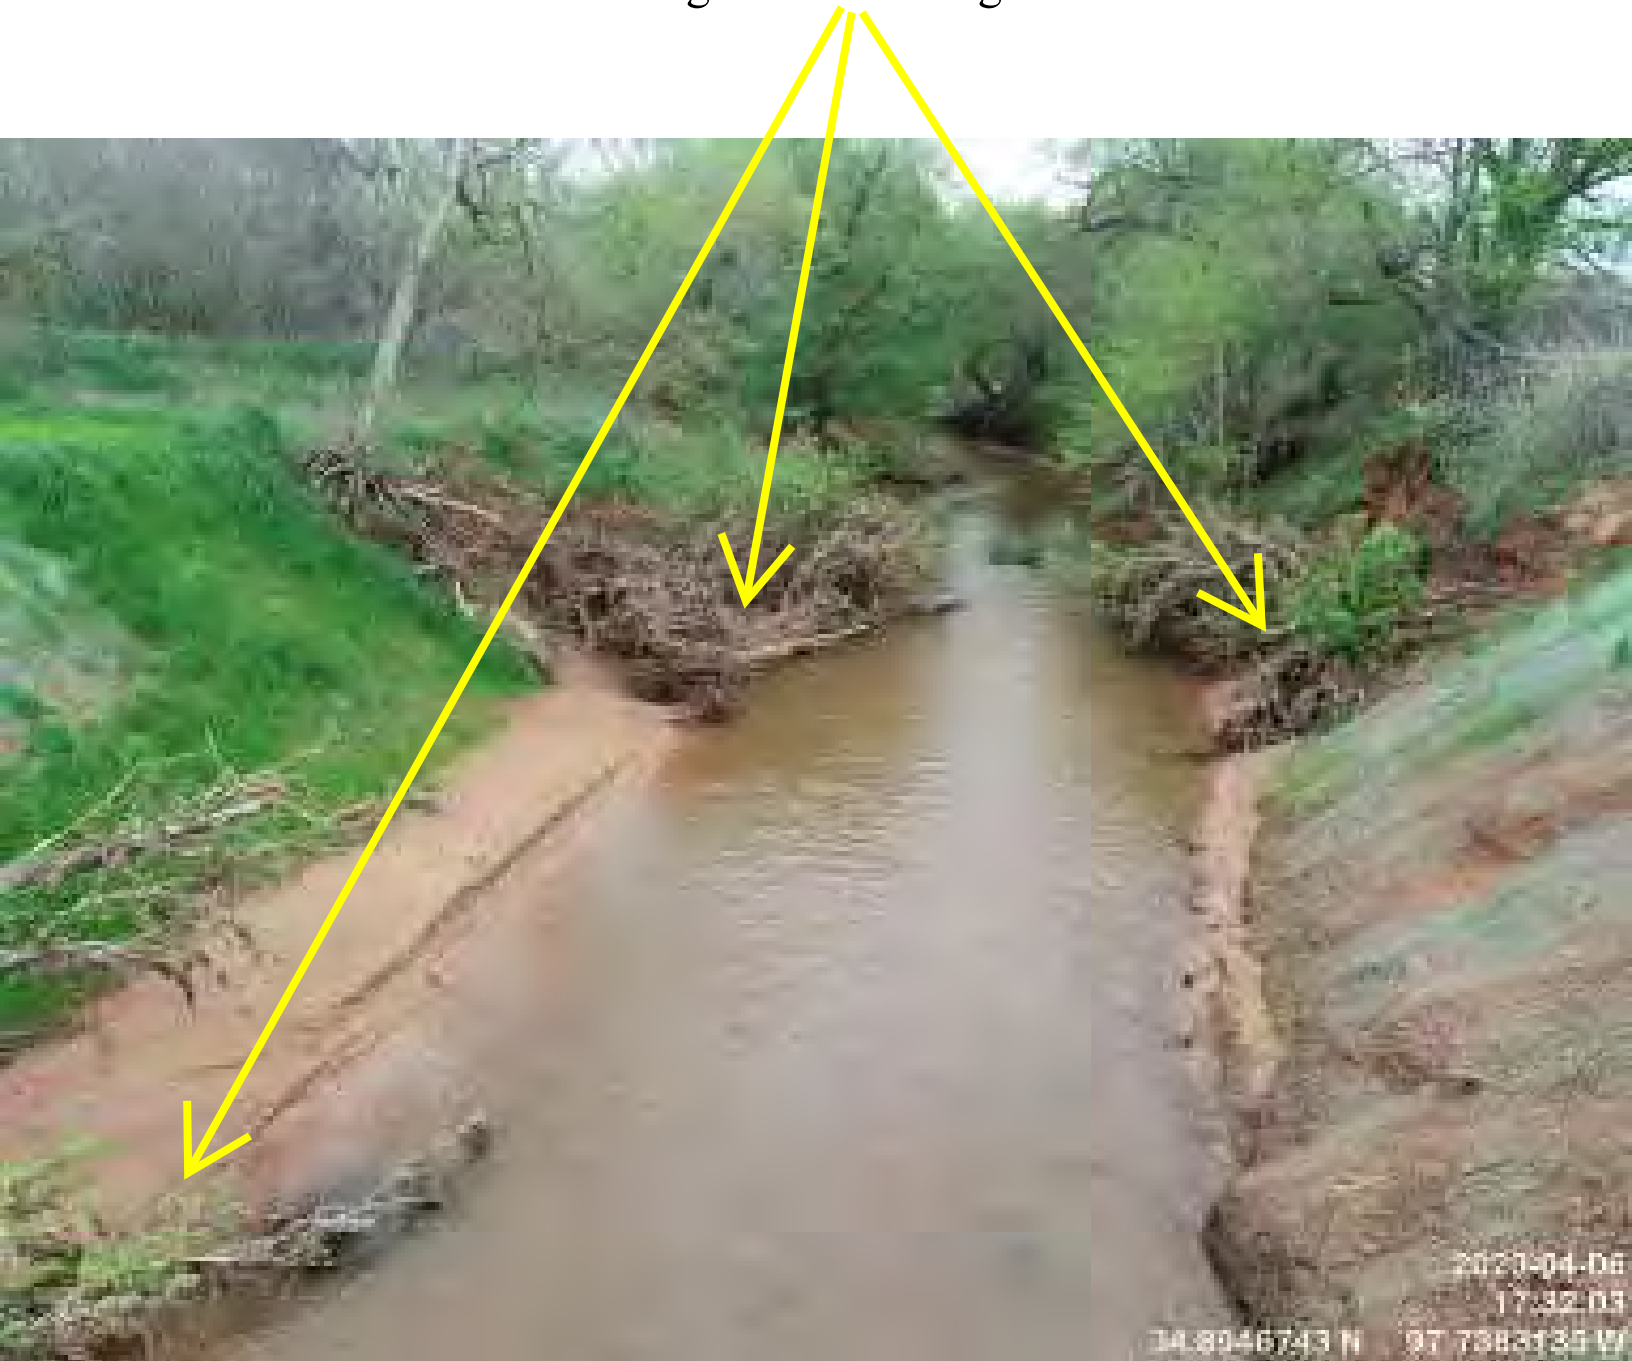
Unstable Creek Bank Causing Trees and Vegetation to Slide into Creek

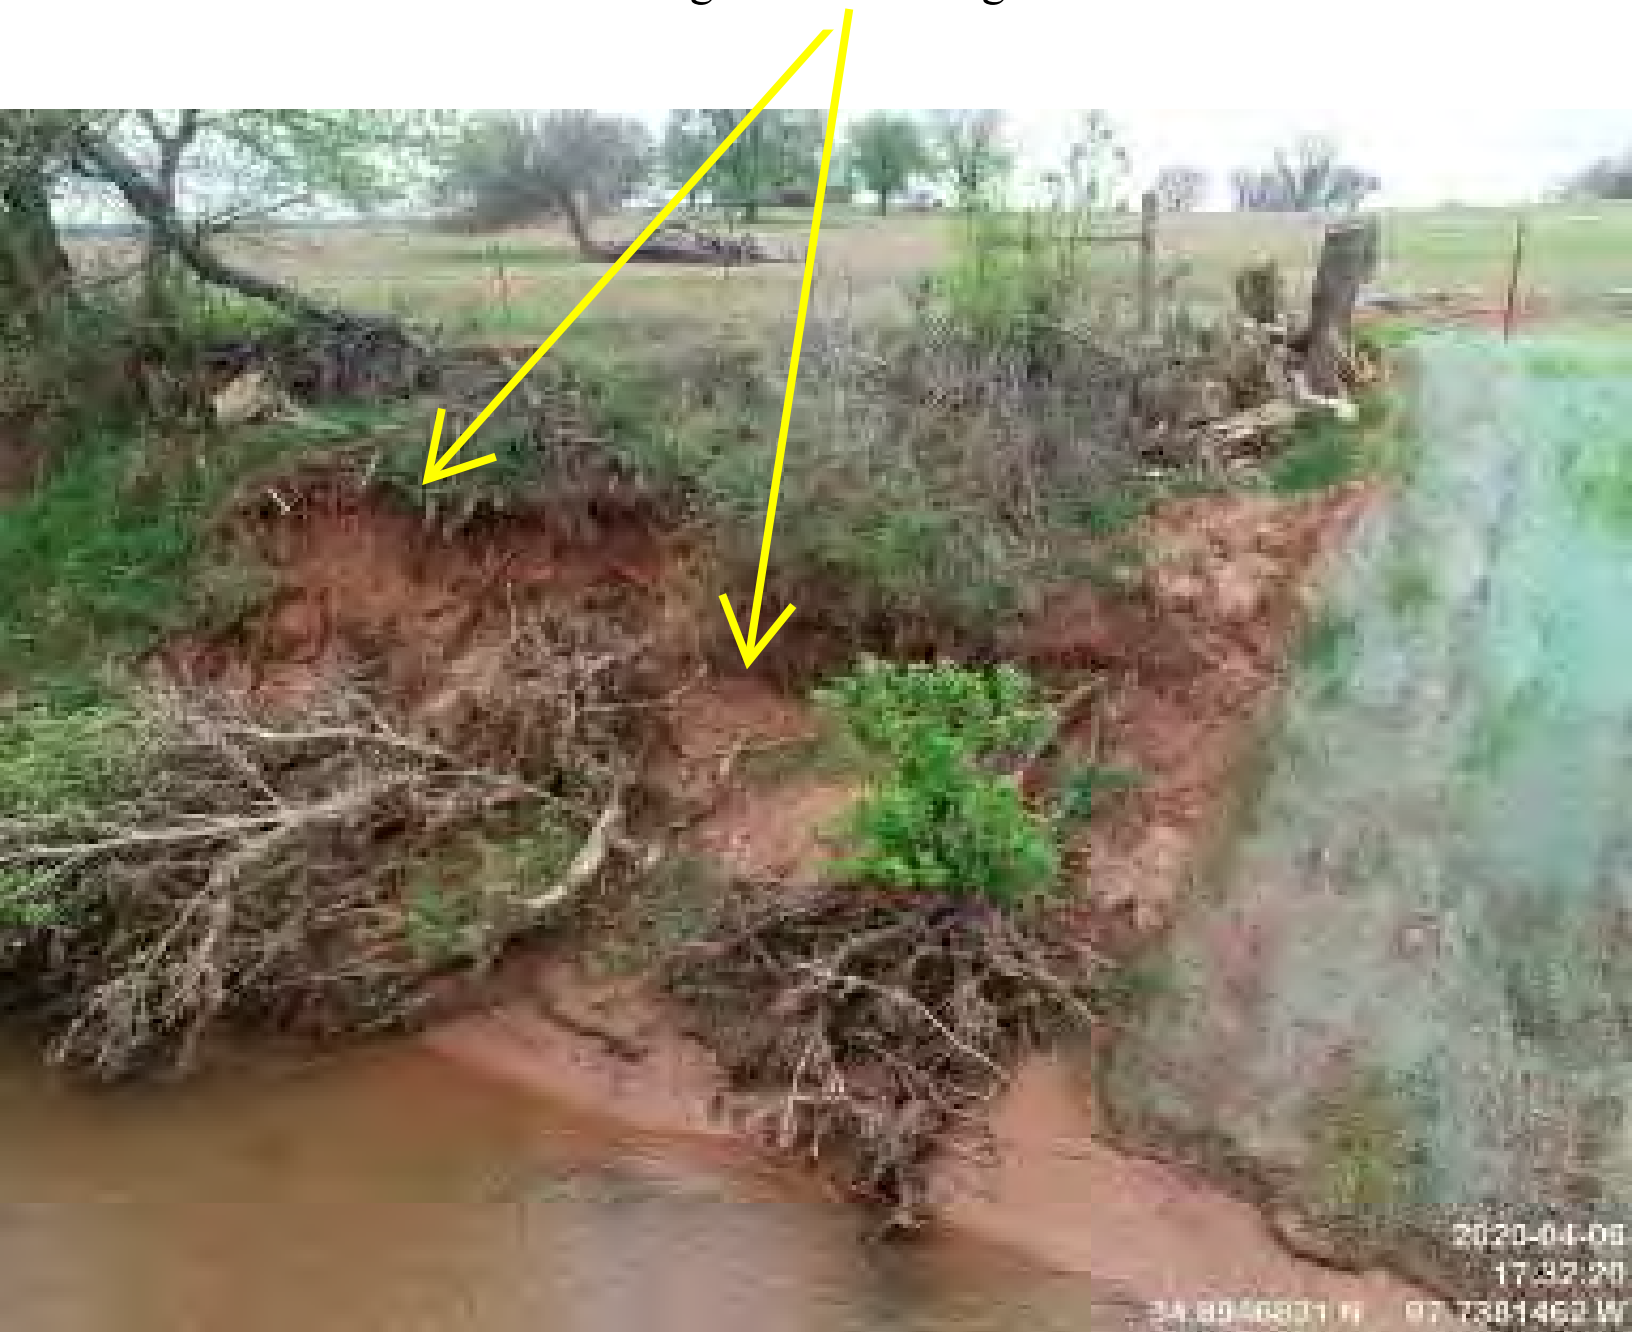
Unstable Creek Bank Causing Trees and Vegetation to Slide into Creek
