Robert Squires - Squires Consulting LLC
Landowner Advocate

Opening Statement for May 5, 2021 Subcommittee on Civil Rights and Civil Liberties Hearing:
“Pipelines Over People (Part II): Midship Pipeline’s Disregard for Landowners in Its Pathway”

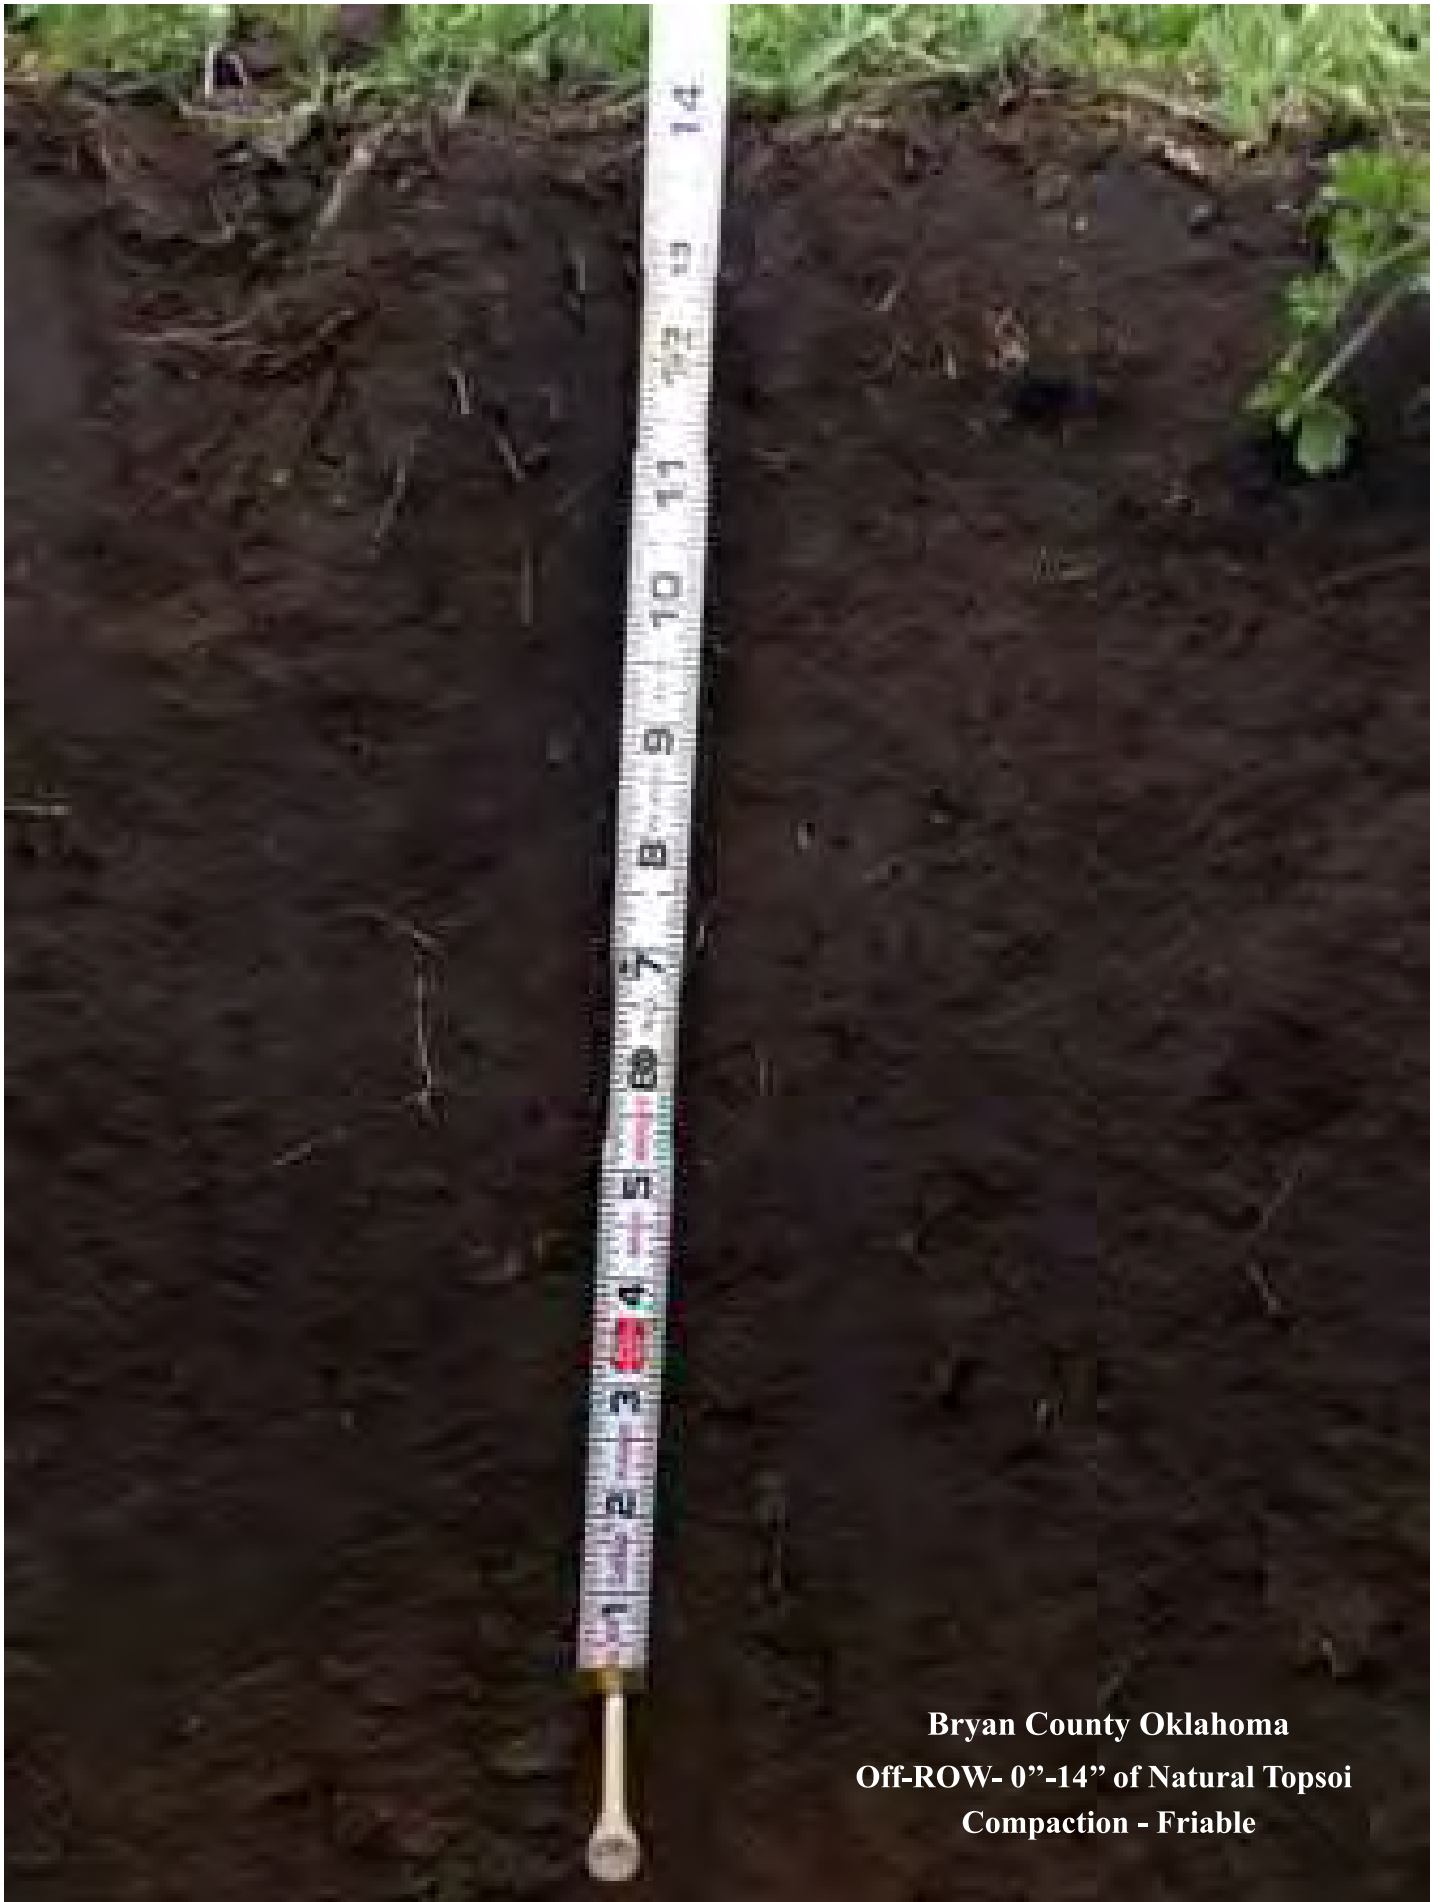
**Bryan County, Oklahoma
Gene Grounds Soil Investigation
Off-ROW Topsoil is up to 14" Deep
Midship Easement has No Natural Topsoil
and Extremely Compacted with Several
Large Rocks.**

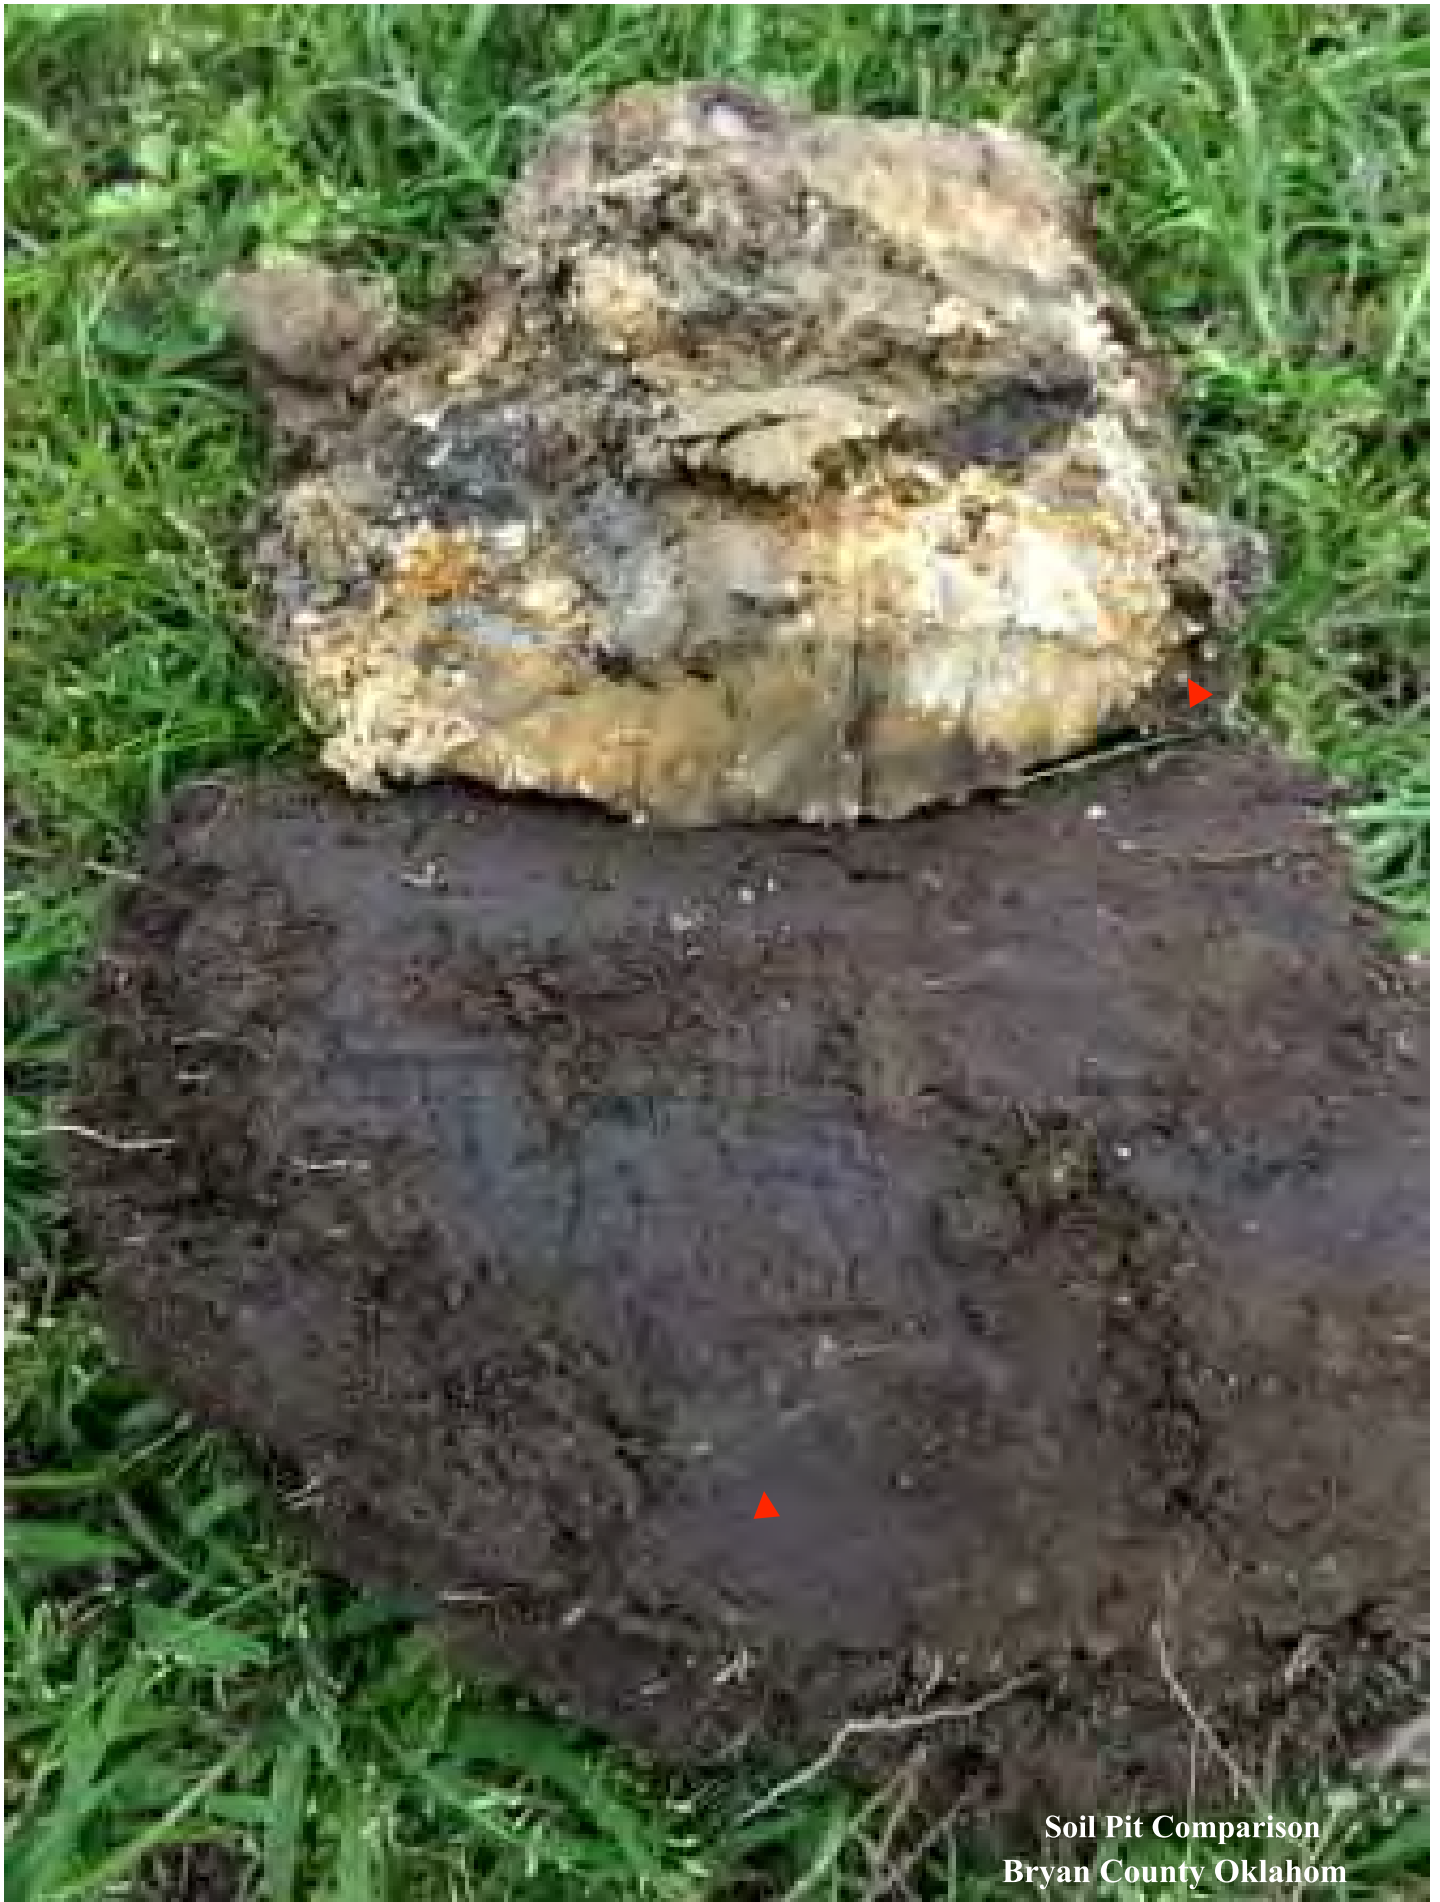
**Bryan County Oklahoma
In-ROW - 0" of Natural Topsoil
Compaction - Extreme -
Exceeds the Limit**

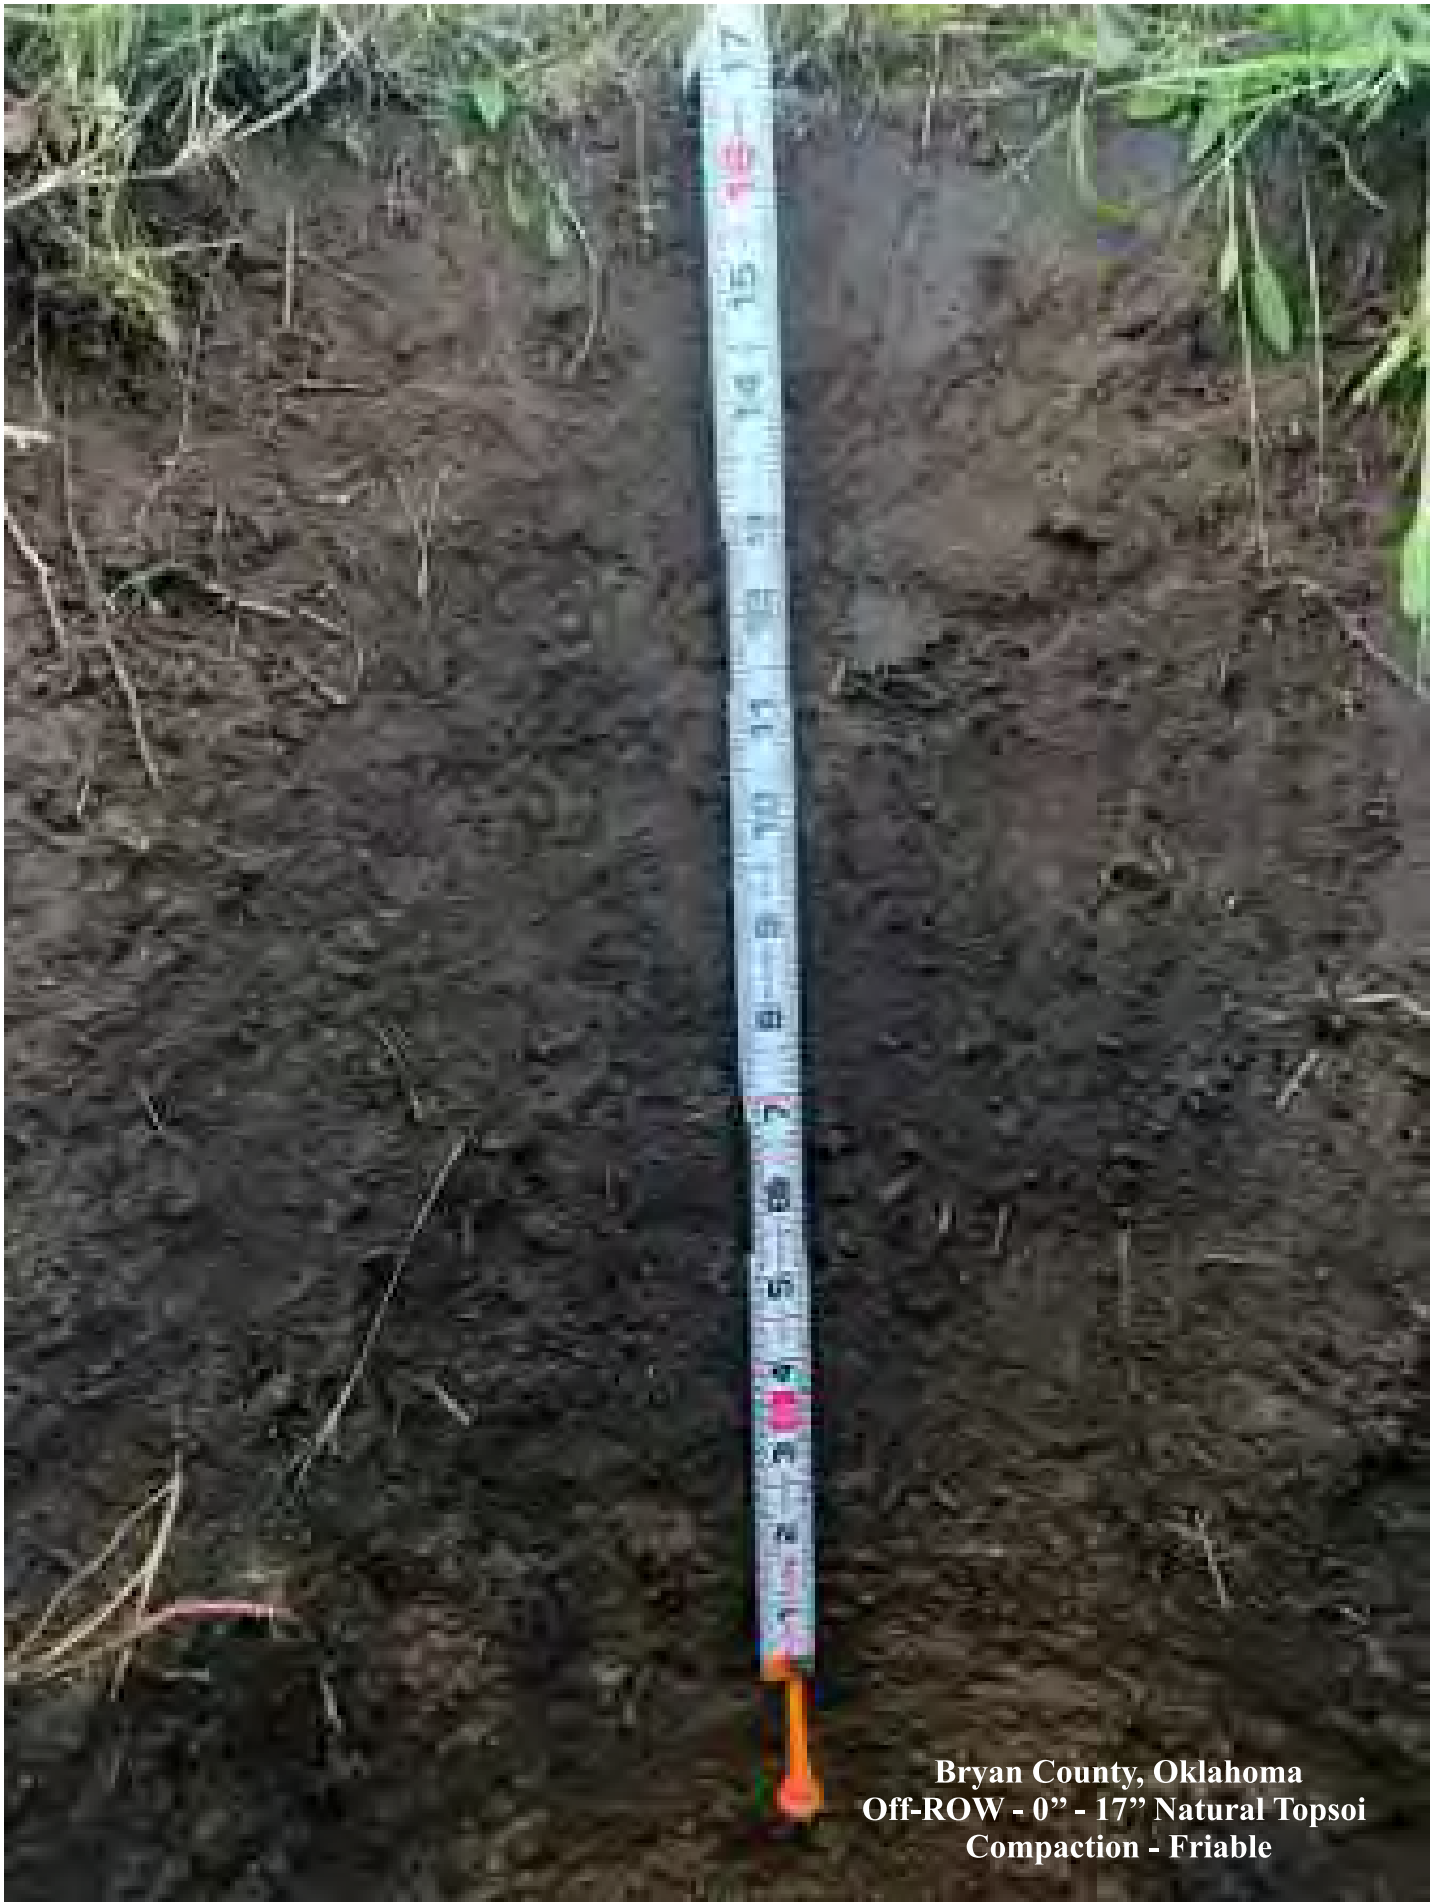
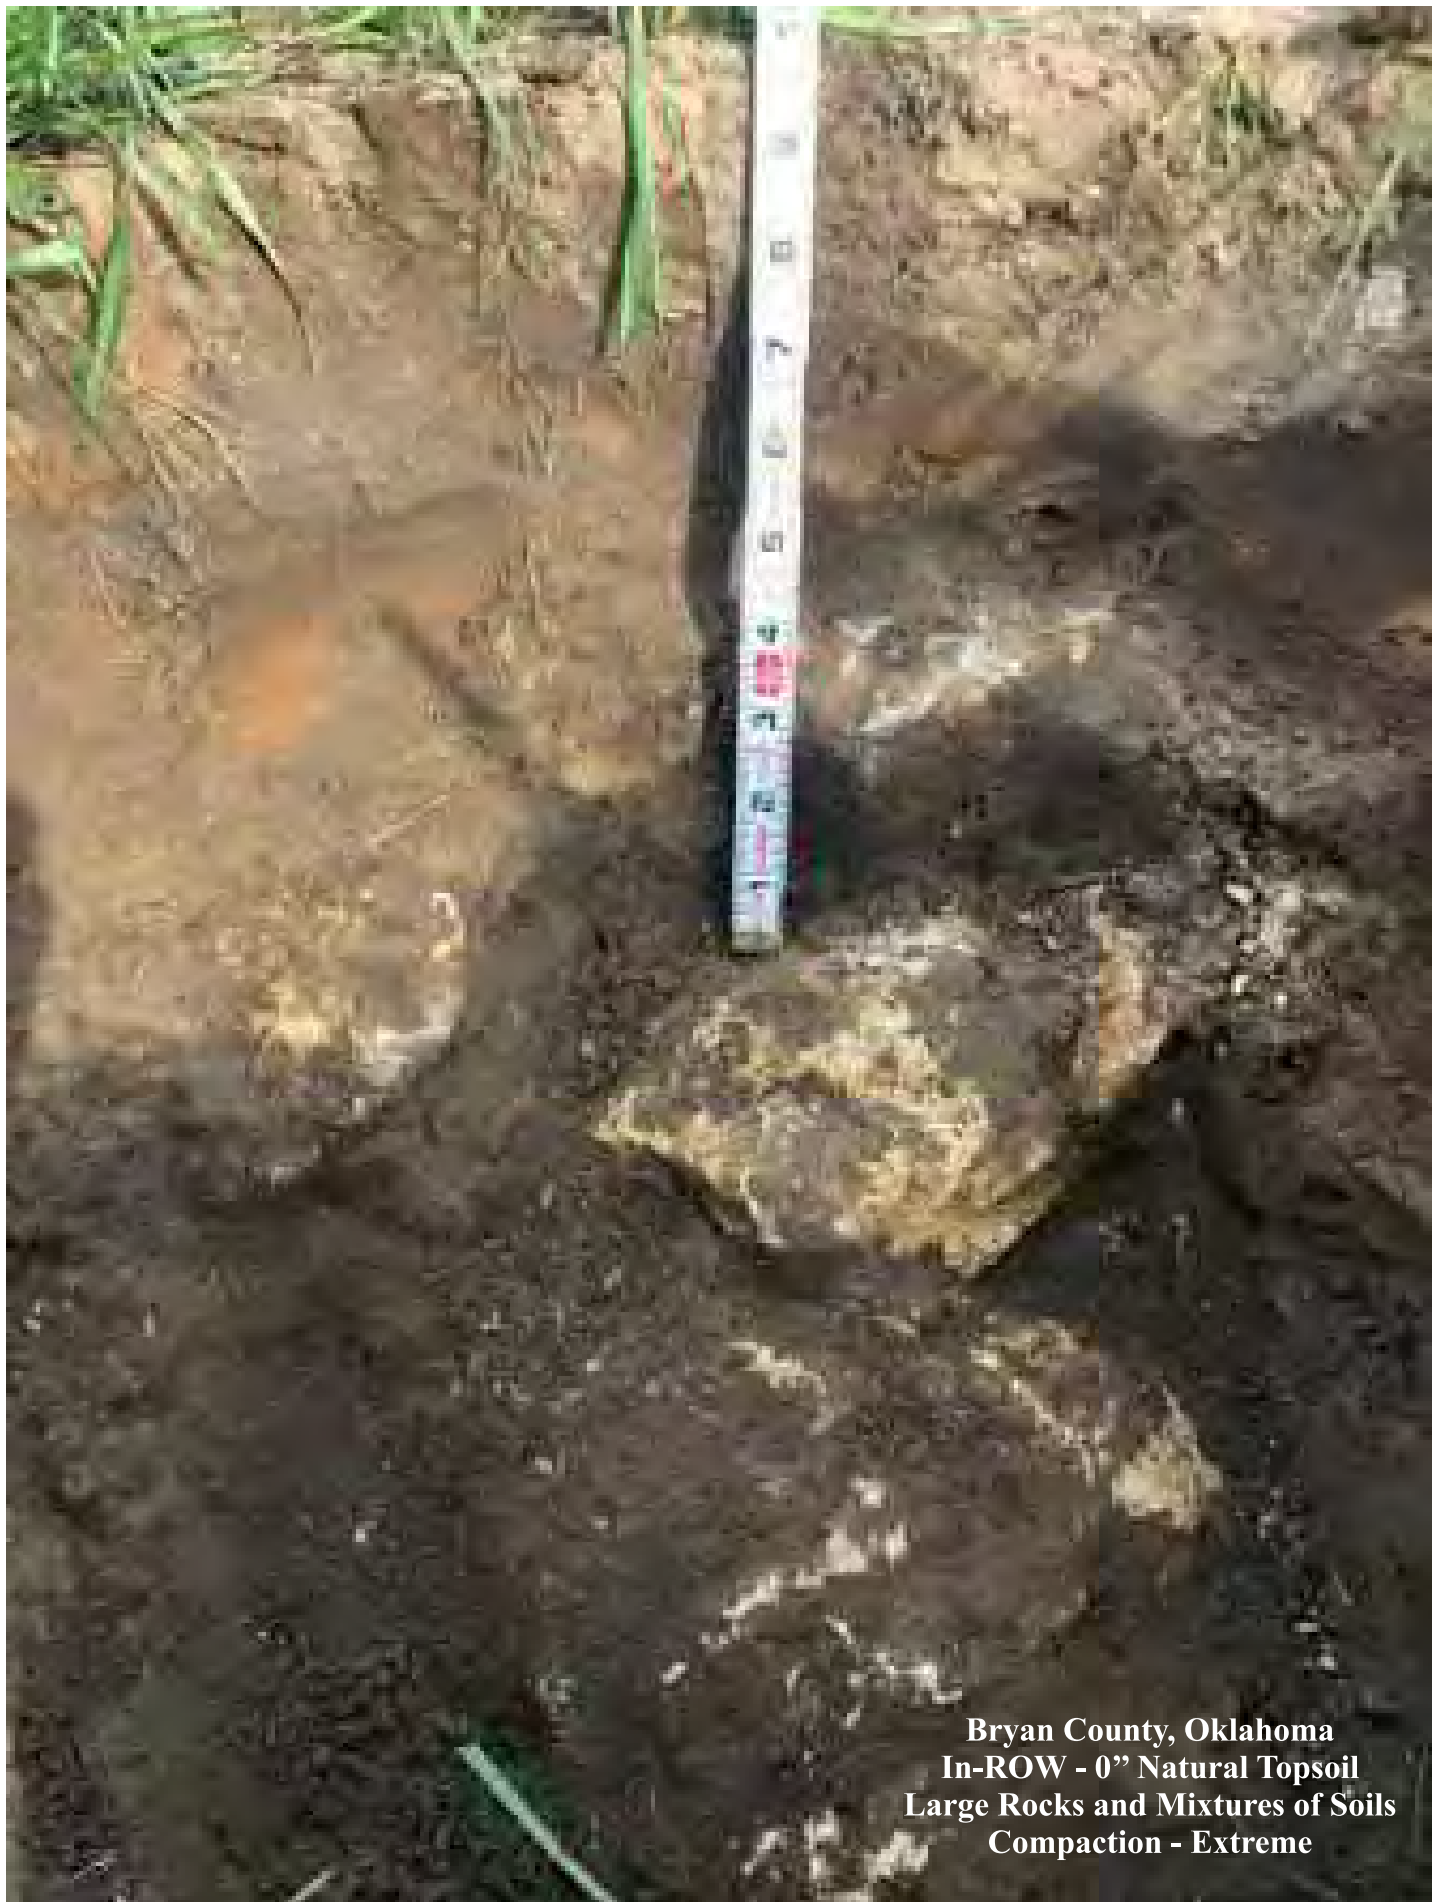
**Bryan County, Oklahoma
James Anderson Soil Investigation
Off-ROW Topsoil is up to 17" Deep
Midship Easement has No Natural Topsoil
and Extremely Compacted with Several
Large Rocks.**

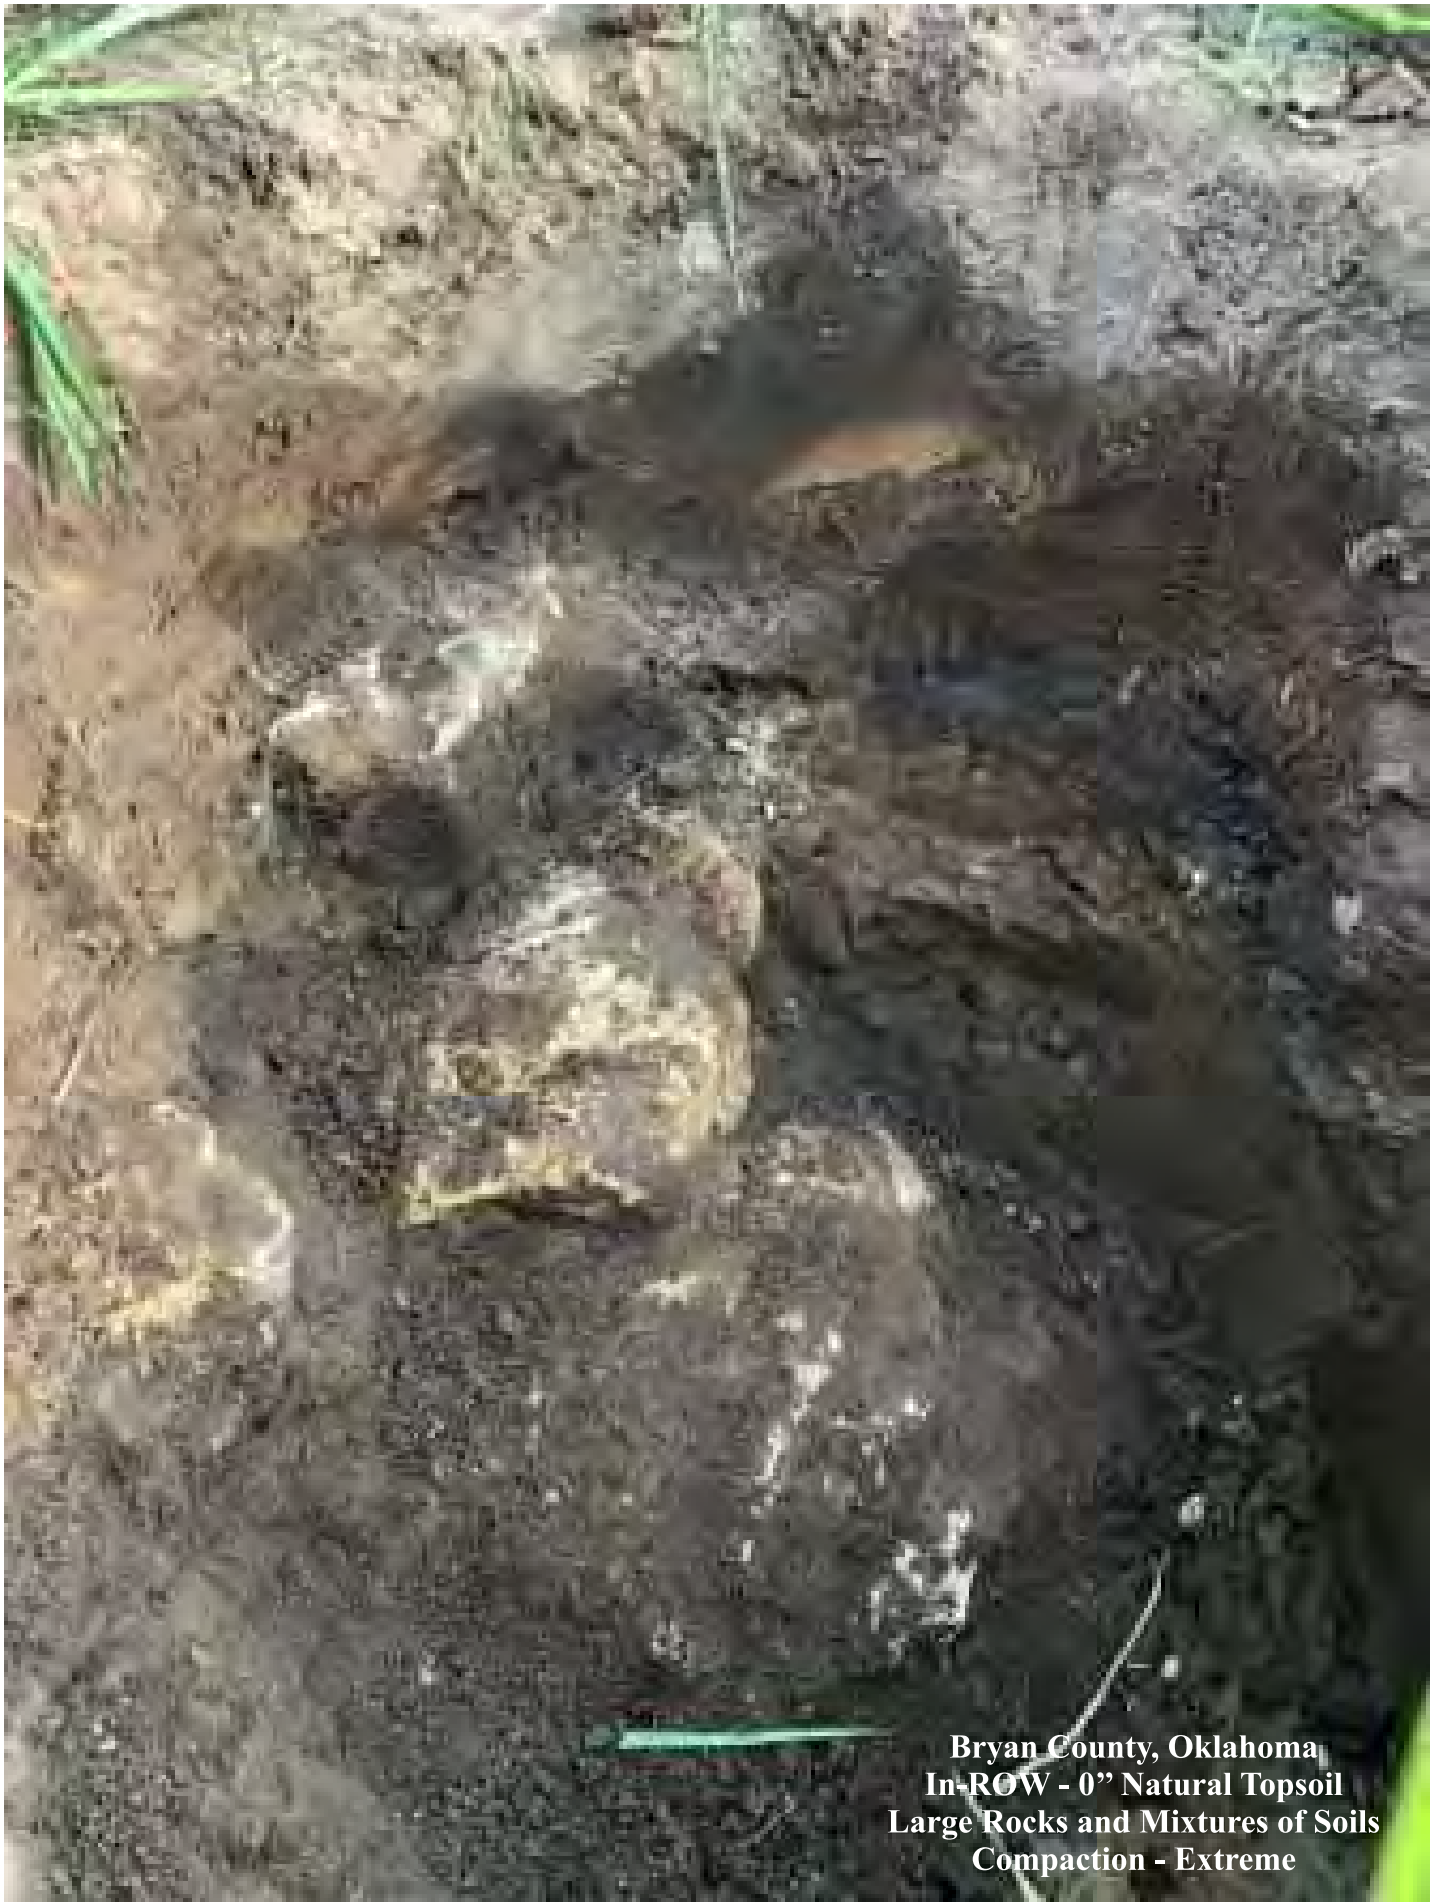
**Bryan County, Oklahoma
In-ROW - 0" Natural Topsoil
Large Rocks and Mixtures of Soils
Compaction - Extreme**

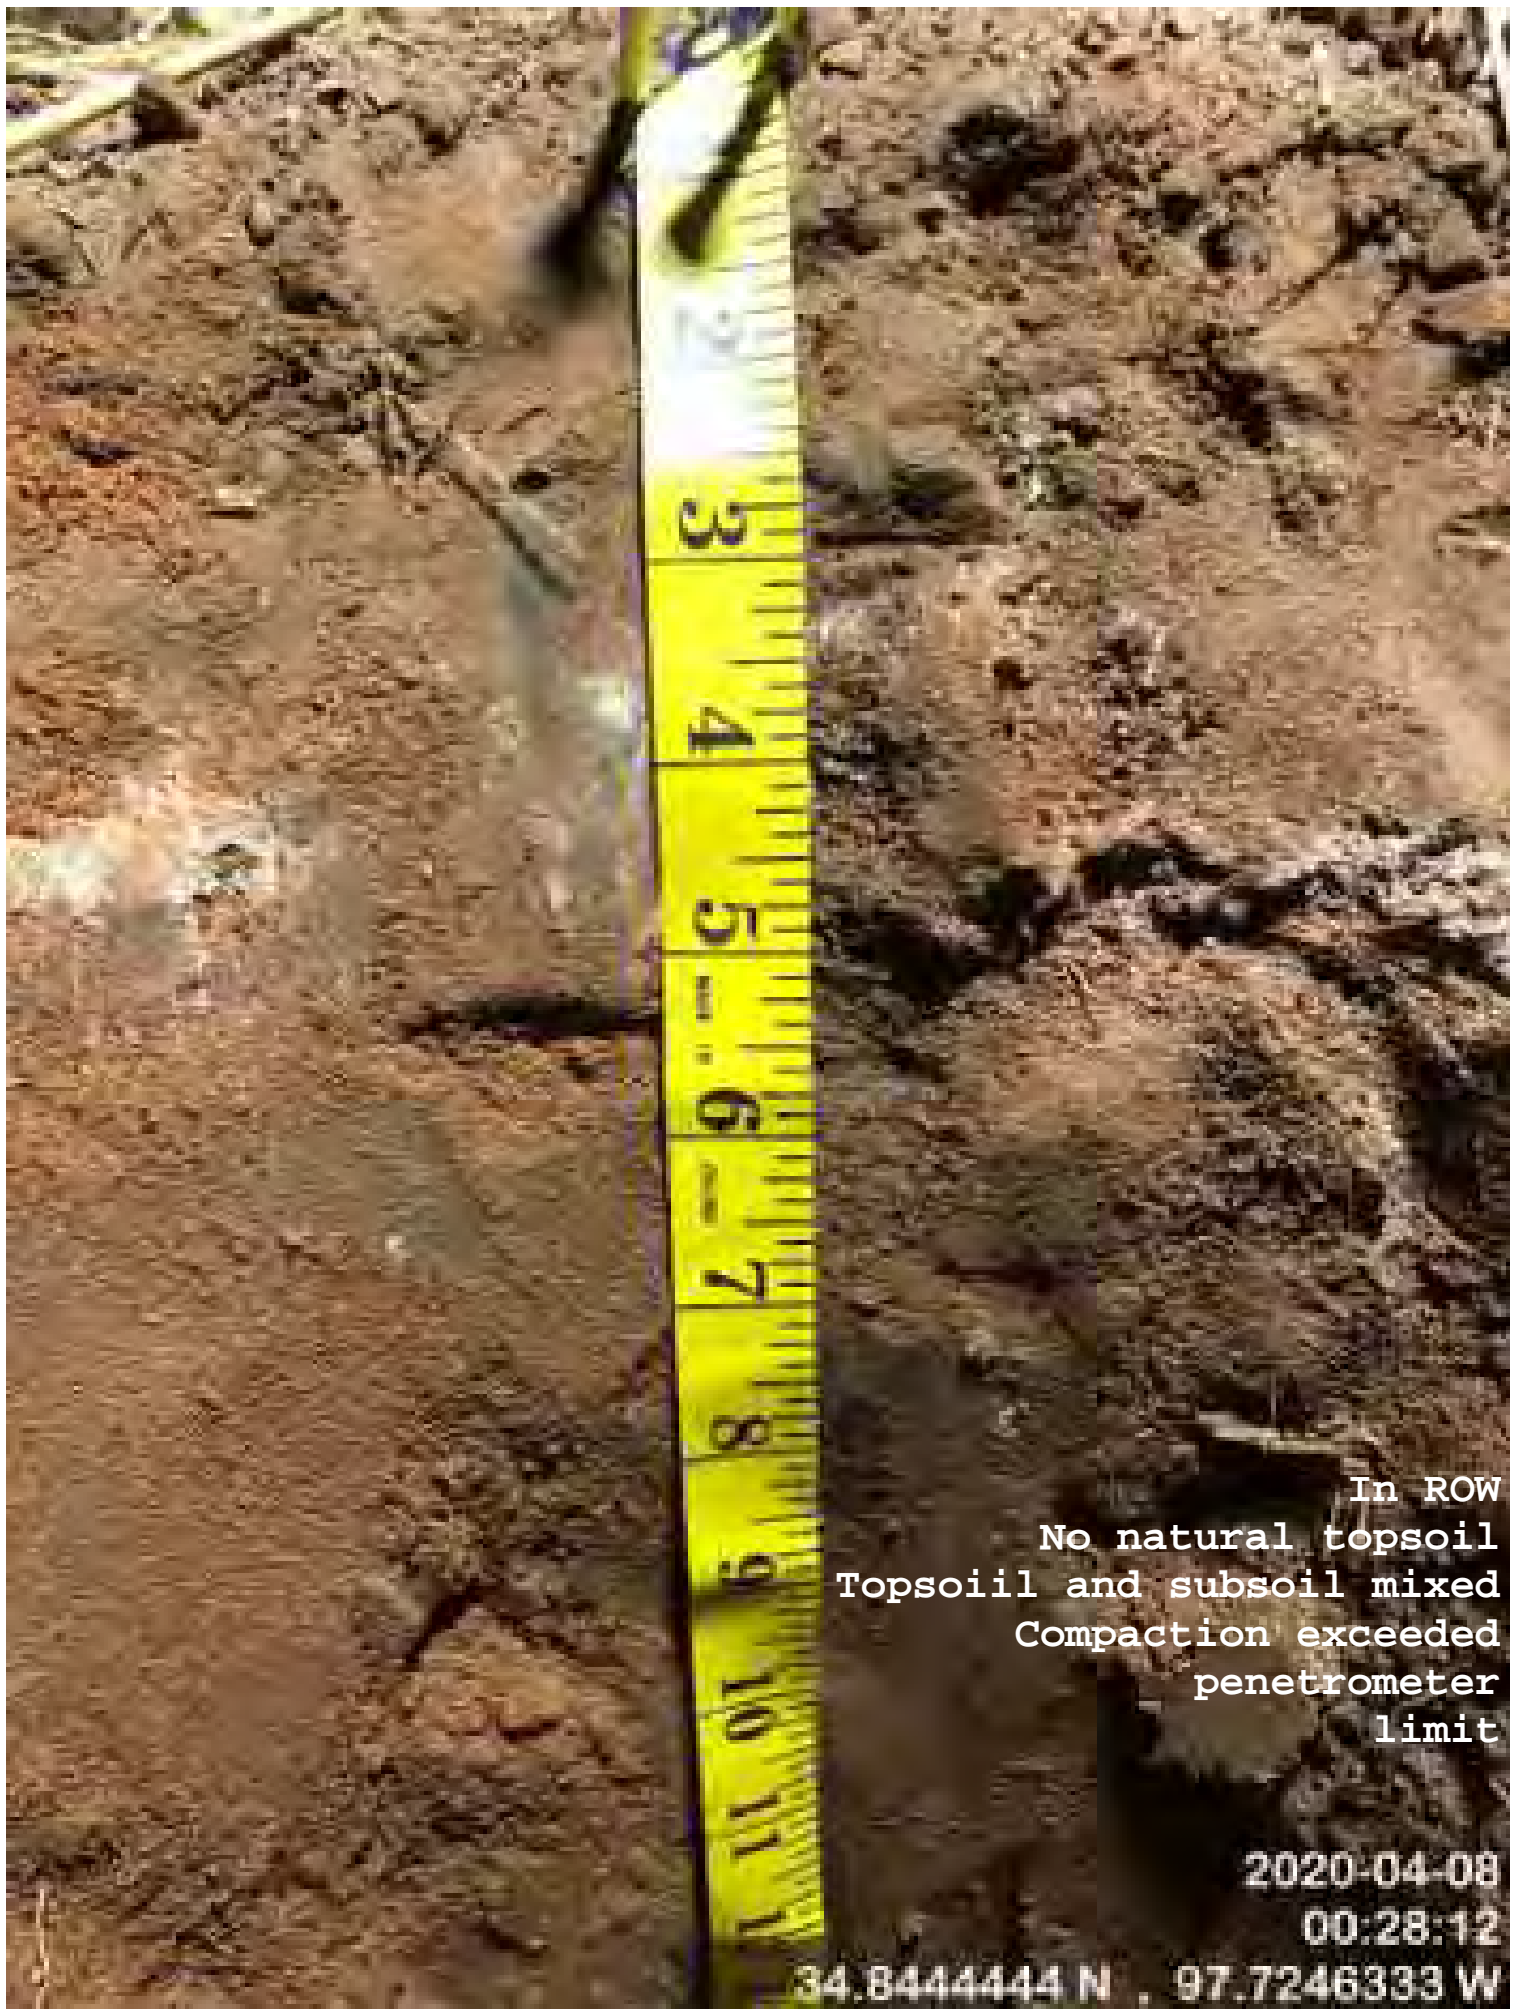
In ROW
No natural topsoil
Topsoil and subsoil mixed
Compaction exceeded
penetrometer
limit

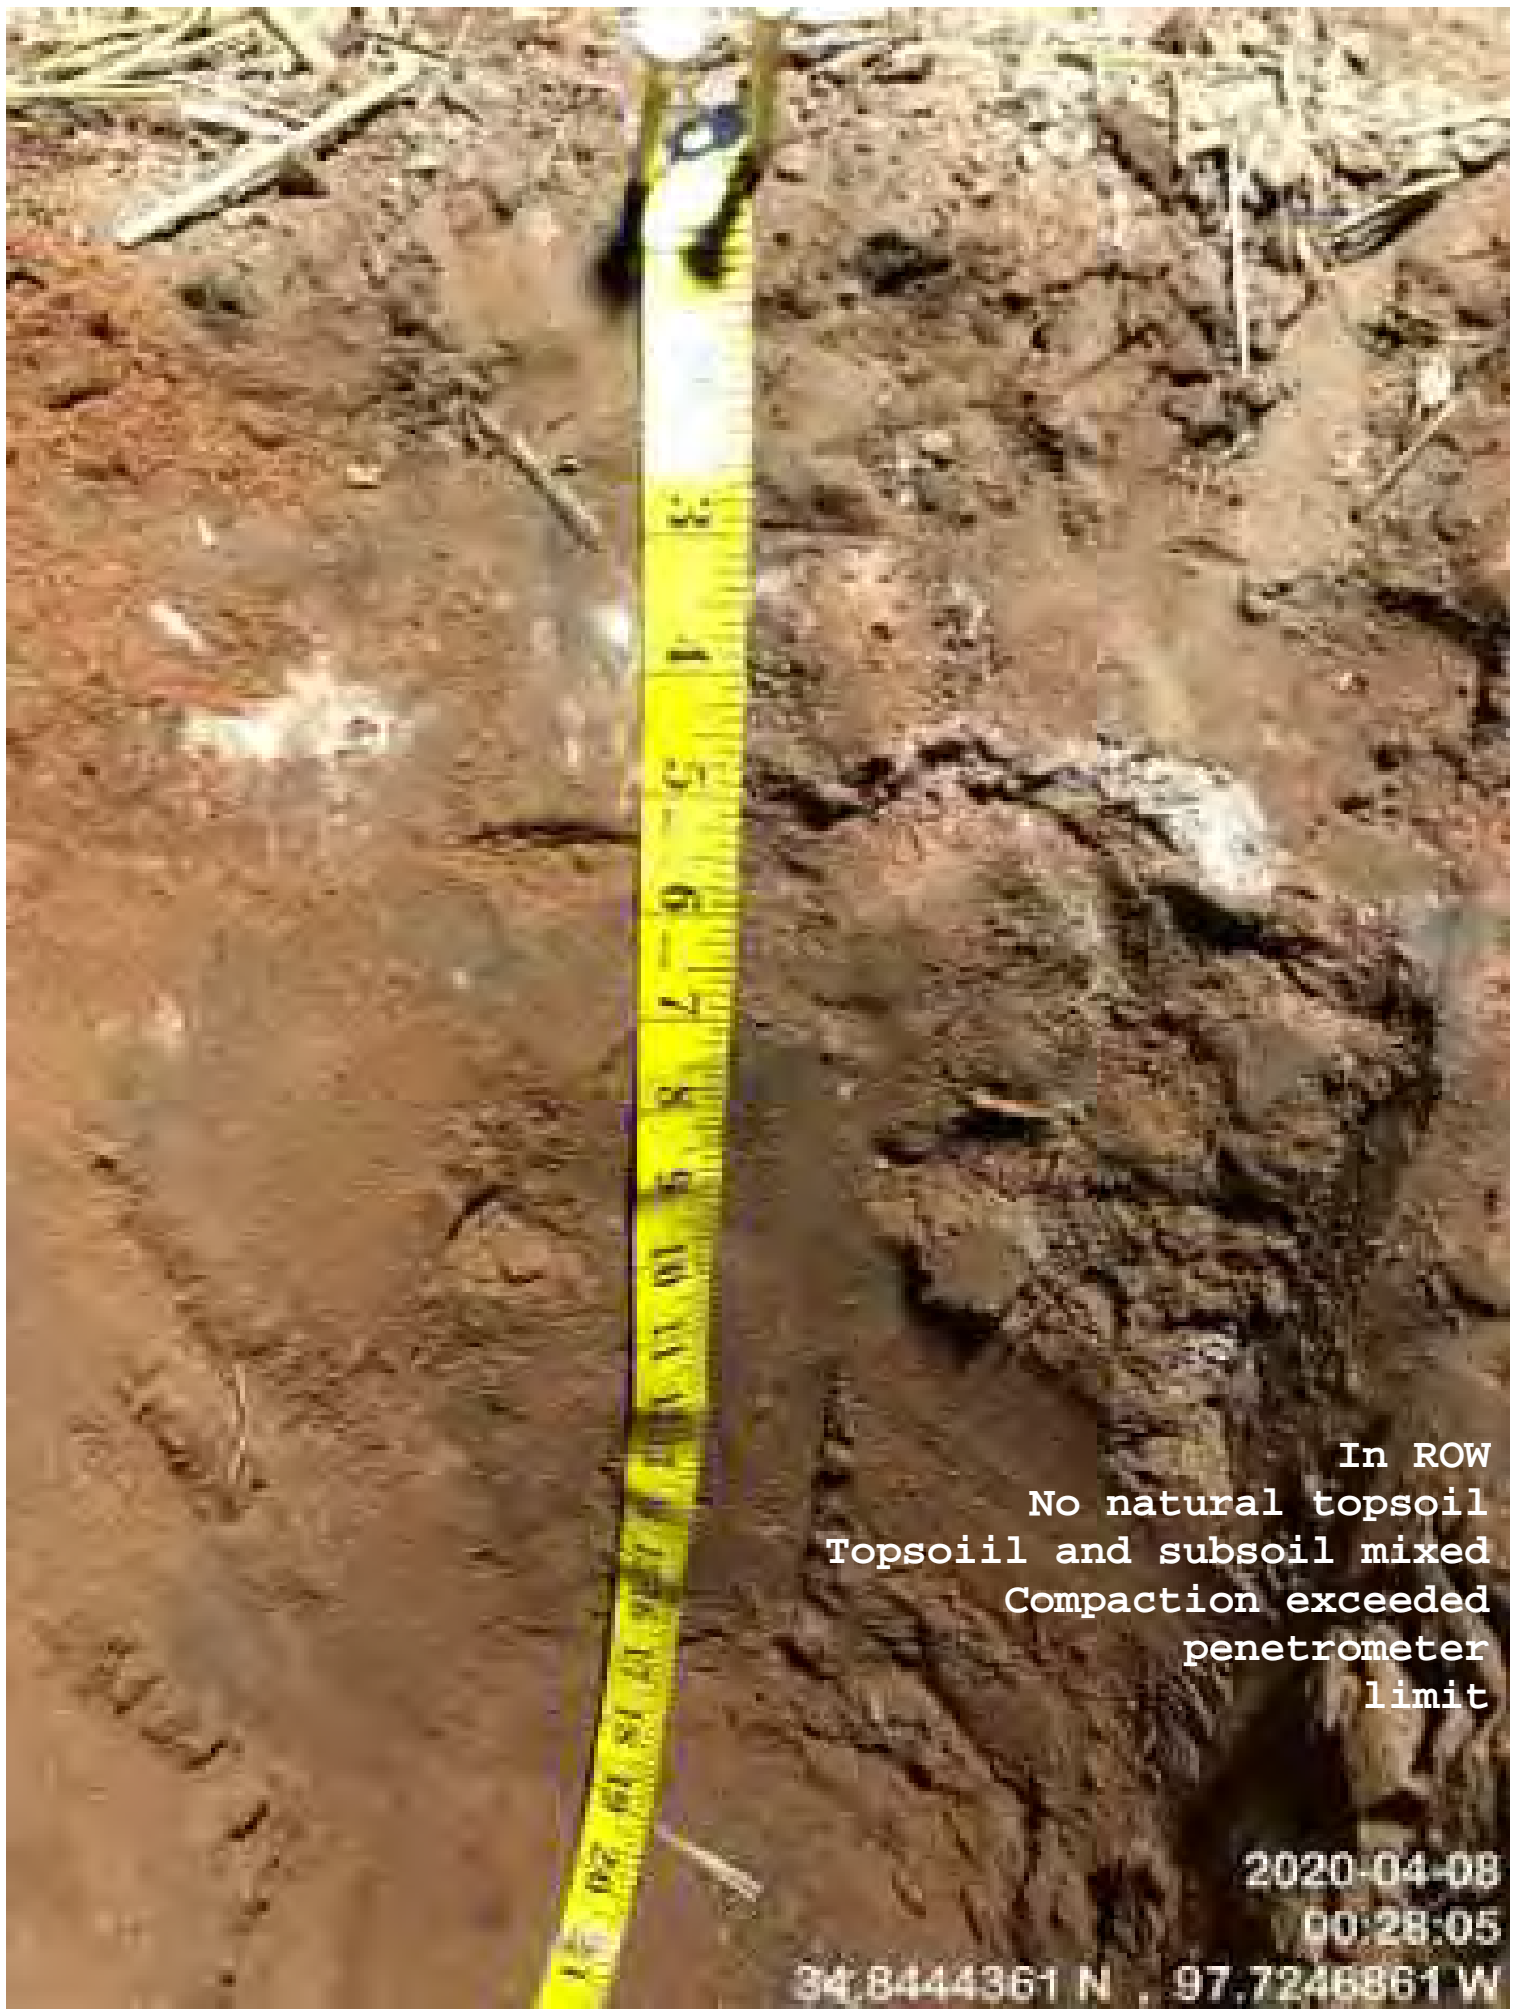
In ROW
No natural topsoil
Topsoil and subsoil mixed
Compaction exceeded
penetrometer
limit

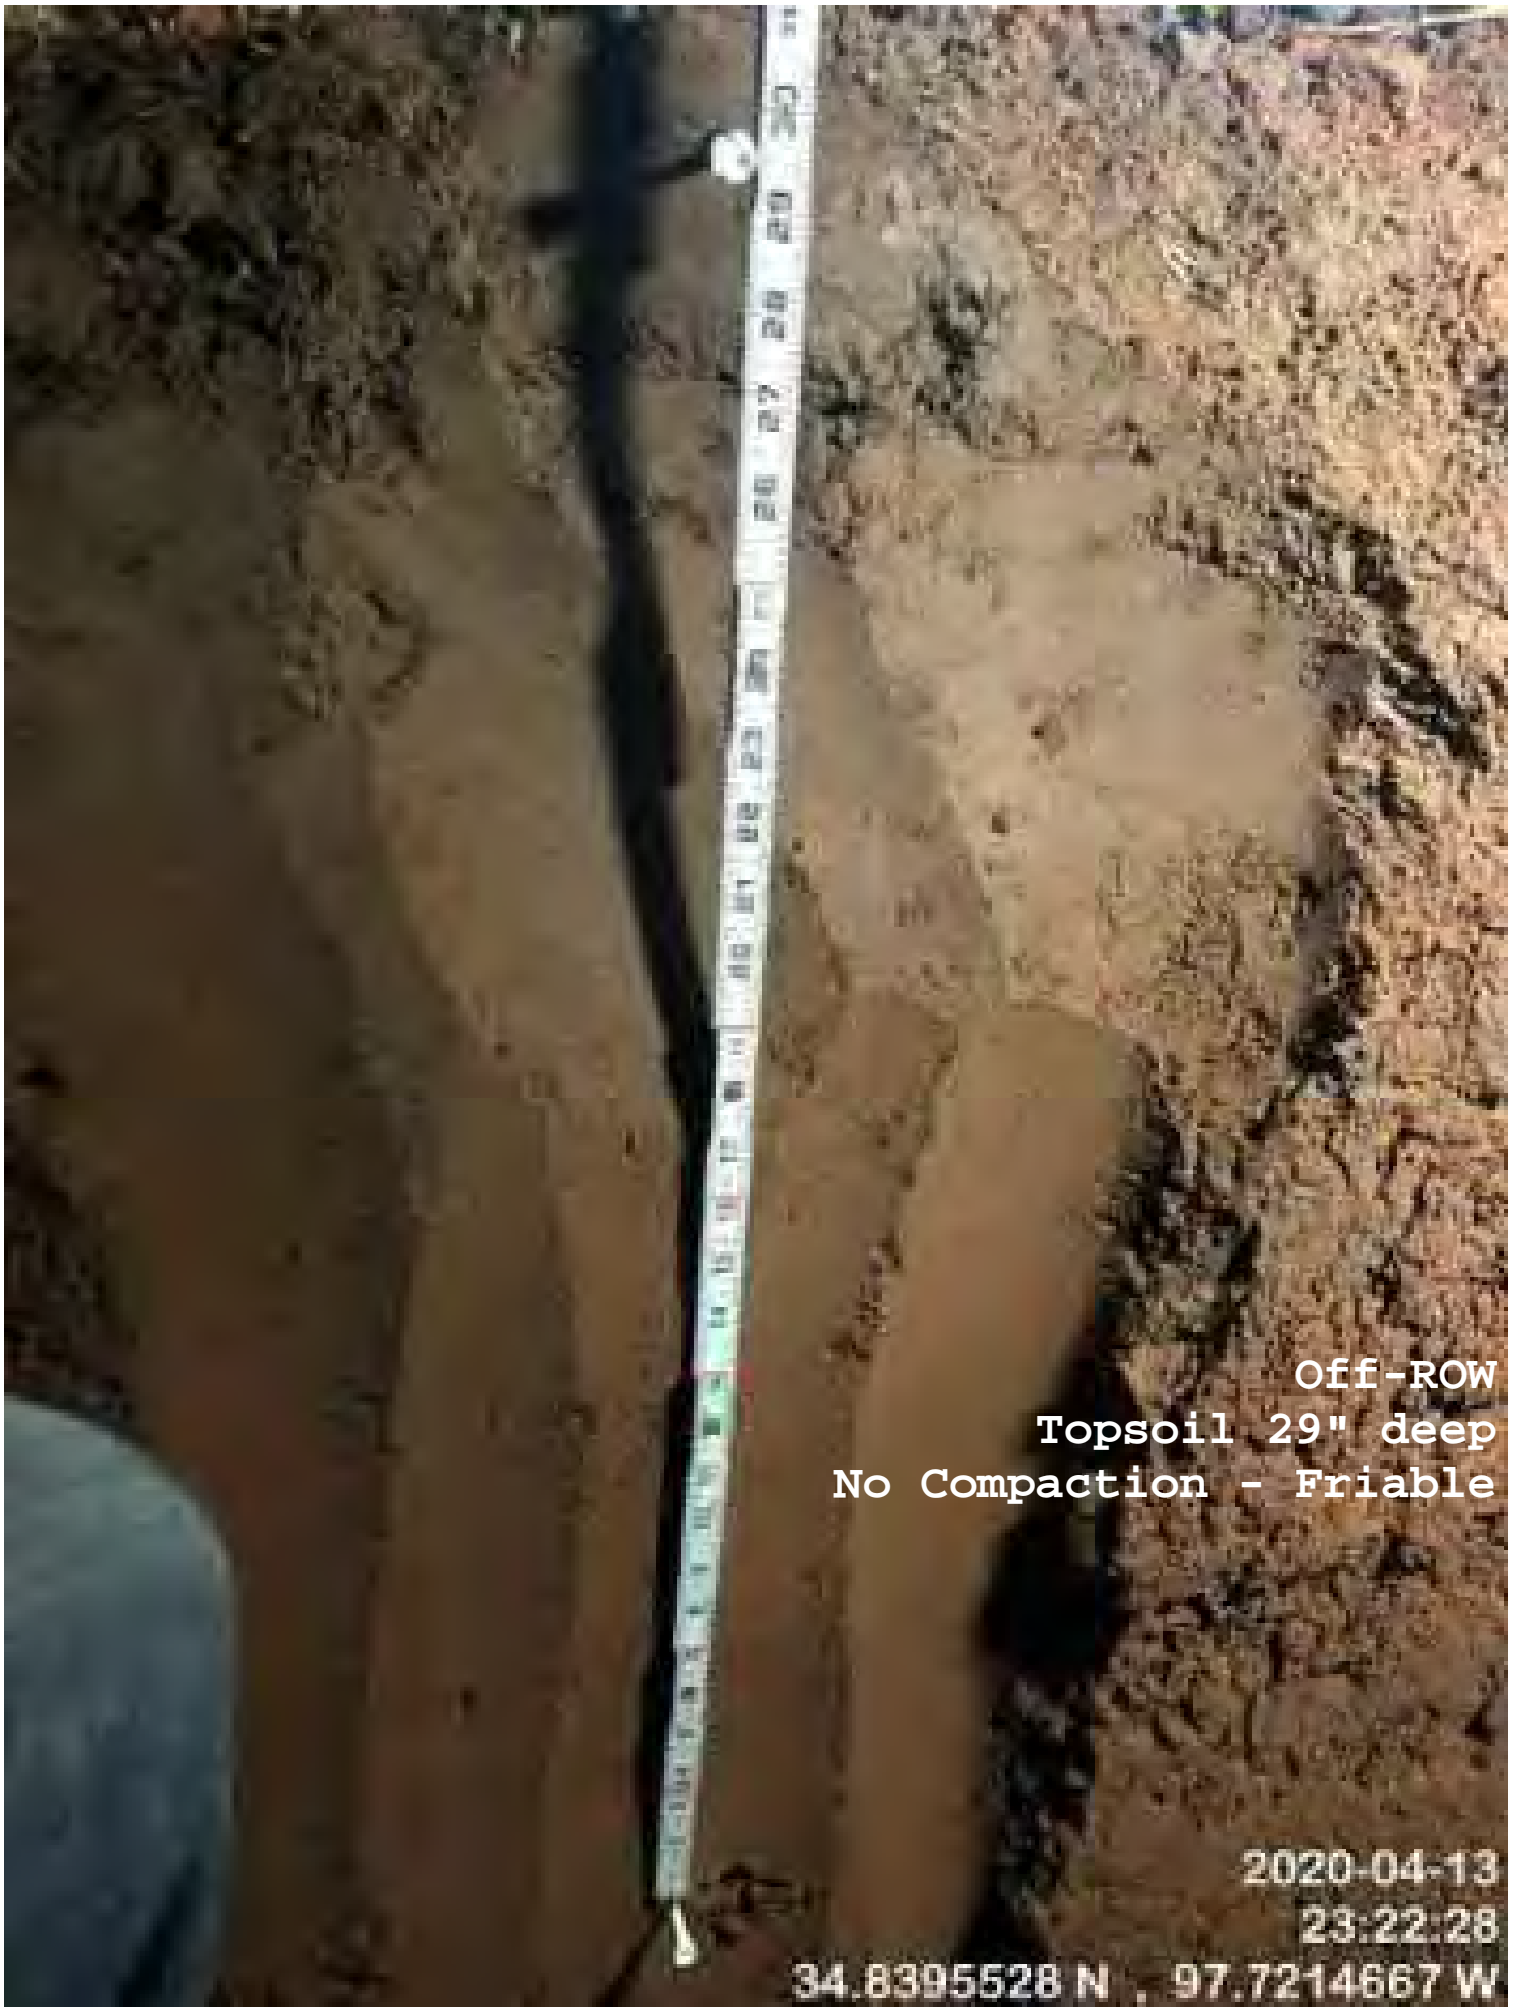
off-ROW
Topsoil 29" deep
No Compaction - Friable
