Robert Squires - Squires Consulting LLC
Landowner Advocate

Opening Statement for May 5, 2021 Subcommittee on Civil Rights and Civil Liberties Hearing:
“Pipelines Over People (Part II): Midship Pipeline’s Disregard for Landowners in Its Pathway”

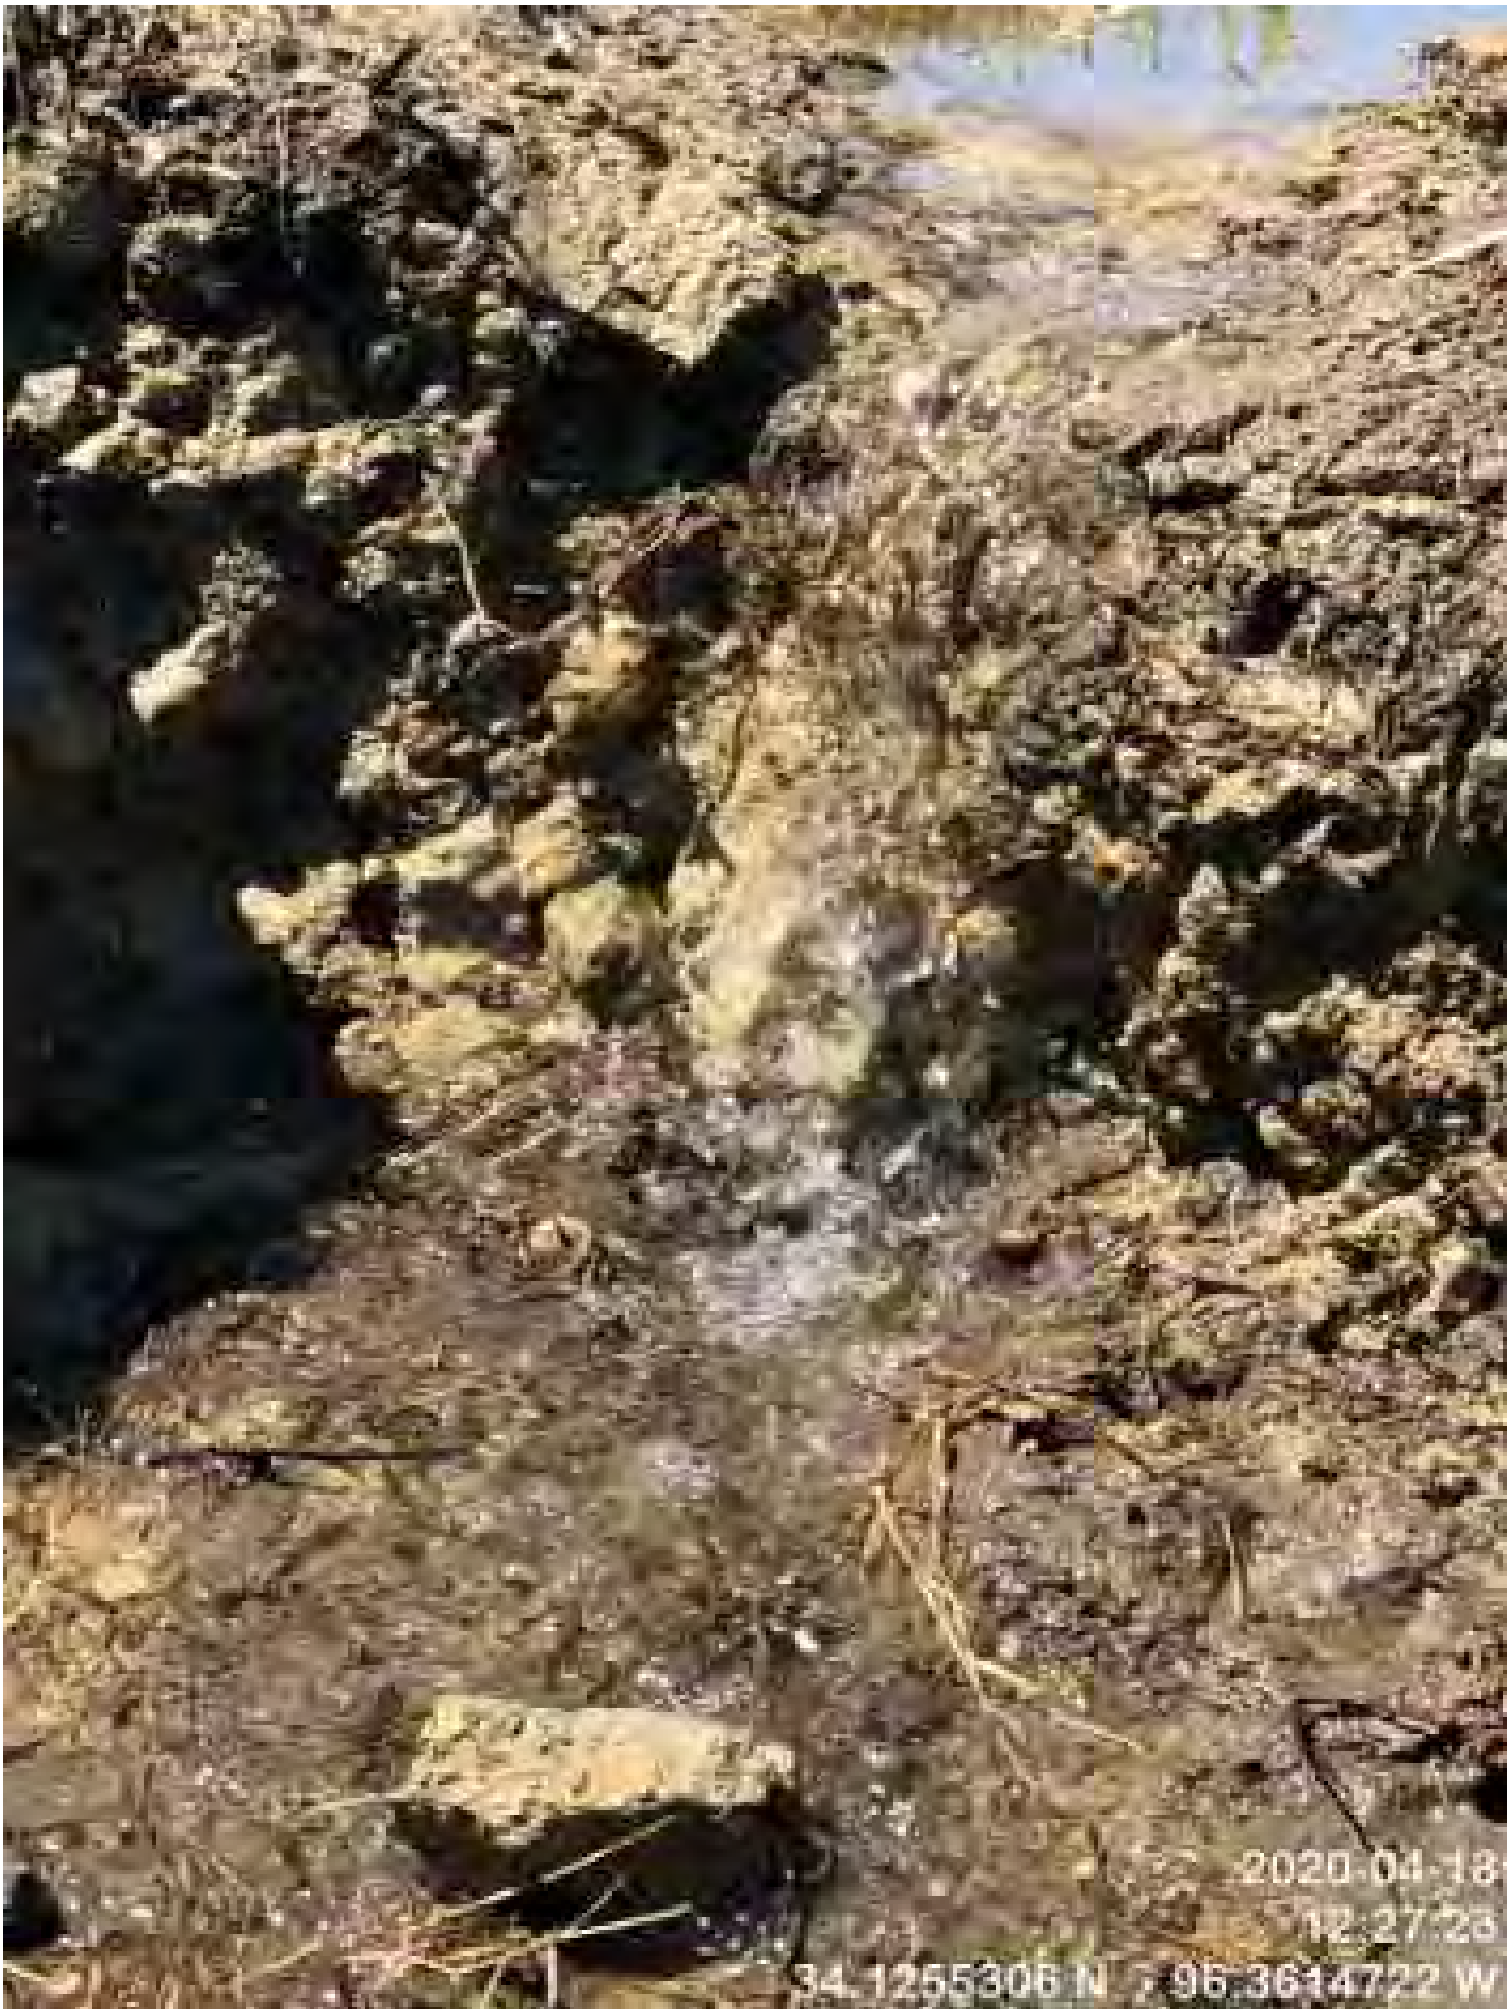
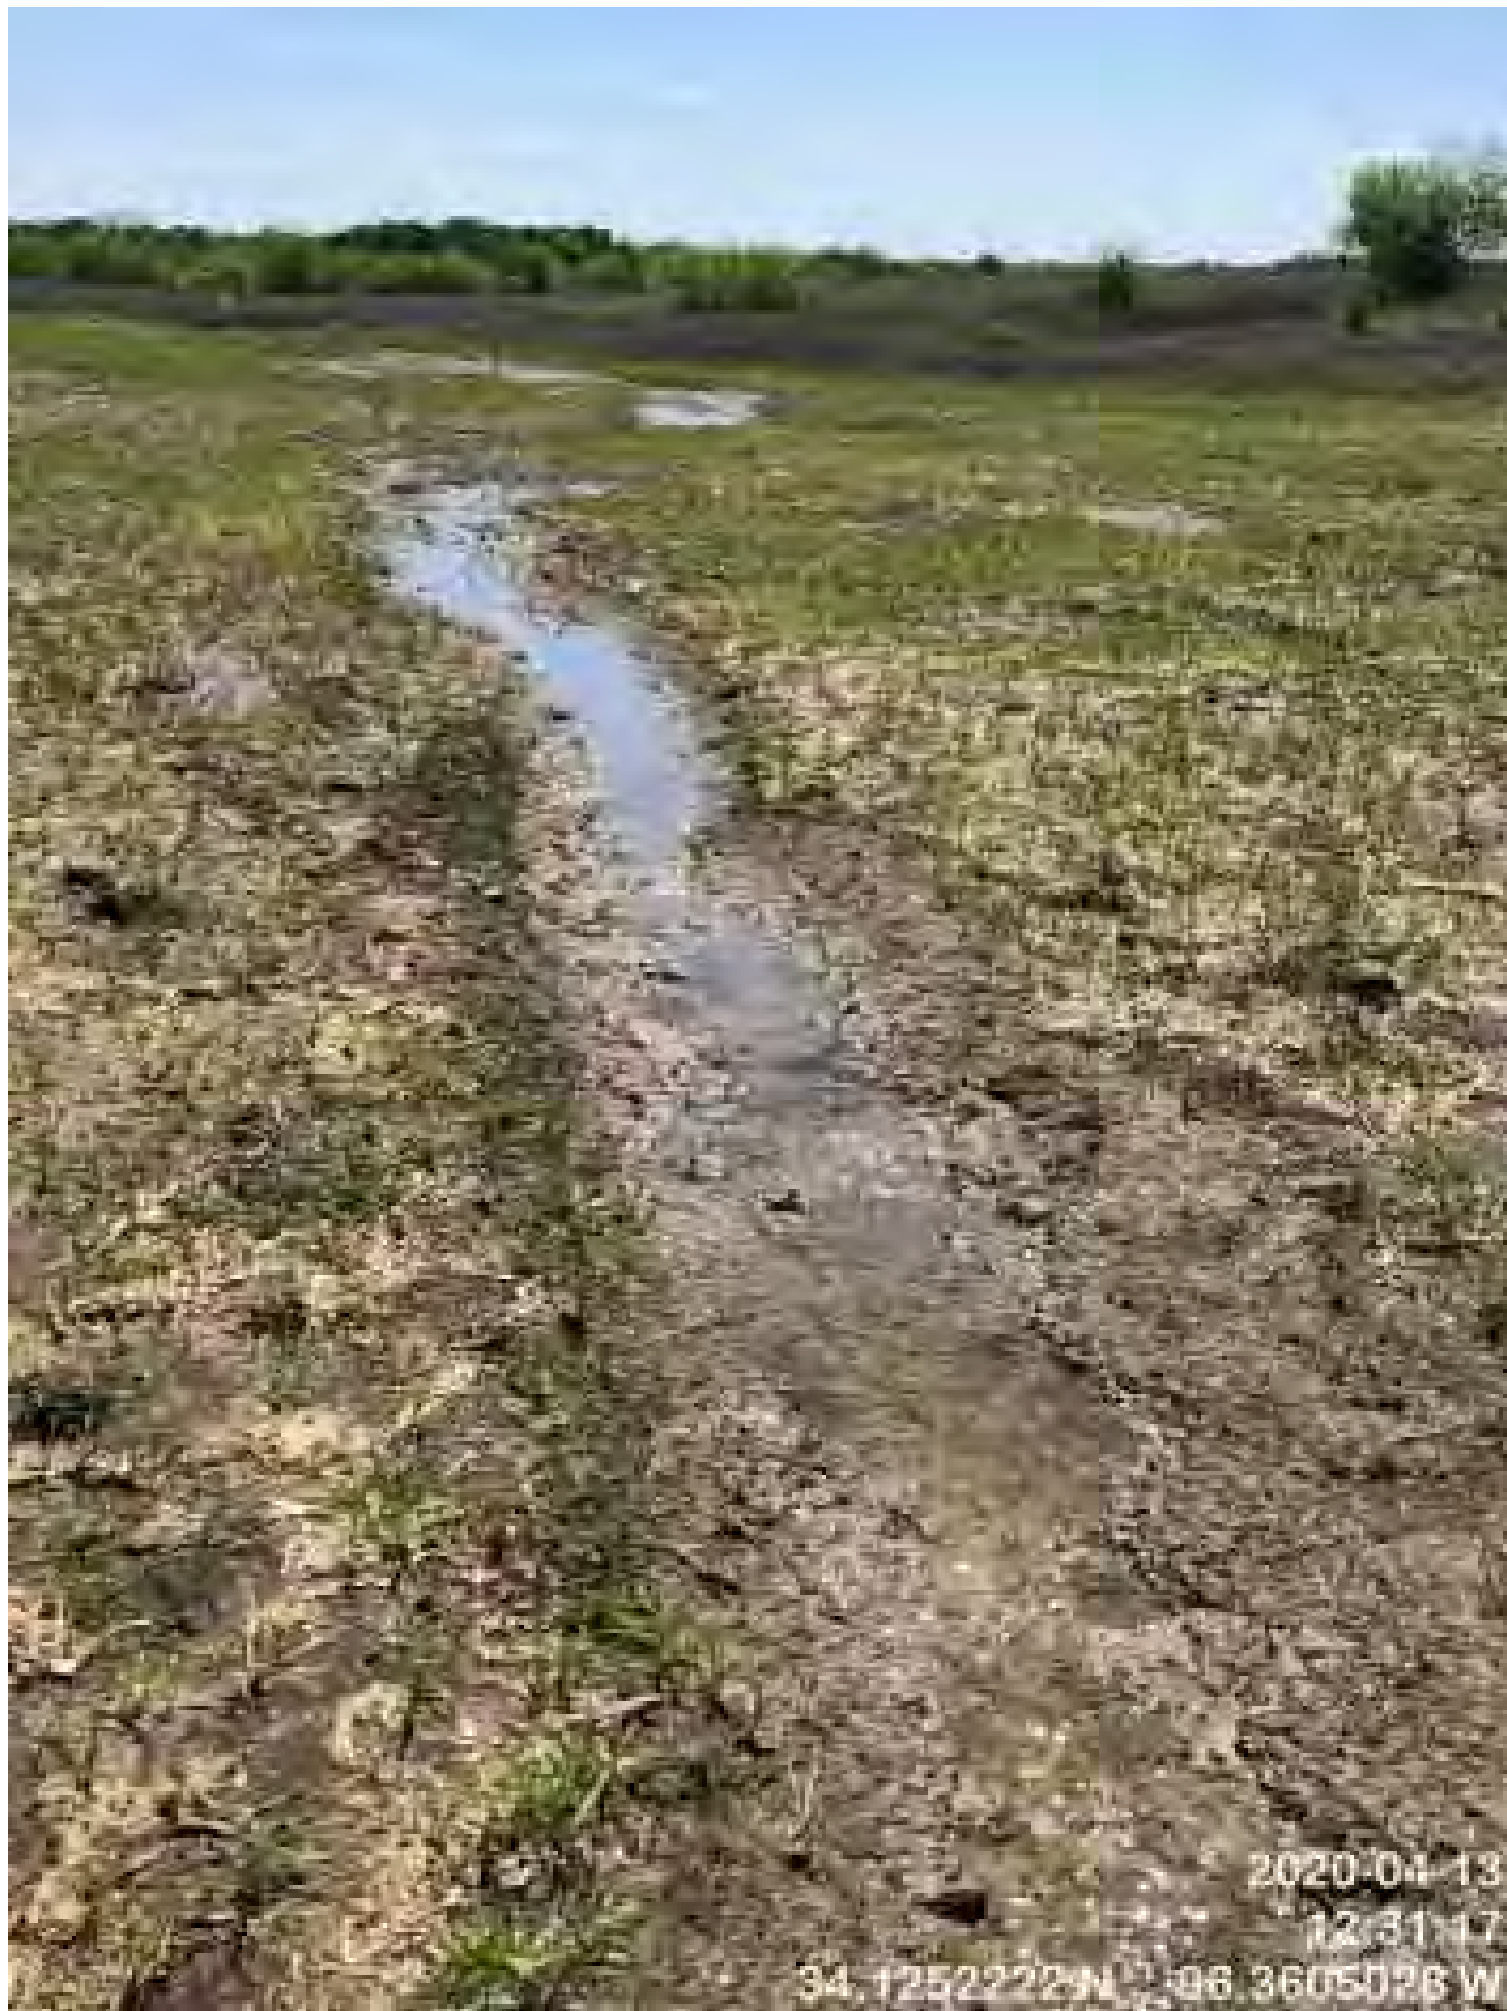
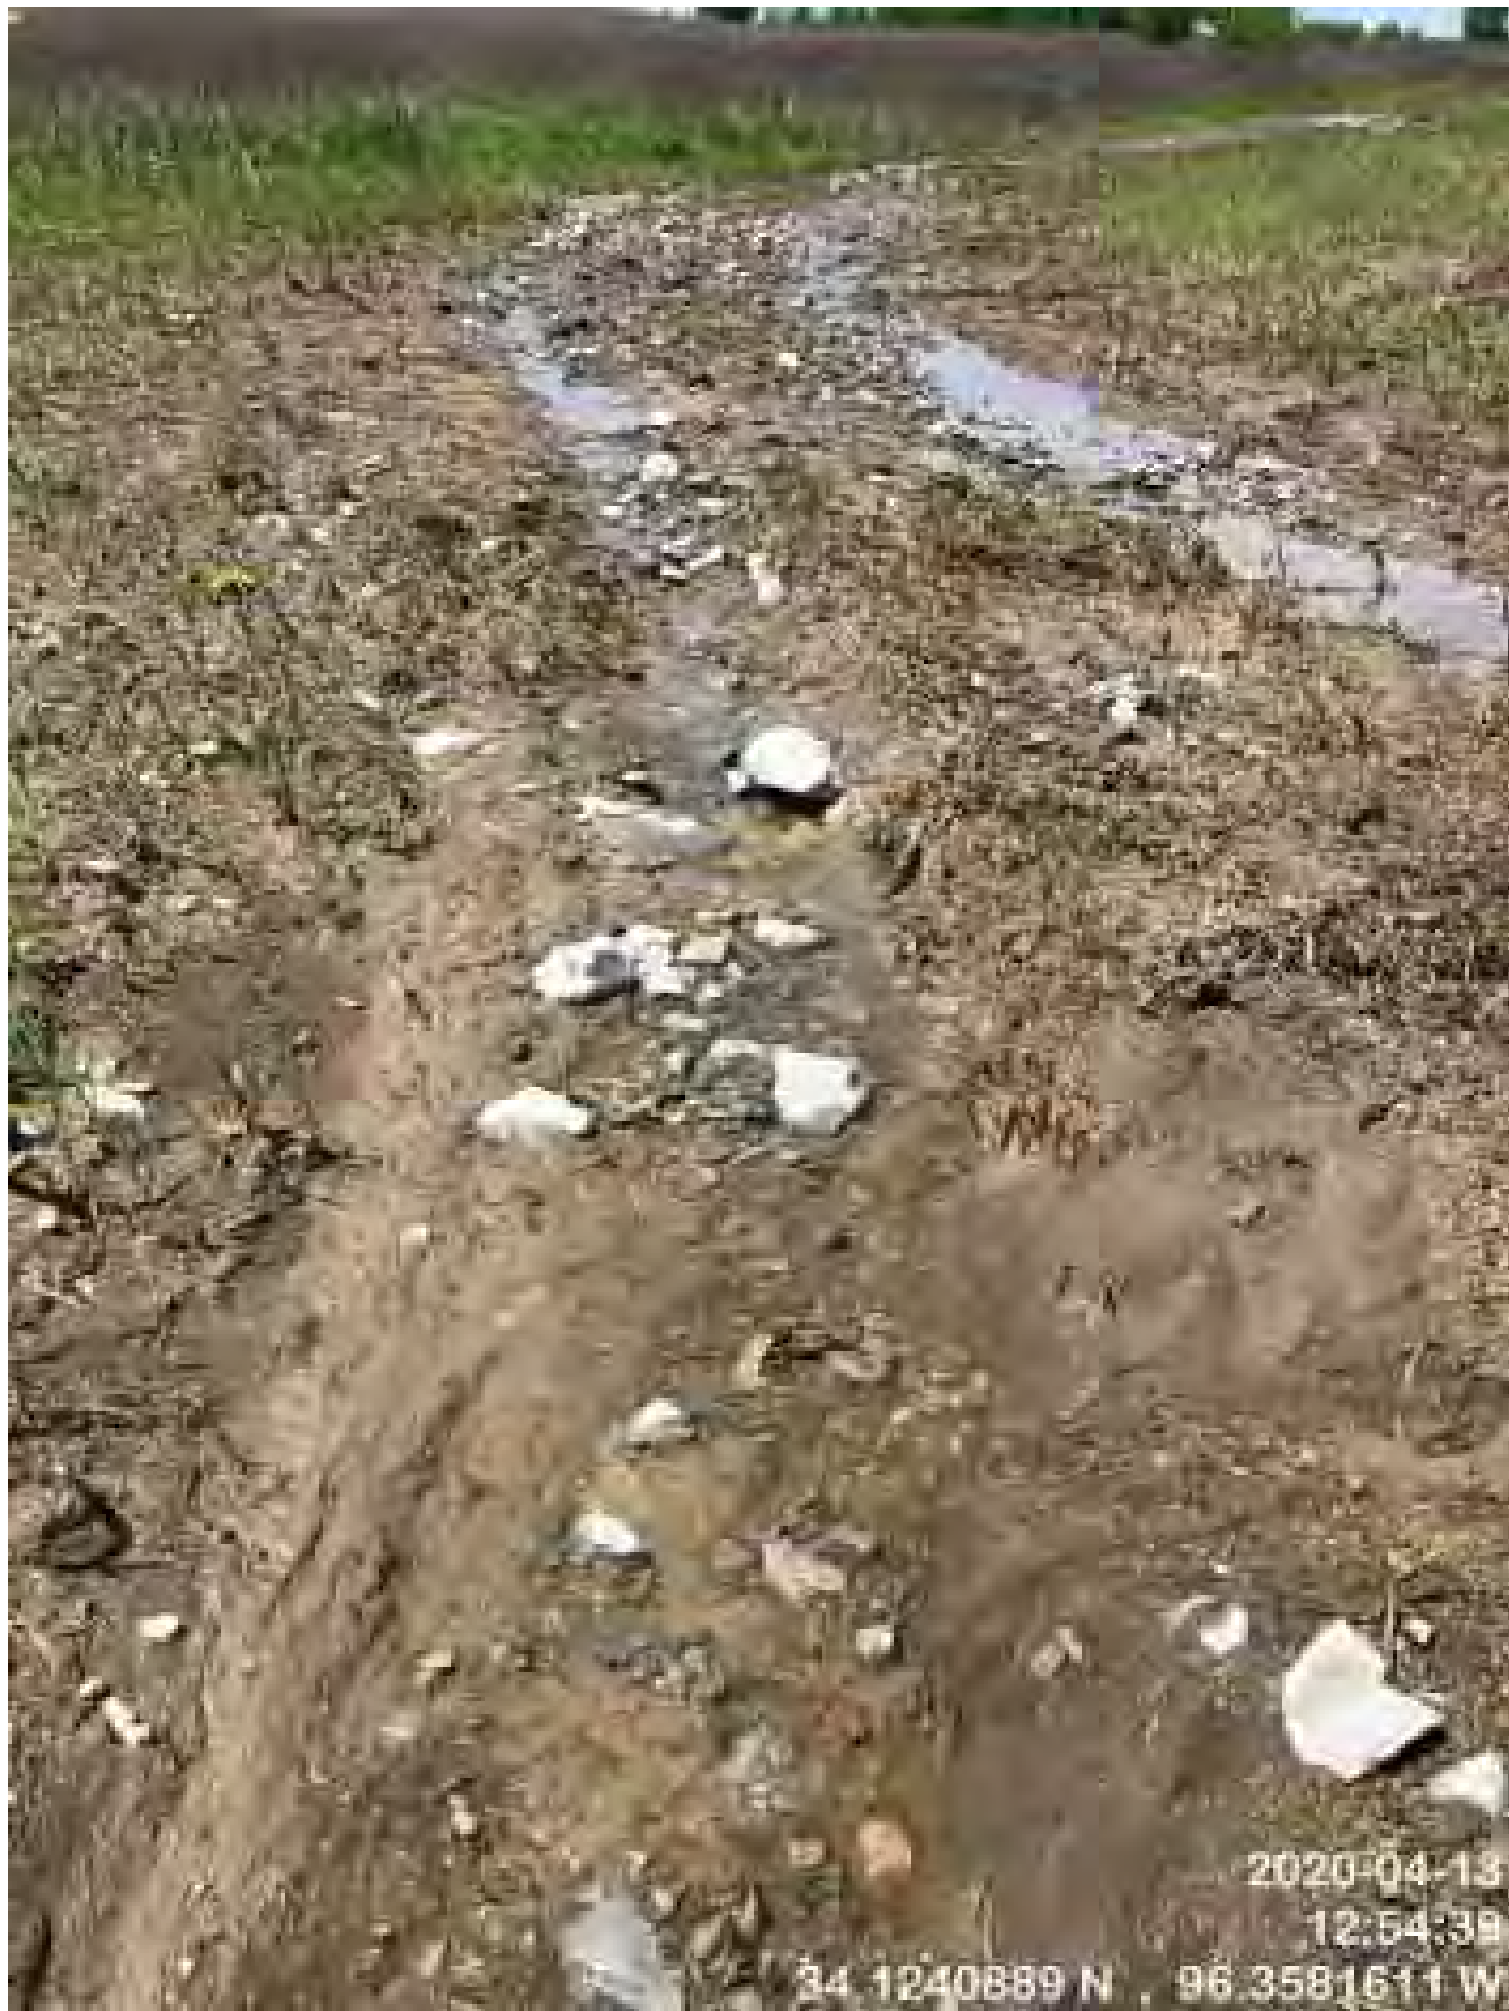
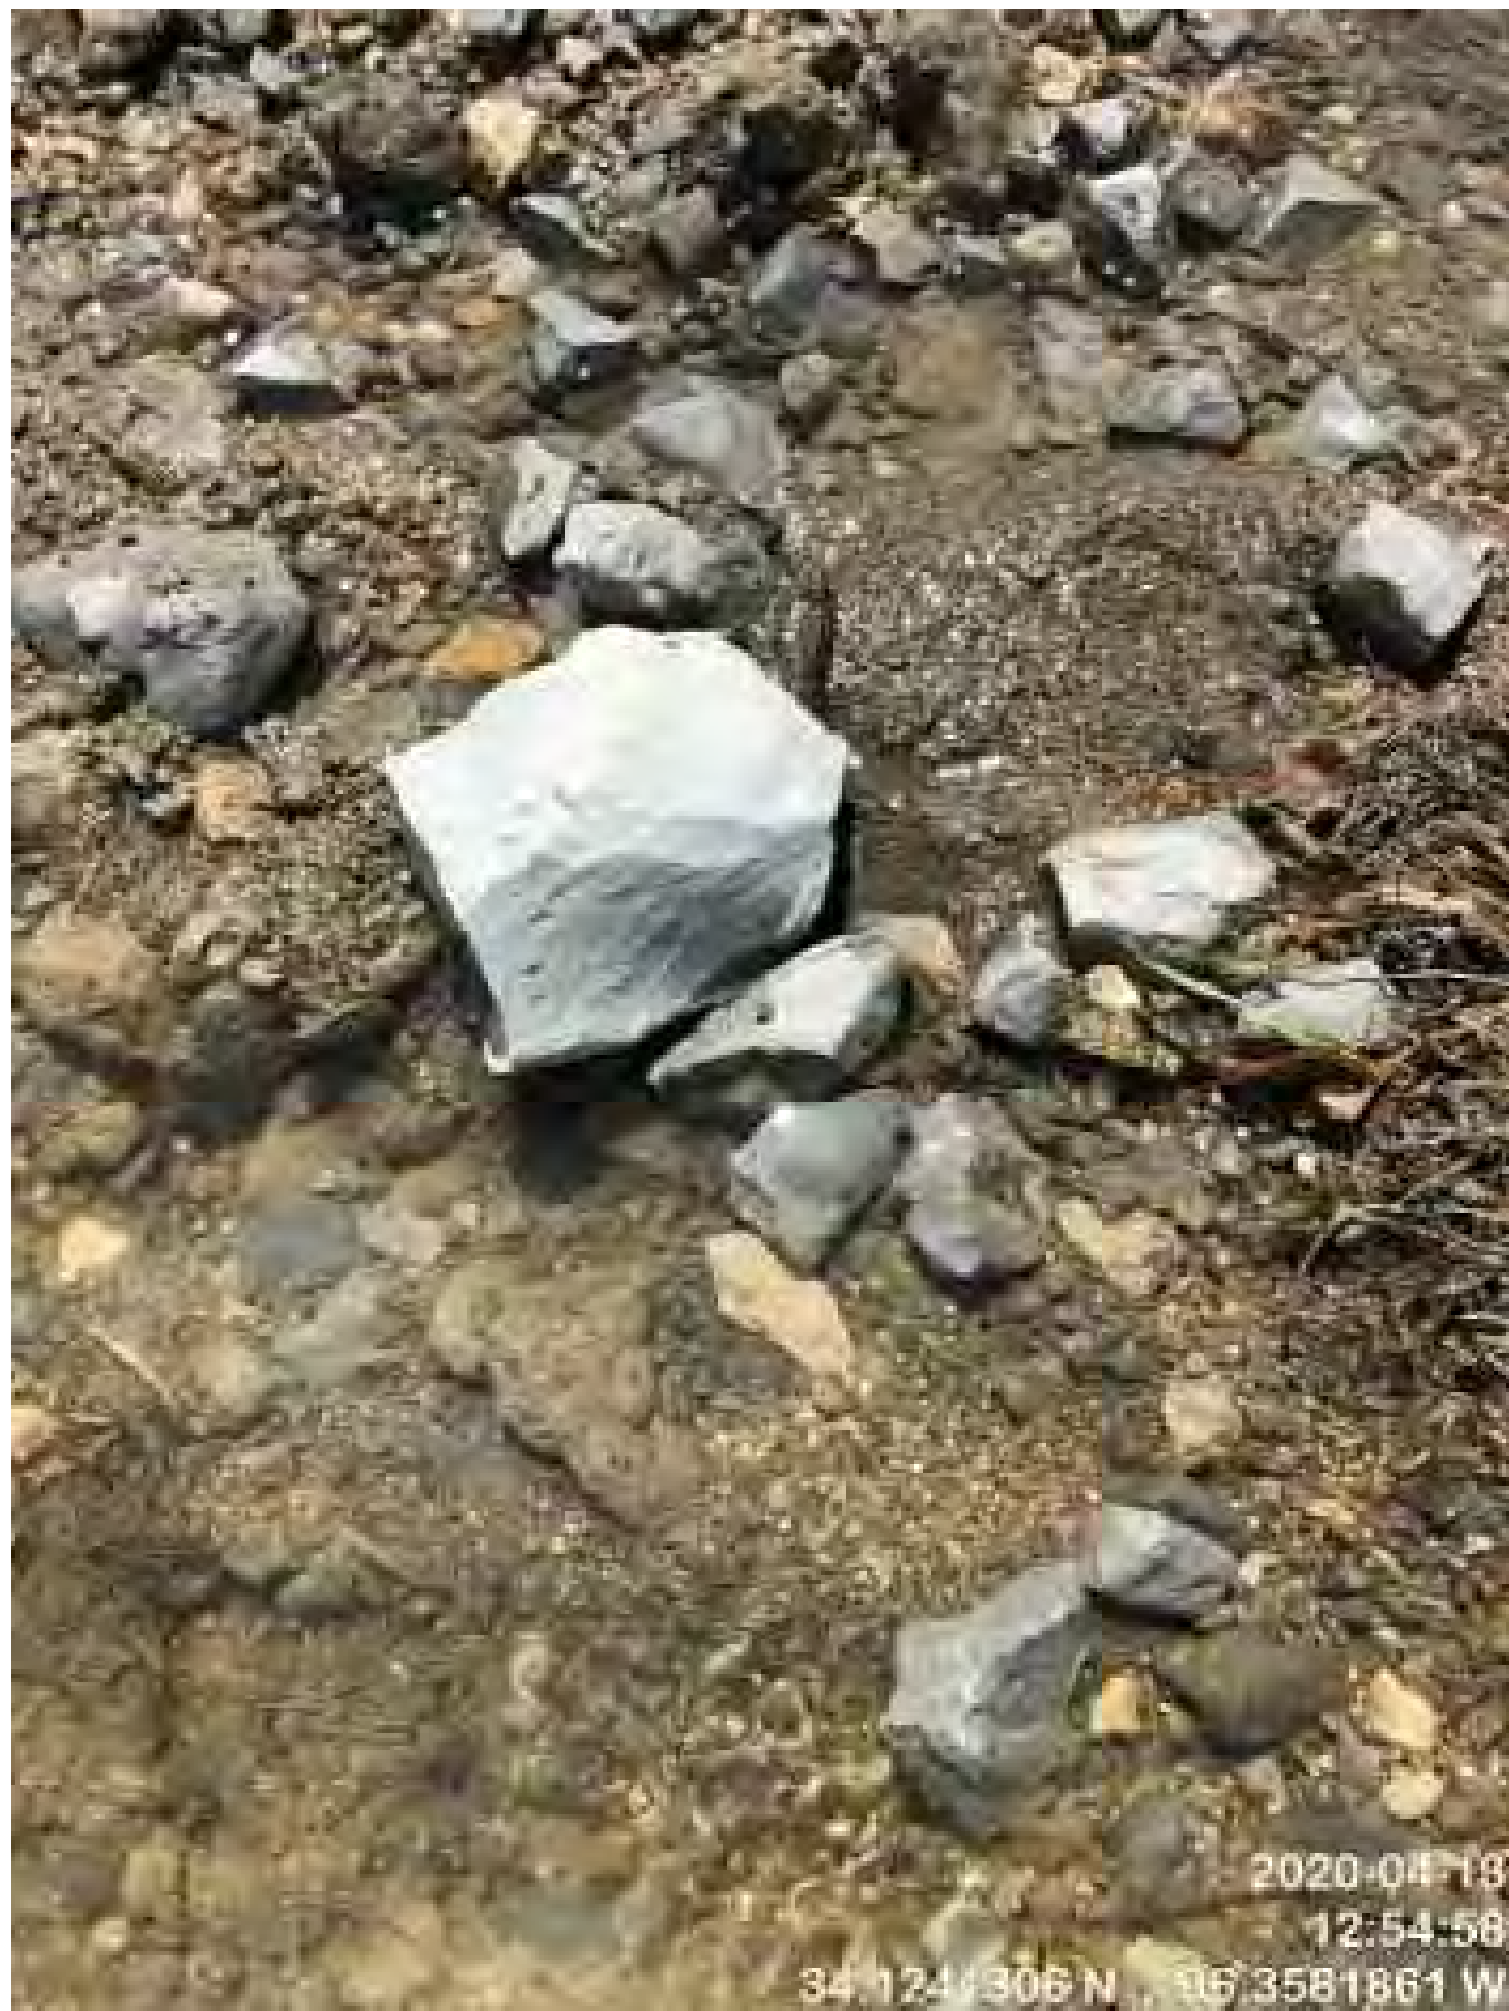
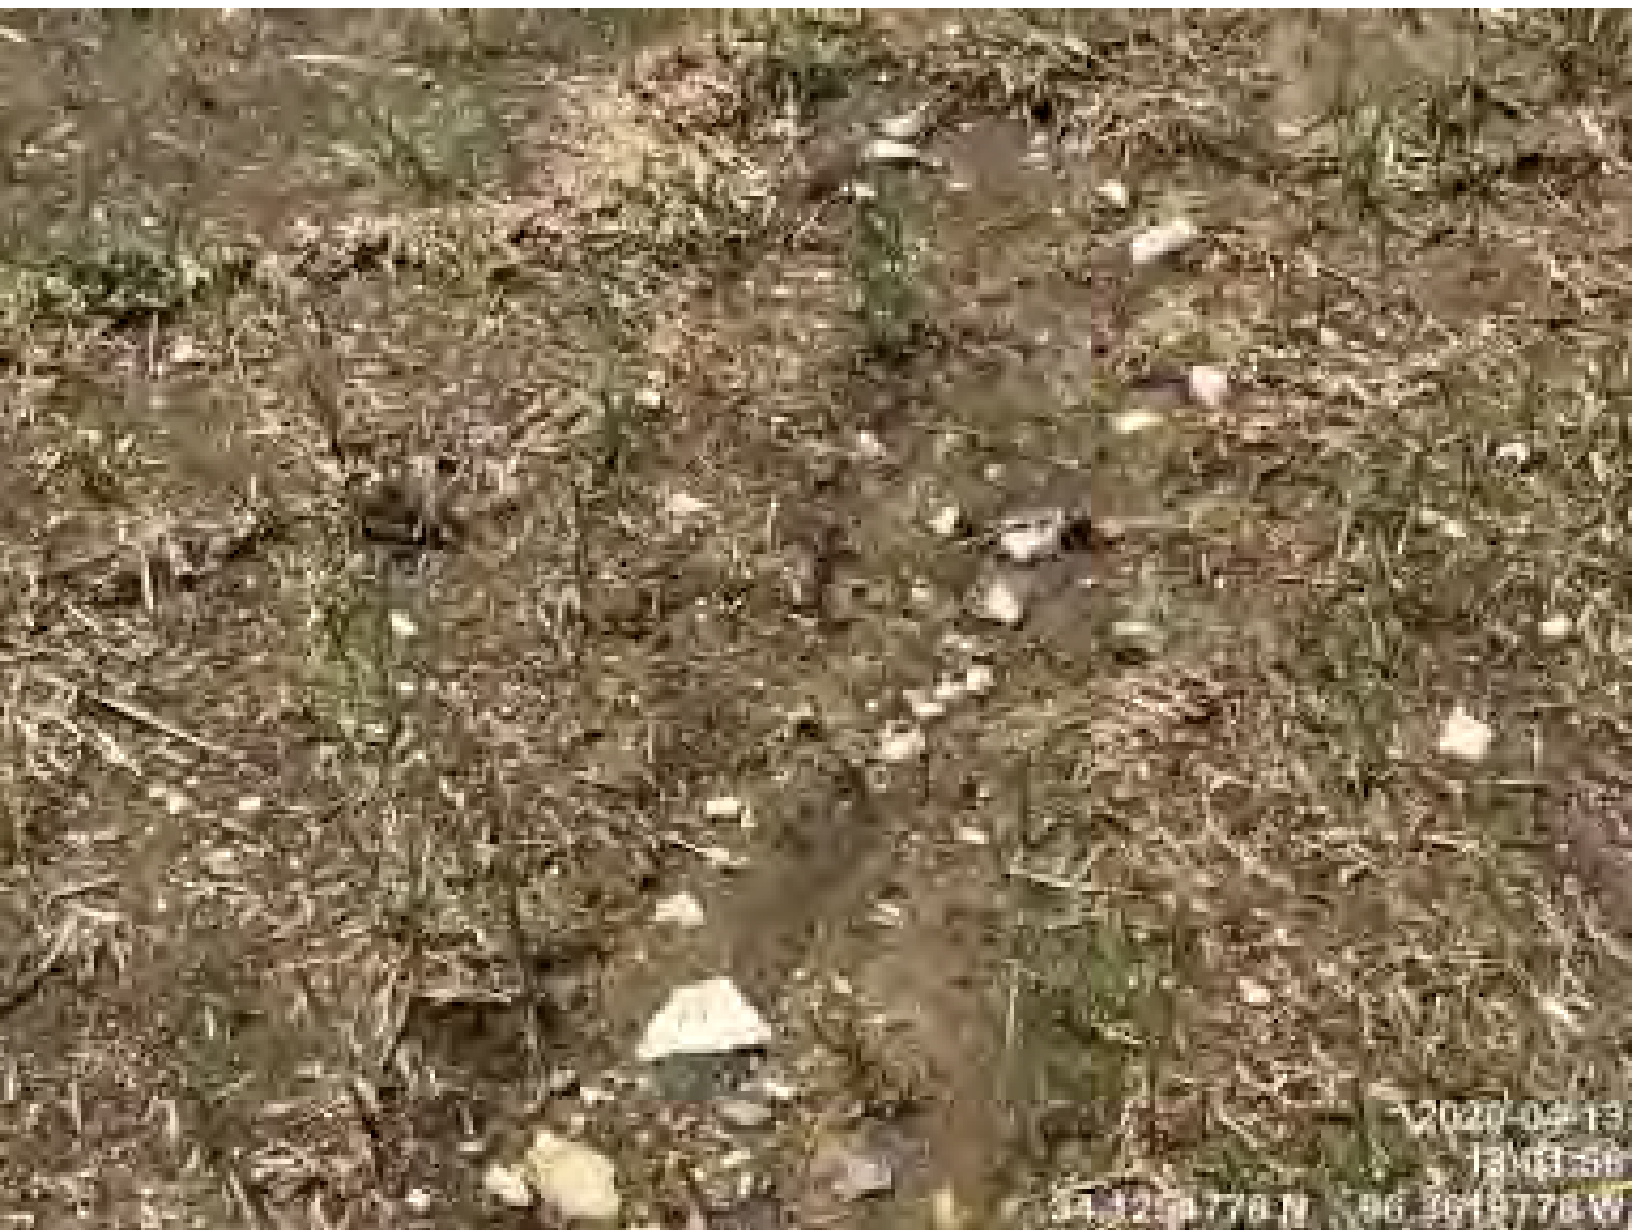
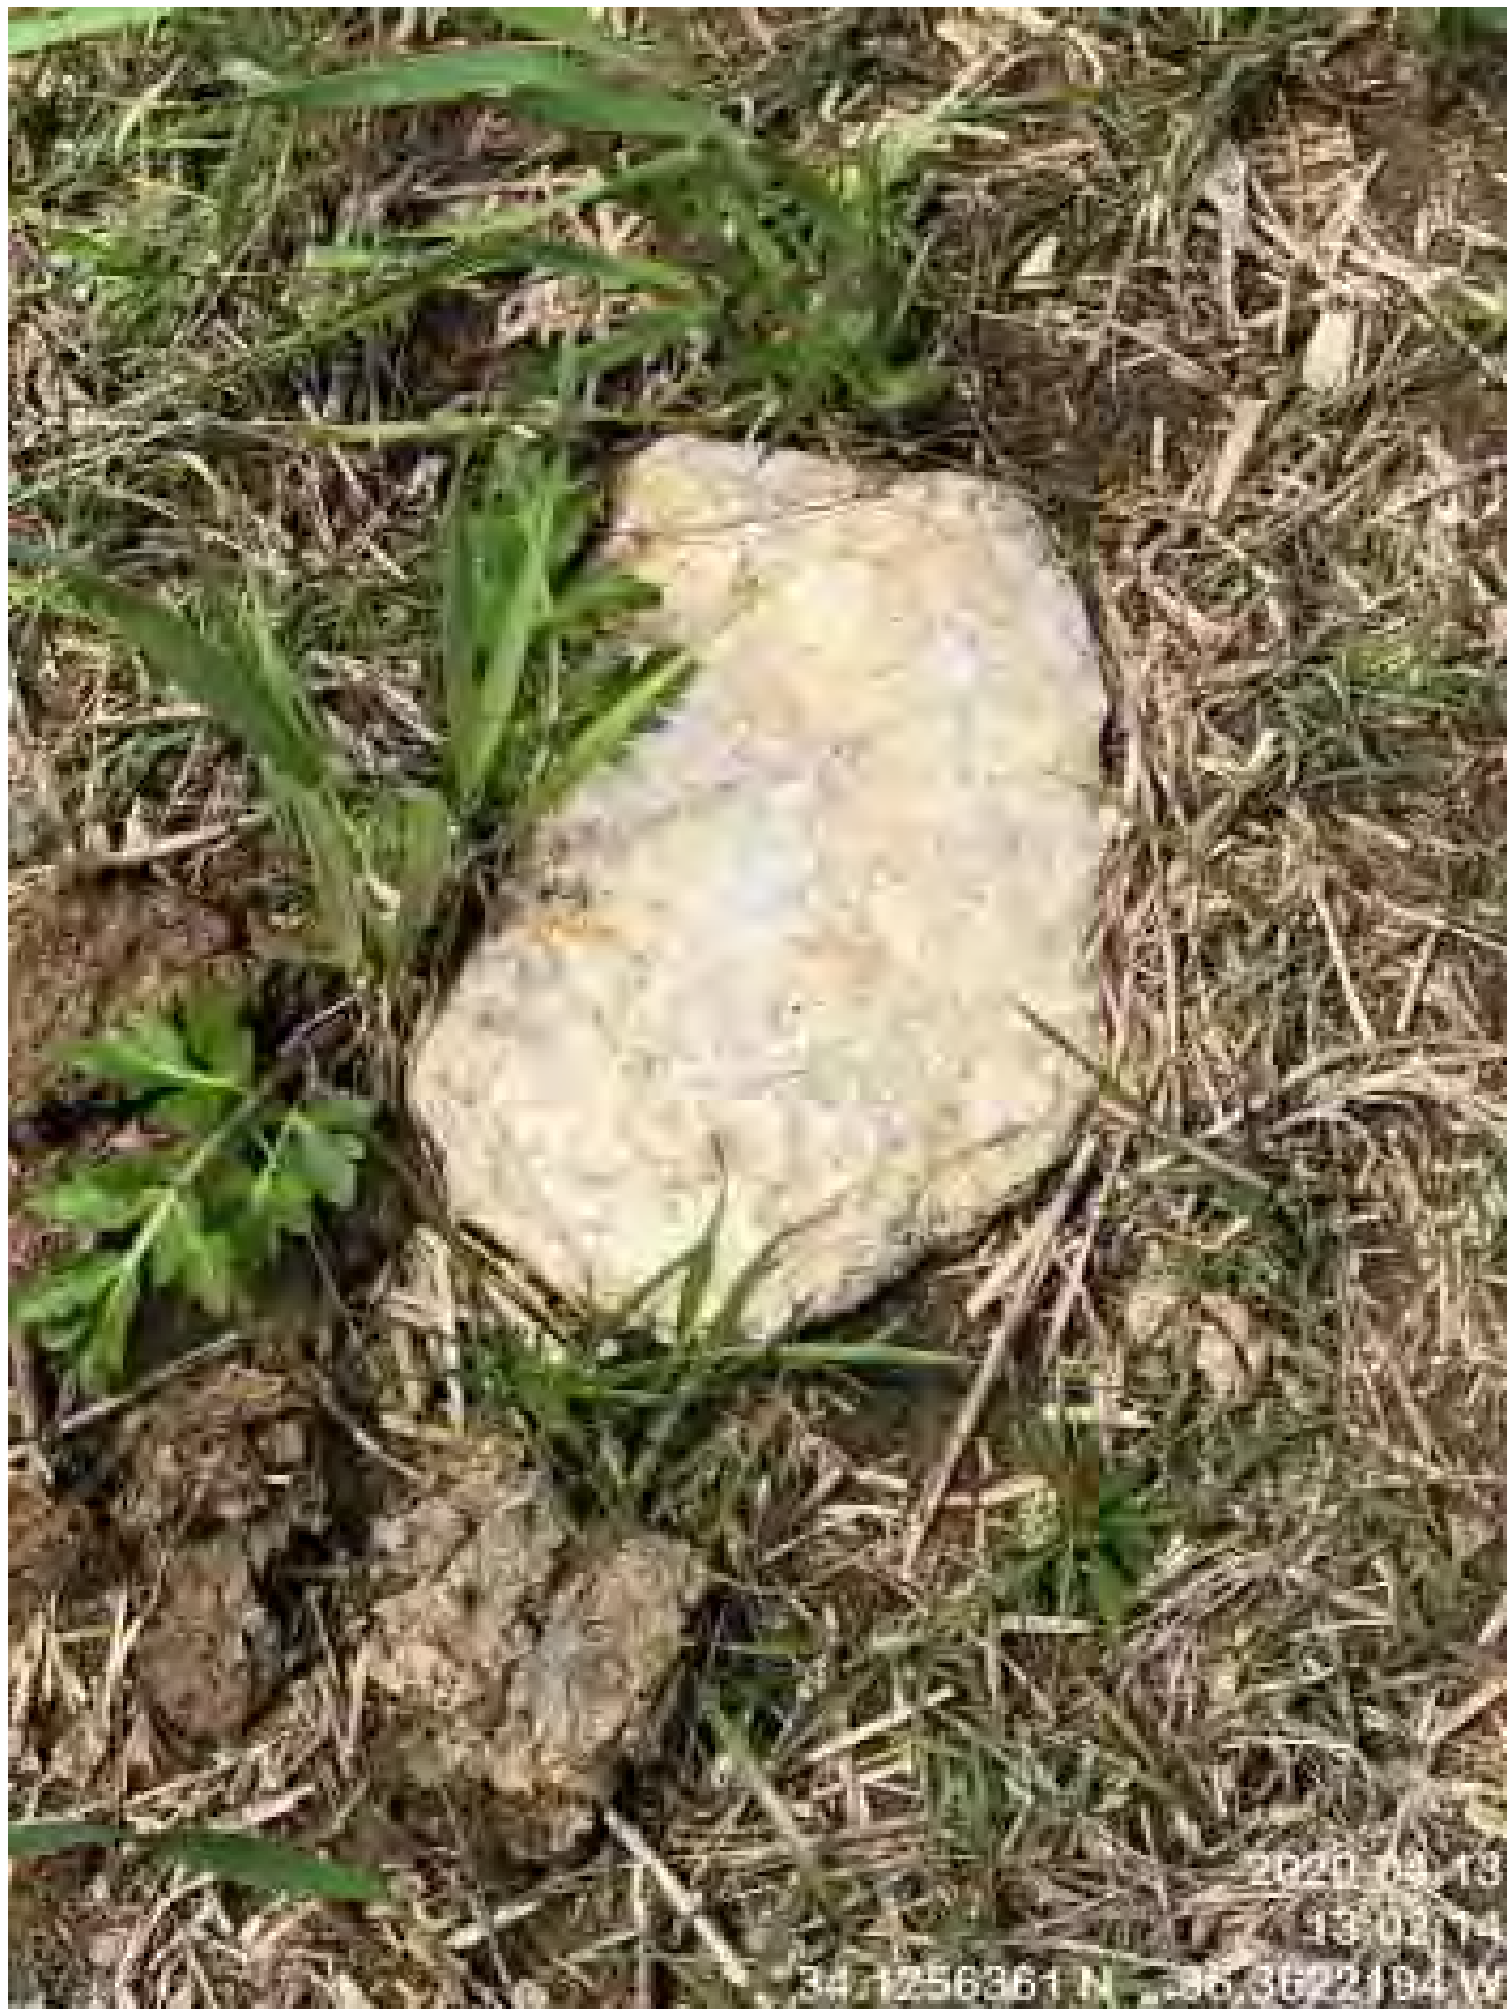
April 13, 2020 Site Inspection
Lee & Anna Chappa
BR-0890.000
Mile Post: MP 176
Bryan County, Oklahoma

Site Inspection Findings:

- 1.) High levels of rock and blasting material mixed into soil. (FERC Plan: V. A. 3-6.)
 - a. Affected areas naturally have between 4 - 6% rock fragments with a maximum size of 74 mm.
 - b. Affected areas naturally have less than 1% rock fragments with a maximum size of 249 mm.
- 2.) Soil Compaction (FERC Plan: V. C. 1-3.)
 - a. Off-ROW Penetrometer reading: Around 160 psi in multiple locations.
 - b. In-ROW Penetrometer reading: 300 psi limit exceeded in every on-ROW location.
- 3.) Severe erosion on and off ROW (FERC Plan: IV. F. 1, 3-4.)
- 4.) Ponding
