Robert Squires - Squires Consulting LLC
Landowner Advocate

Opening Statement for May 5, 2021 Subcommittee on Civil Rights and Civil Liberties Hearing:
“Pipelines Over People (Part II): Midship Pipeline’s Disregard for Landowners in Its Pathway”

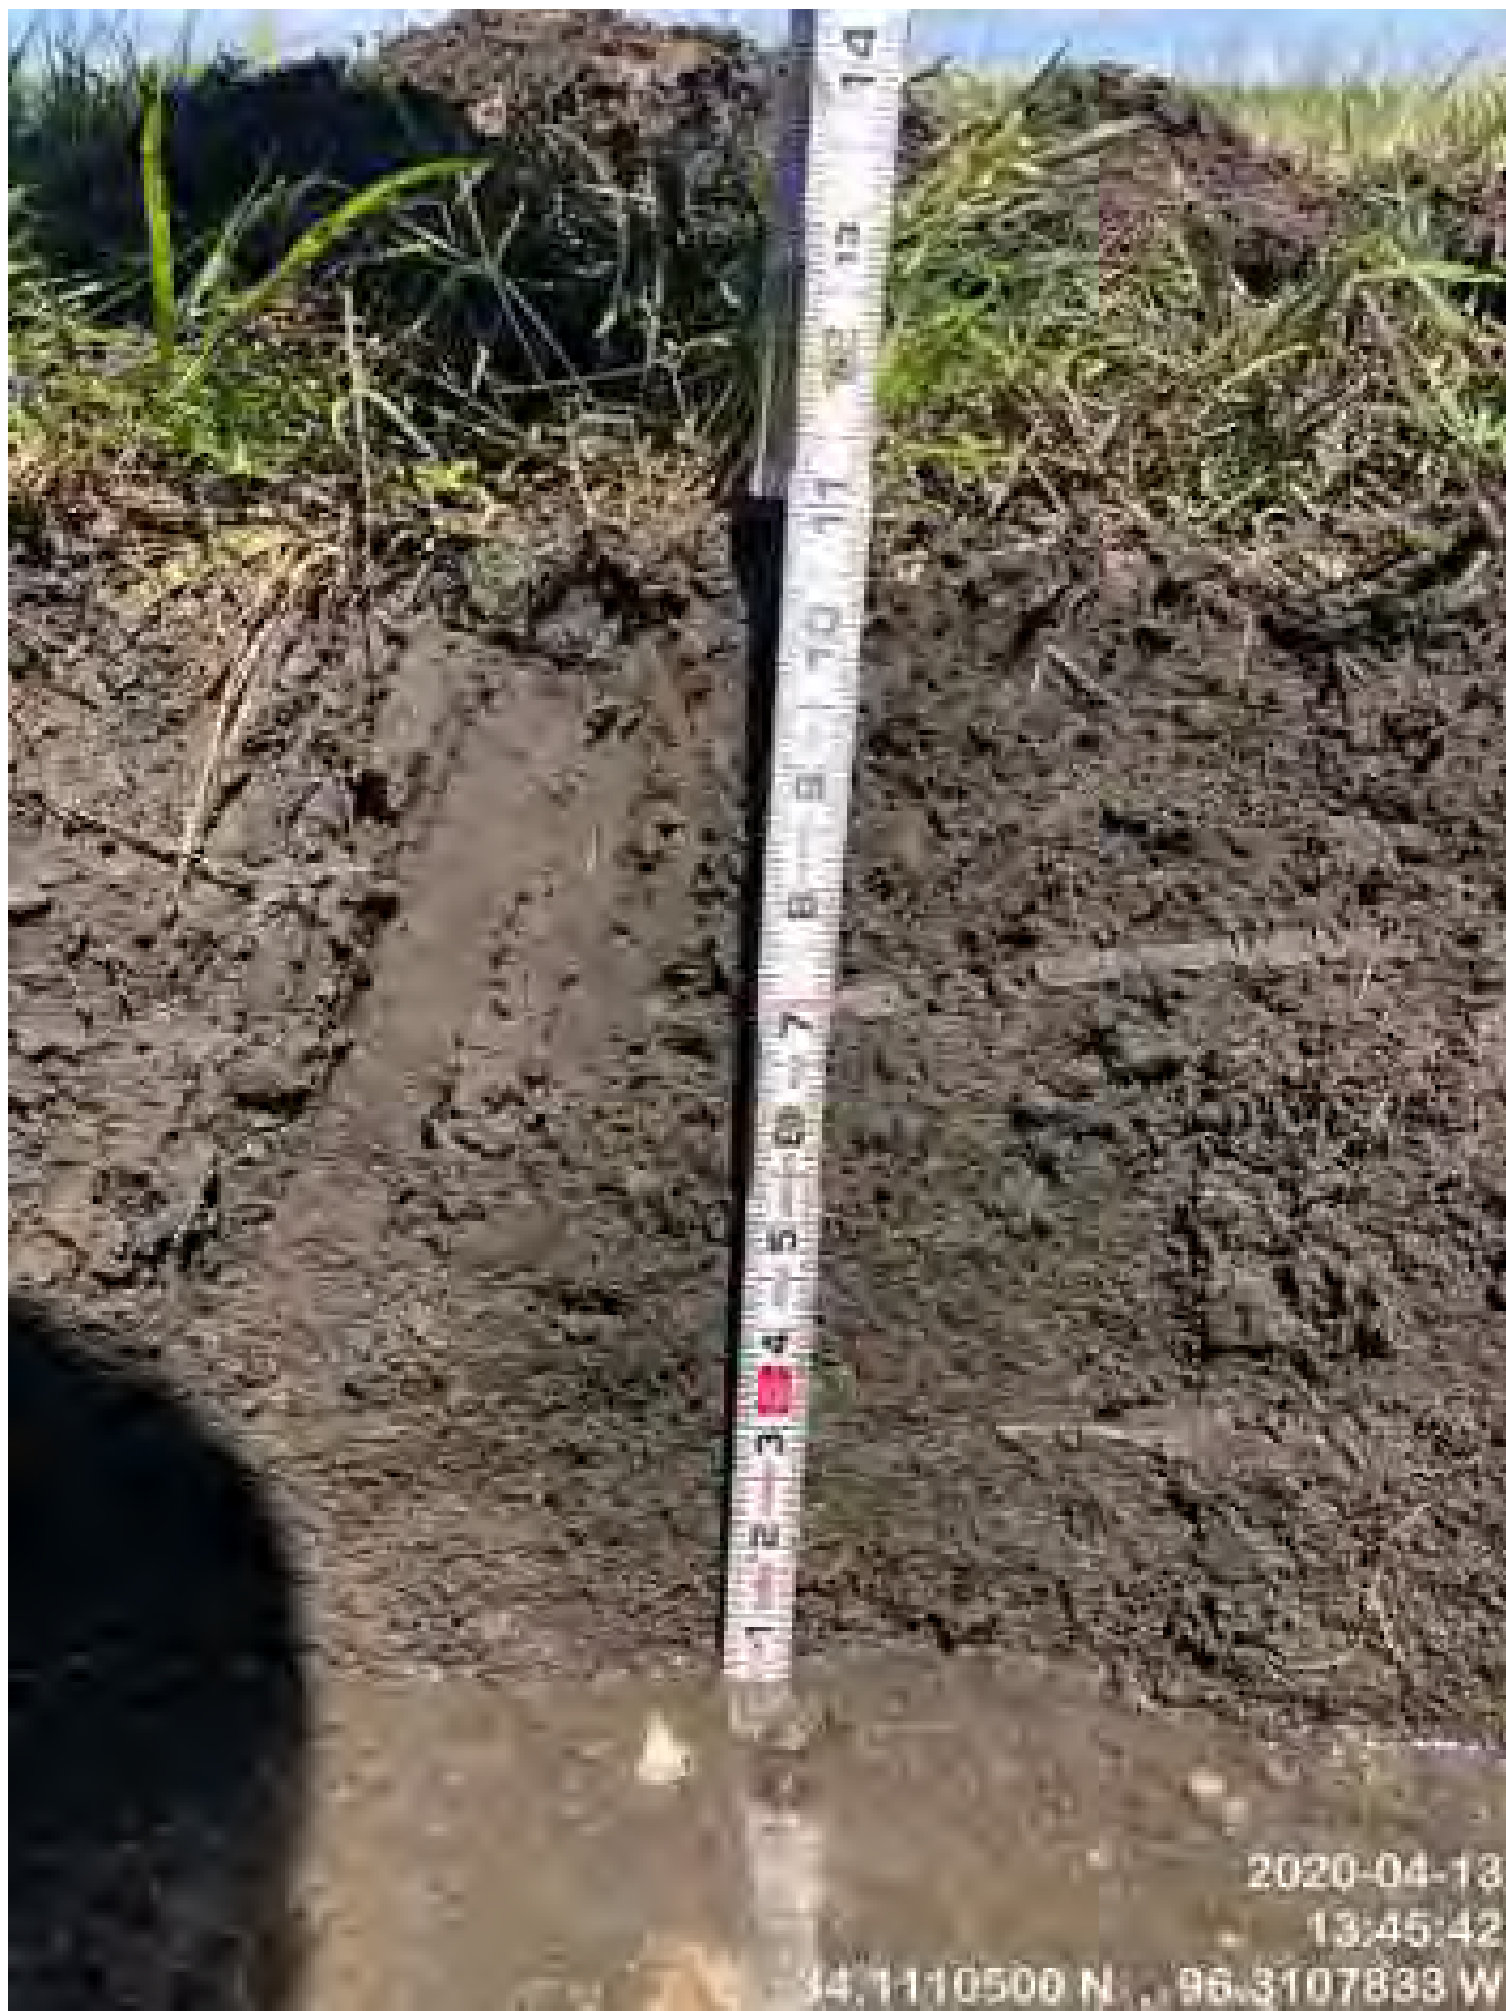
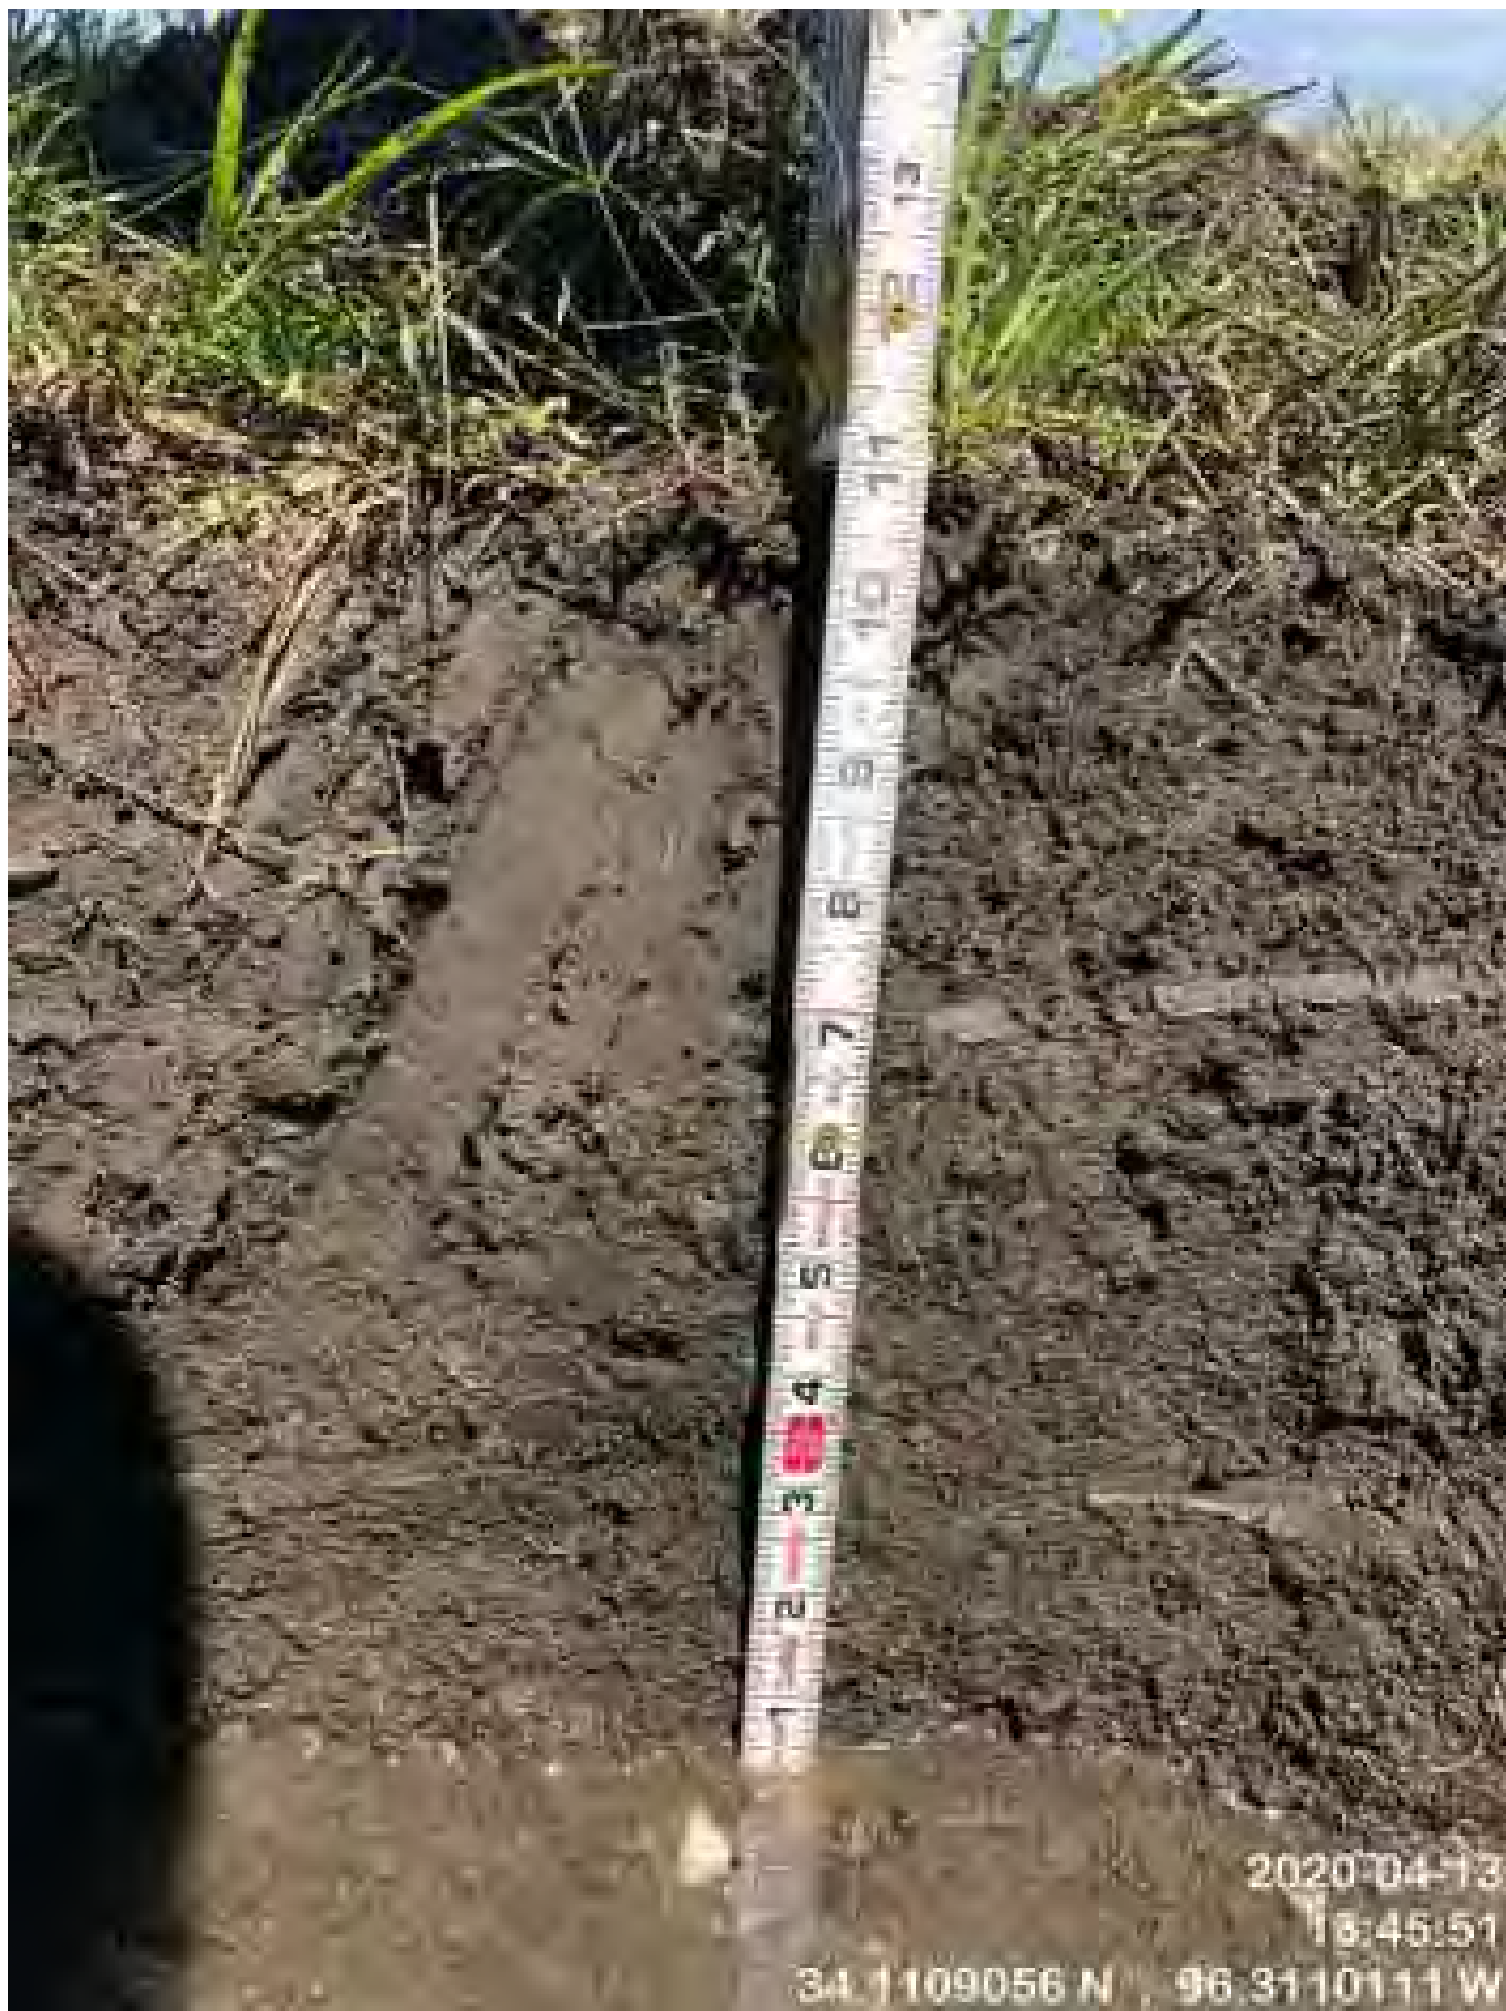
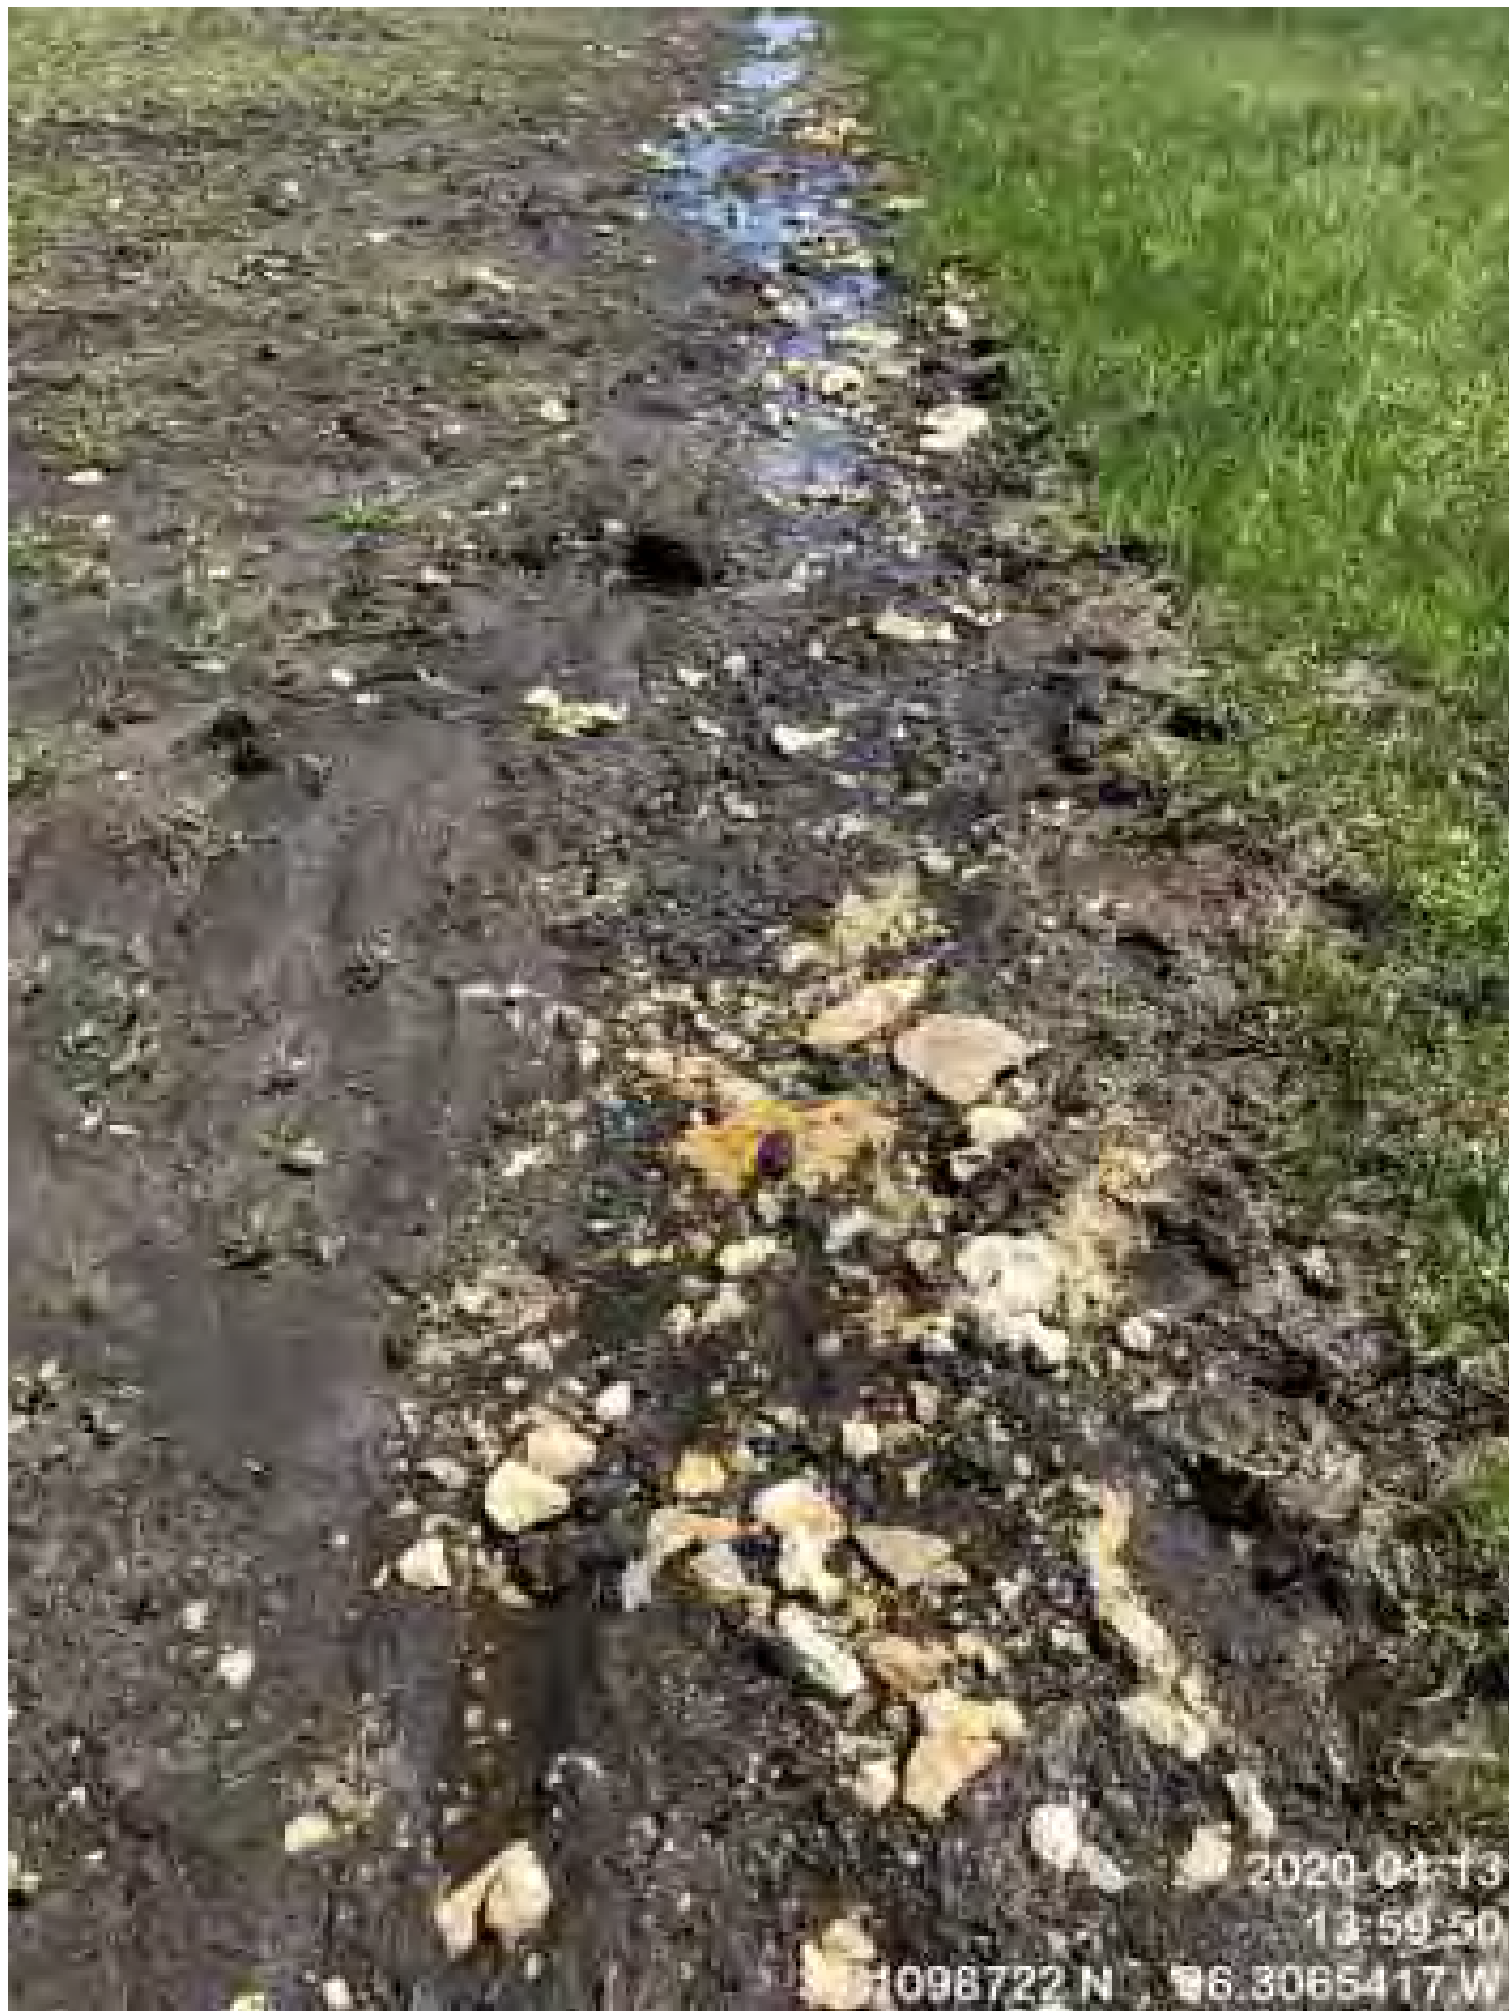
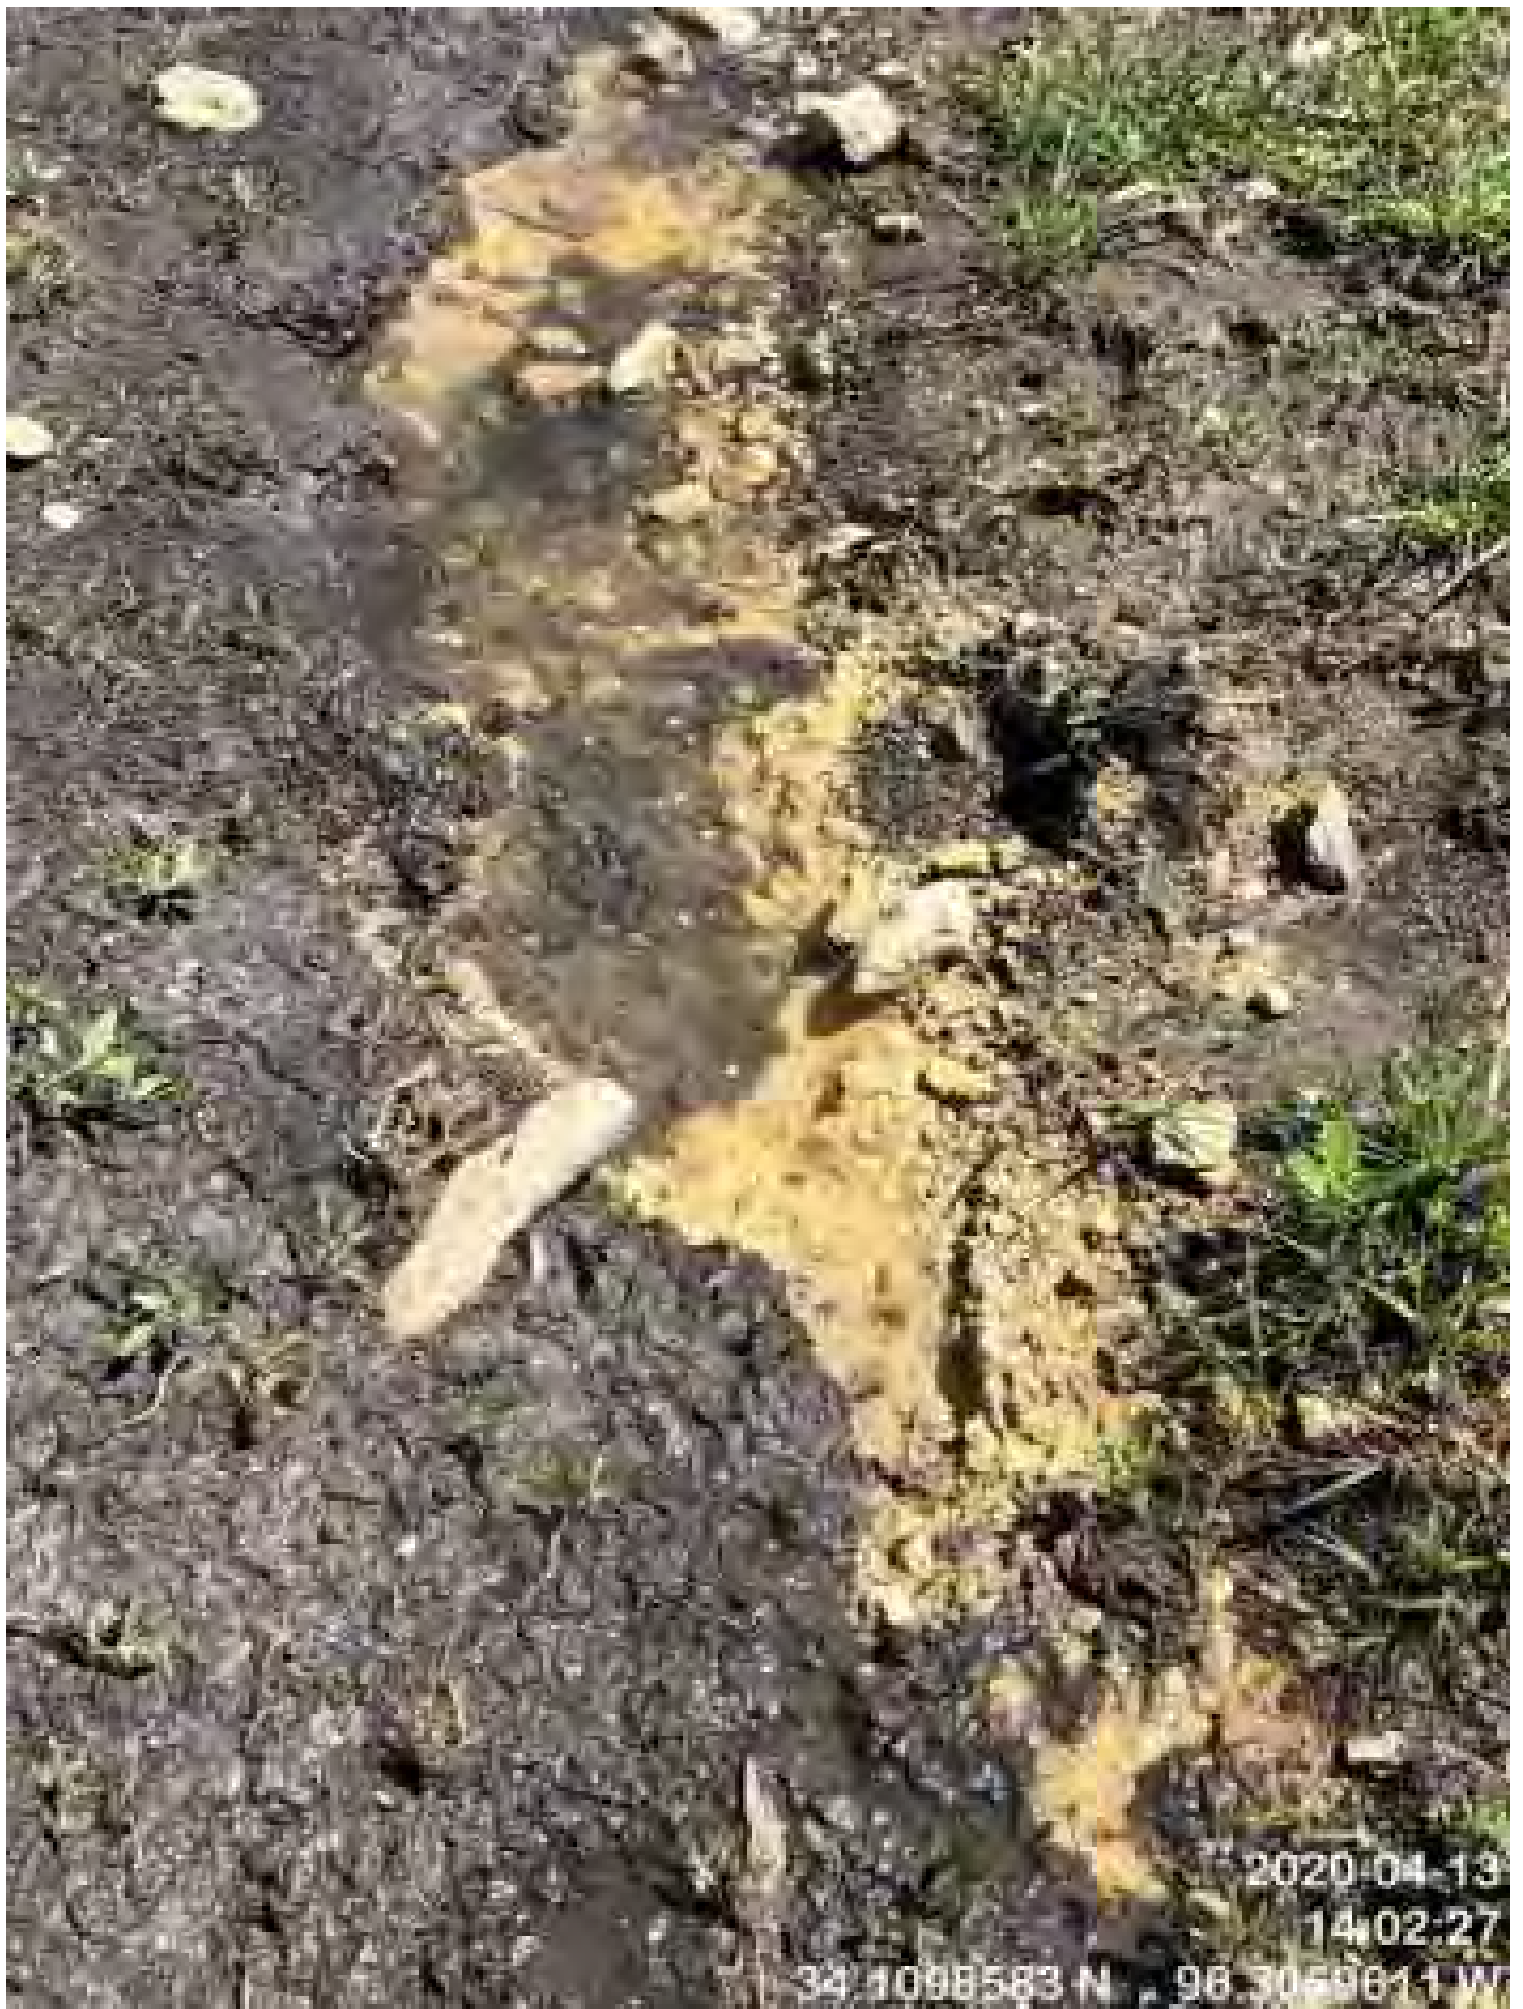
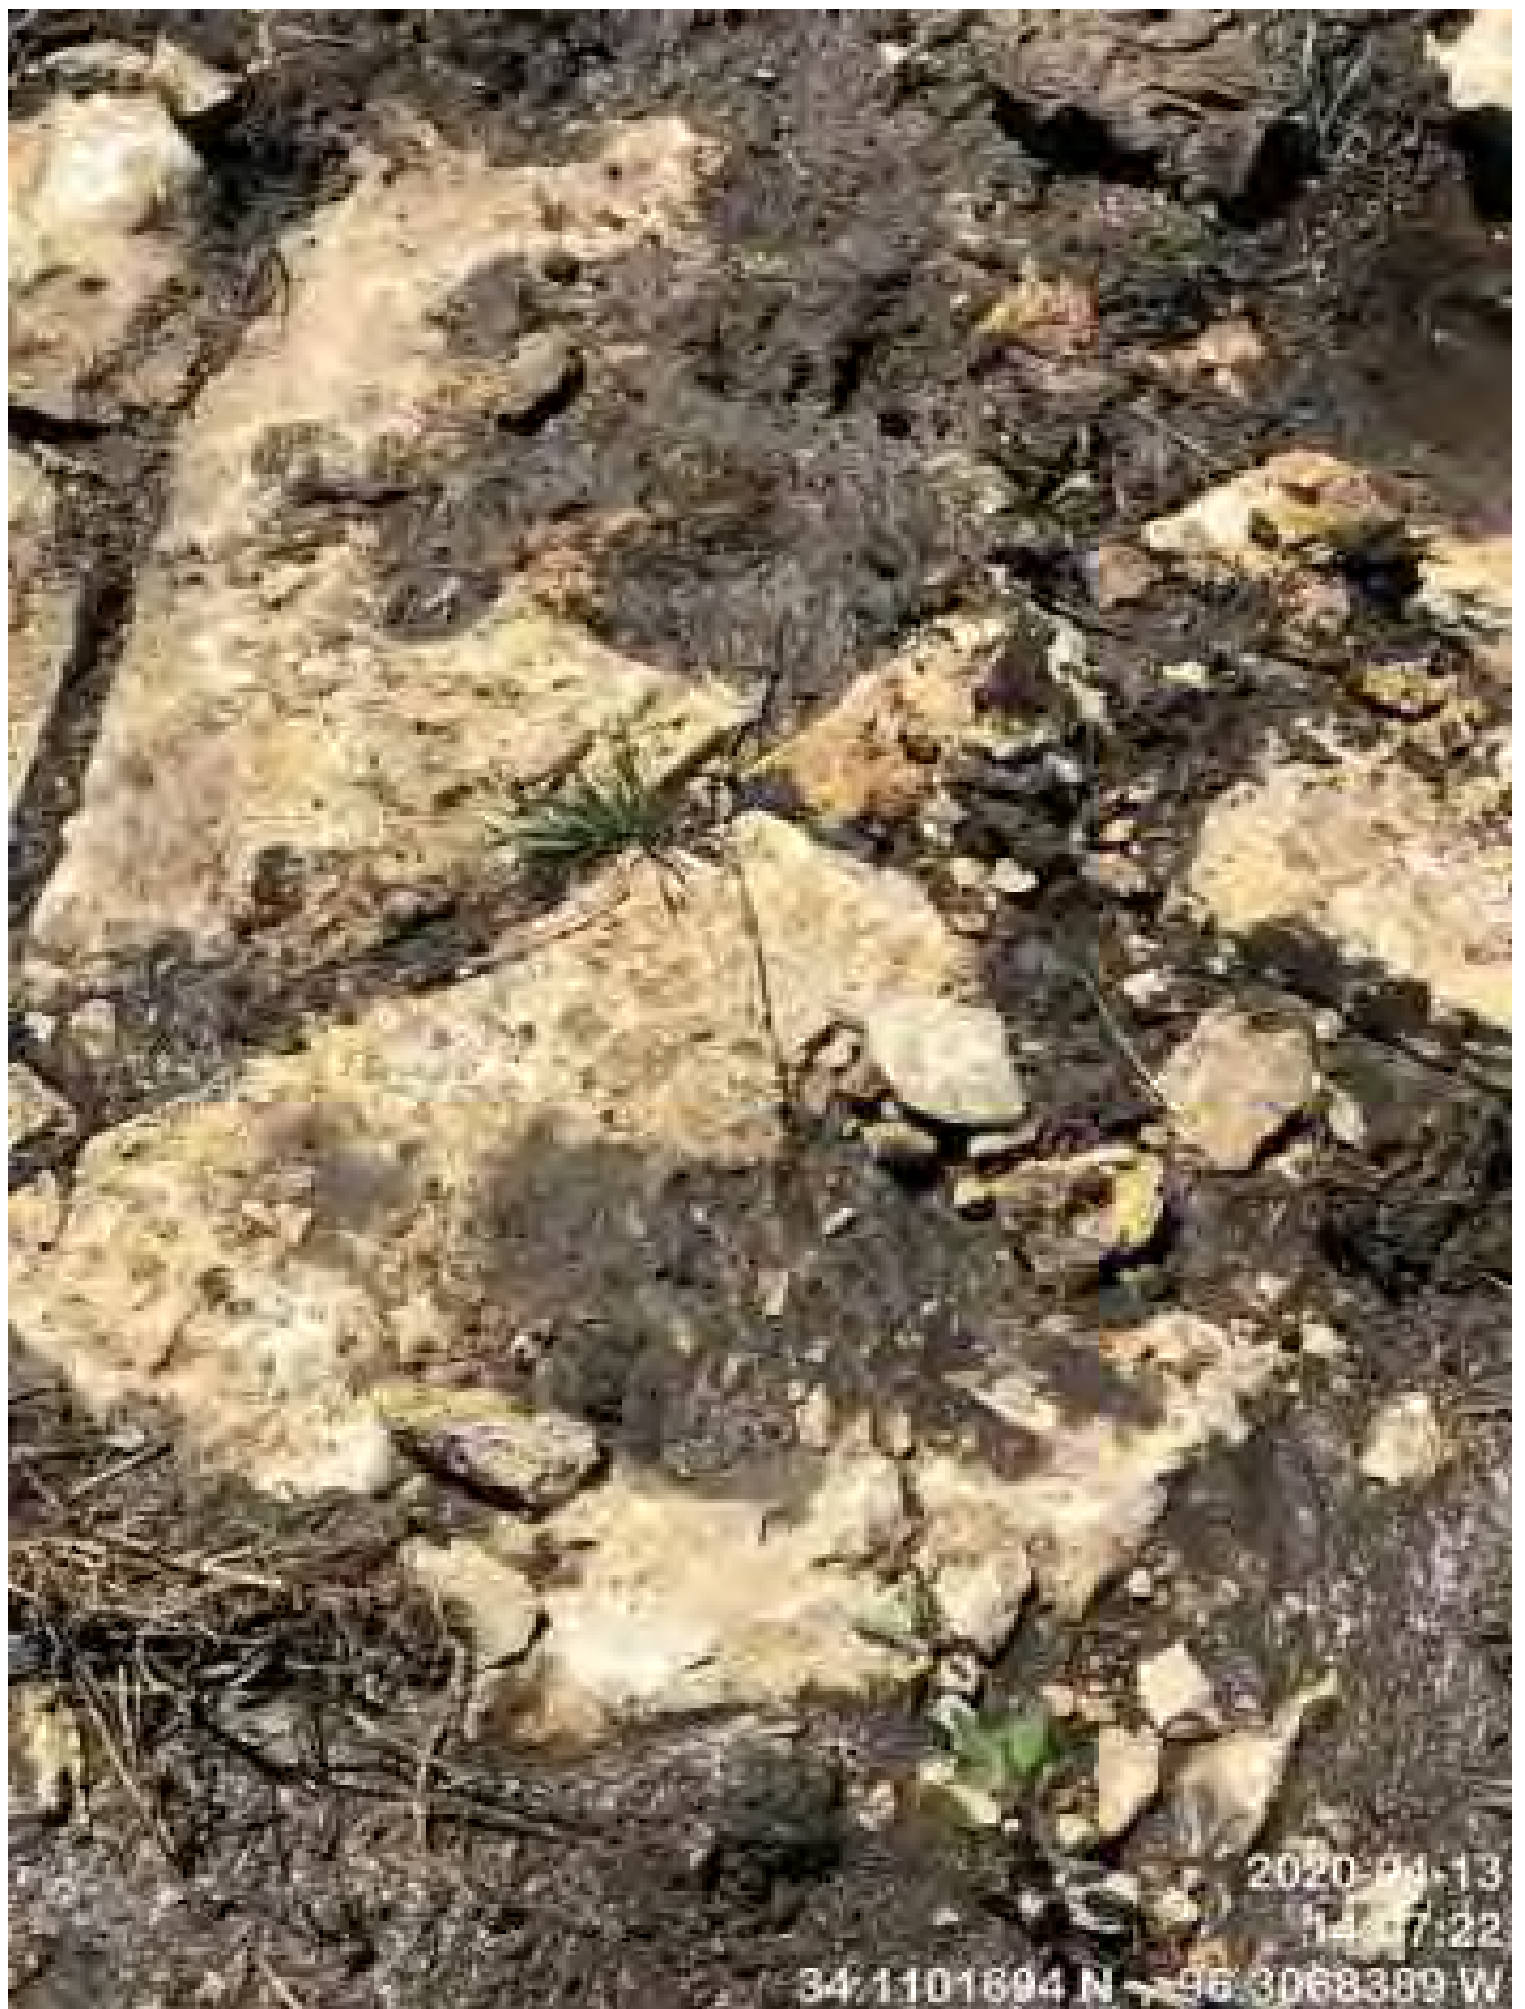
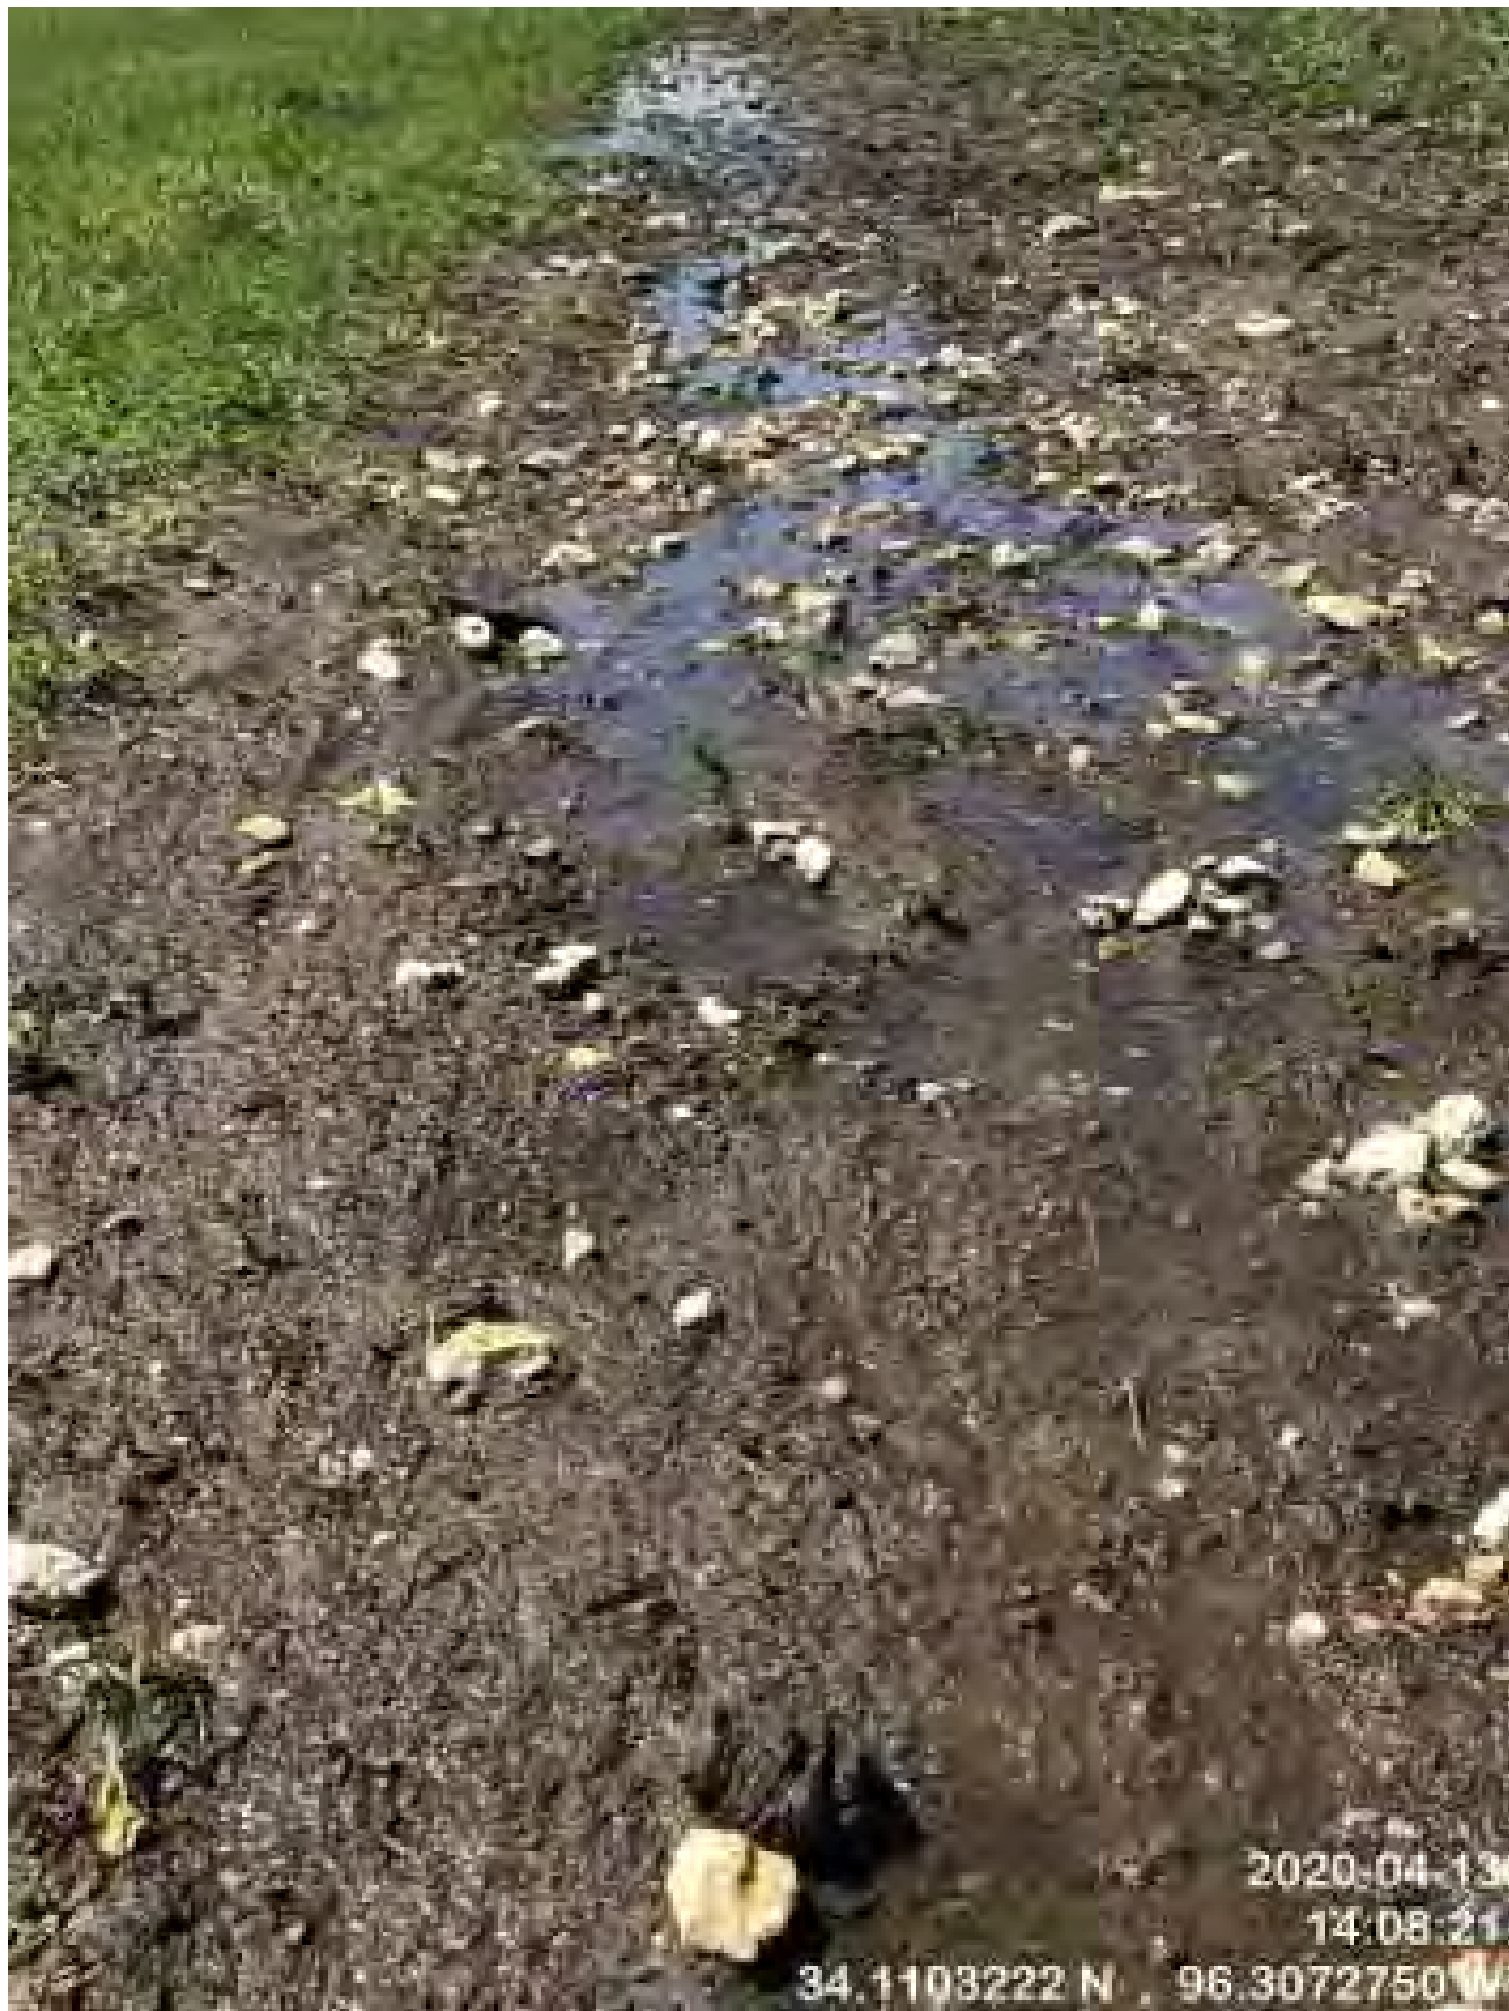
Site Inspection Findings:

- 1.) Soil Compaction (FERC Plan: V. C. 1-3.)
 - a. Off-ROW Penetrometer reading: Around 175 psi in multiple locations.
 - b. In-ROW Penetrometer reading: 300 psi limit exceeded in every on-ROW location.
- 2.) High levels of rock and blasting material mixed into soil. (FERC Plan: V. A. 3-6.)
 - a. In top 20" affected areas naturally have around 6% rock fragments with a maximum size of 74 mm.
 - b. In top 20" affected areas naturally have around 1% rock fragments with a maximum size of 249 mm.
