Robert Squires - Squires Consulting LLC
Landowner Advocate

Opening Statement for May 5, 2021 Subcommittee on Civil Rights and Civil Liberties Hearing:
“Pipelines Over People (Part II): Midship Pipeline’s Disregard for Landowners in Its Pathway”

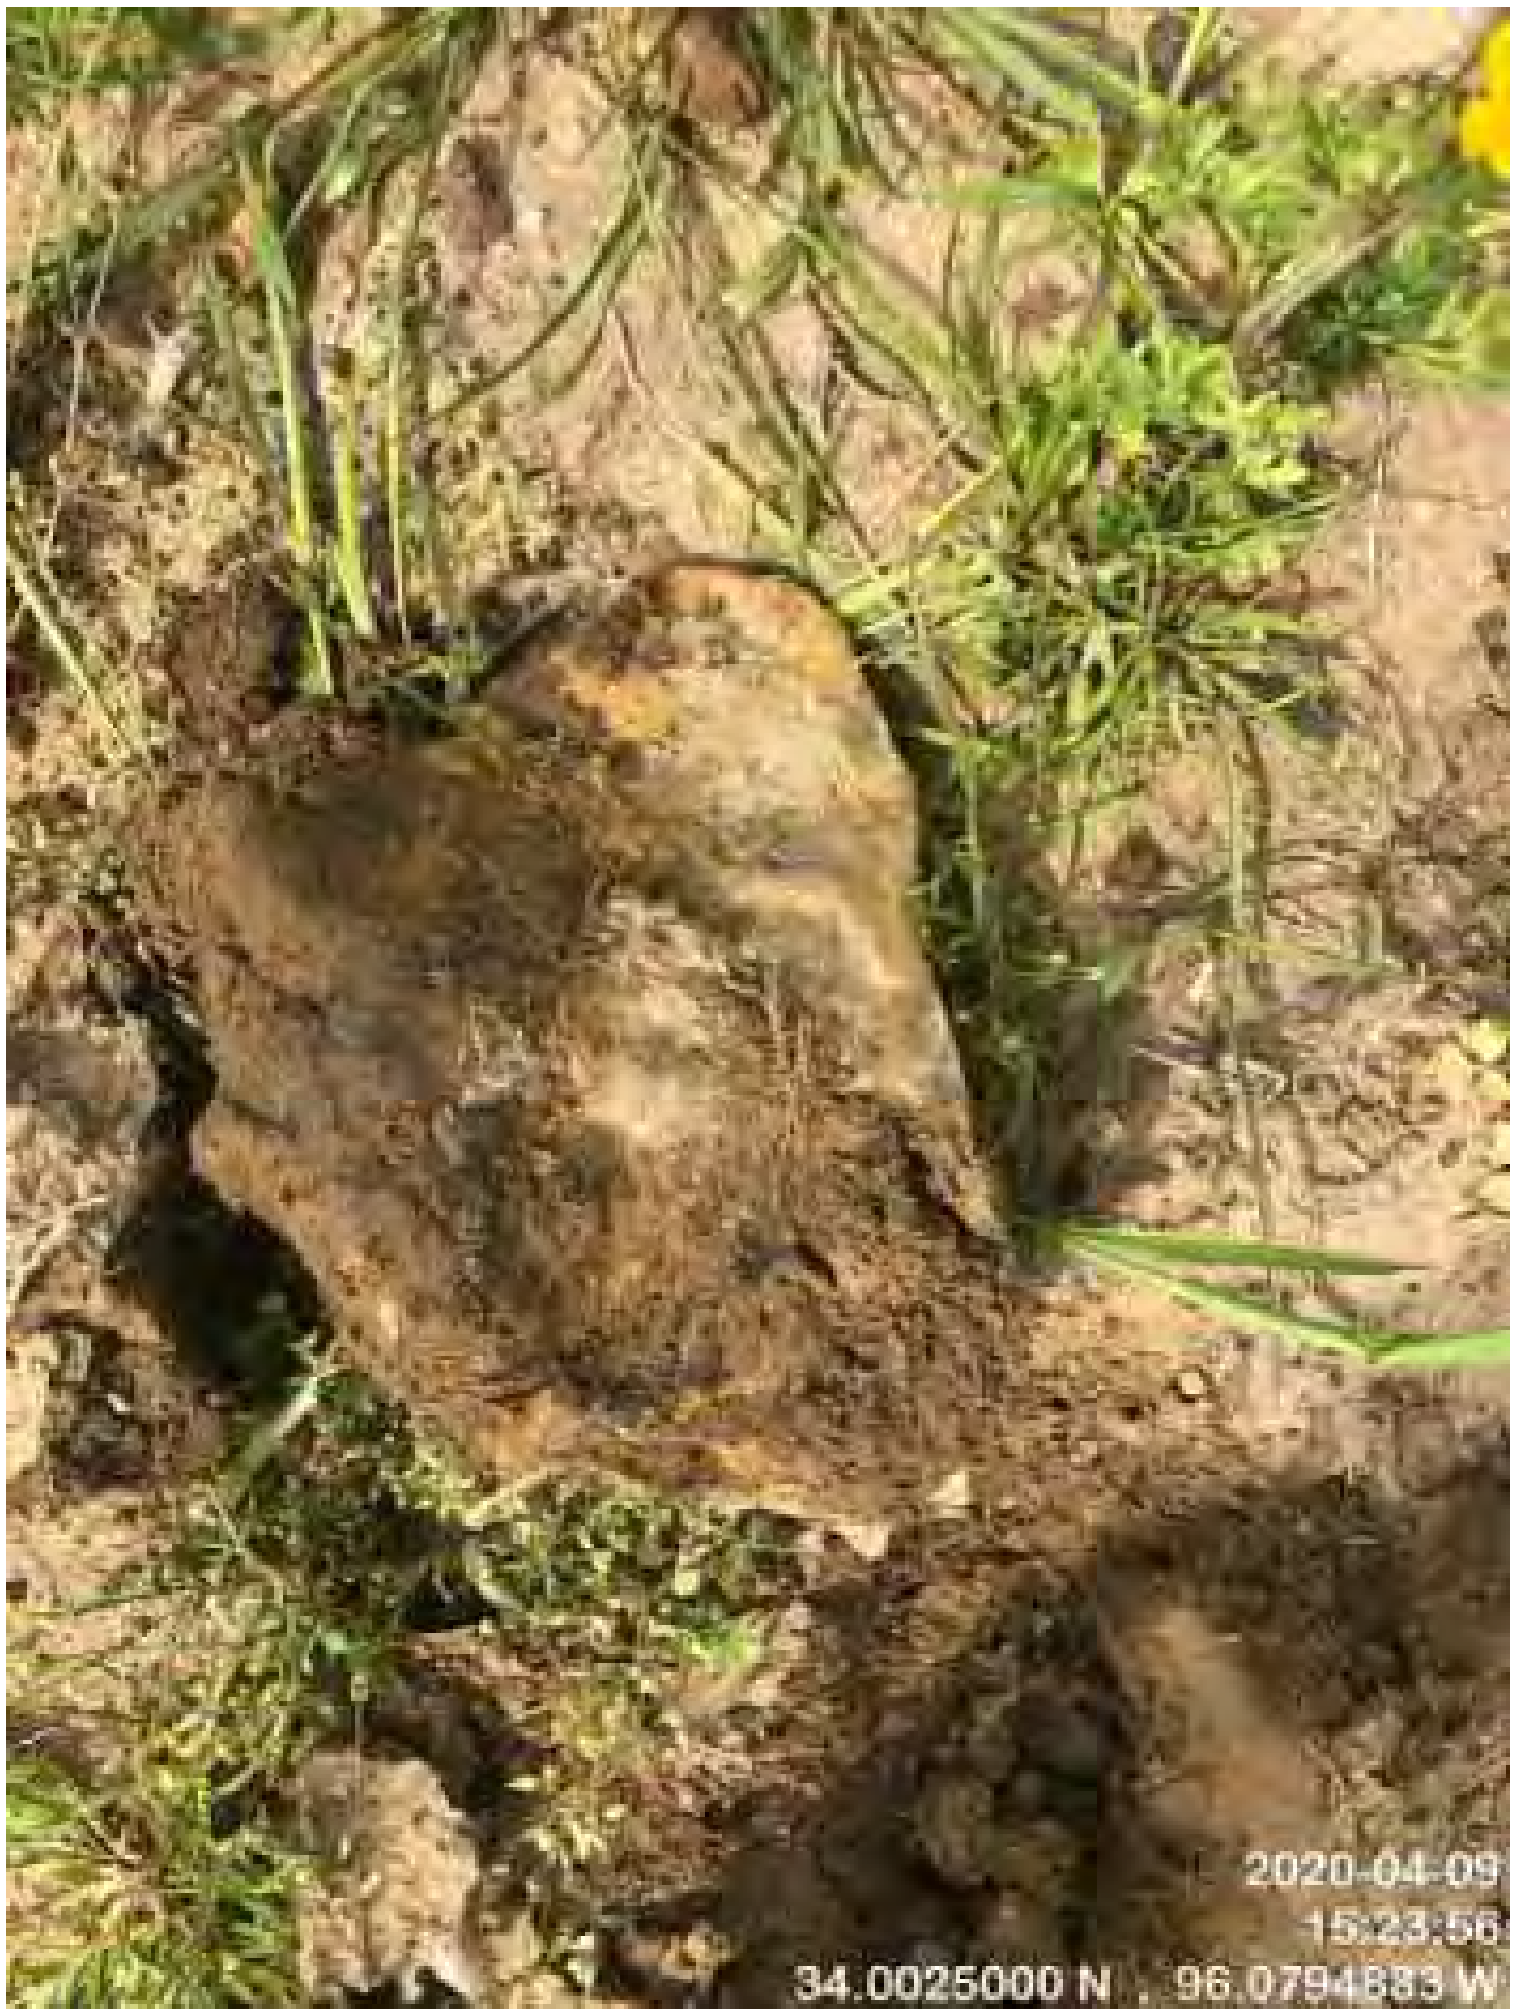
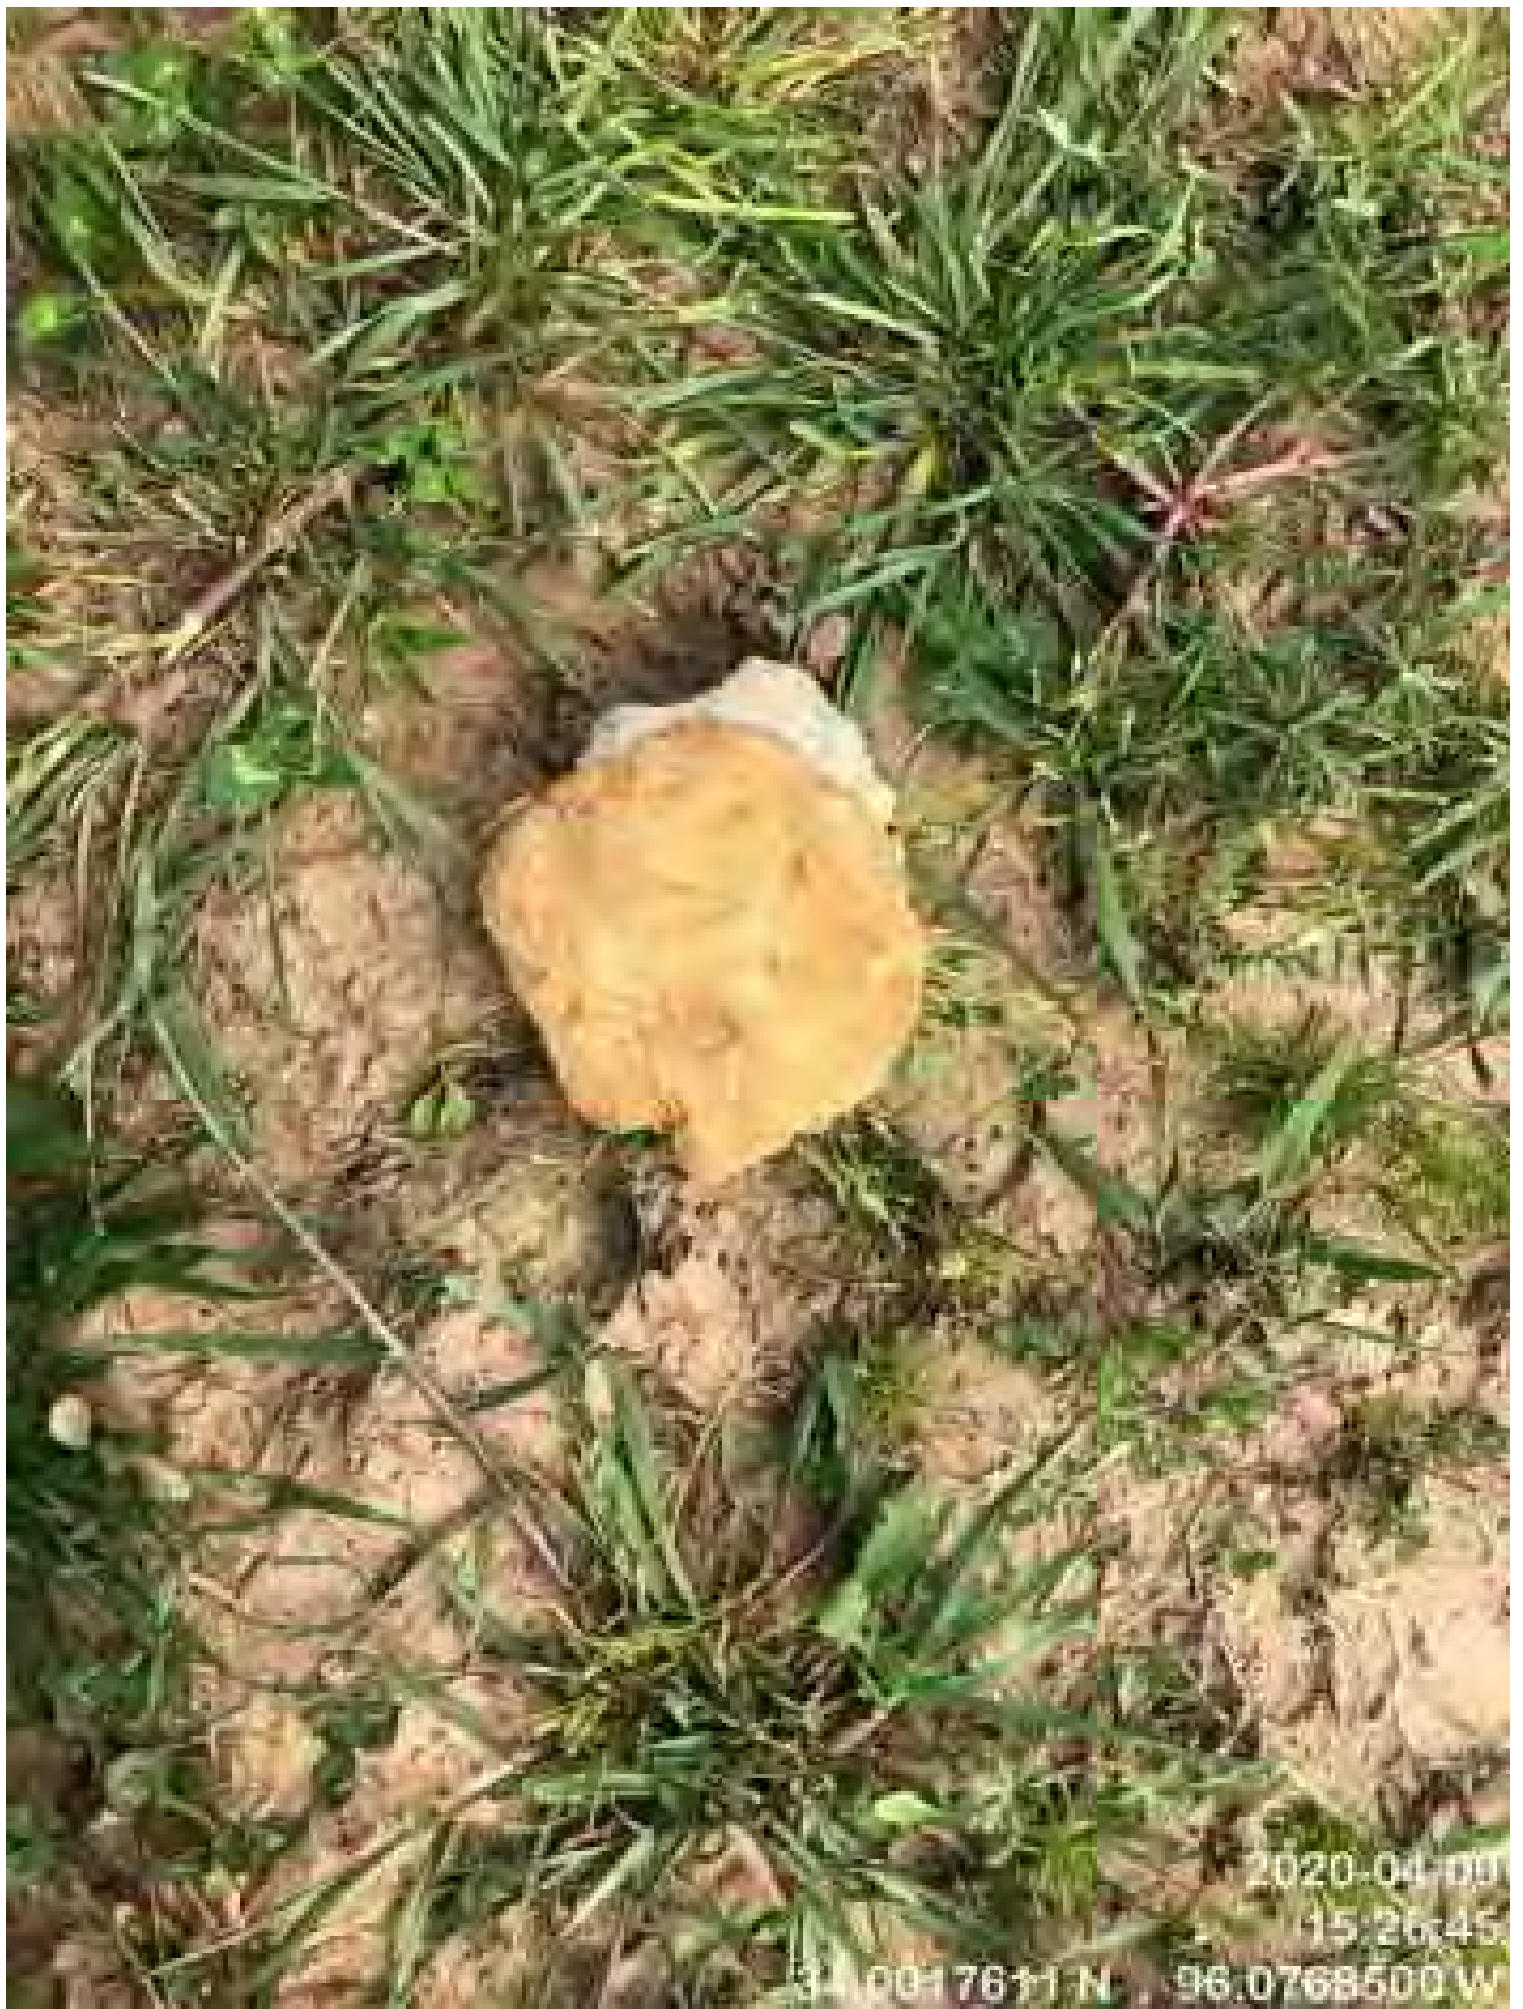
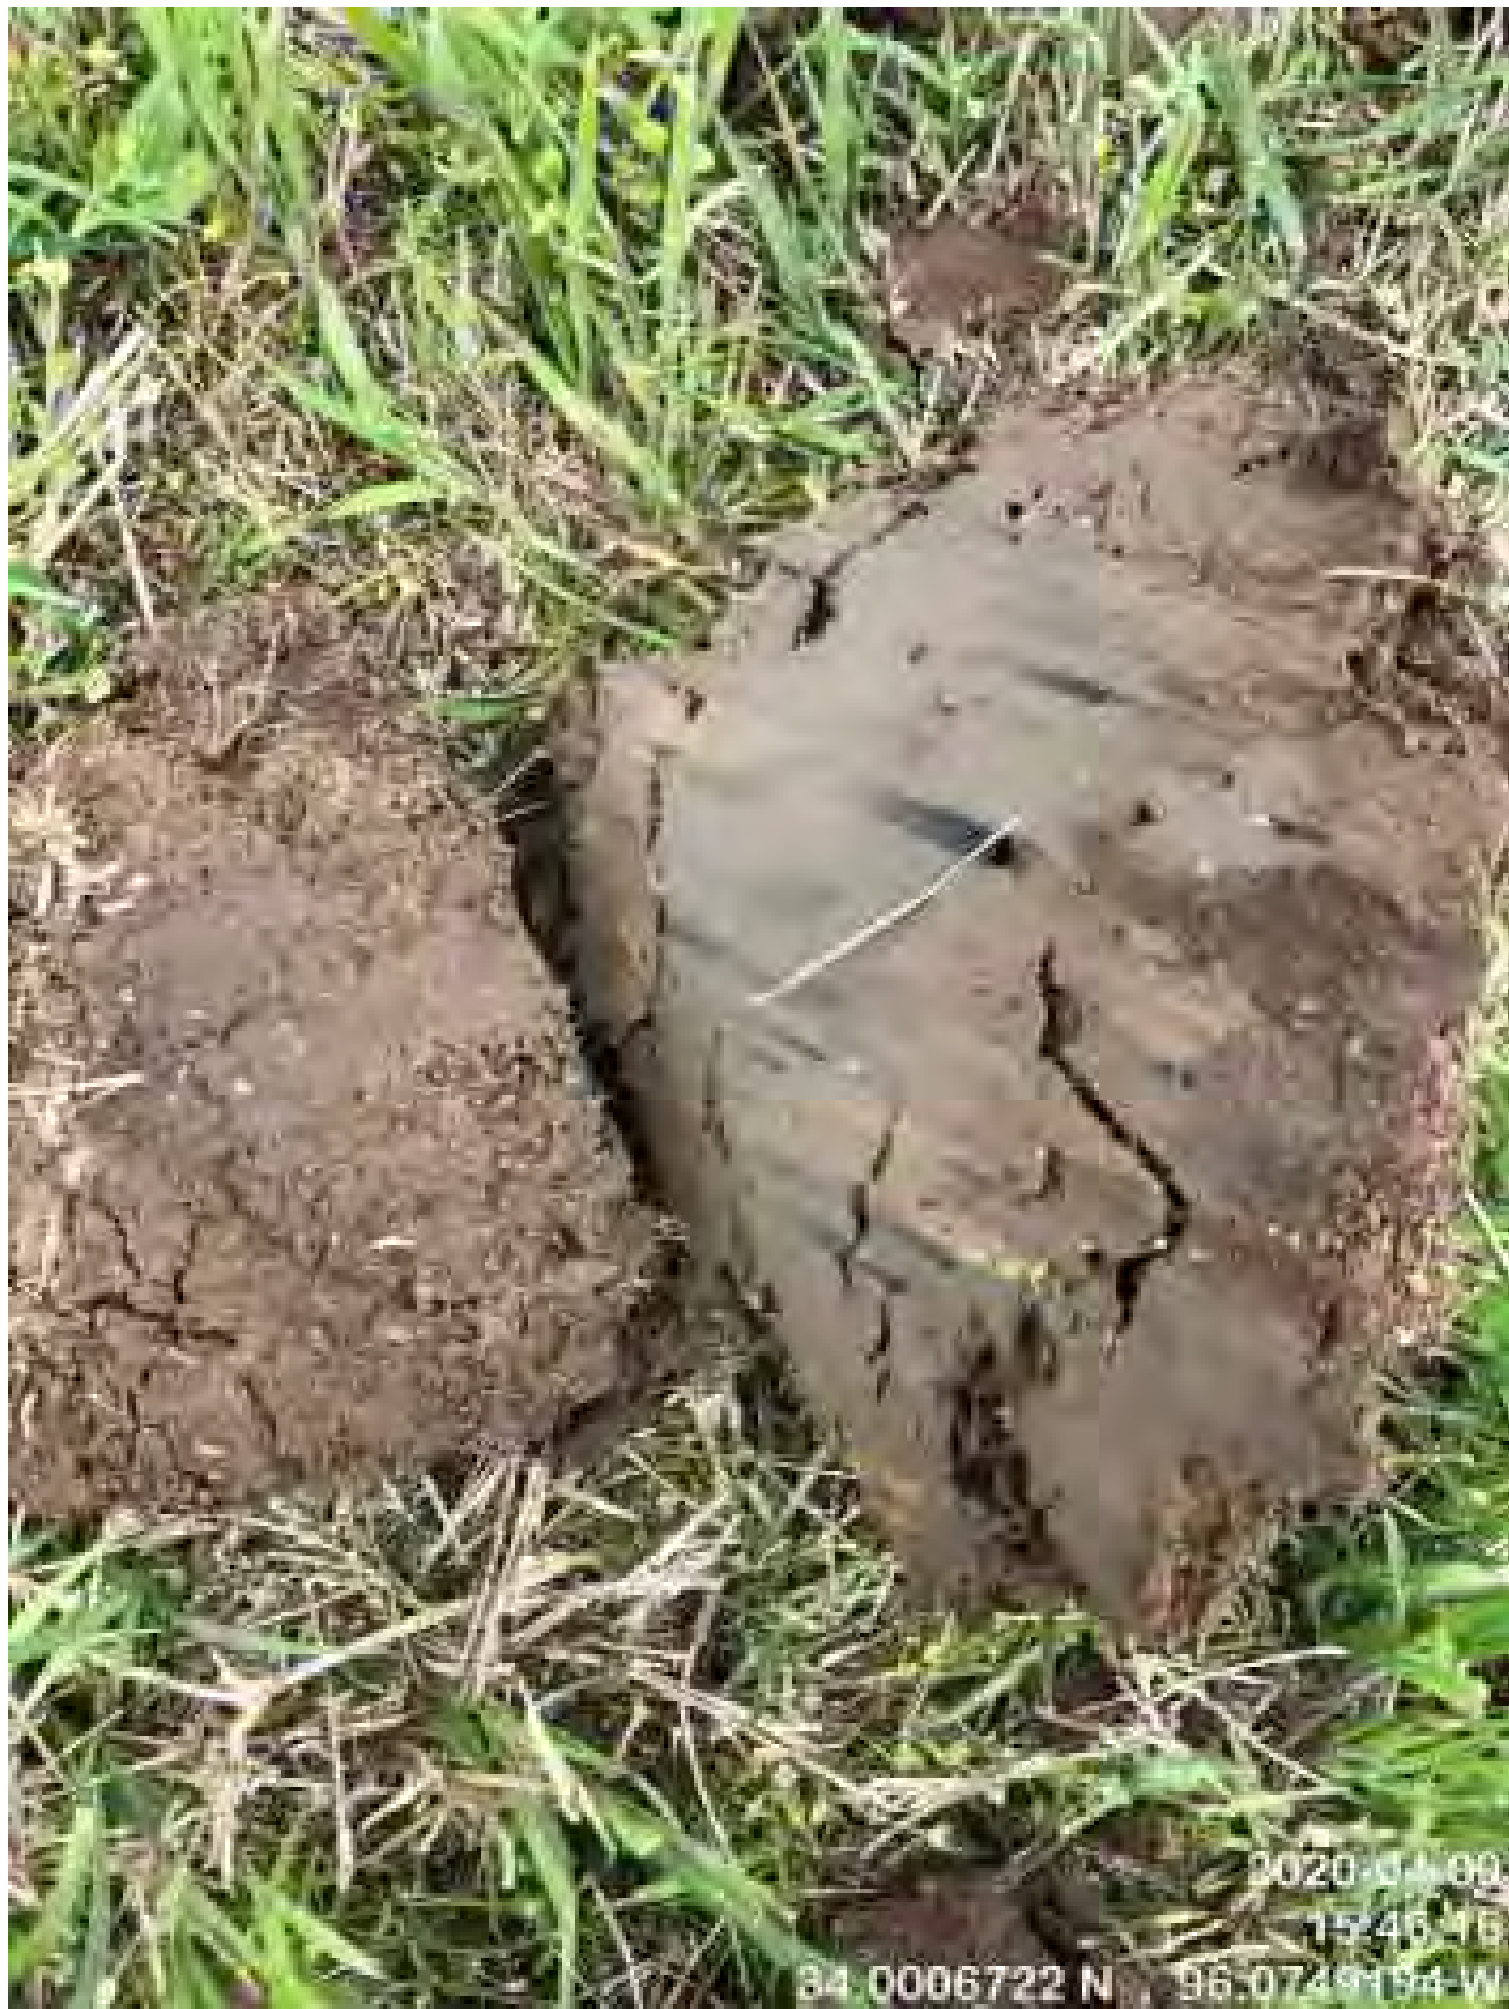
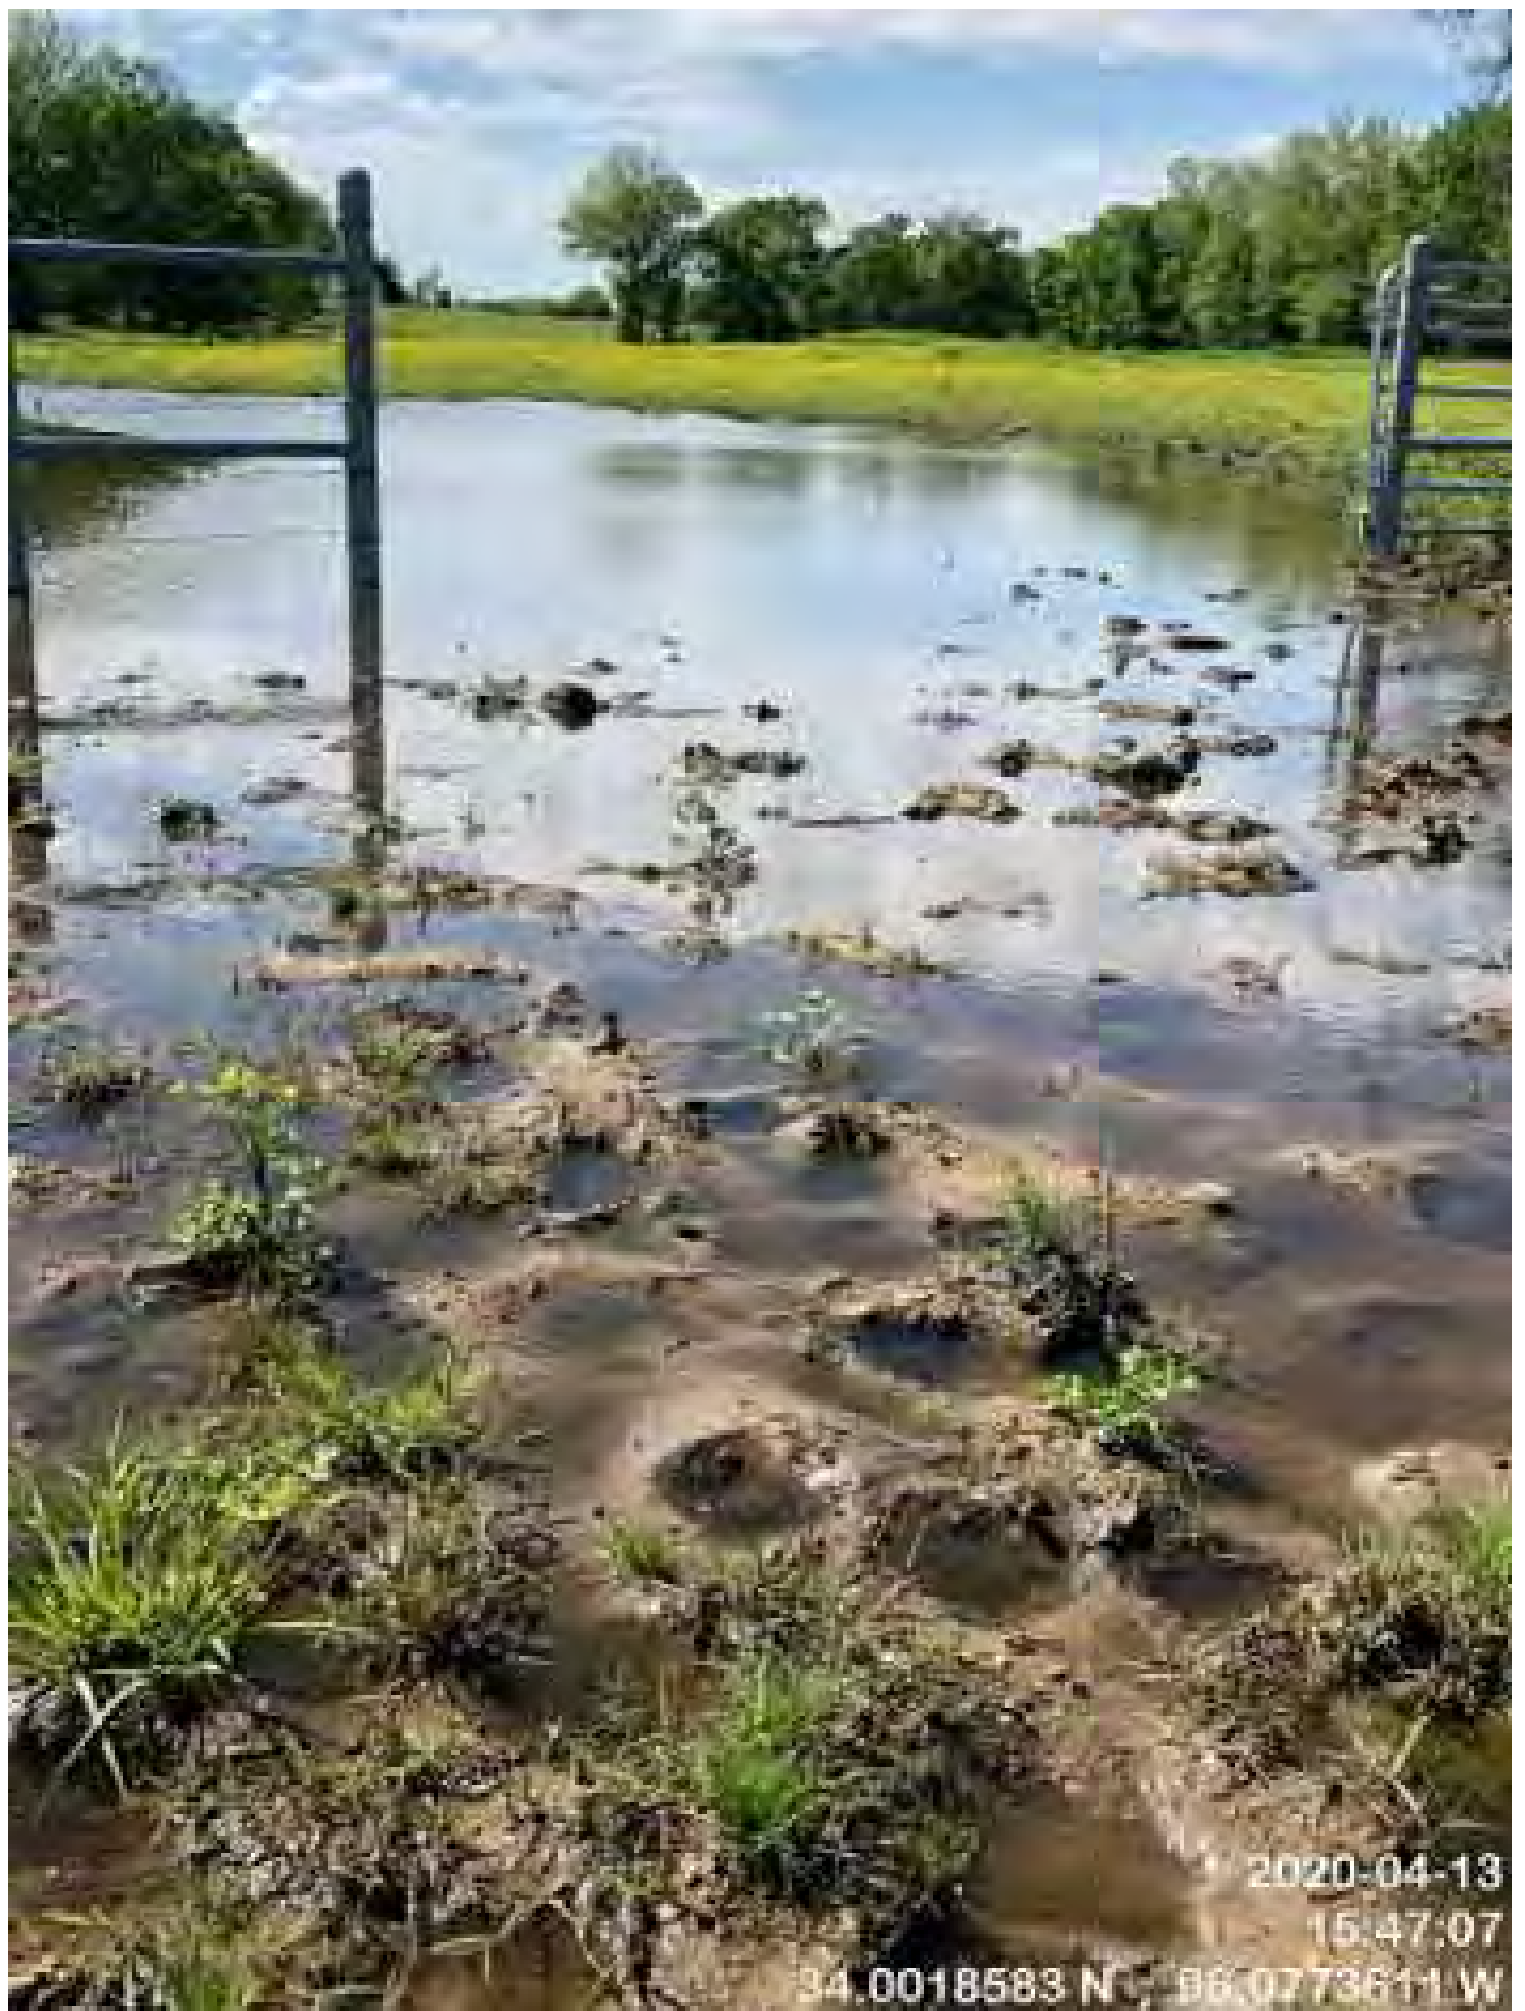
April 13, 2020 Site Inspection
James & Linda Ingram
BR-0988.000, BR-0990.000, BR-0992.000
Mile Post: MP 194.5 - 195.5
Bryan County, Oklahoma

- 1.) High levels of rock and blasting material mixed into soil. (FERC Plan: V. A. 3-6.)
 - a. Affected areas naturally have less than 1% rock fragments with a maximum size of 74 mm (NRCS).
- 2.) Importation of approx. 31,000 cubic yards of topsoil for 16.69 acres of ROW. (FERC Plan: IV. B. 1-6.)
 - a. Off-ROW topsoil: 14" (verified by existing NRCS soil surveys)
 - b. In-ROW topsoil: 0" found in multiple locations.
- 3.) Soil Compaction (FERC Plan: V. C. 1-3.)
 - a. Off-ROW Penetrometer reading: Around 180 psi in multiple locations.
 - b. In-ROW Penetrometer reading: 300 psi limit exceeded in every off-ROW location.
