Robert Squires - Squires Consulting LLC
Landowner Advocate

Opening Statement for May 5, 2021 Subcommittee on Civil Rights and Civil Liberties Hearing:
“Pipelines Over People (Part II): Midship Pipeline’s Disregard for Landowners in Its Pathway”

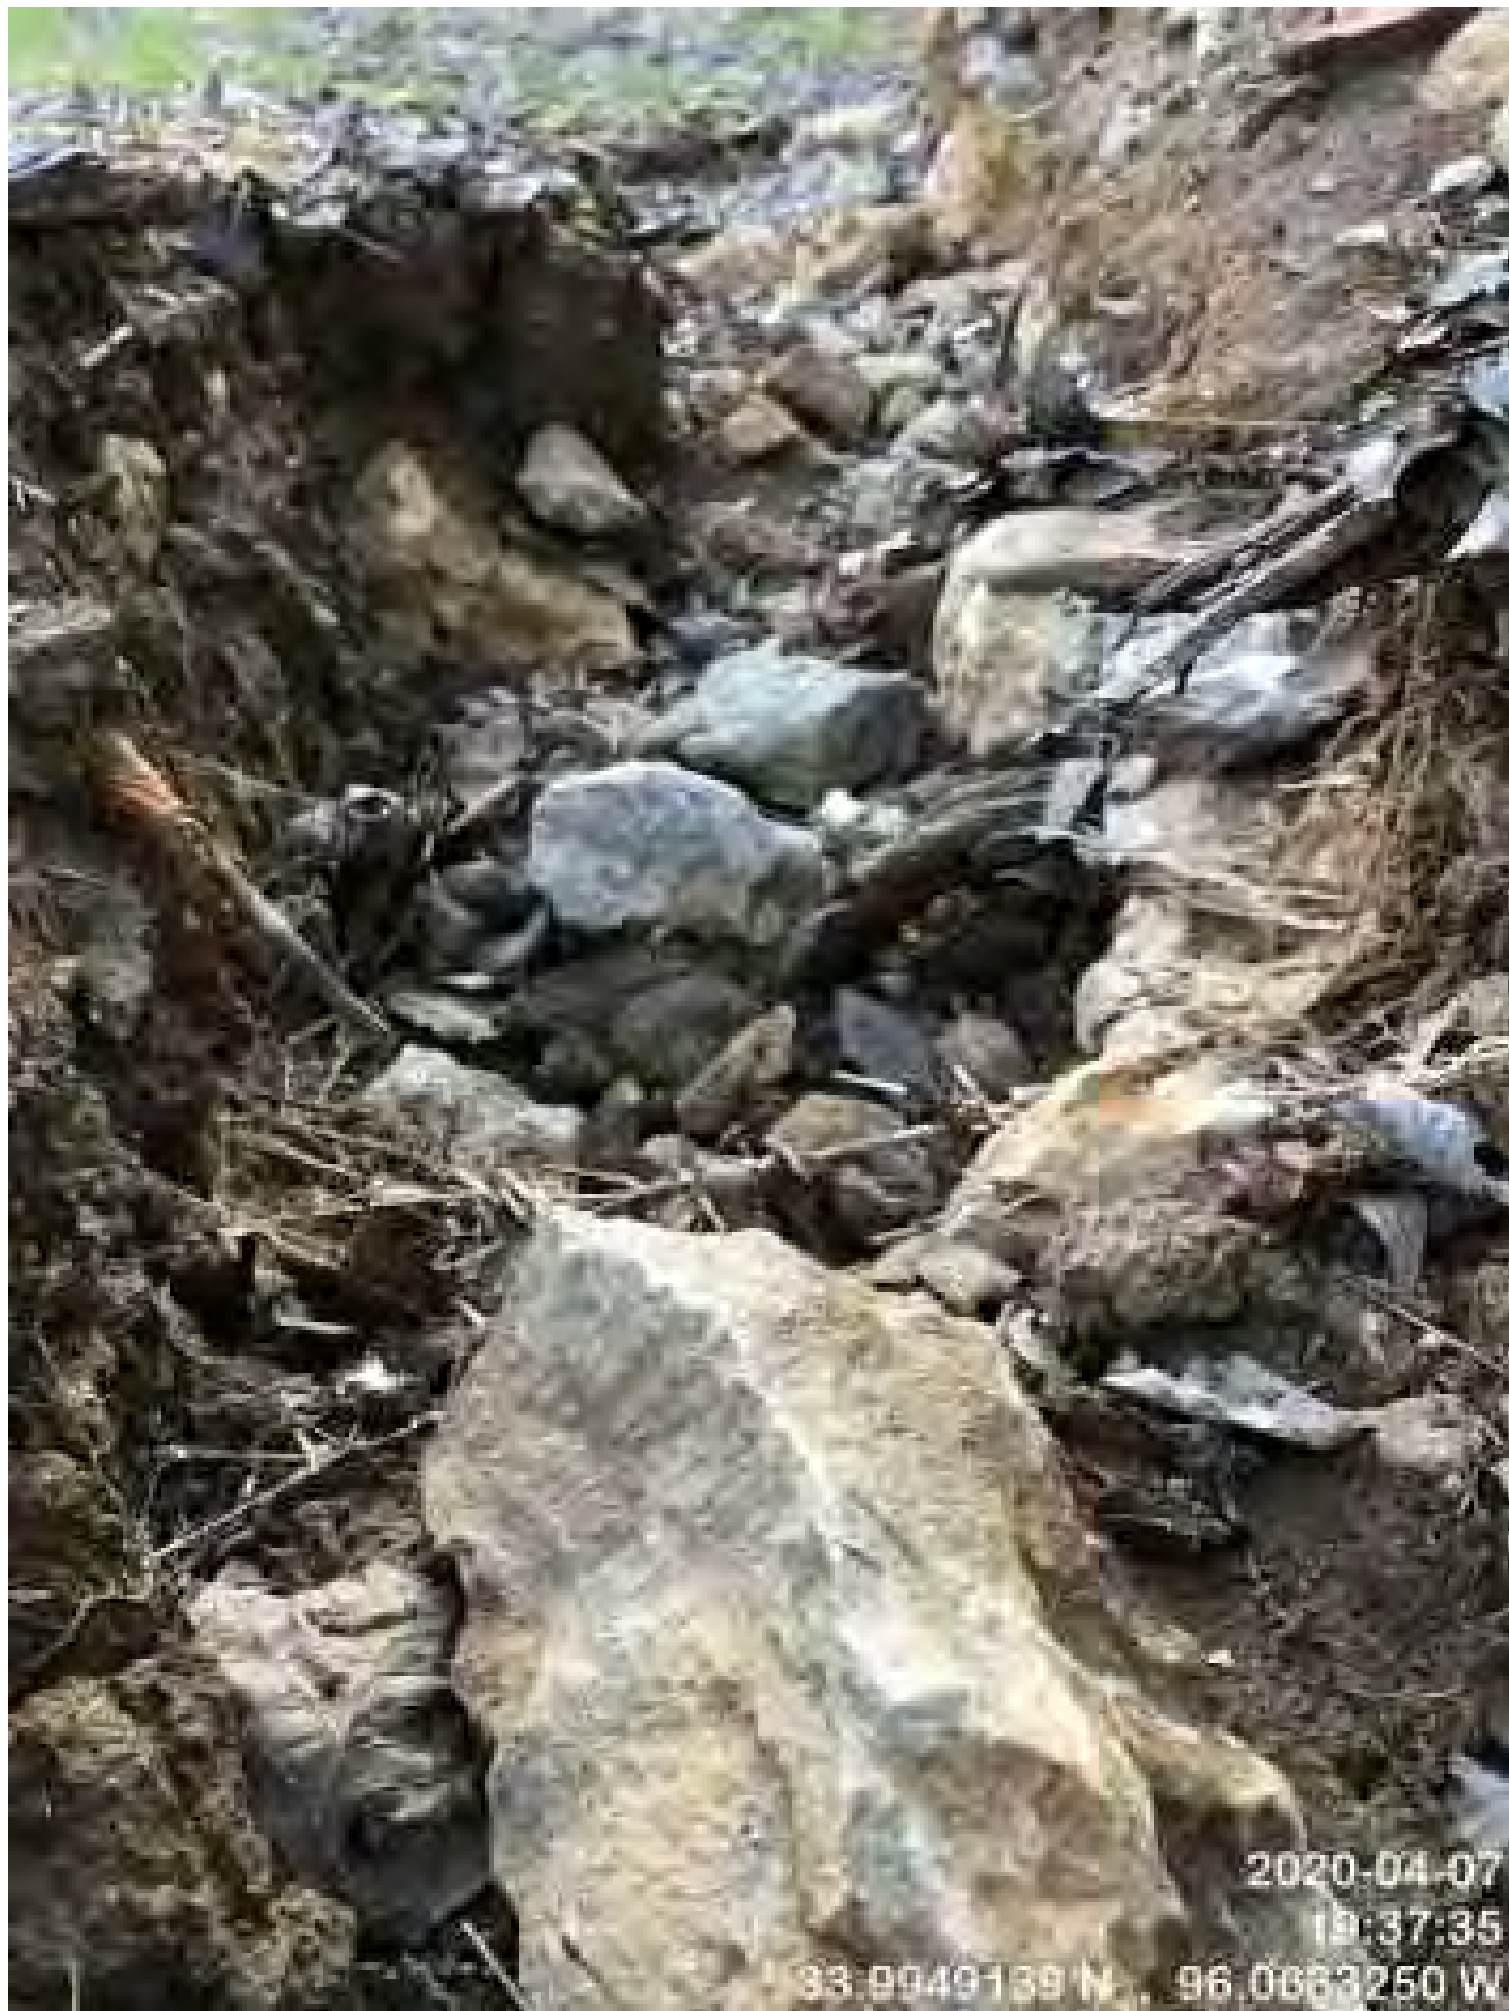
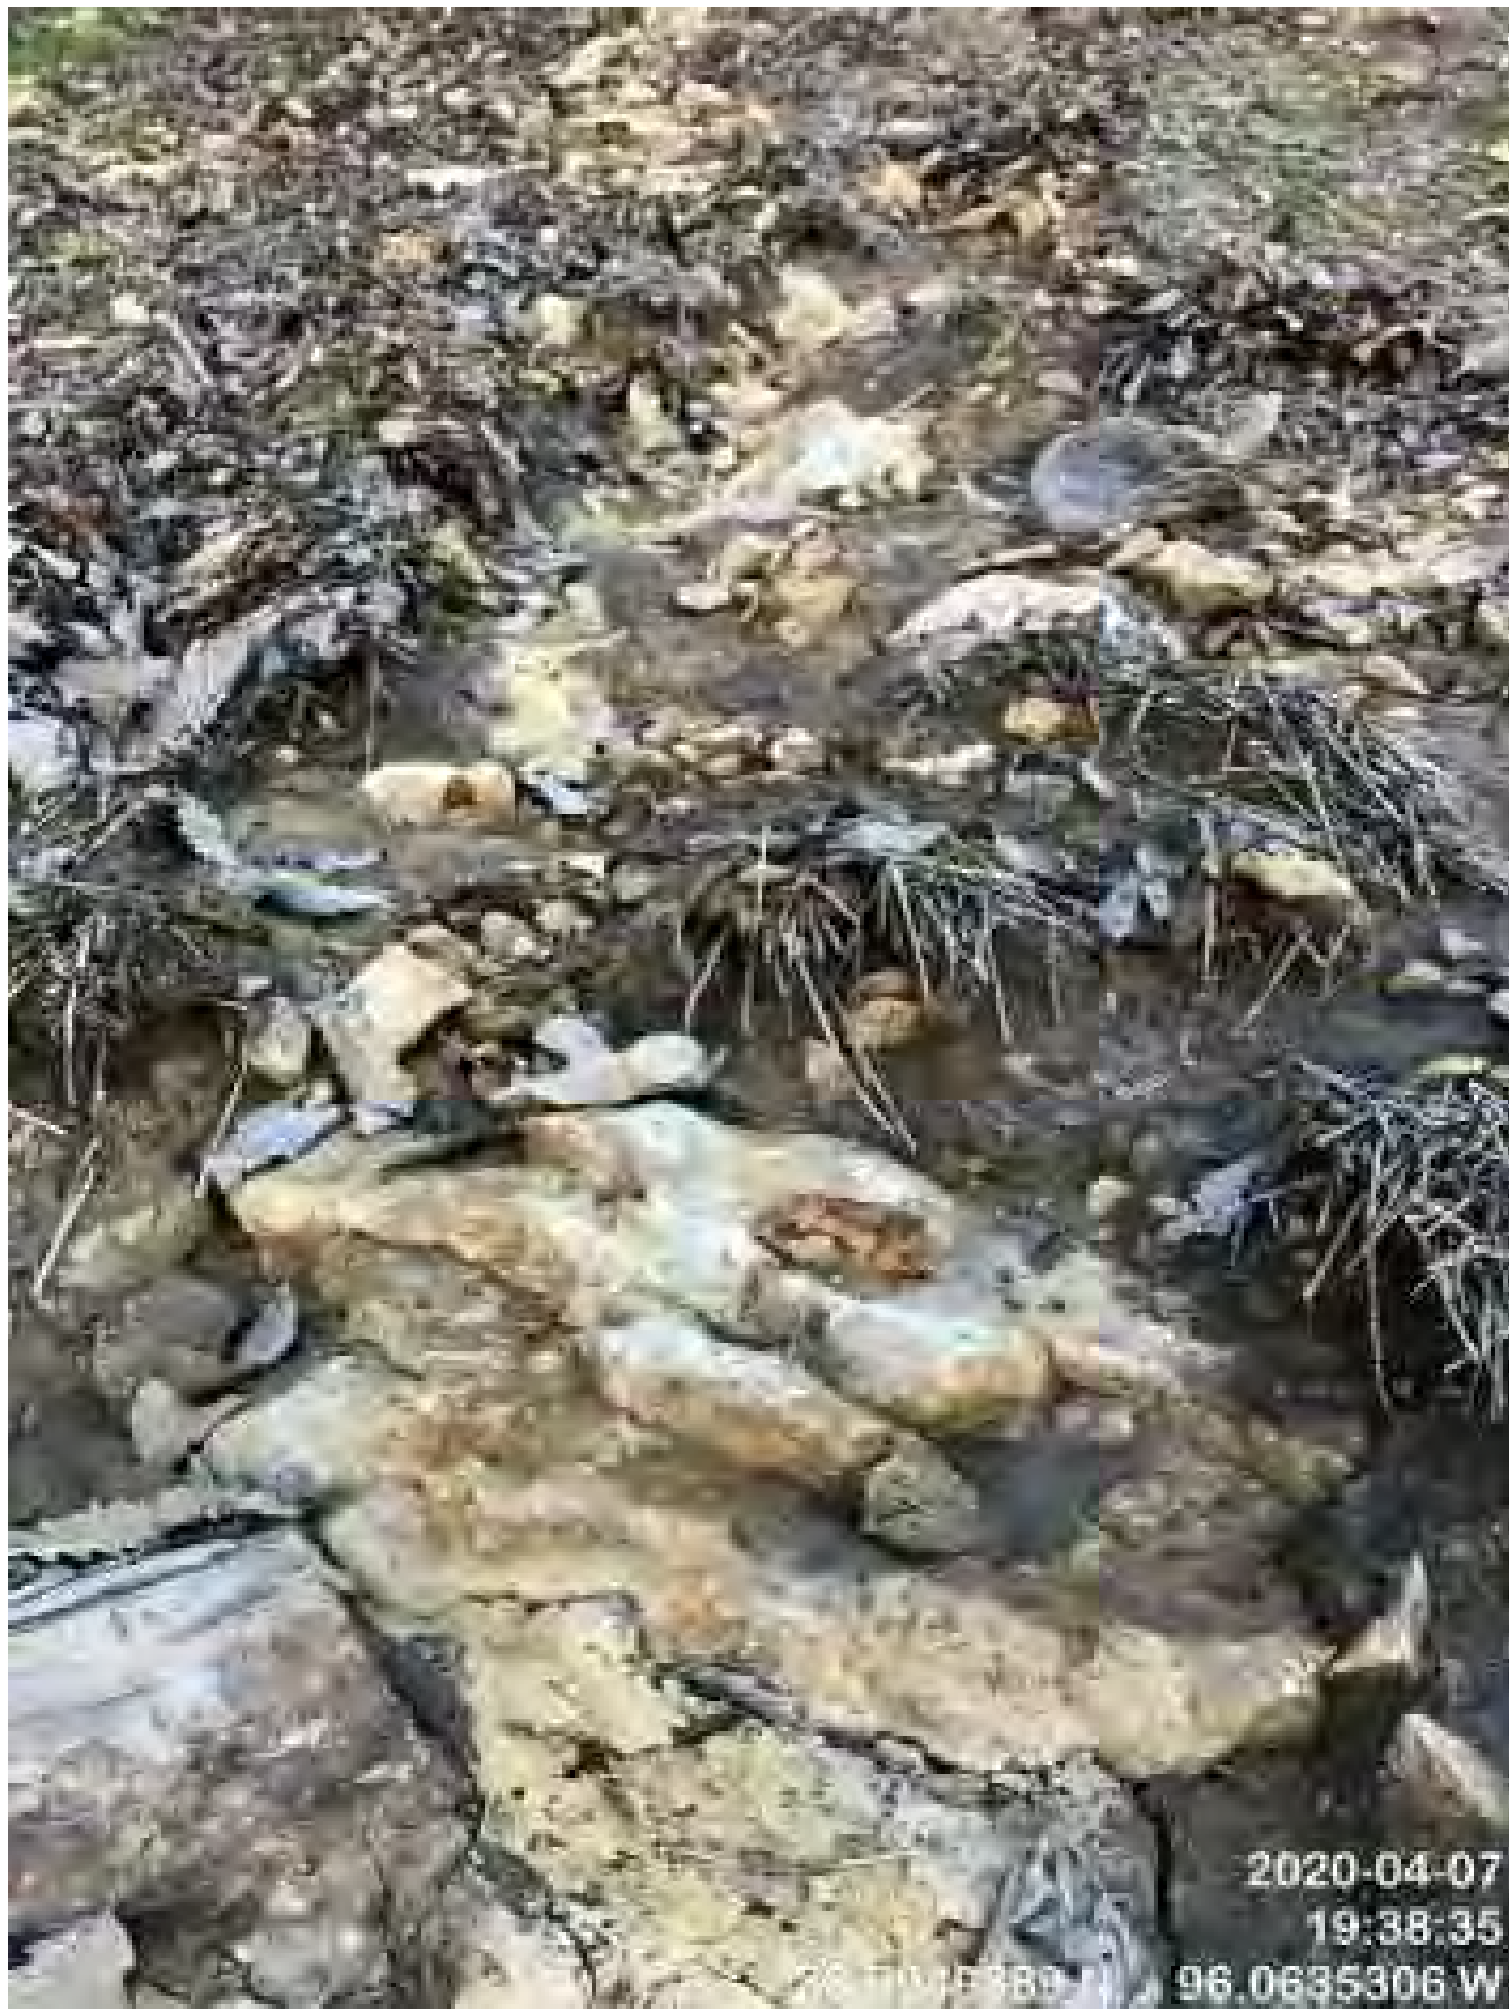
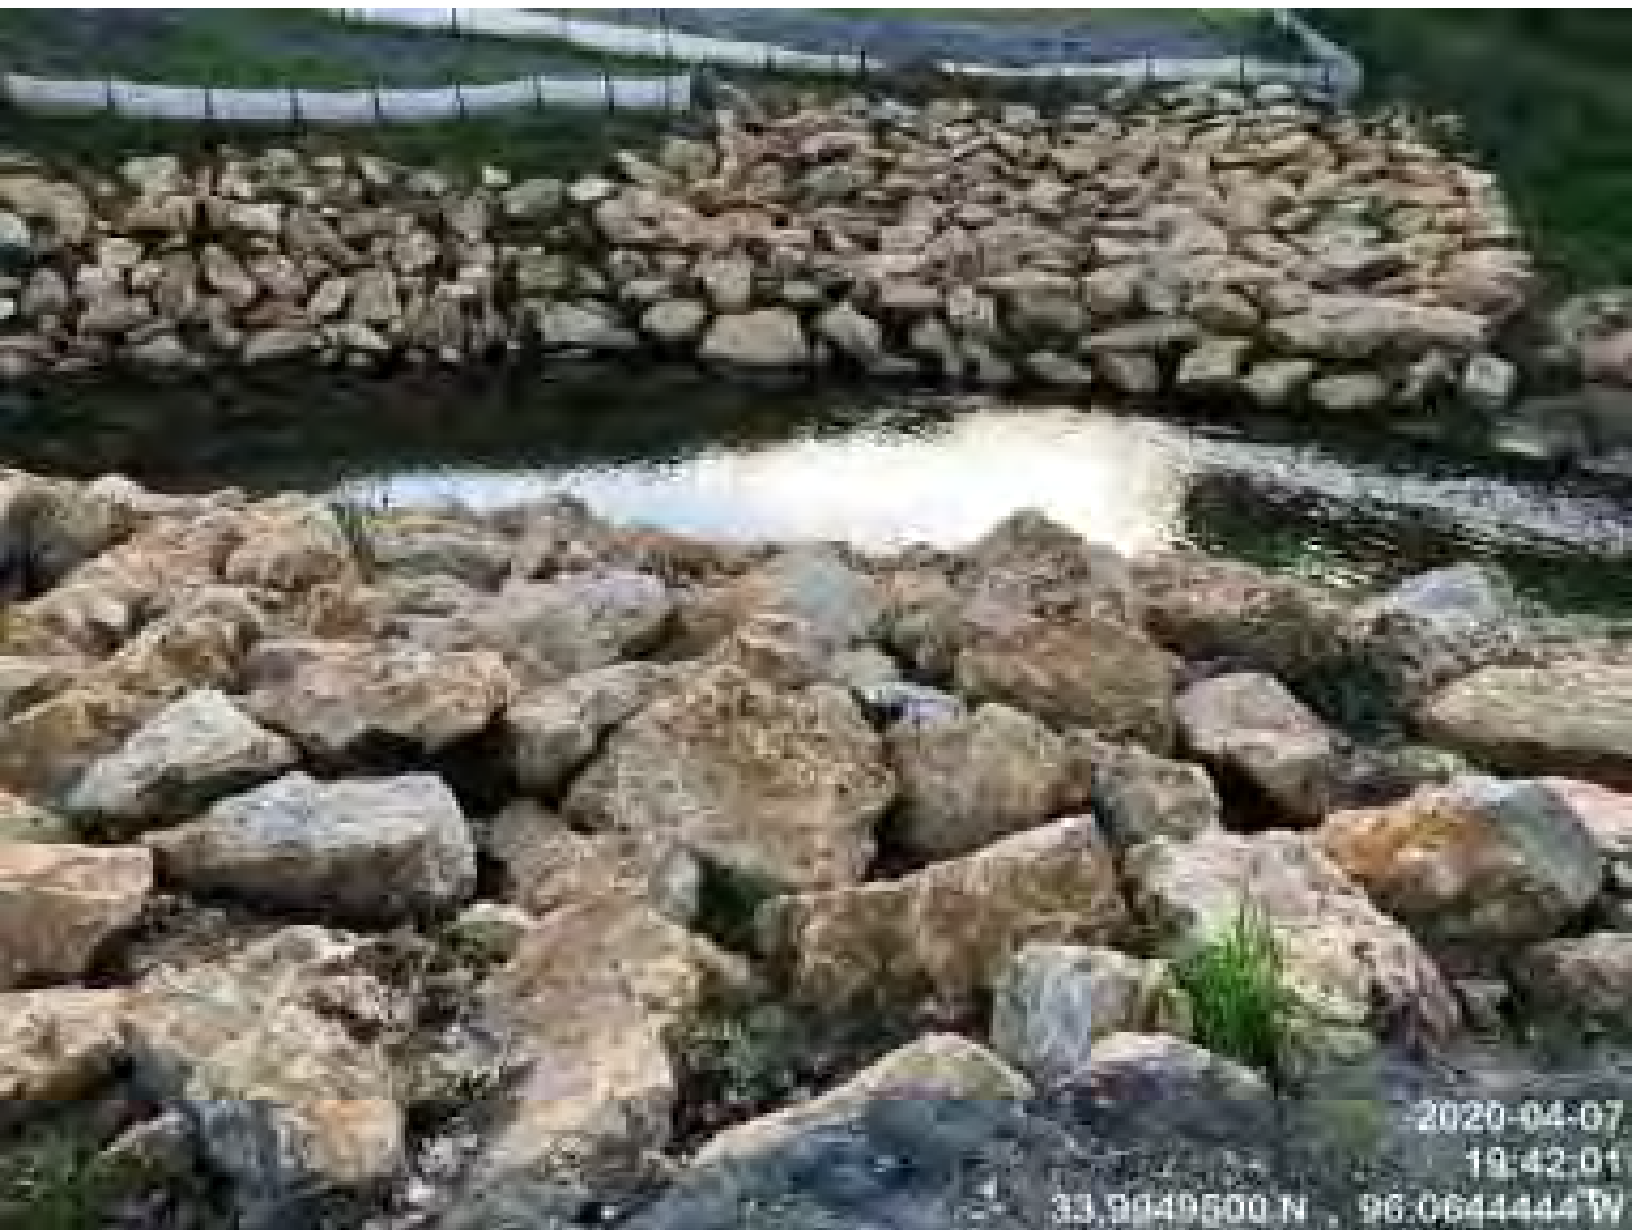
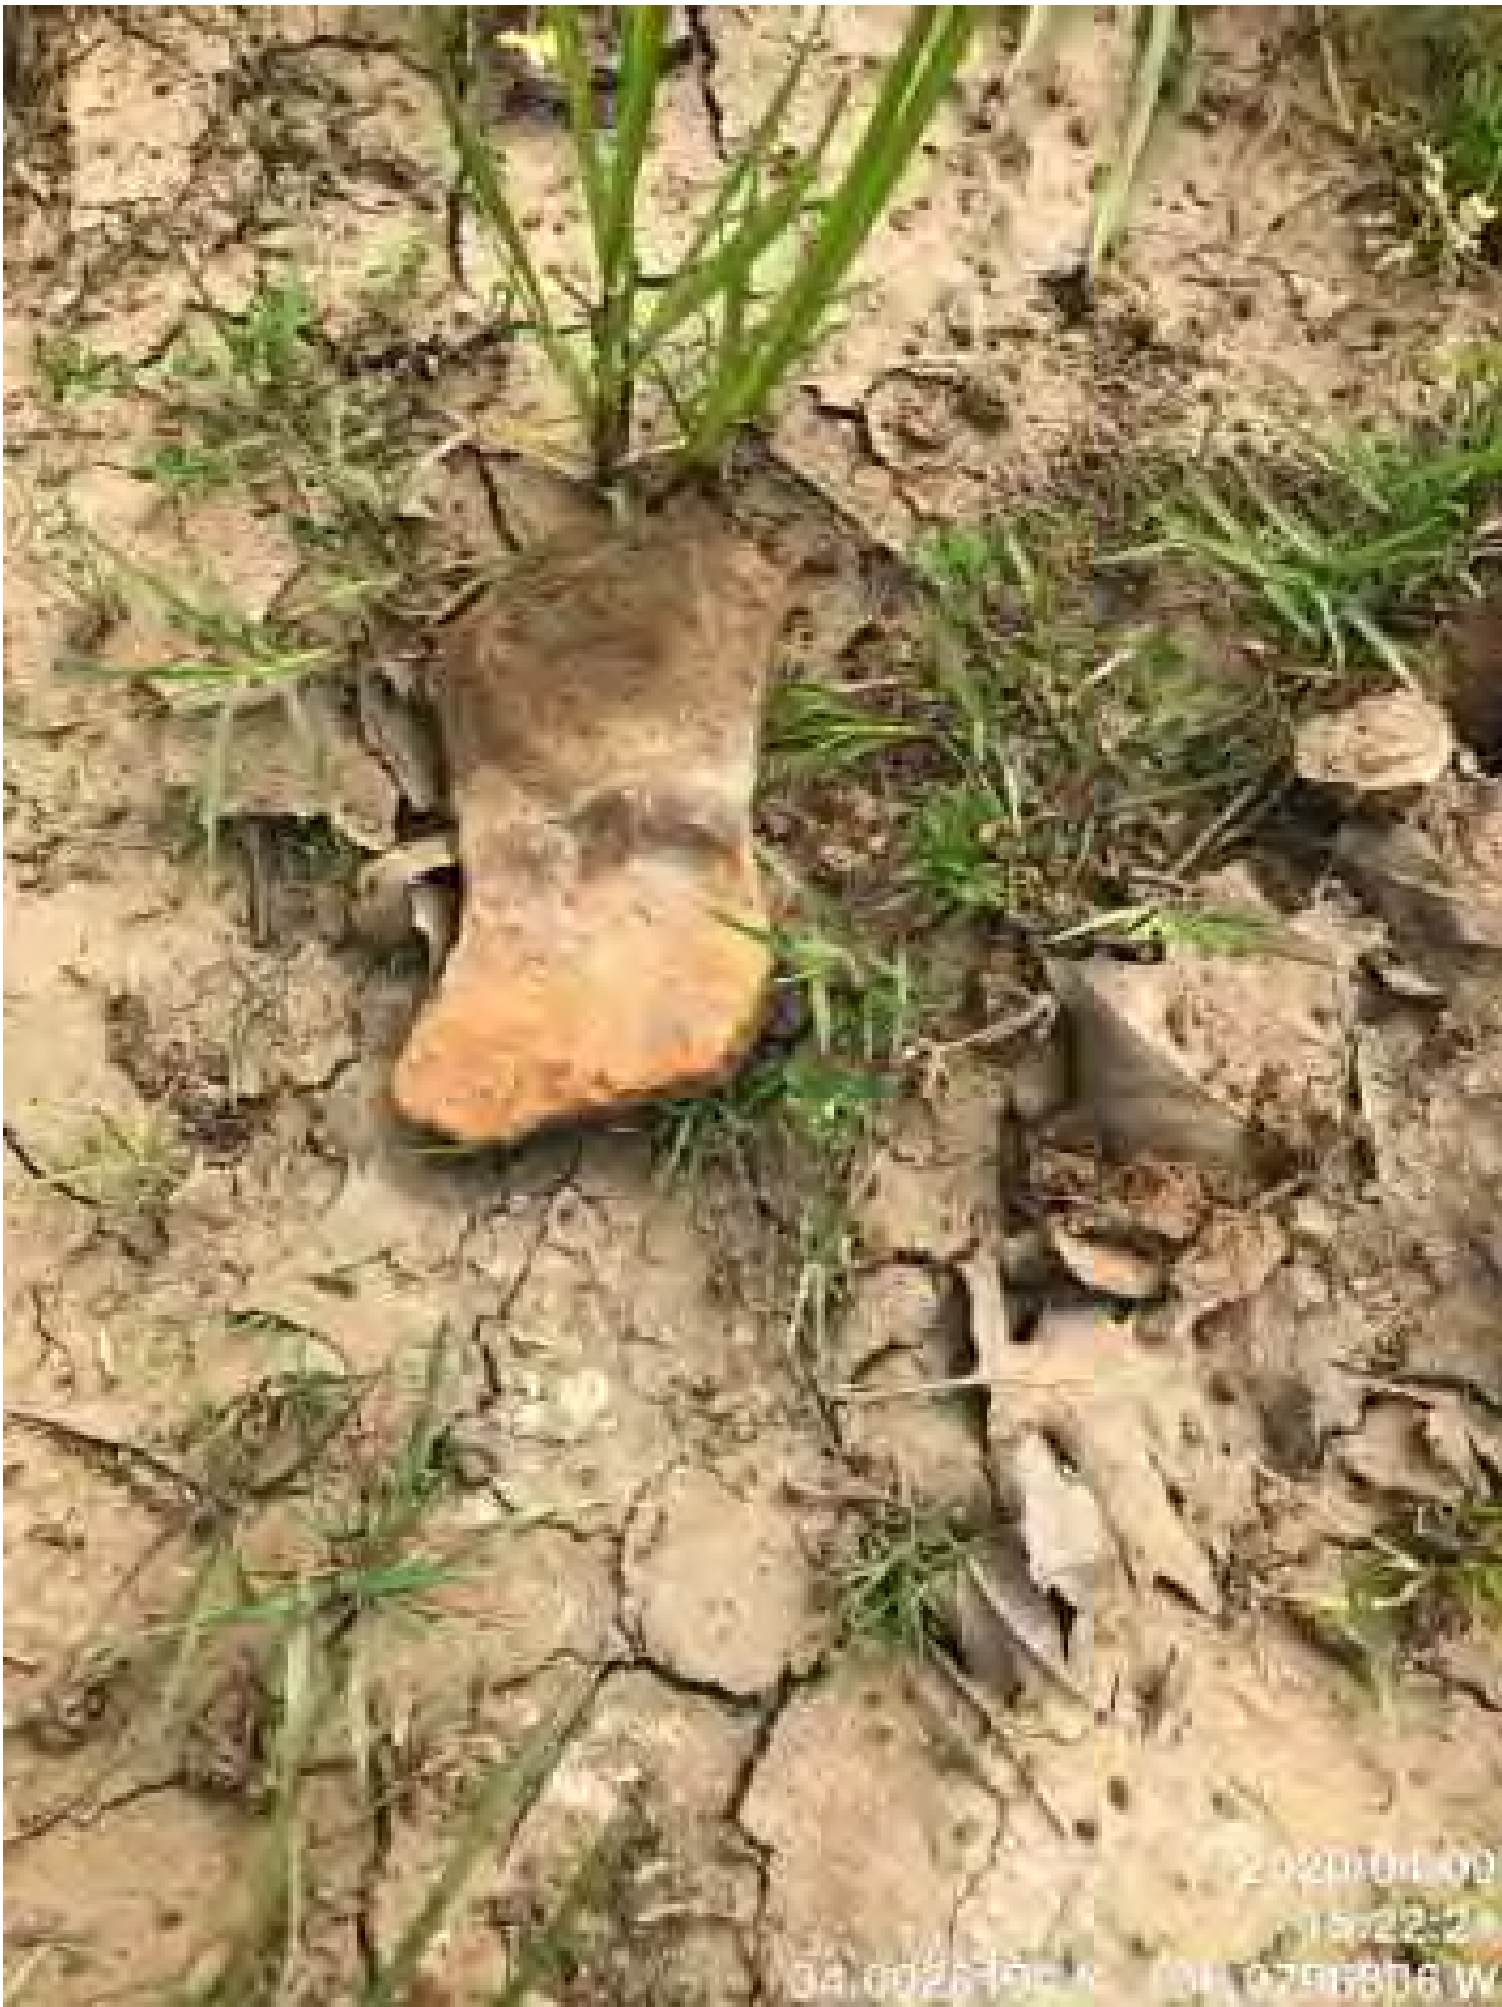
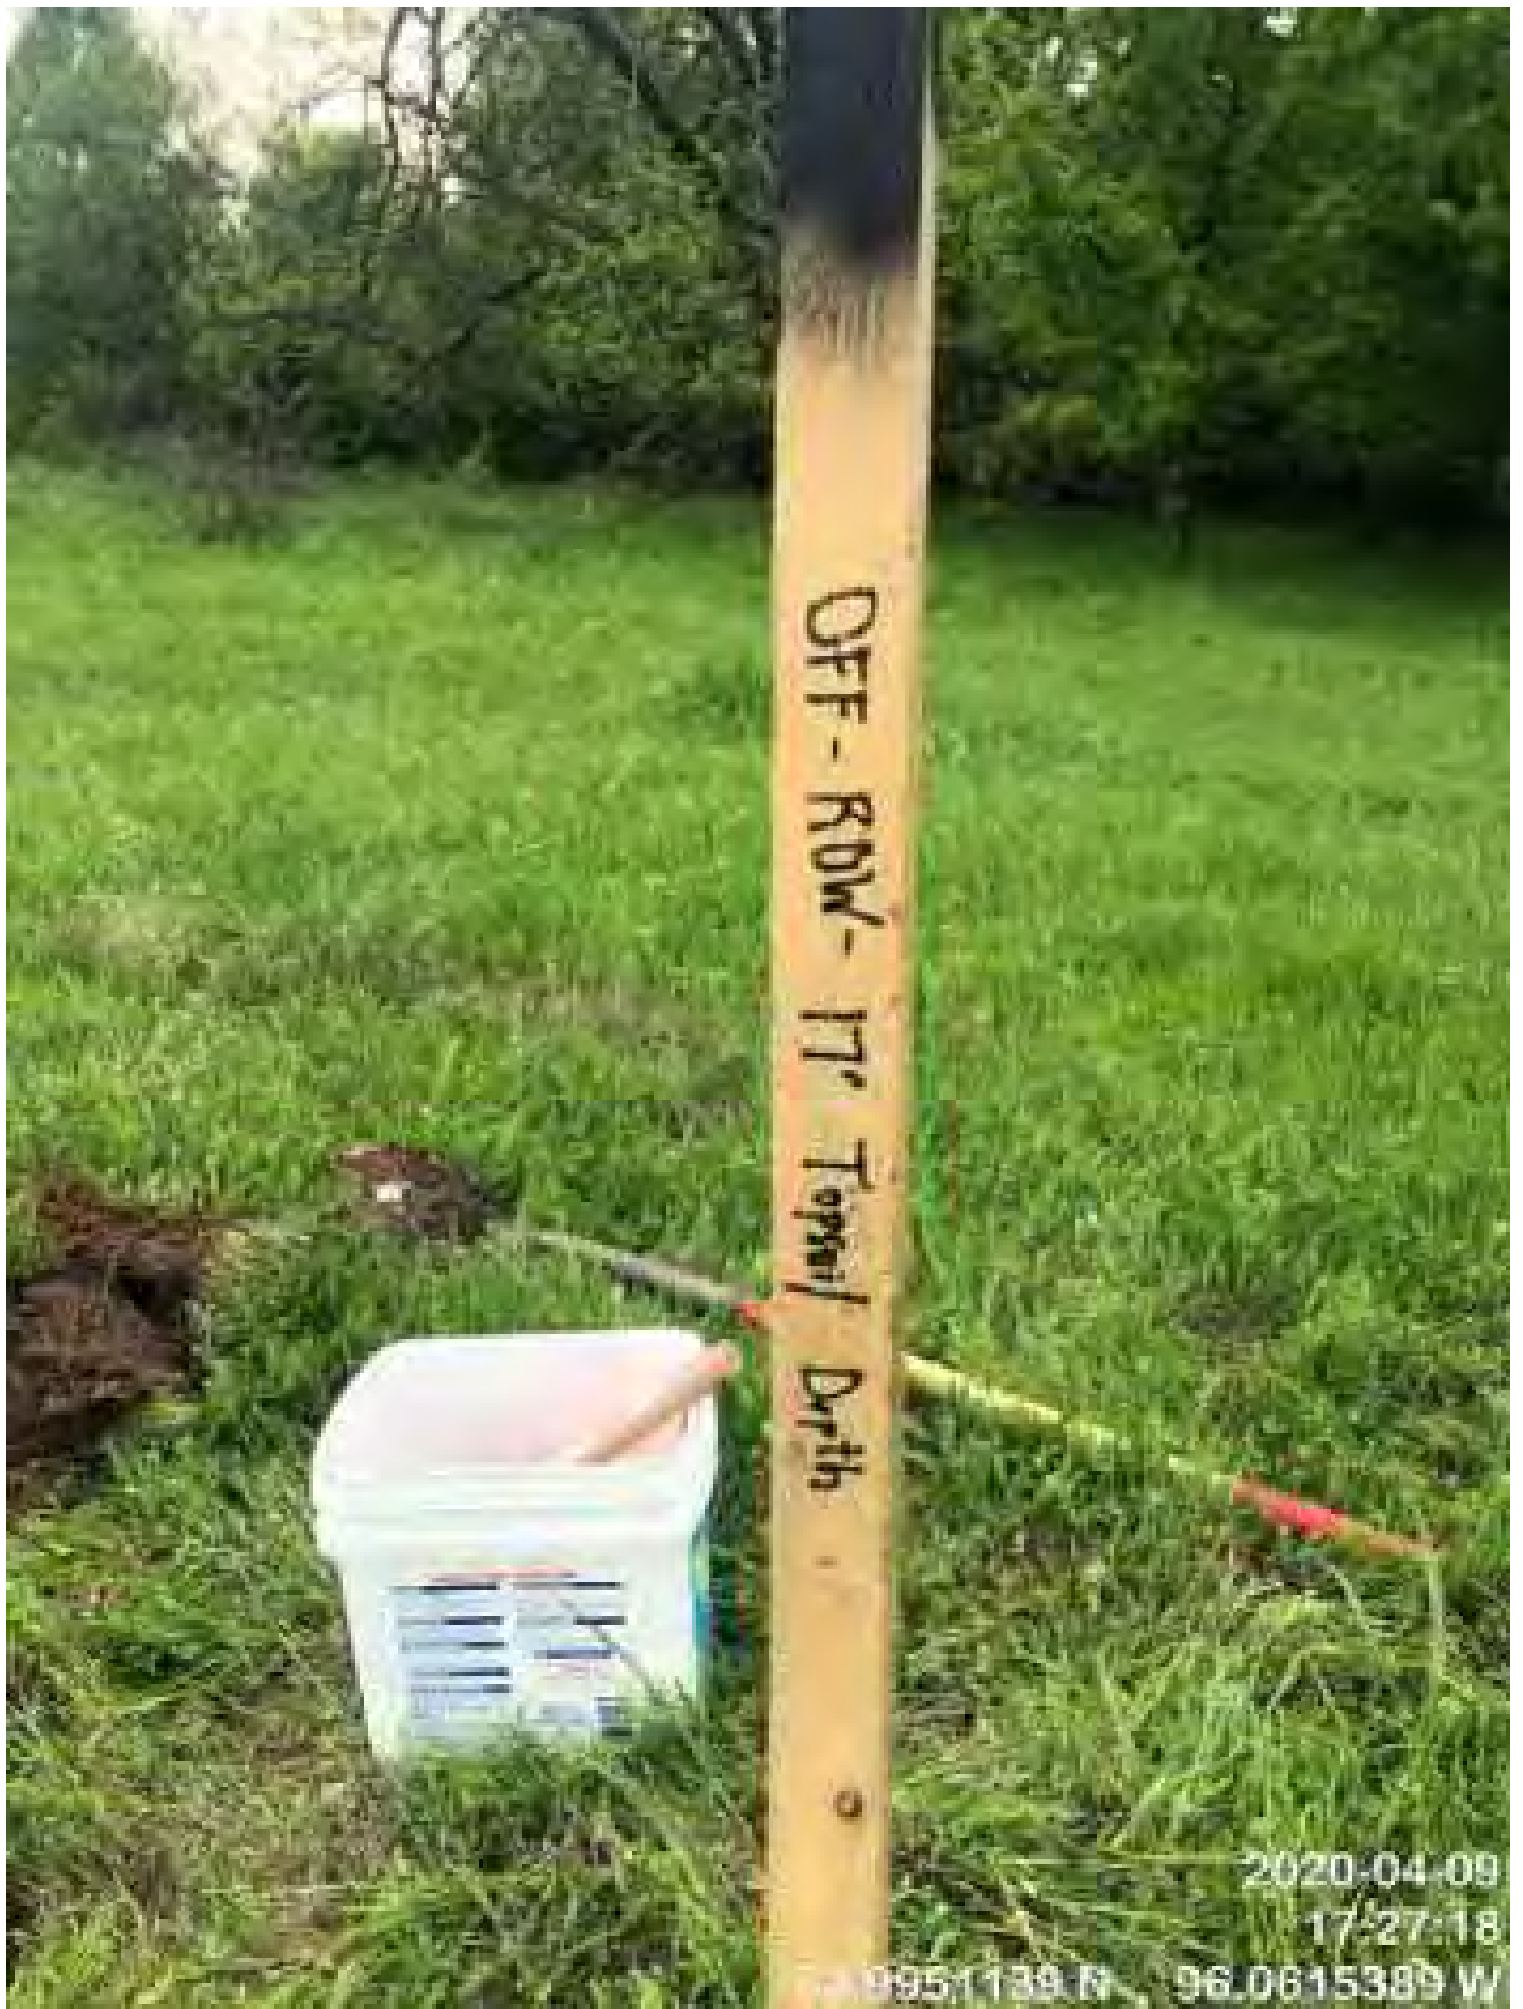
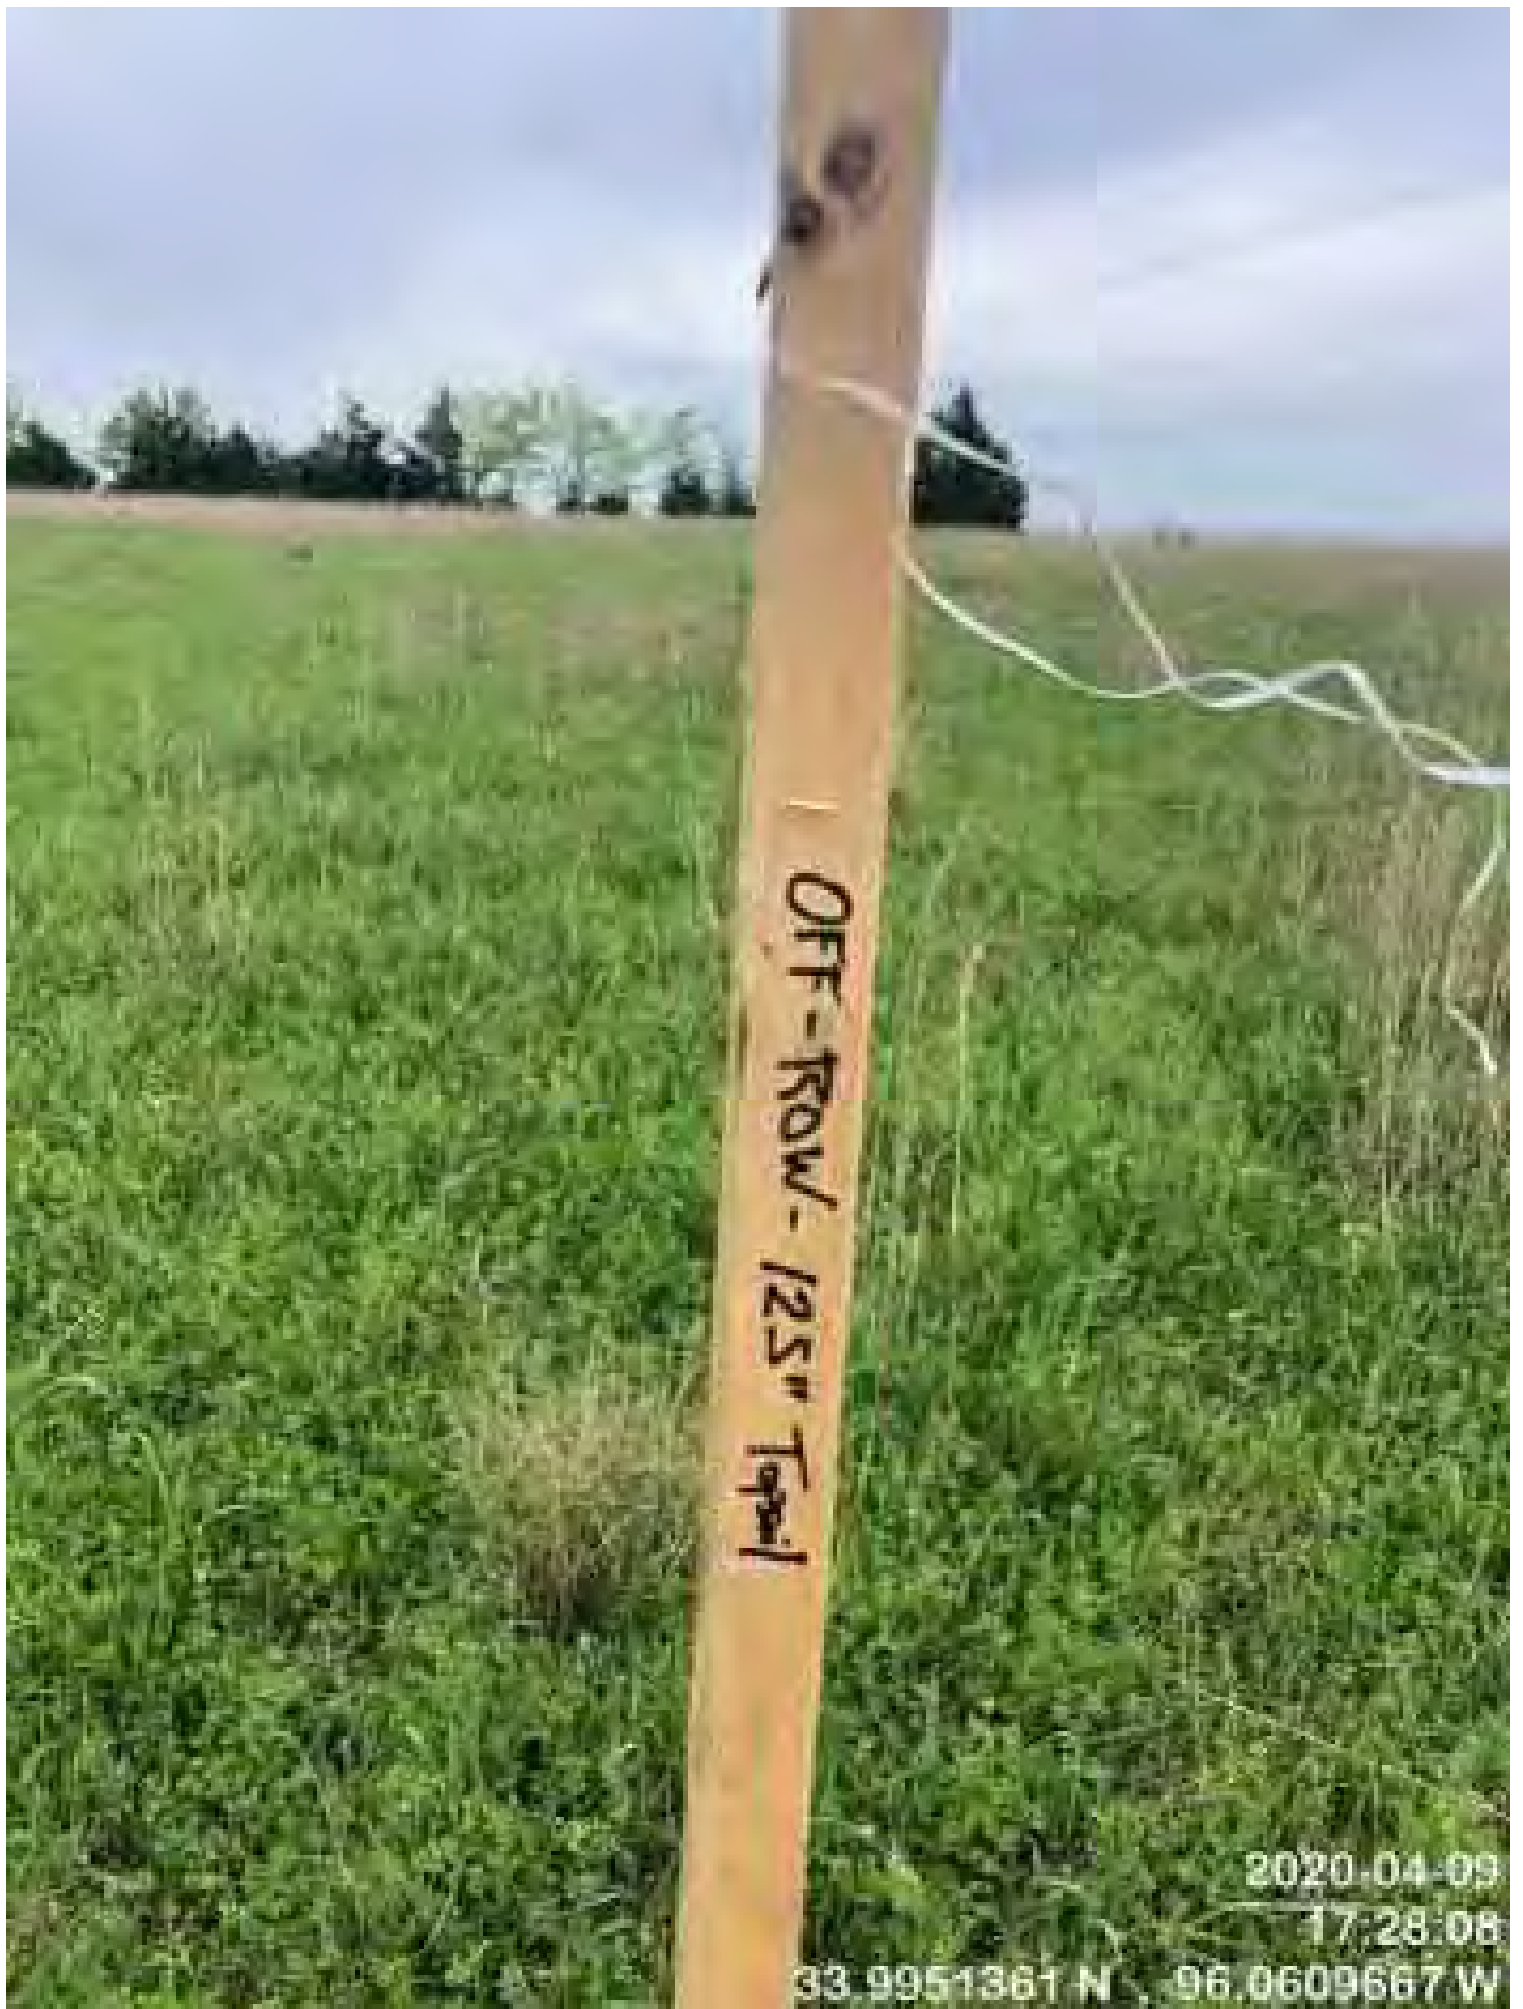
April 13, 2020 Site Inspection
Anderson Family Trust
BR-0994.000, BR-0995.000, BR-0996.000
Mile Post: MP 195.75 - 196.25
Bryan County, Oklahoma

- 1.) High levels of rock and blasting material mixed into soil. (FERC Plan: V. A. 3-6.)
 - a. Affected areas naturally have less than 1% rock fragments with a maximum size of 74 mm (NRCS).
- 2.) Importation of approx. 27.860 cubic yards of topsoil for 12.19 acres of ROW. (FERC Plan: IV. B. 1-6.)
 - a. Off-ROW topsoil: 17" (verified by existing NRCS soil surveys)
 - b. In-ROW topsoil: 0" found in multiple locations.
- 3.) Soil Compaction (FERC Plan: V. C. 1-3.)
 - a. Off-ROW Penetrometer reading: Around 150-180 psi in multiple locations.
 - b. In-ROW Penetrometer reading: 300 psi limit exceeded in every off-ROW location.
- 4.) Construction debris used for creek lining without landowner permission. (FERC Plan: V. A. 3.)
