Robert Squires - Squires Consulting LLC
Landowner Advocate

Opening Statement for May 5, 2021 Subcommittee on Civil Rights and Civil Liberties Hearing:
“Pipelines Over People (Part II): Midship Pipeline’s Disregard for Landowners in Its Pathway”

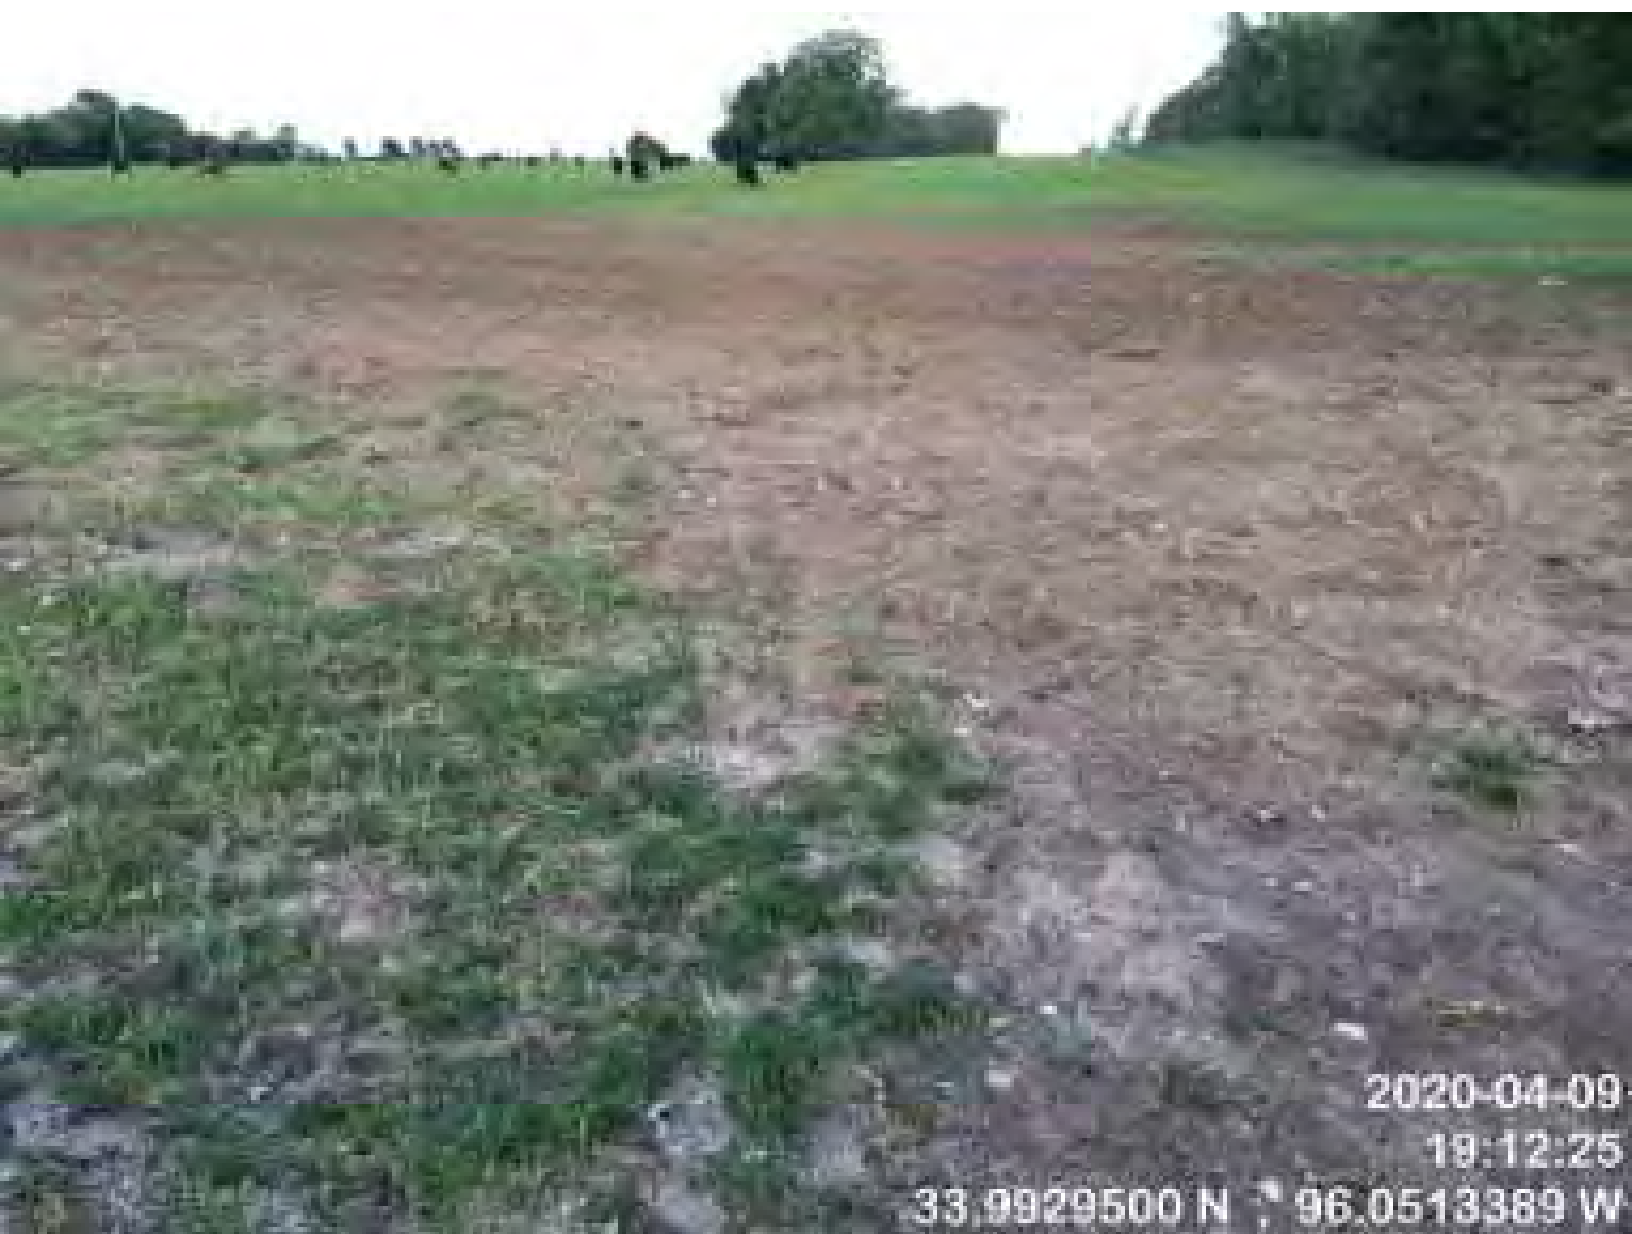
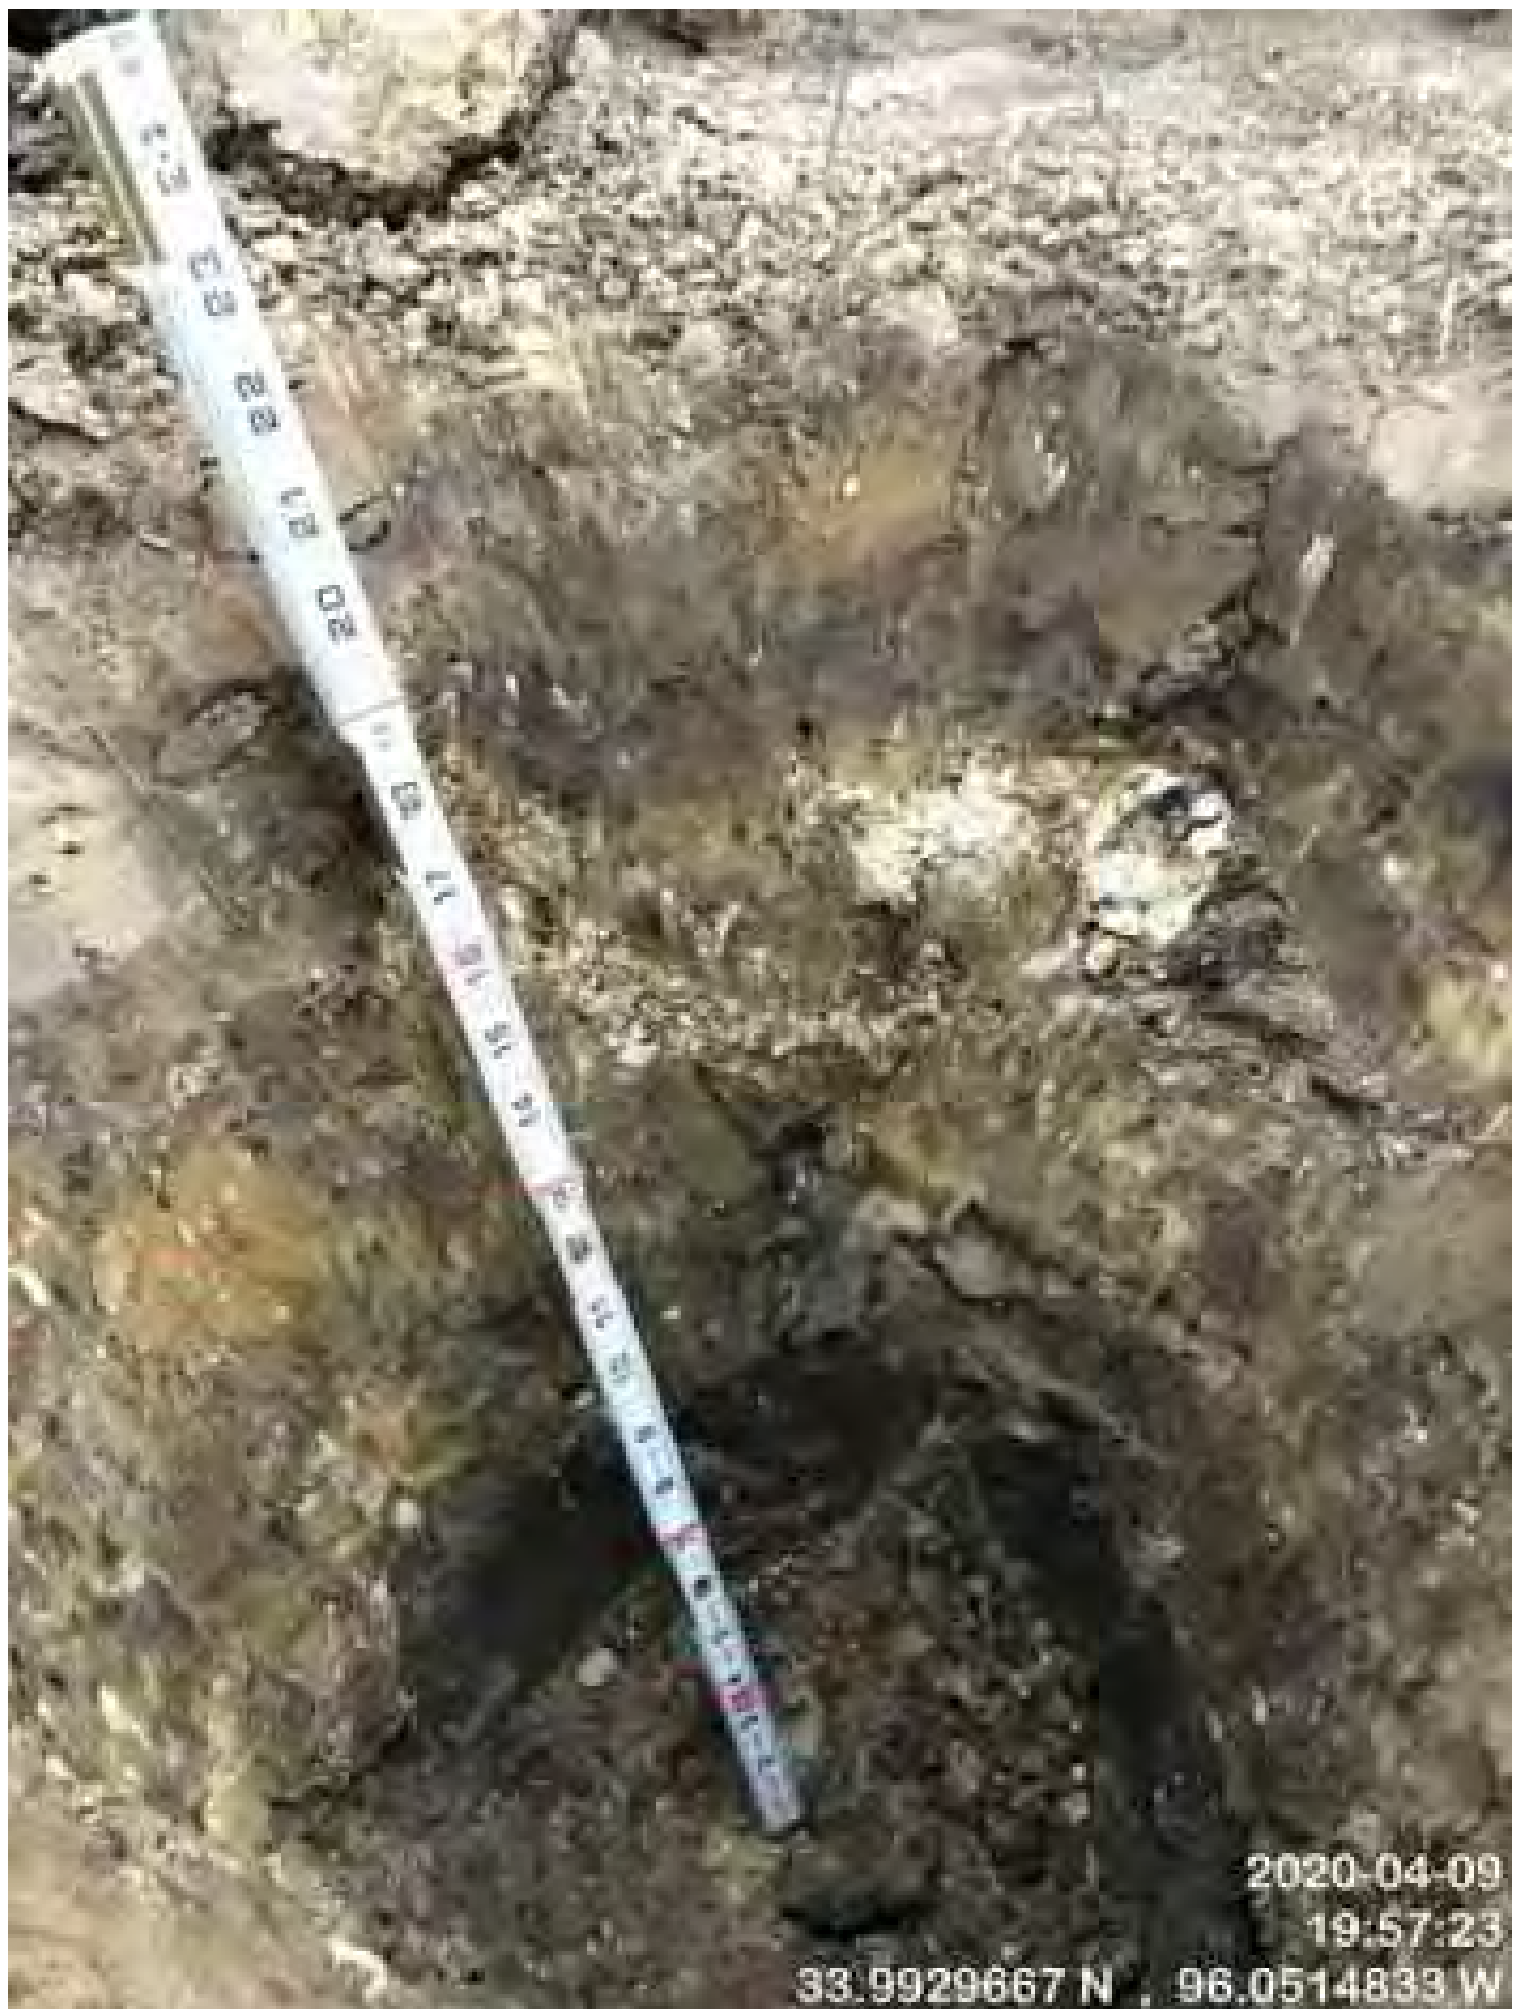
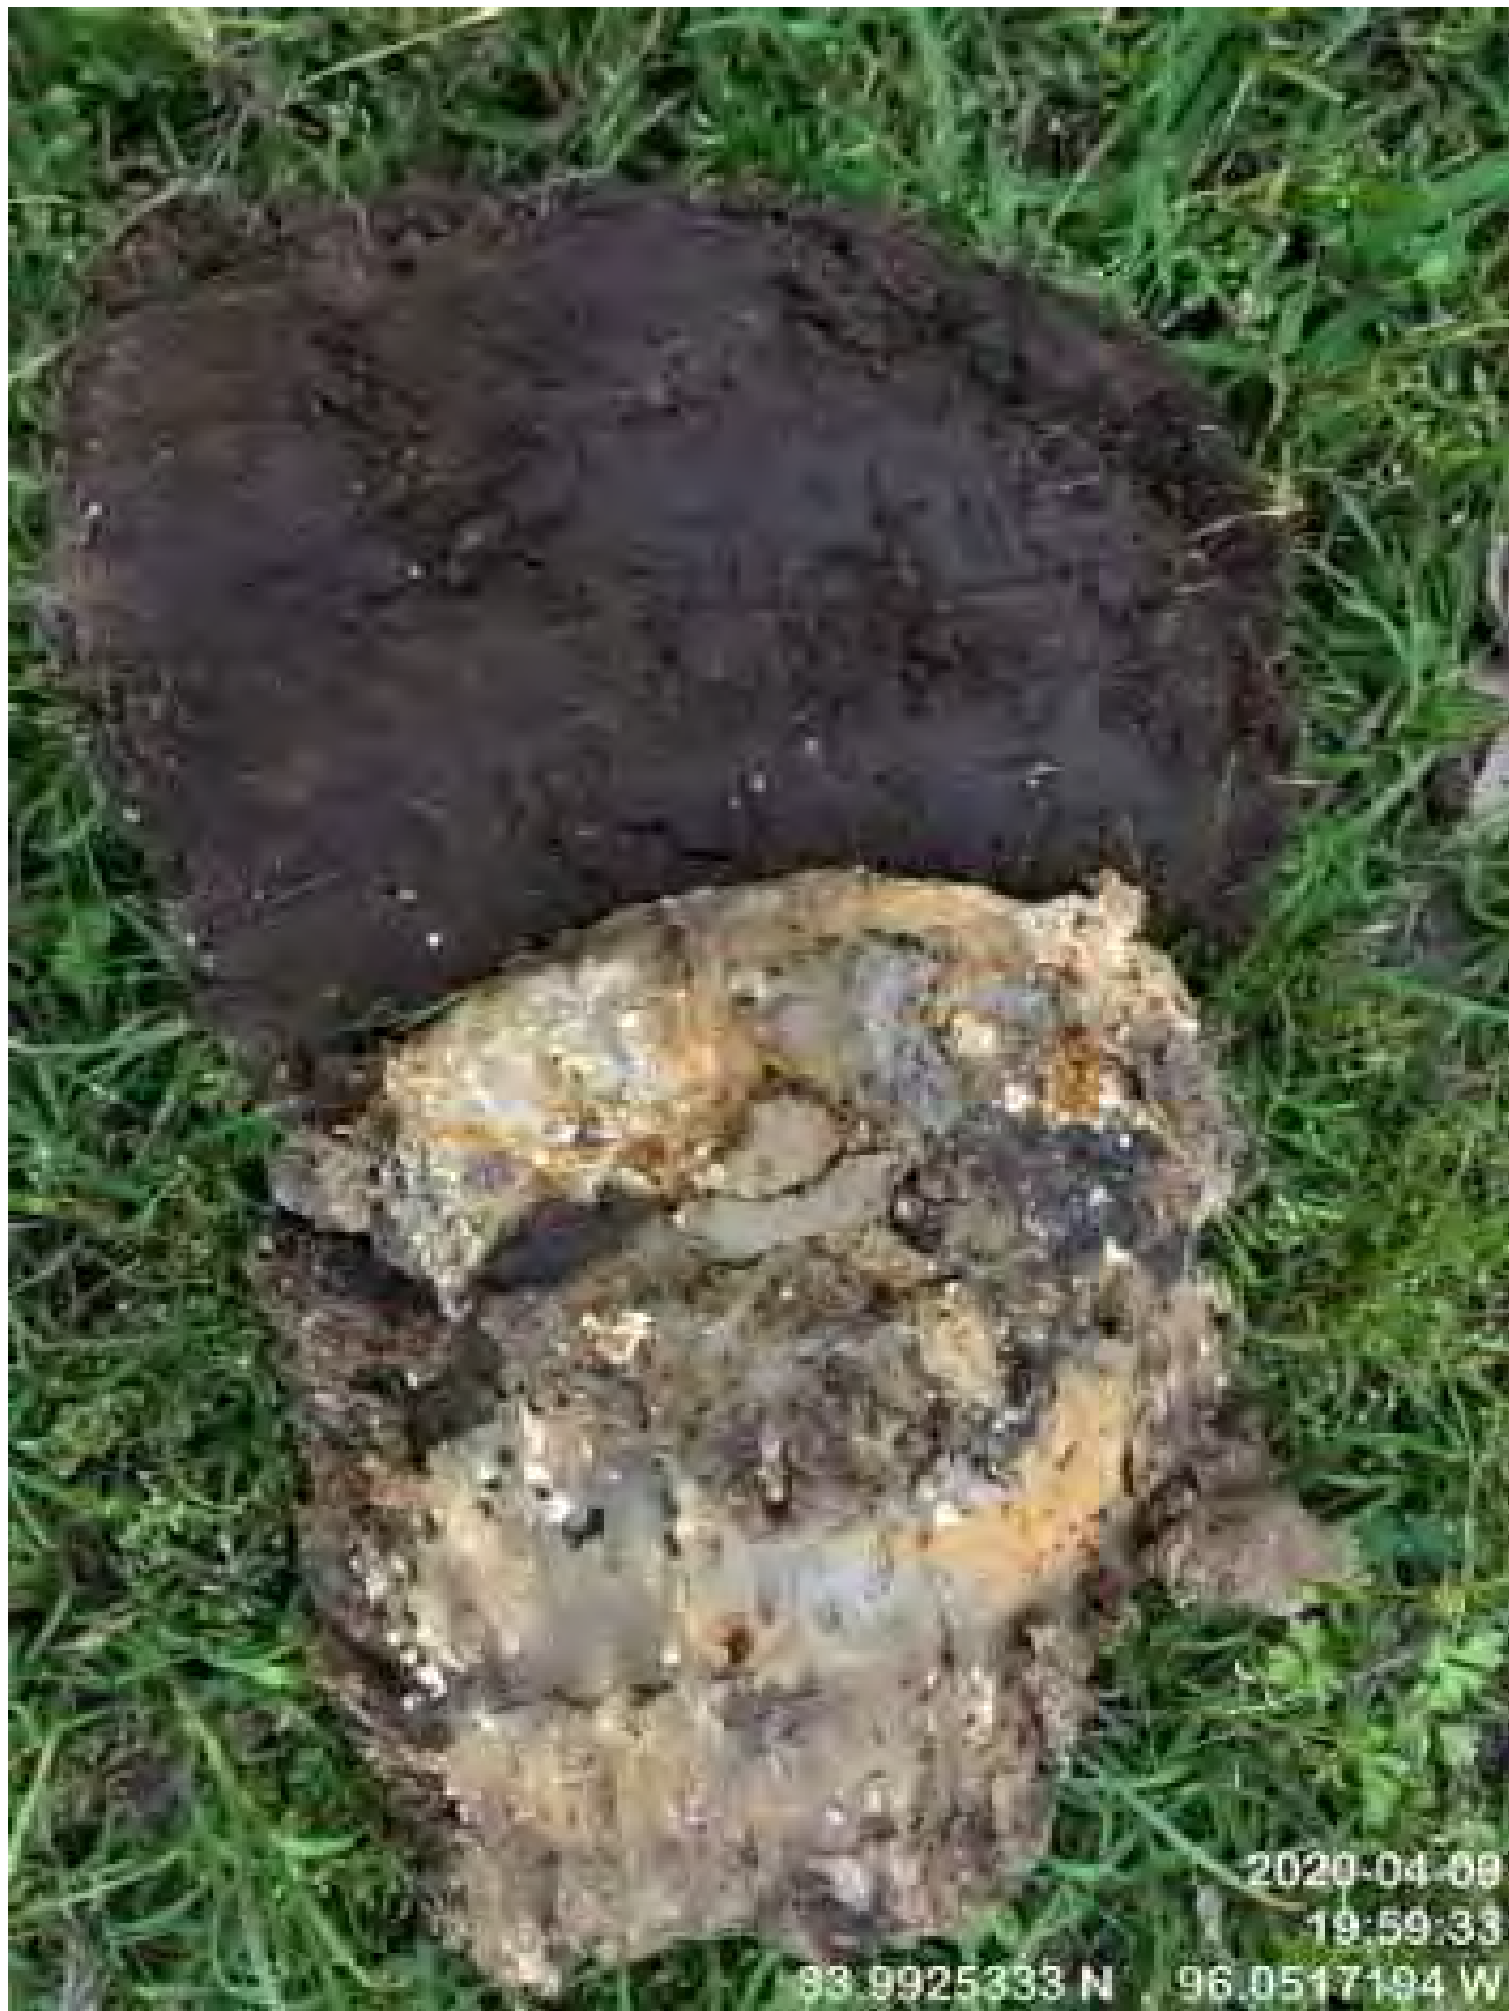
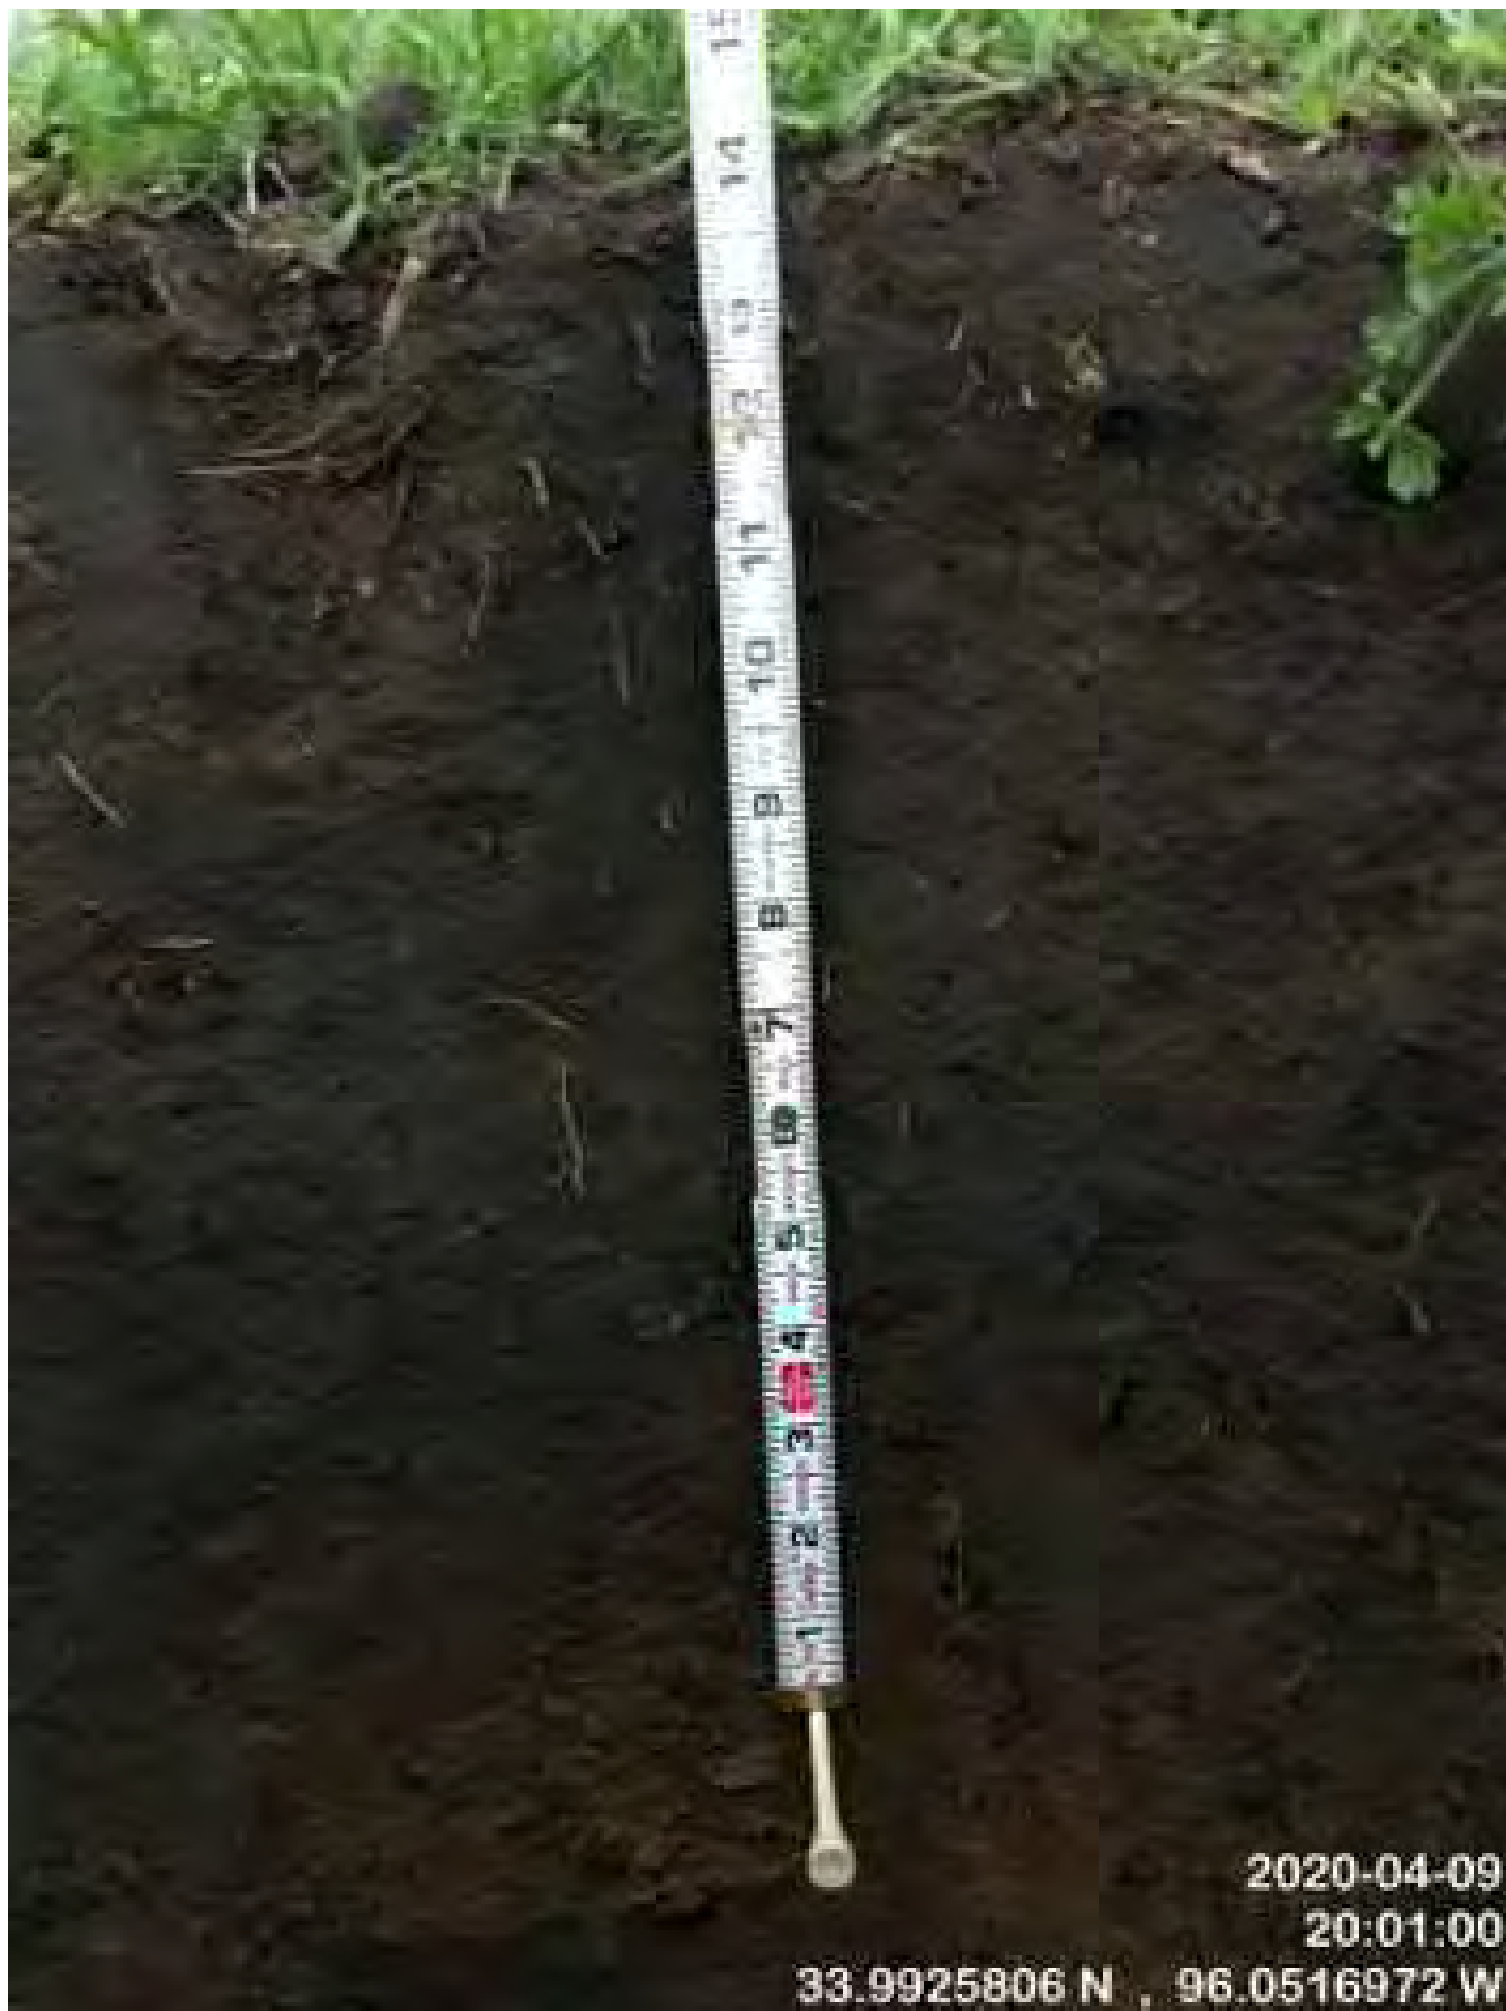
**April 13, 2020 Site Inspection
Nolen & Jackie Grounds
BR-1000.000, BR-1001.000
Mile Post: MP 196.5
Bryan County, Oklahoma**

- 1.) High levels of rock and blasting material mixed into soil. (FERC Plan: V. A. 3-6.)
 - a. Affected areas naturally have around 1% rock fragments with a maximum size of 74 mm (NRCS)
- 2.) Importation of approx. 3,256 cubic yards of topsoil for 1.73 acres of ROW. (FERC Plan: IV. B. 1-6.)
 - a. Off-ROW topsoil: 14" (verified by existing NRCS soil surveys)
 - b. In-ROW topsoil: 0" found in multiple locations.
- 3.) Soil Compaction (FERC Plan: V. C. 1-3.)
 - a. Off-ROW Penetrometer reading: Around 150 psi in multiple locations.
 - b. In-ROW Penetrometer reading: 300 psi limit exceeded in every off-ROW location.
