Robert Squires - Squires Consulting LLC
Landowner Advocate

Opening Statement for May 5, 2021 Subcommittee on Civil Rights and Civil Liberties Hearing:
“Pipelines Over People (Part II): Midship Pipeline’s Disregard for Landowners in Its Pathway”

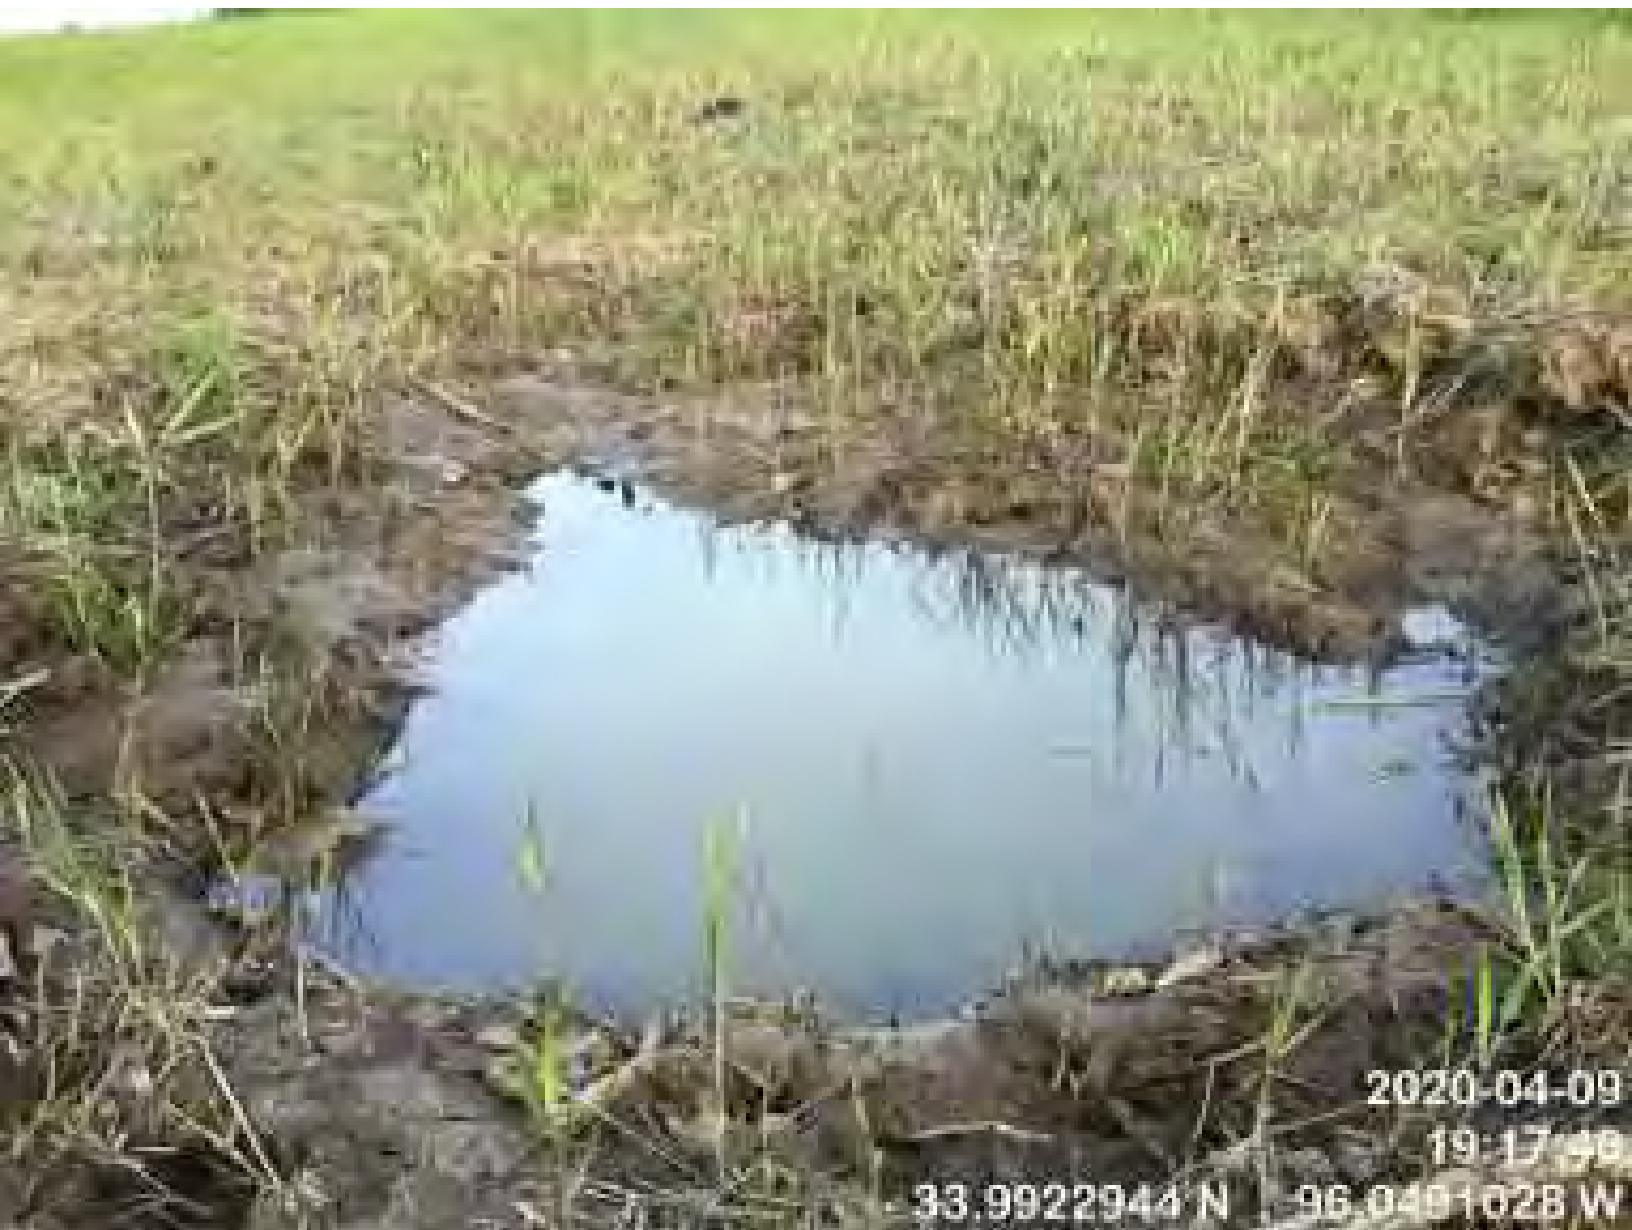
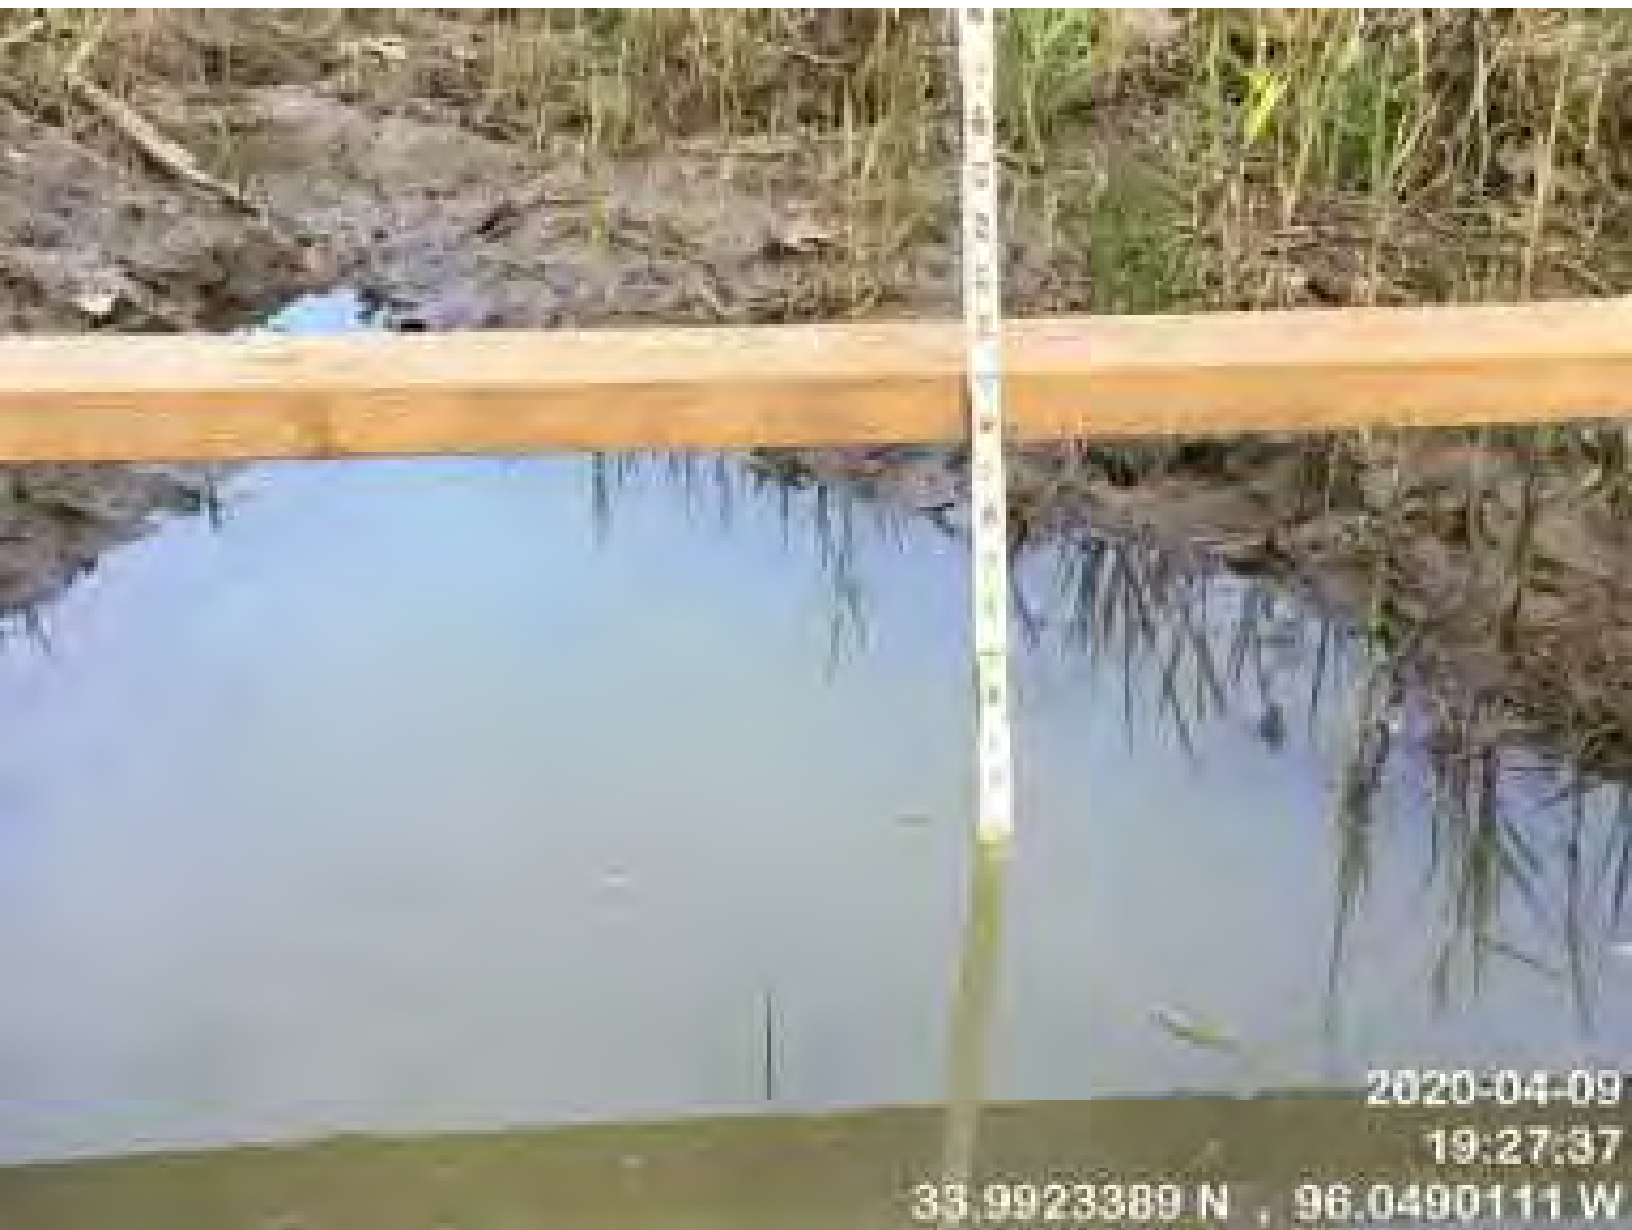
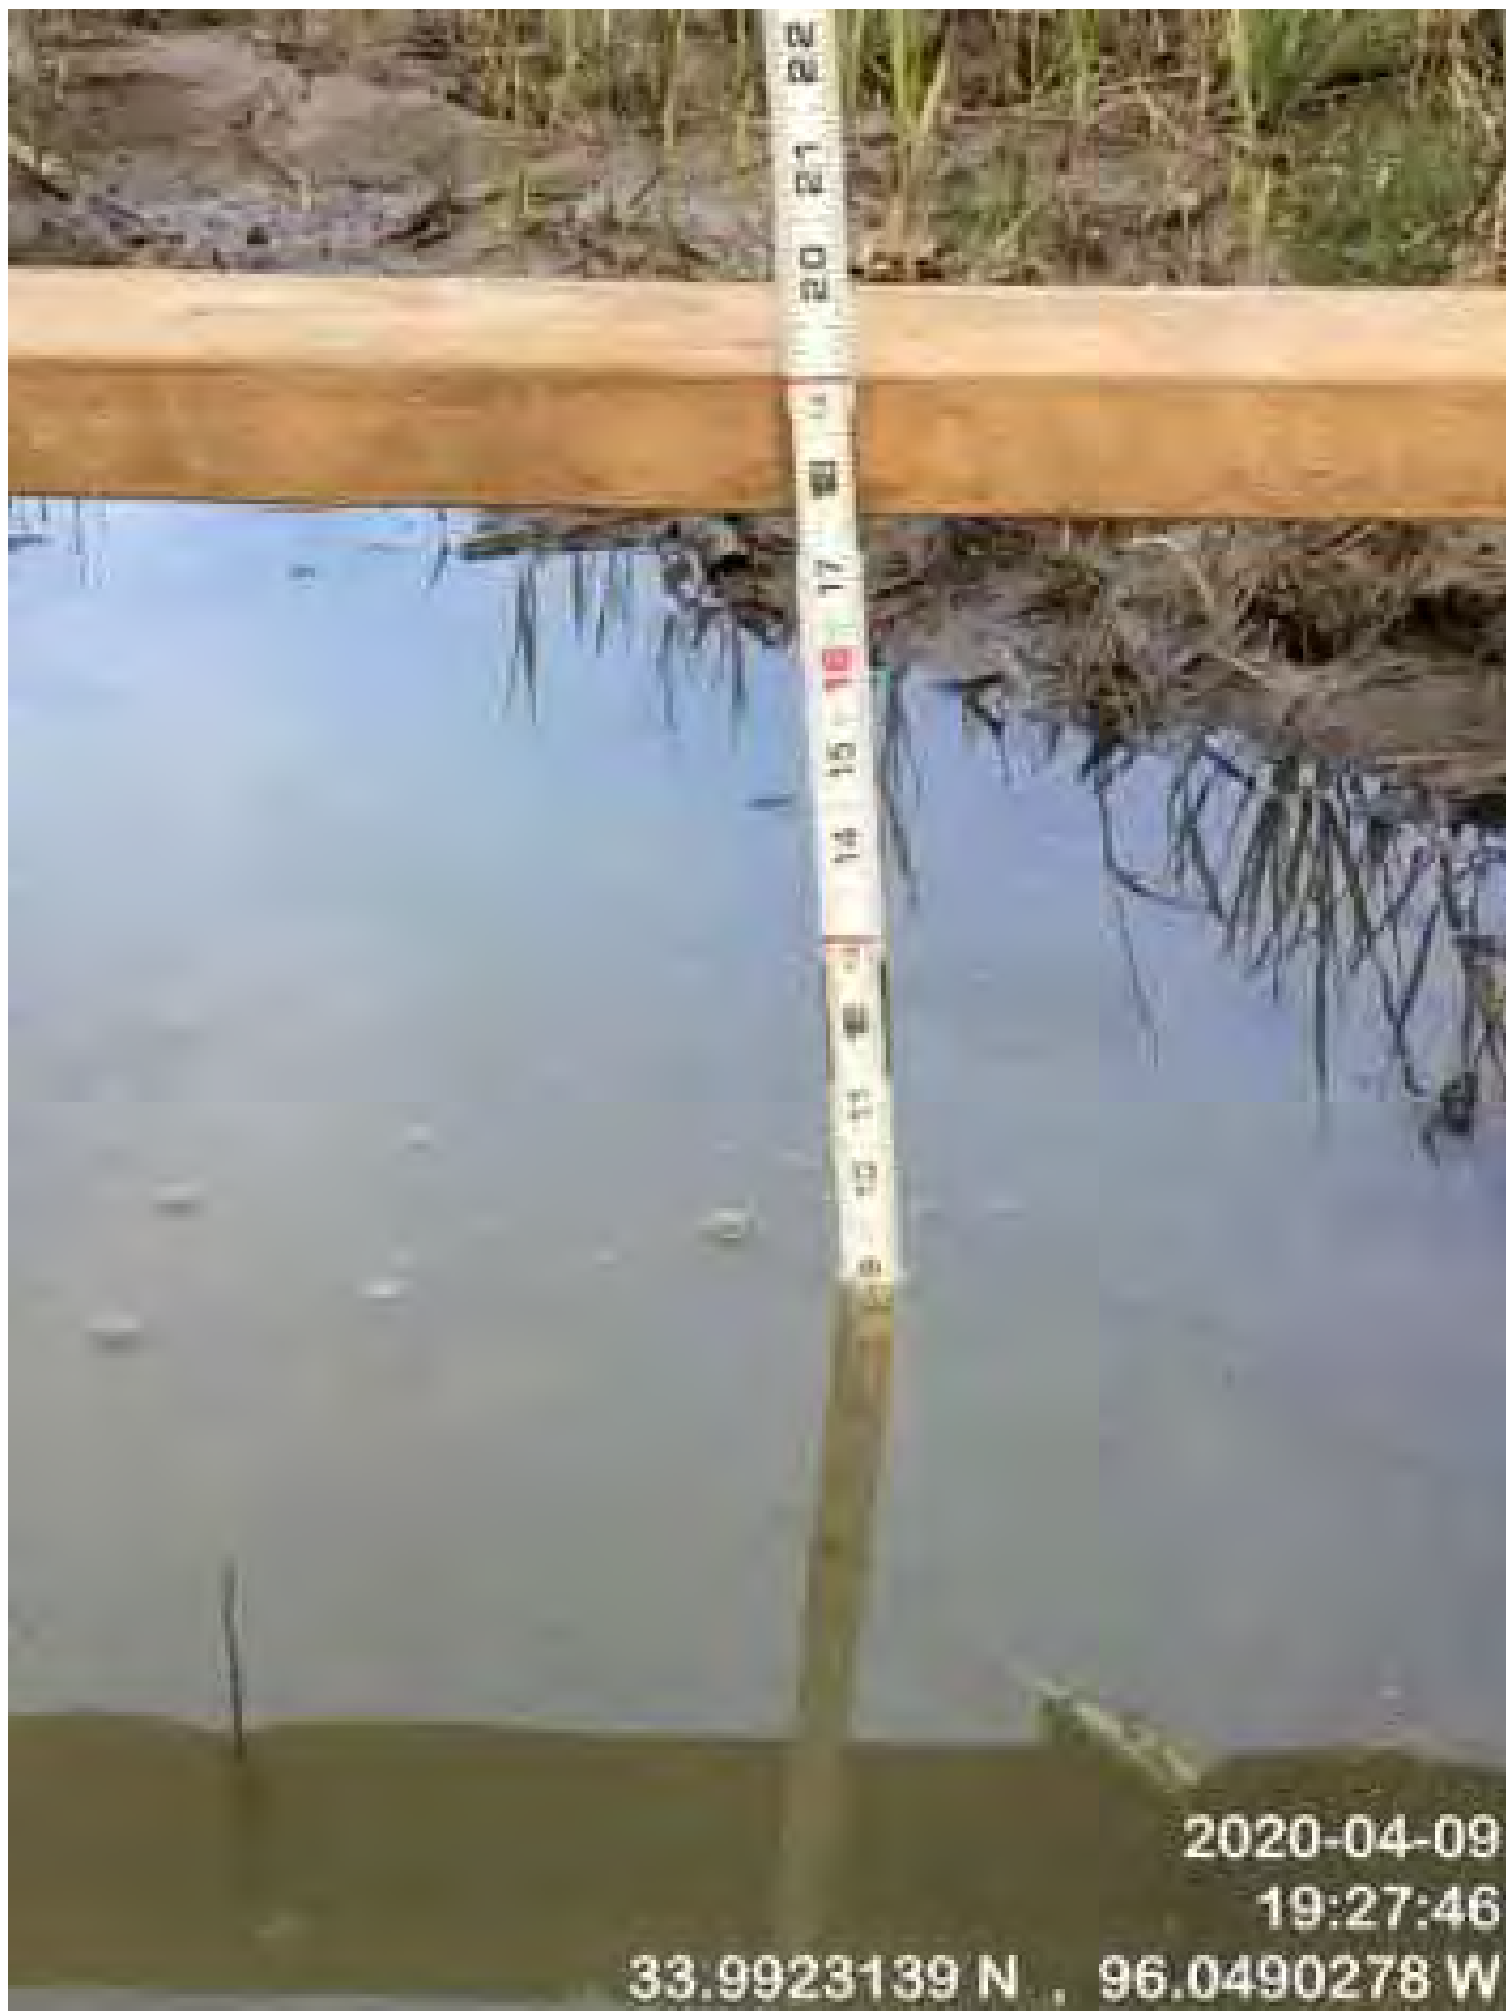
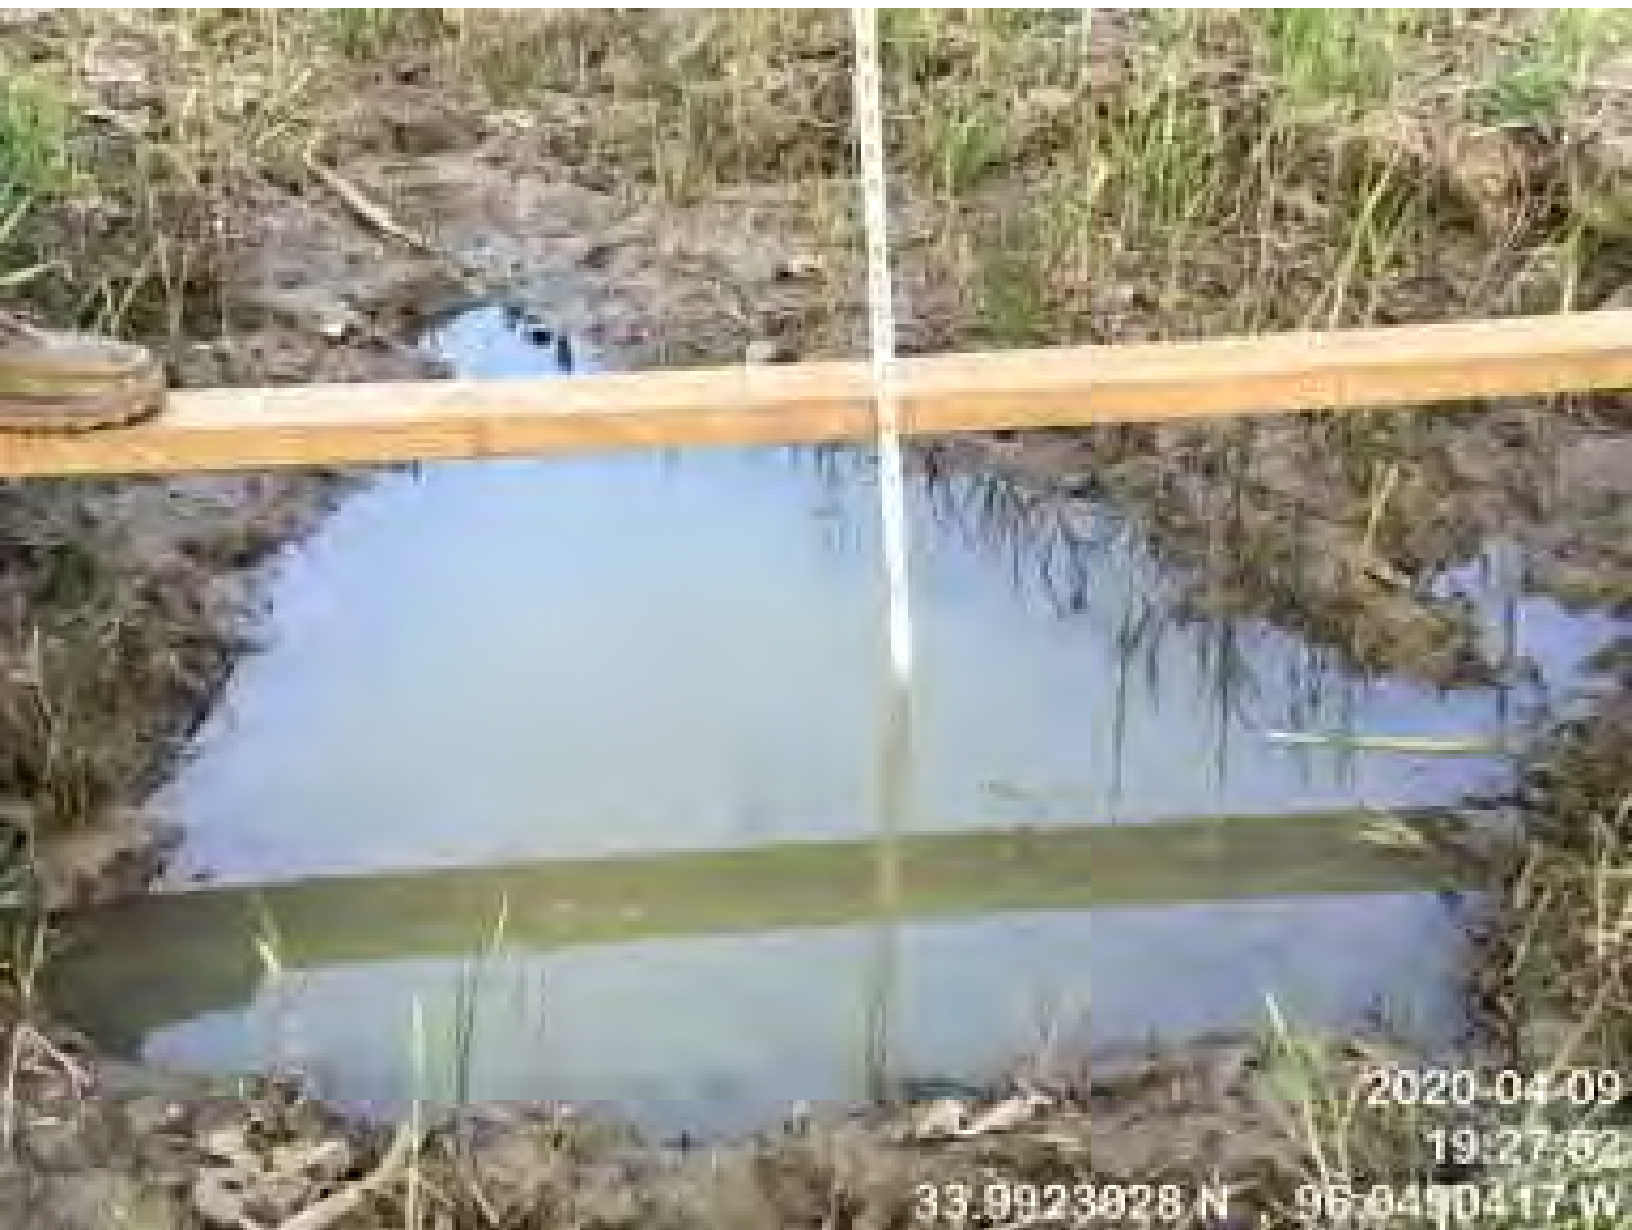
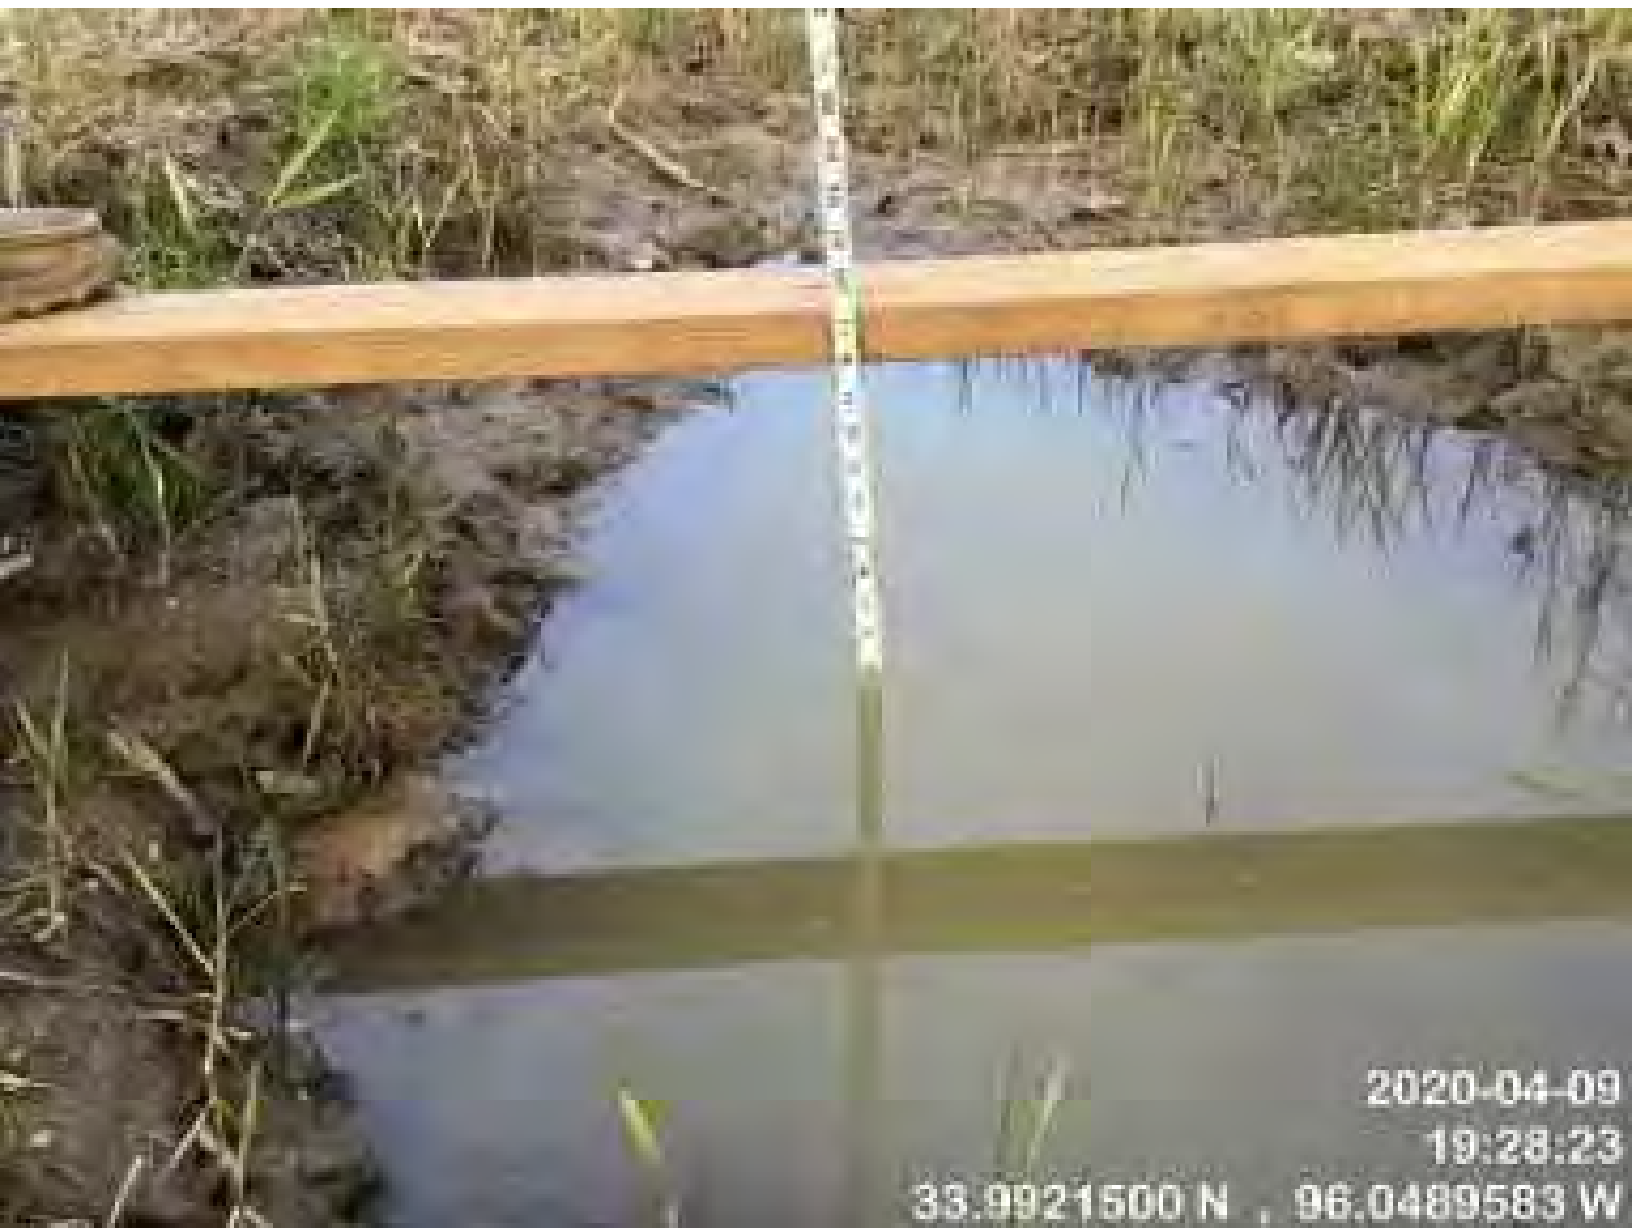
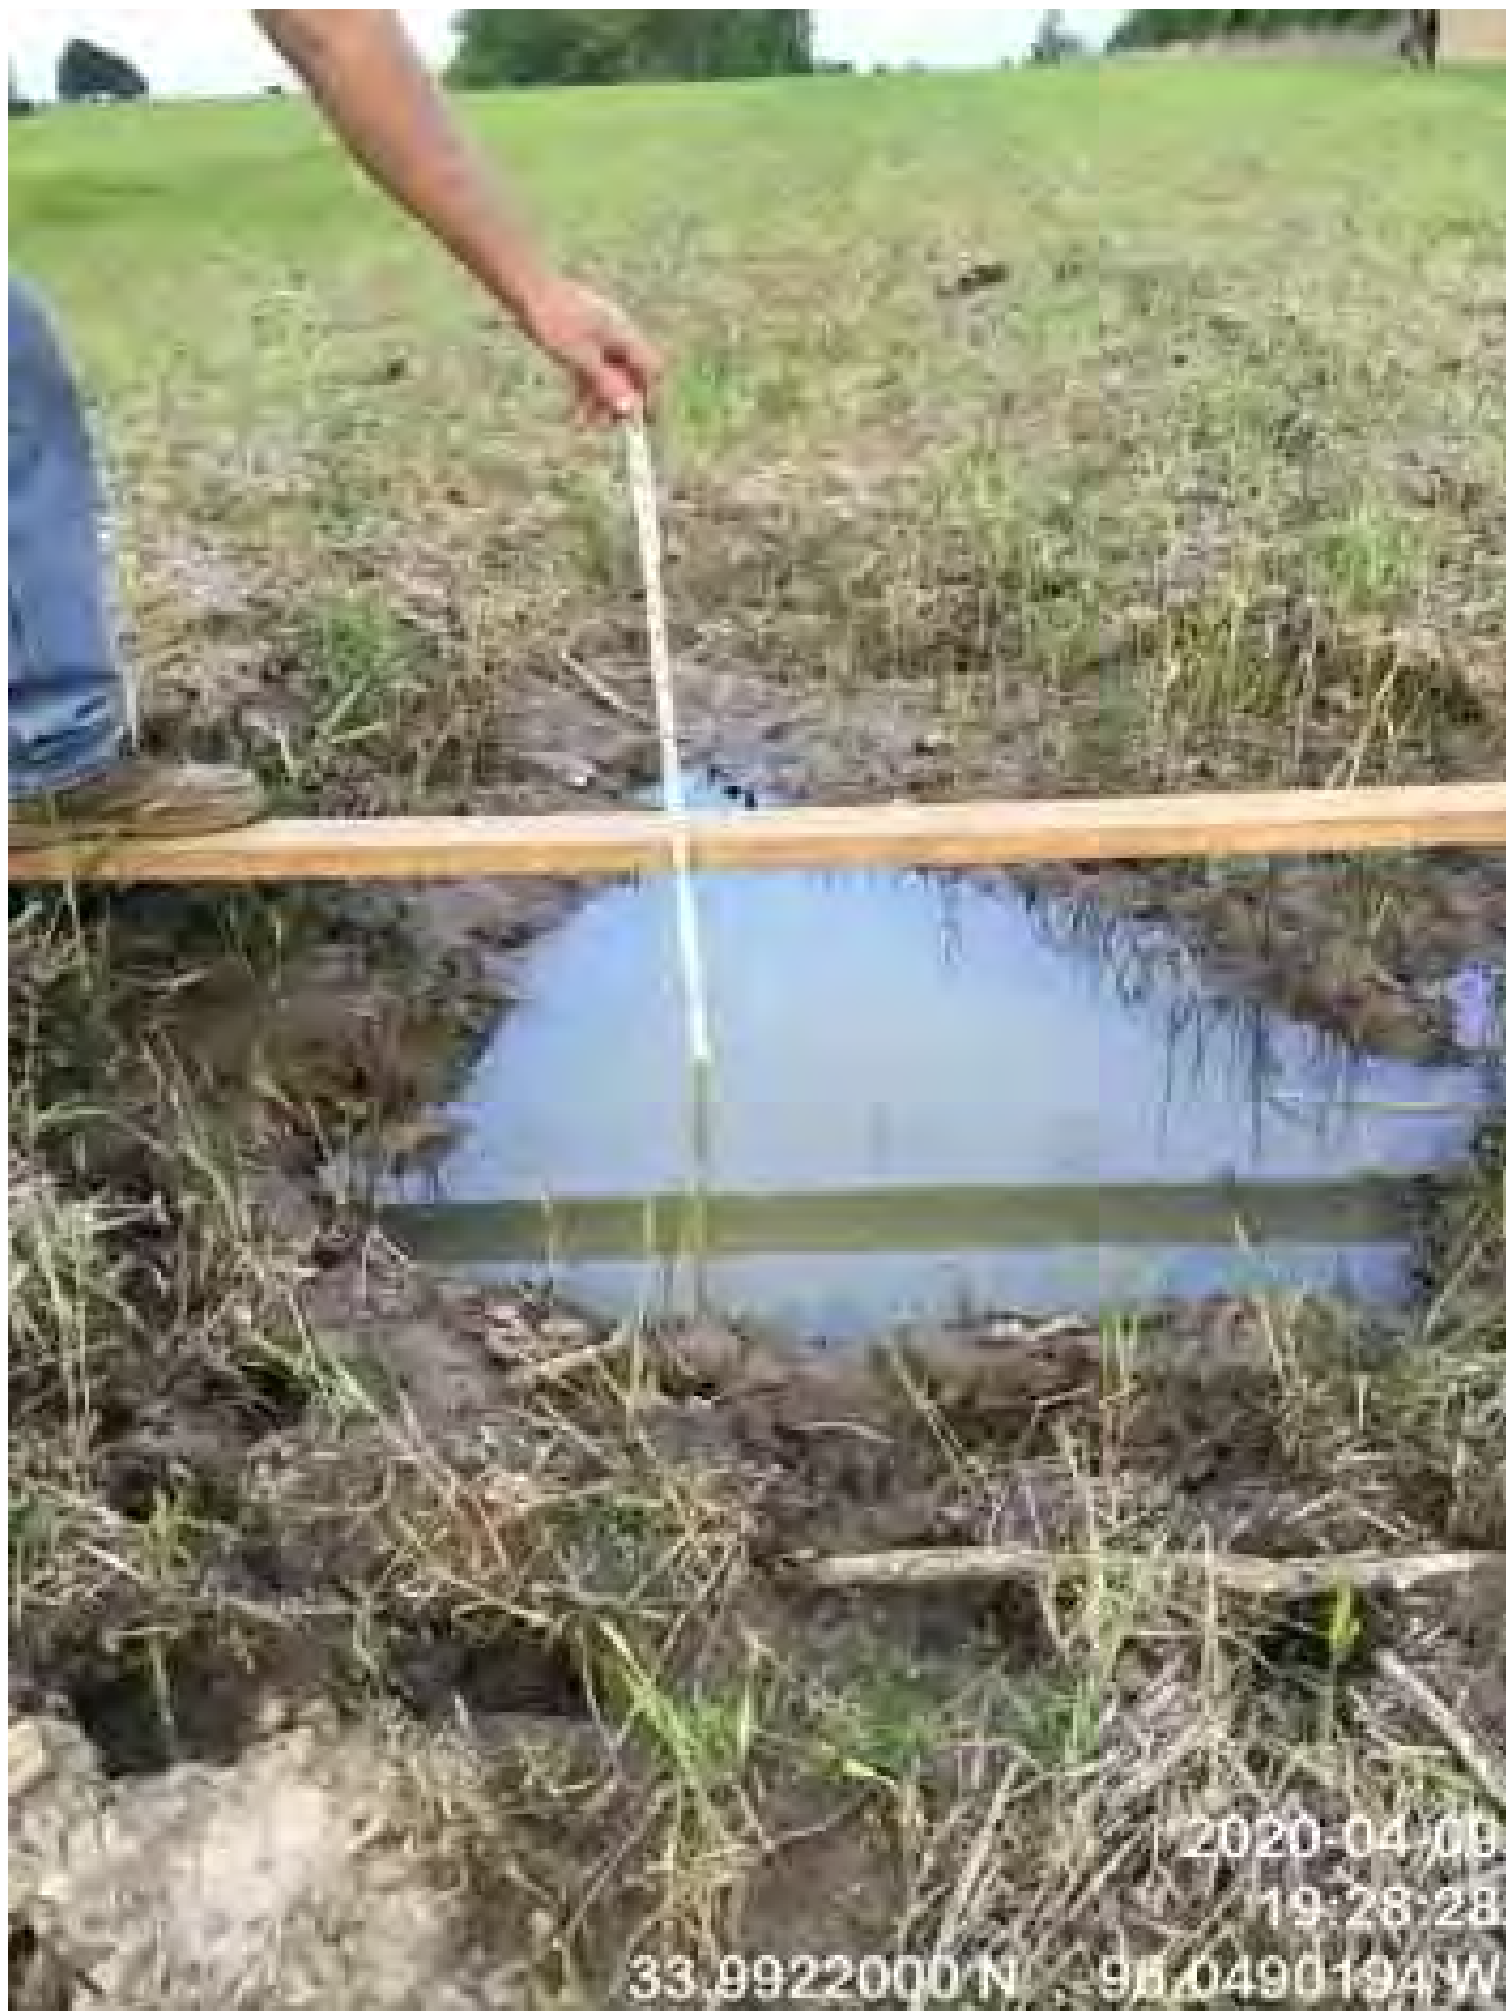
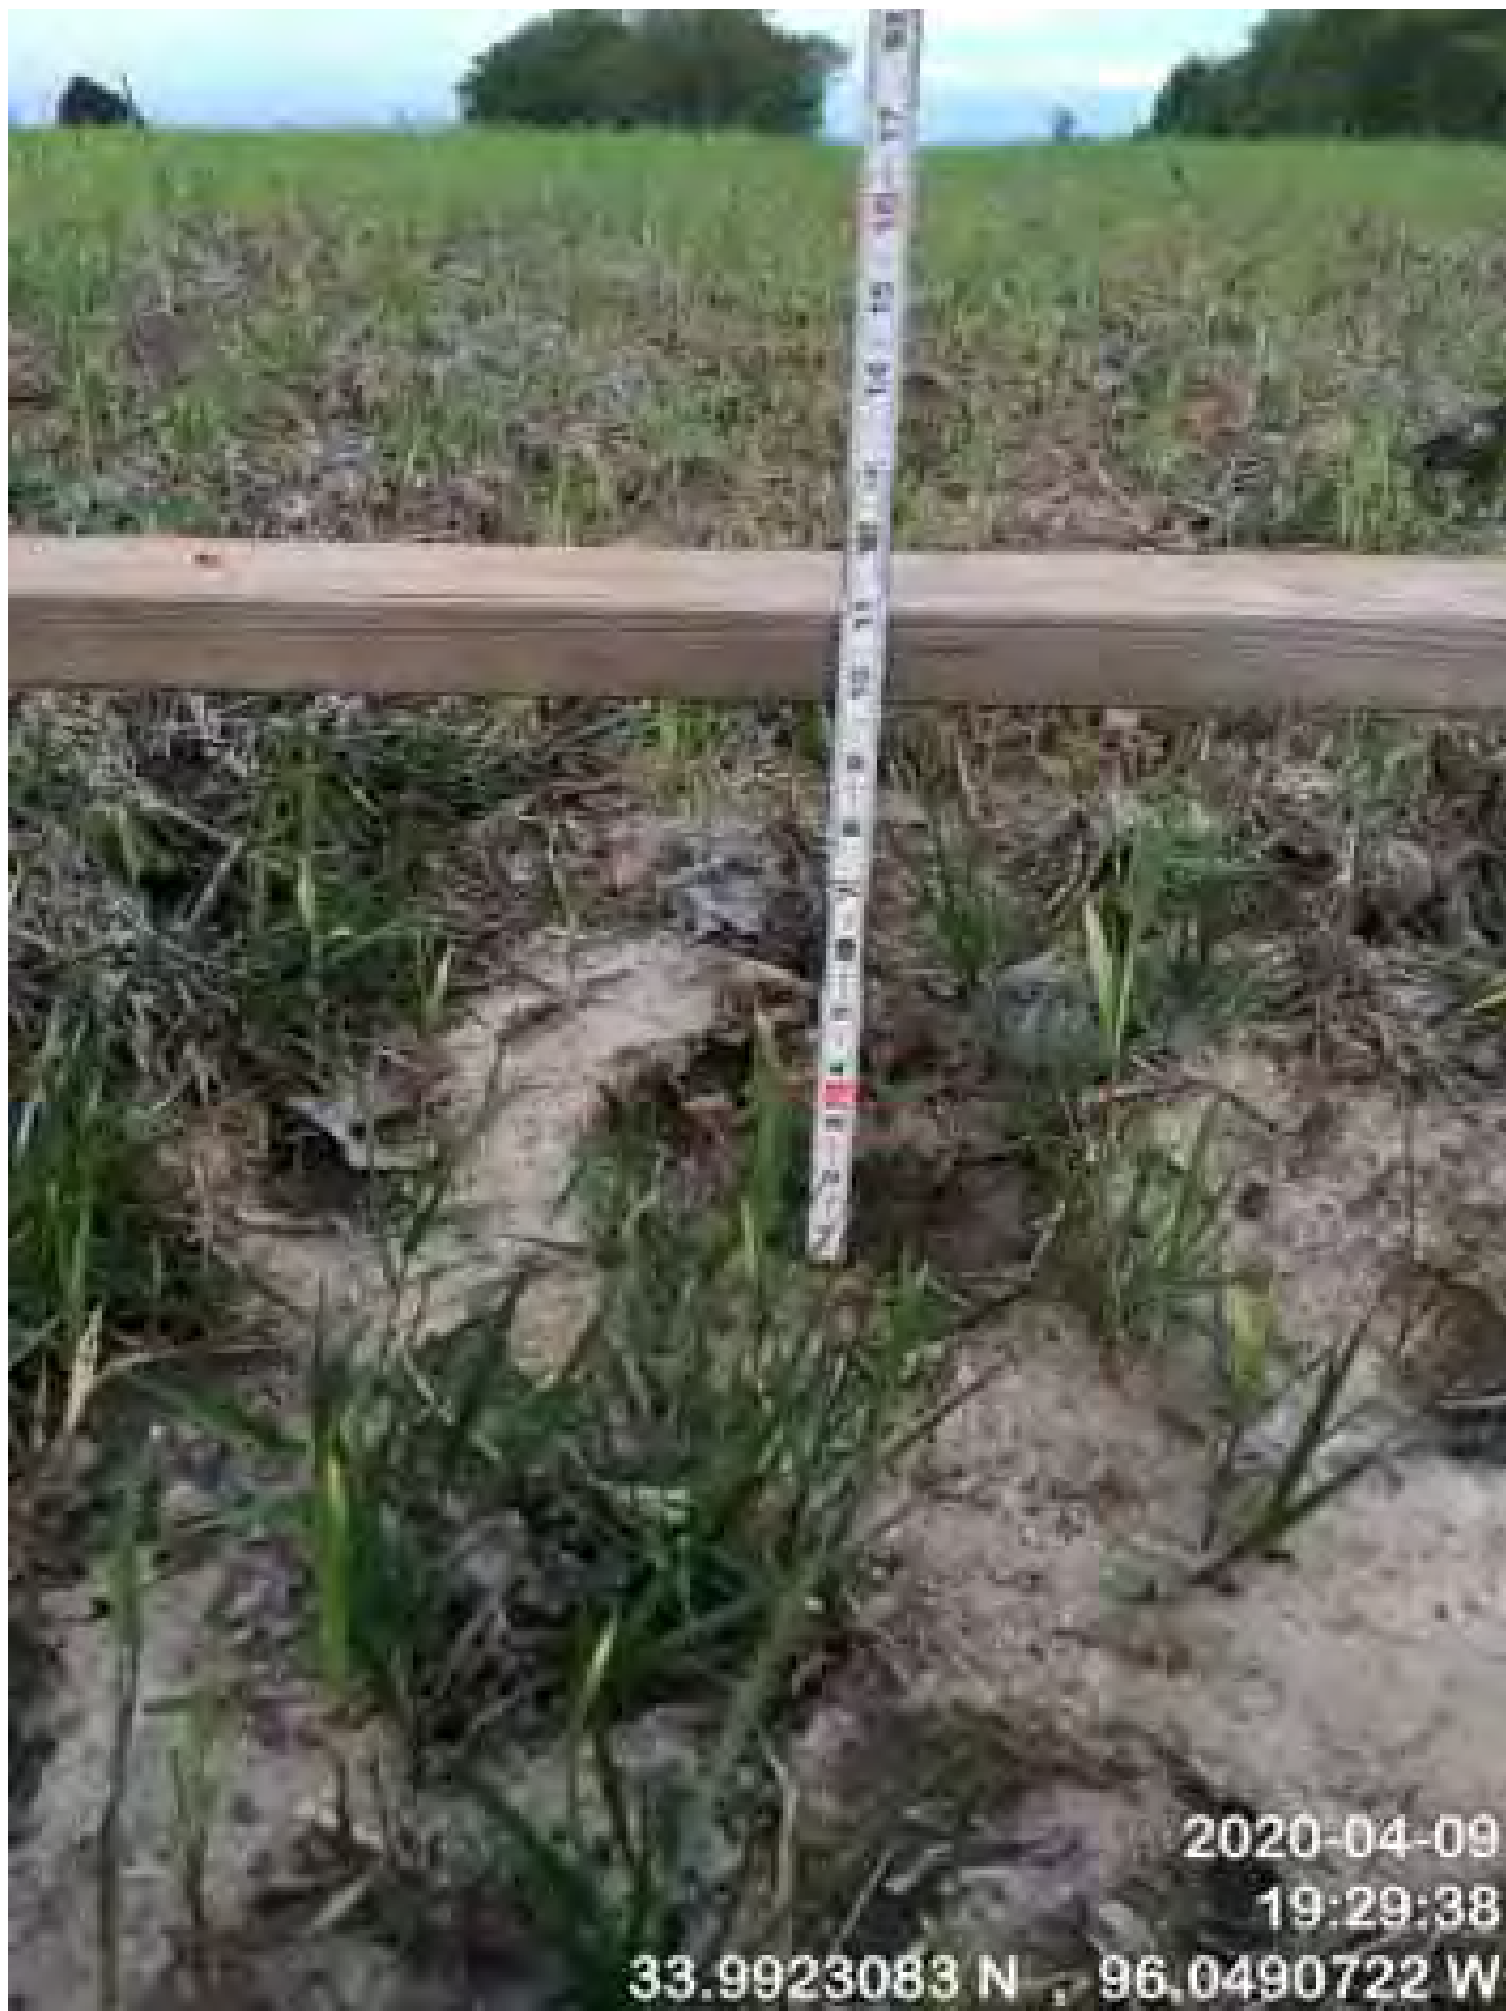
- 1.) Larimore Creek Tributary (SGR-019) is partially dammed with sediment that has entered stream and is impeding natural flow and causing drainage issues throughout the property. (FERC Procedures: V. C. 2-3.)
- 2.) Soil Compaction (FERC Plan: V. C. 1-3.)
 - a. Off-ROW Penetrometer reading: Around 180 psi in multiple locations.
 - b. In-ROW Penetrometer reading: 300 psi limit exceeded in every on-ROW location.
- 3.) Large rocks and construction debris buried in ROW and scattered throughout property. (FERC Plan: V. A. 3-6.)
- 4.) Ponding inside and outside ROW.
- 5.) Soil settlement above pipeline.
