Robert Squires - Squires Consulting LLC
Landowner Advocate

Opening Statement for May 5, 2021 Subcommittee on Civil Rights and Civil Liberties Hearing:
“Pipelines Over People (Part II): Midship Pipeline’s Disregard for Landowners in Its Pathway”

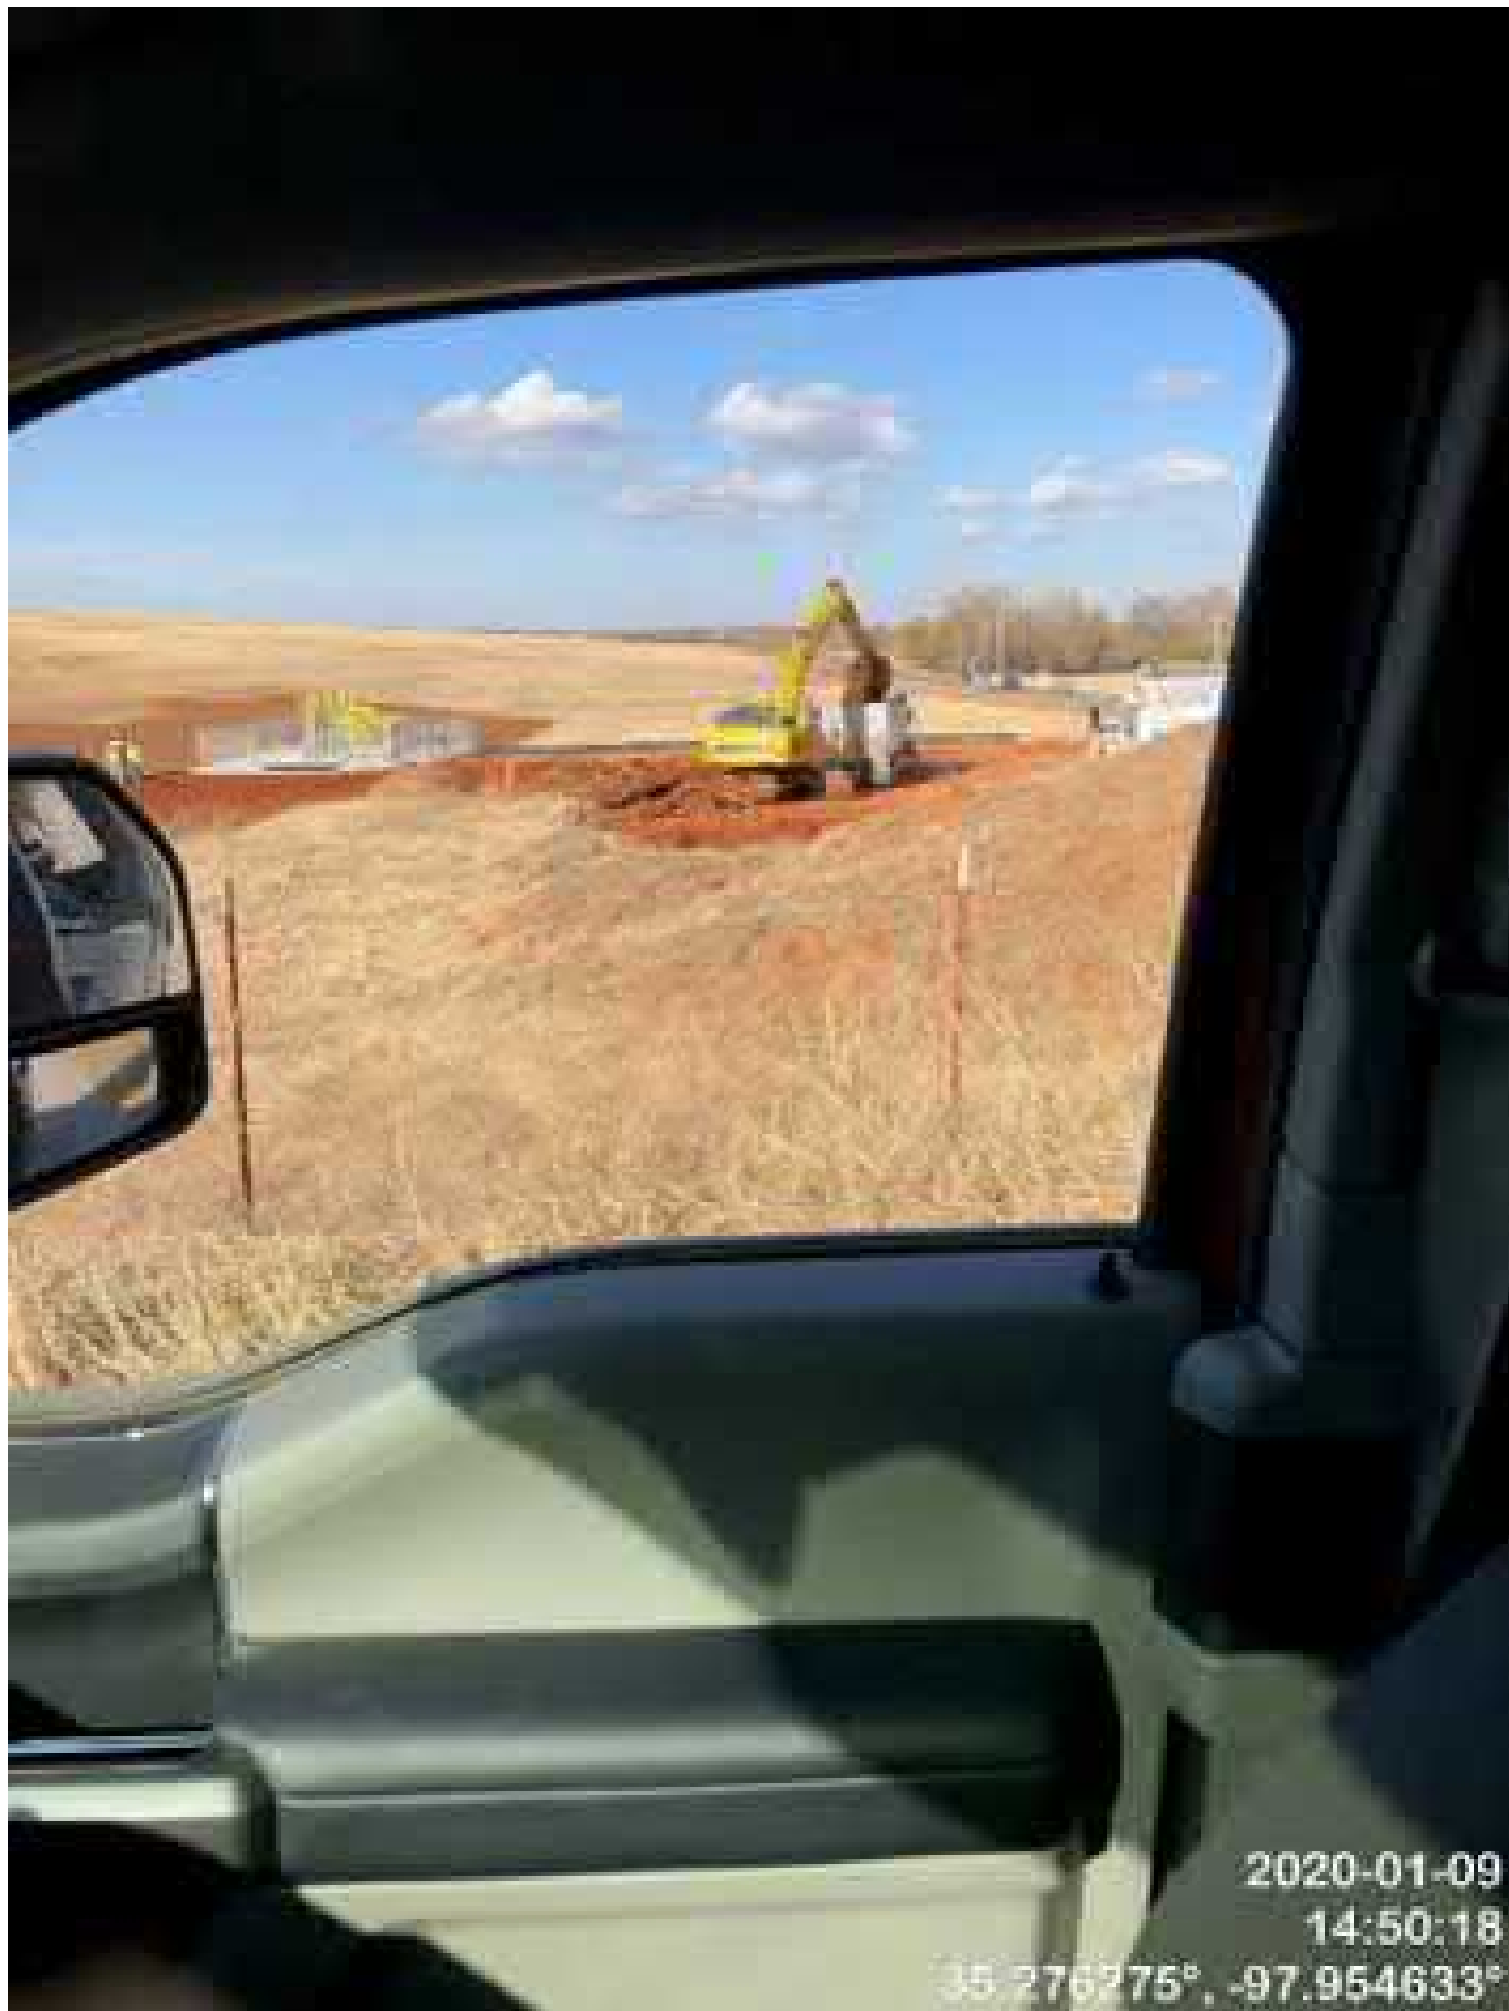
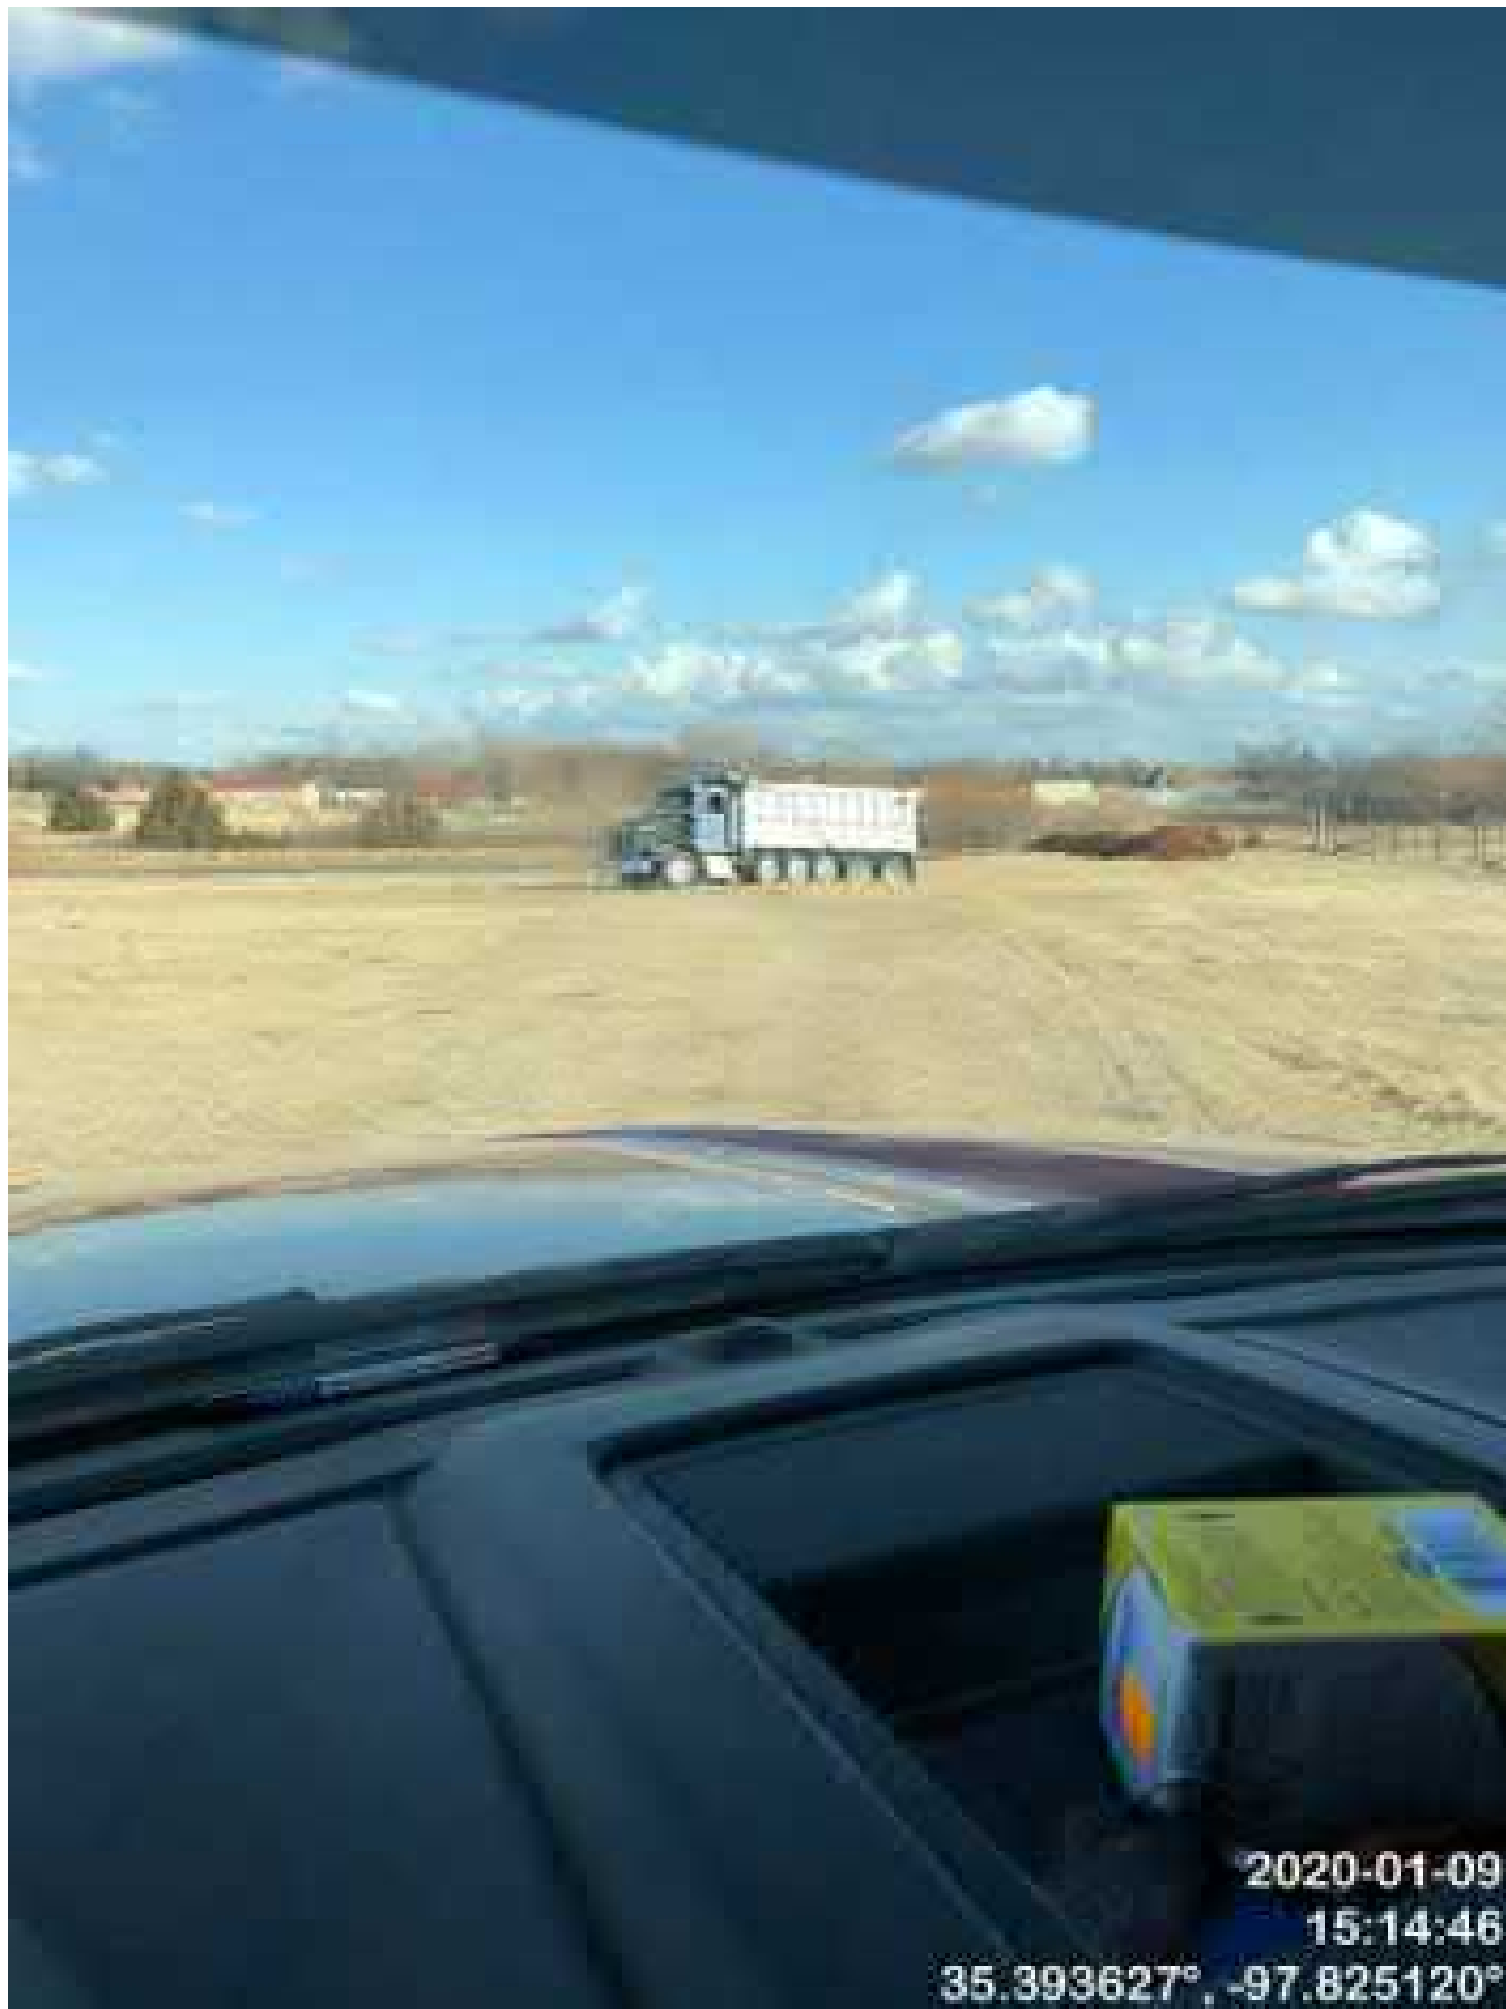
April 14, 2020 Site Inspection
Chris & Christy McComas
GR-0130.010, GR-0131.010, GR-0132.010
Mile Post: MP 34.25 - 34.75
Grady County, Oklahoma

- 1.) Buggy Creek banks unstable and slipping into creek. (FERC Procedures: V. C. 2-3.)
- 2.) On January 9, 2020 around 2-4 pm, approximately 550 cubic yards of topsoil removed and transported off-site to a property unassociated with Midship project.
- 3.) Soil Compaction (FERC Plan: V. C. 1-3.)
 - a. Off-ROW Penetrometer reading: Around 150 psi in multiple locations.
 - b. In-ROW Penetrometer reading: 300 psi limit exceeded in every on-ROW location.

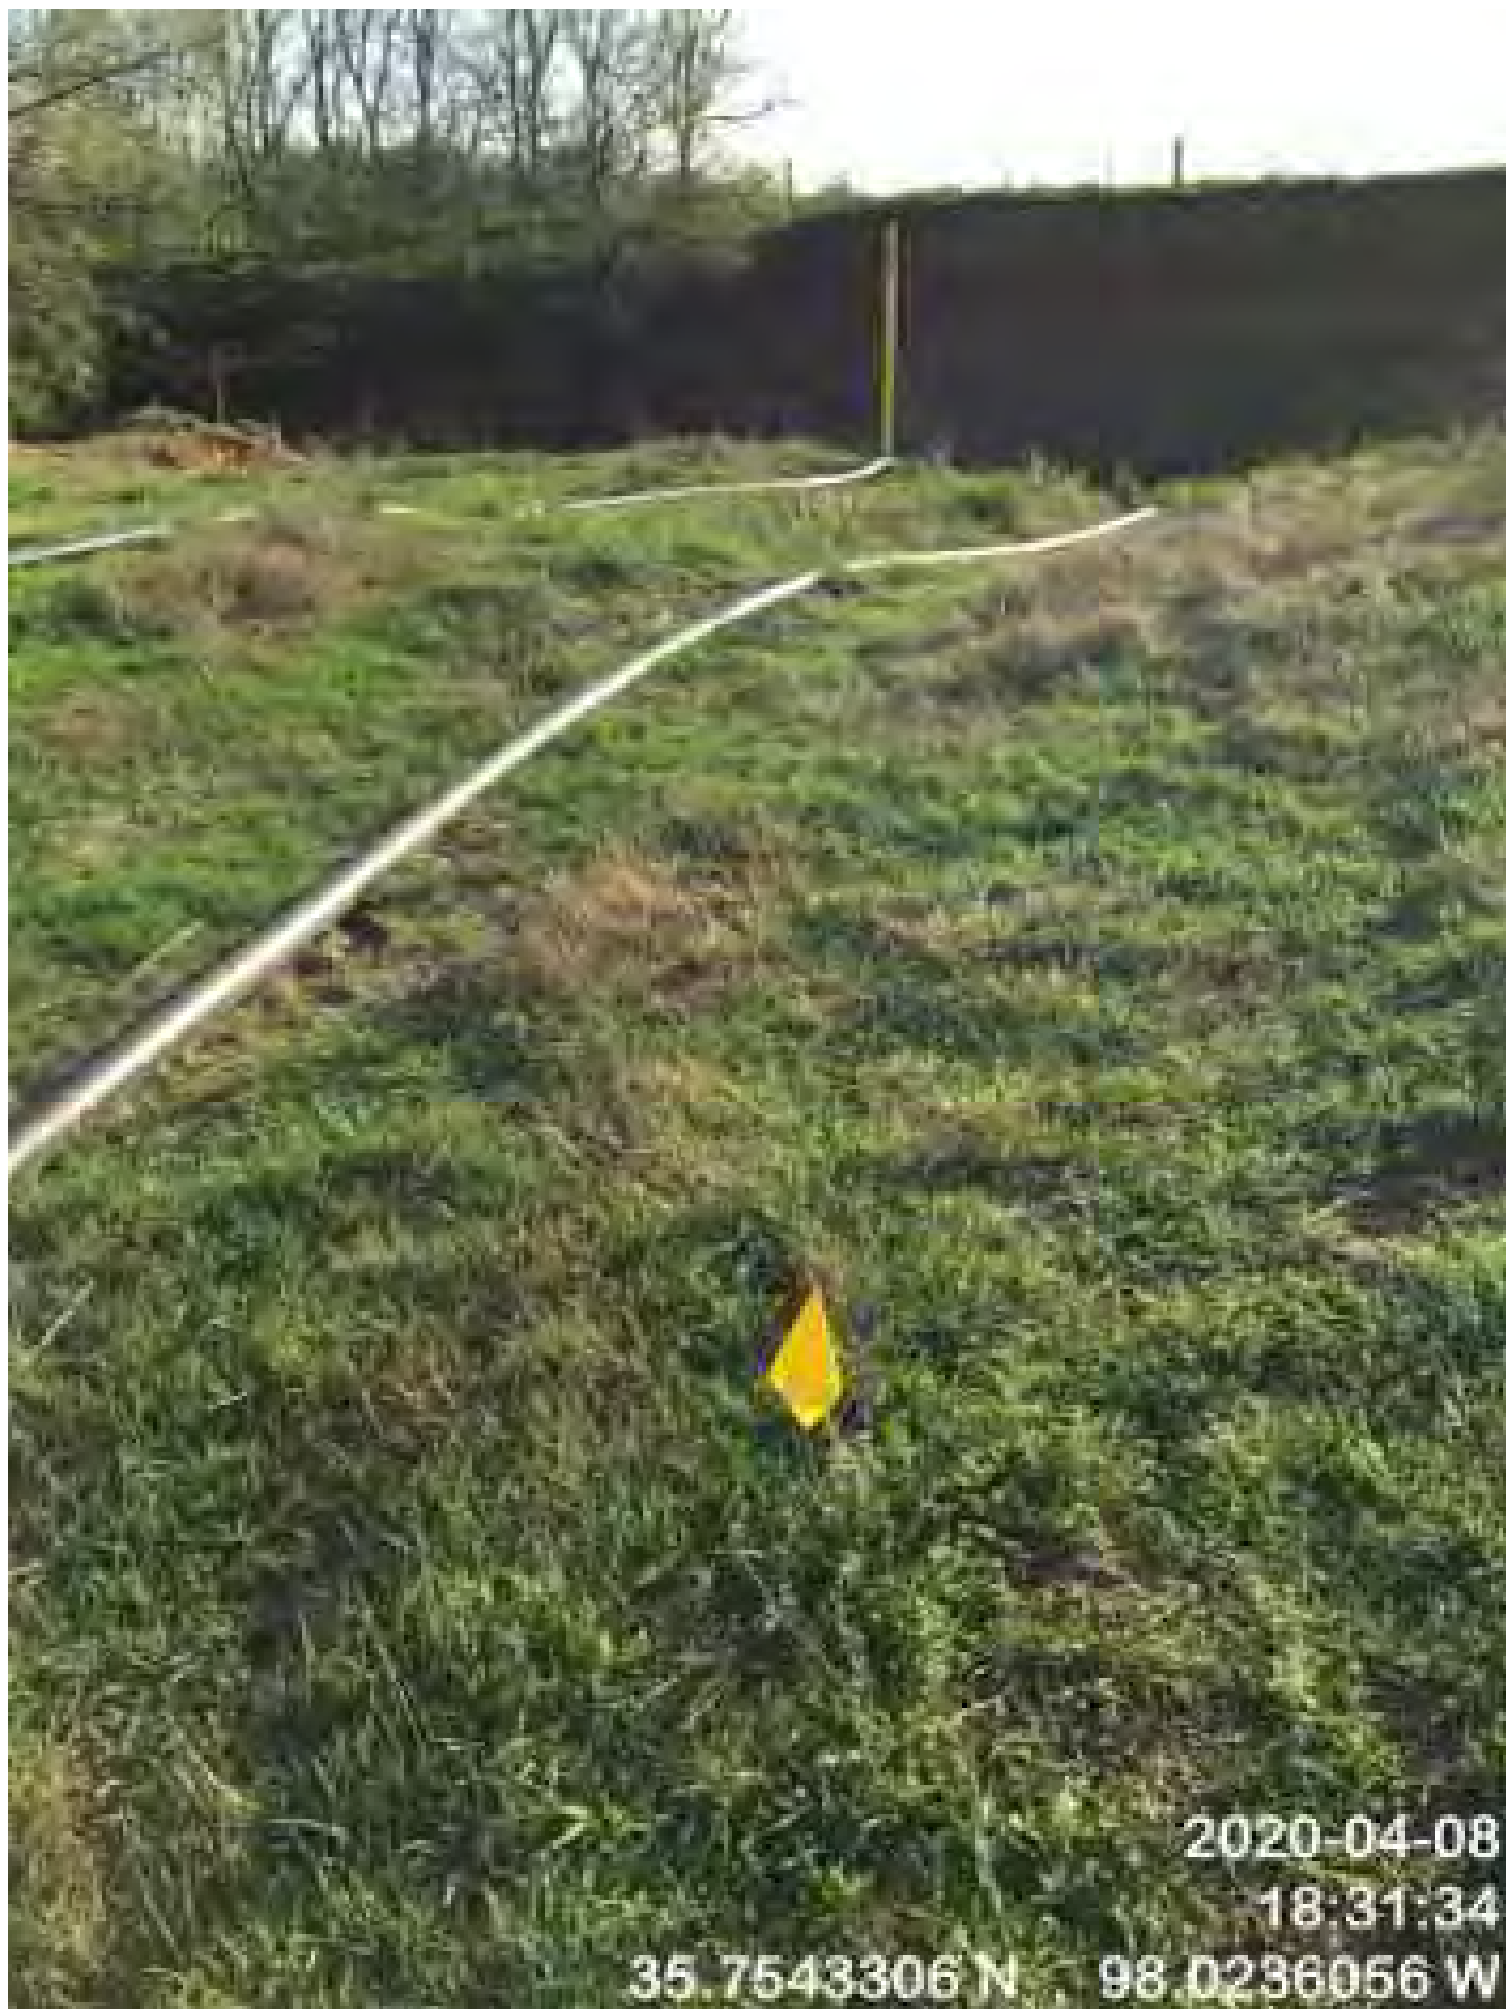
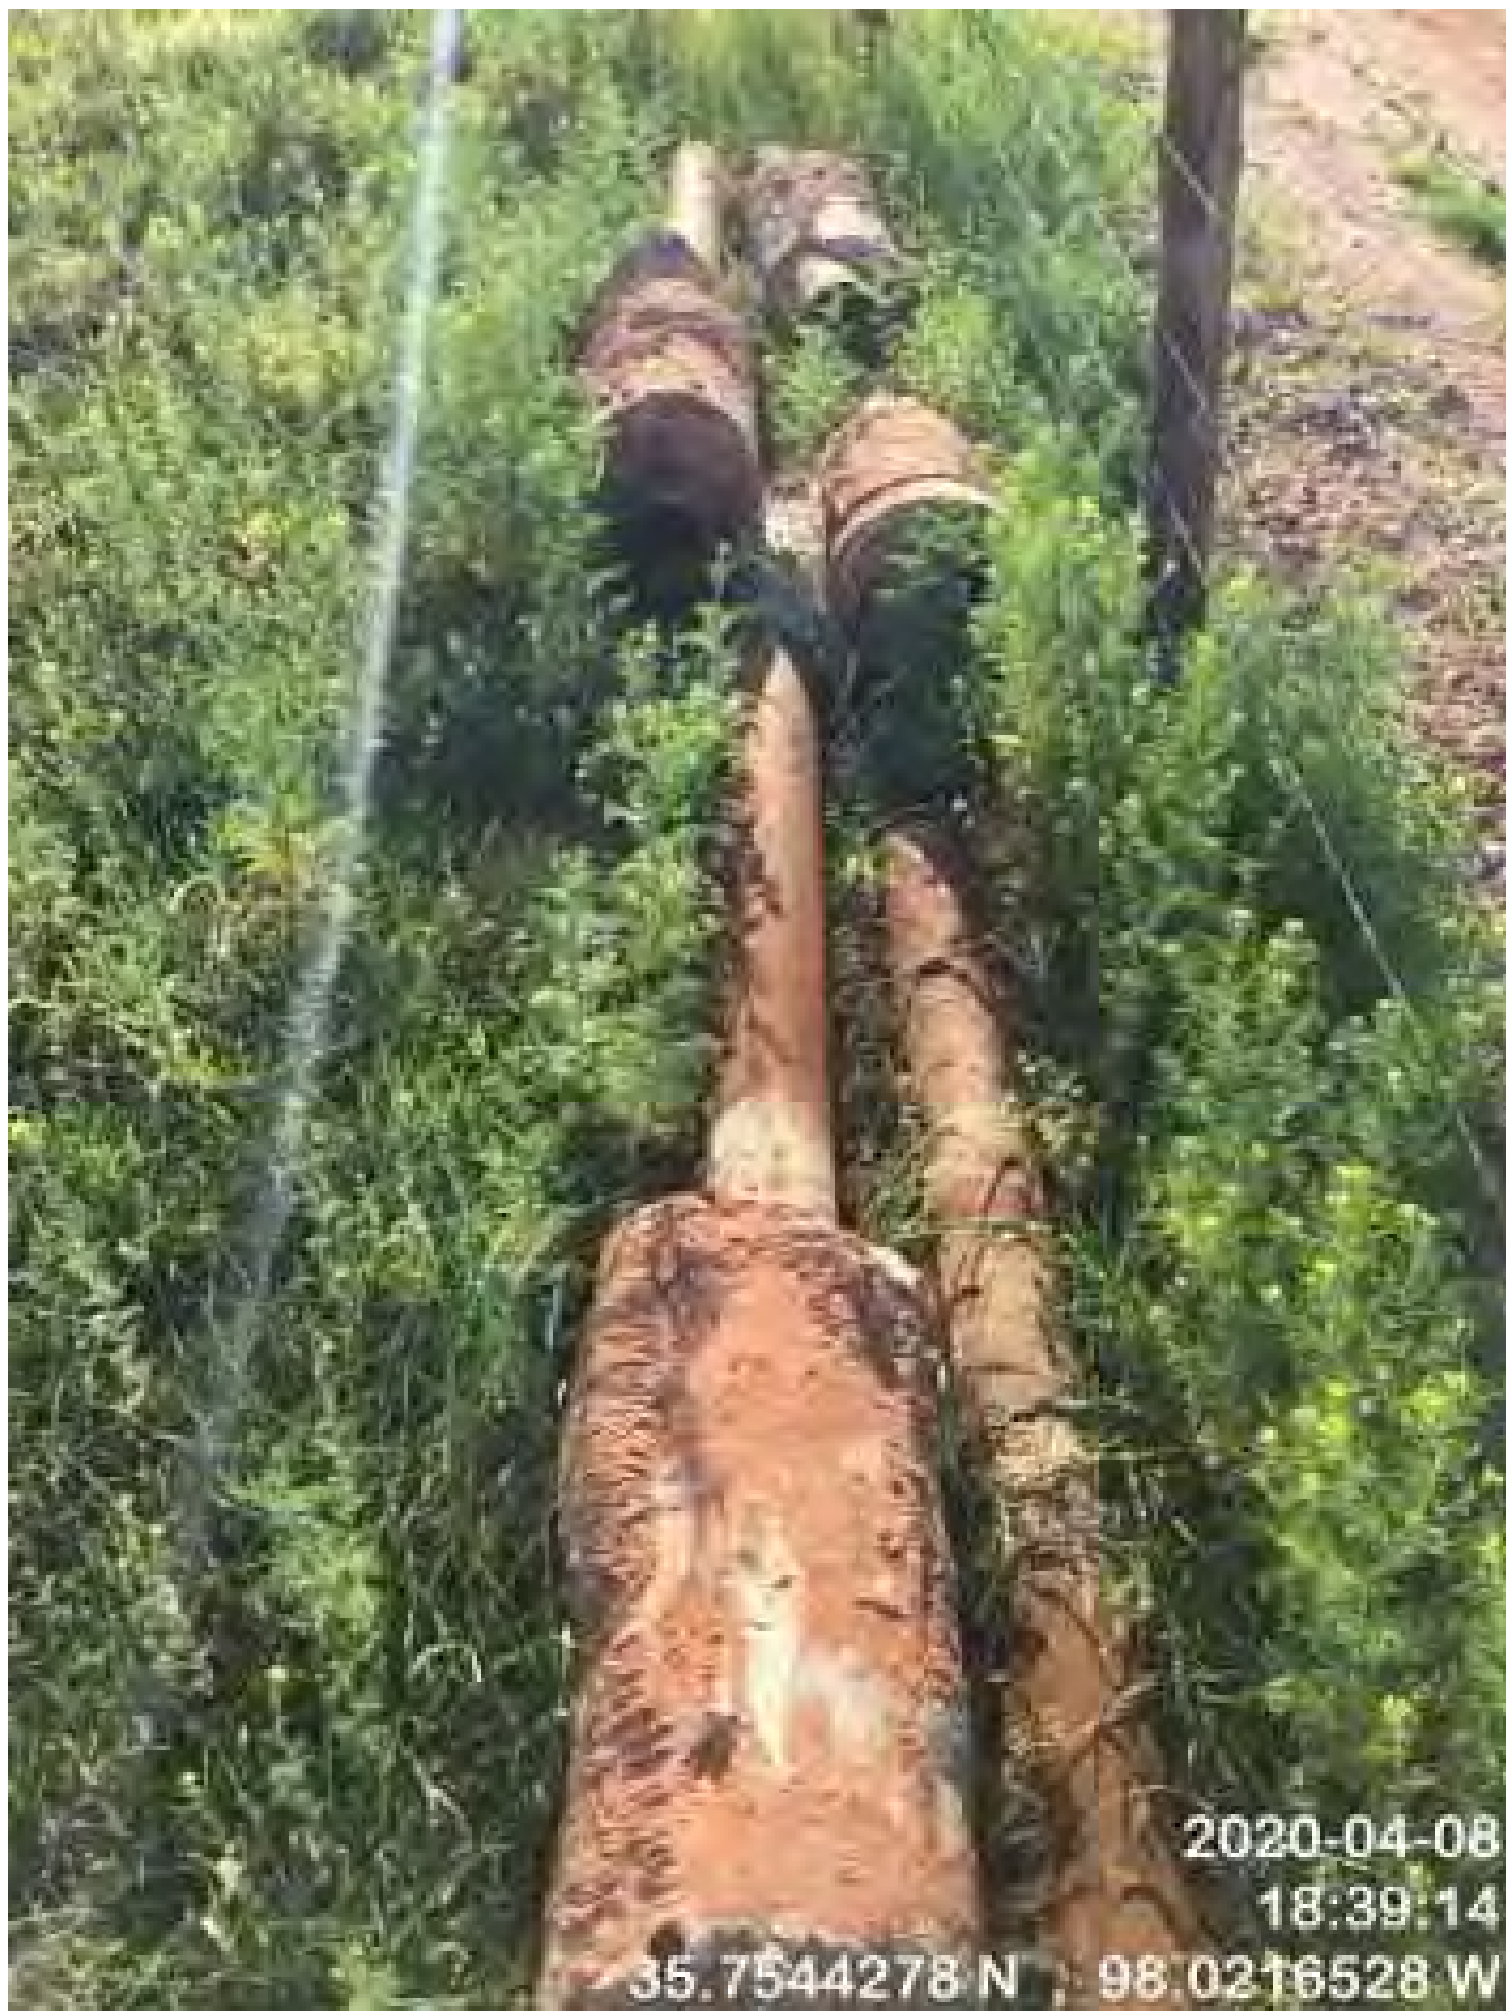
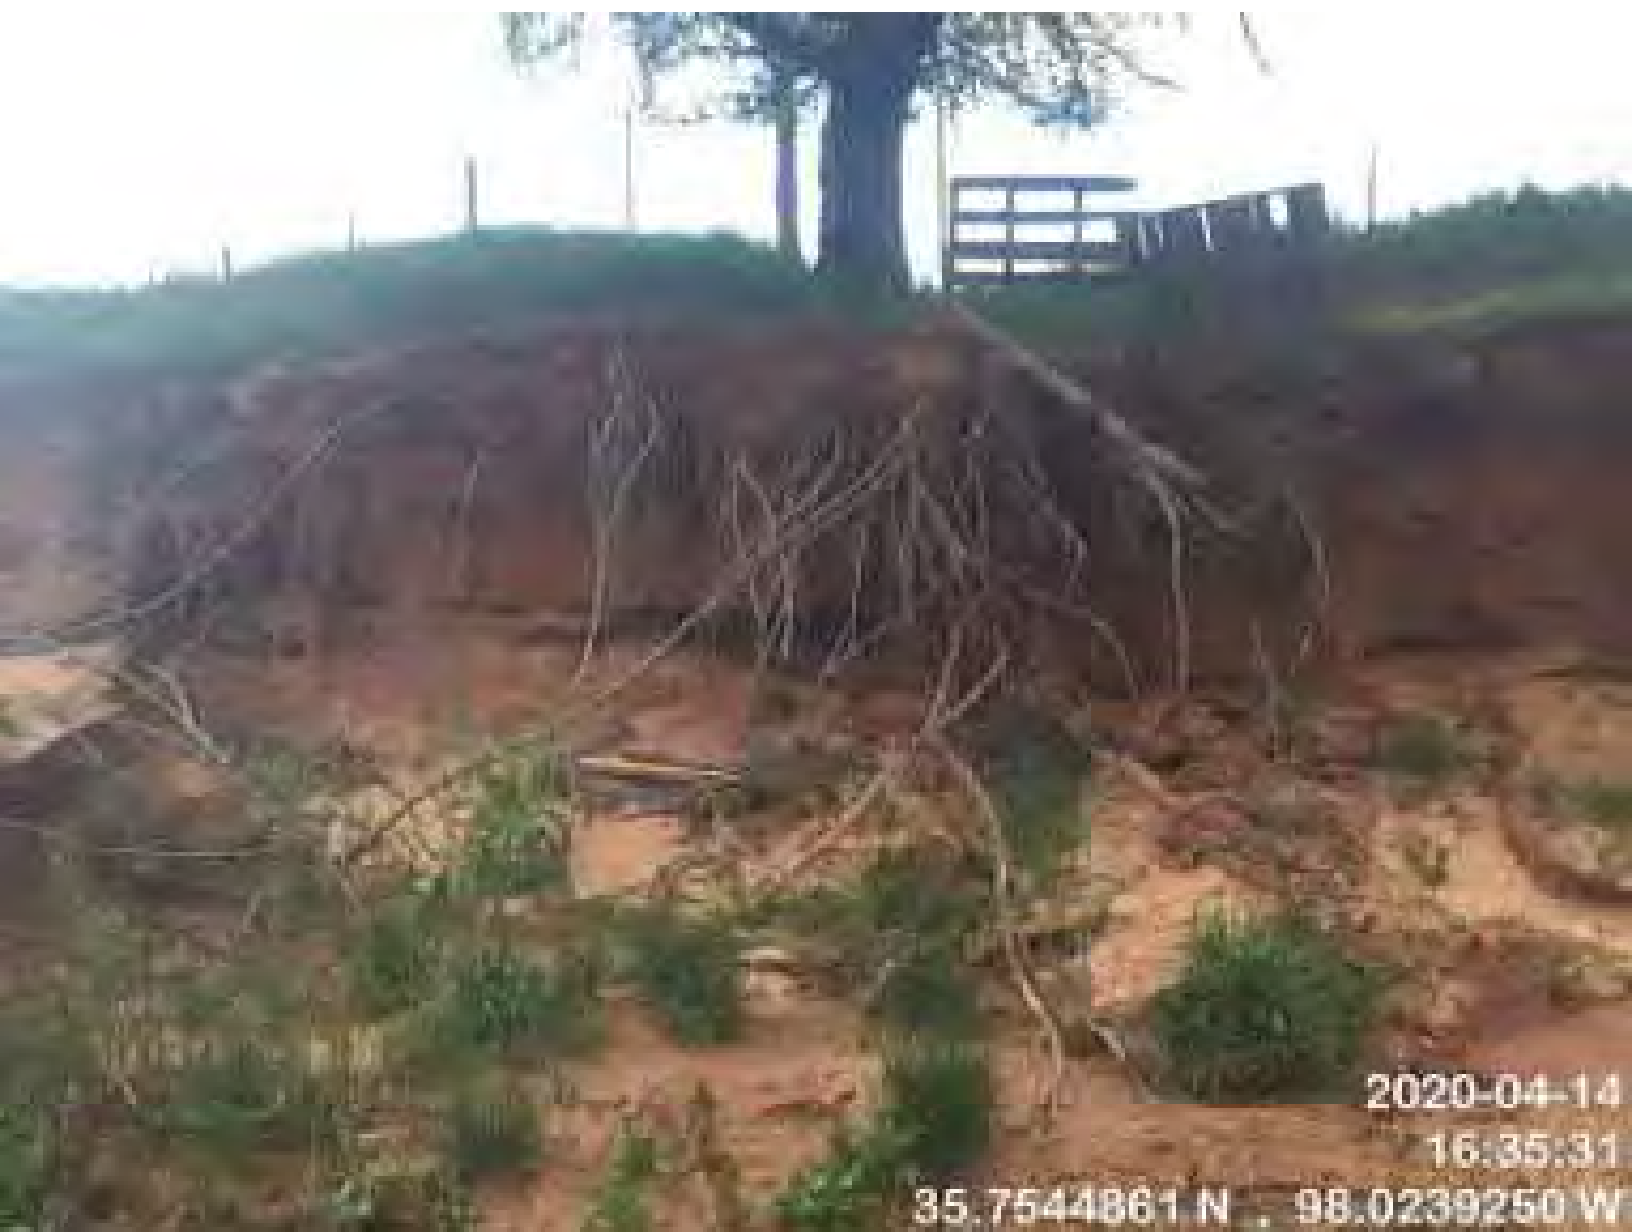
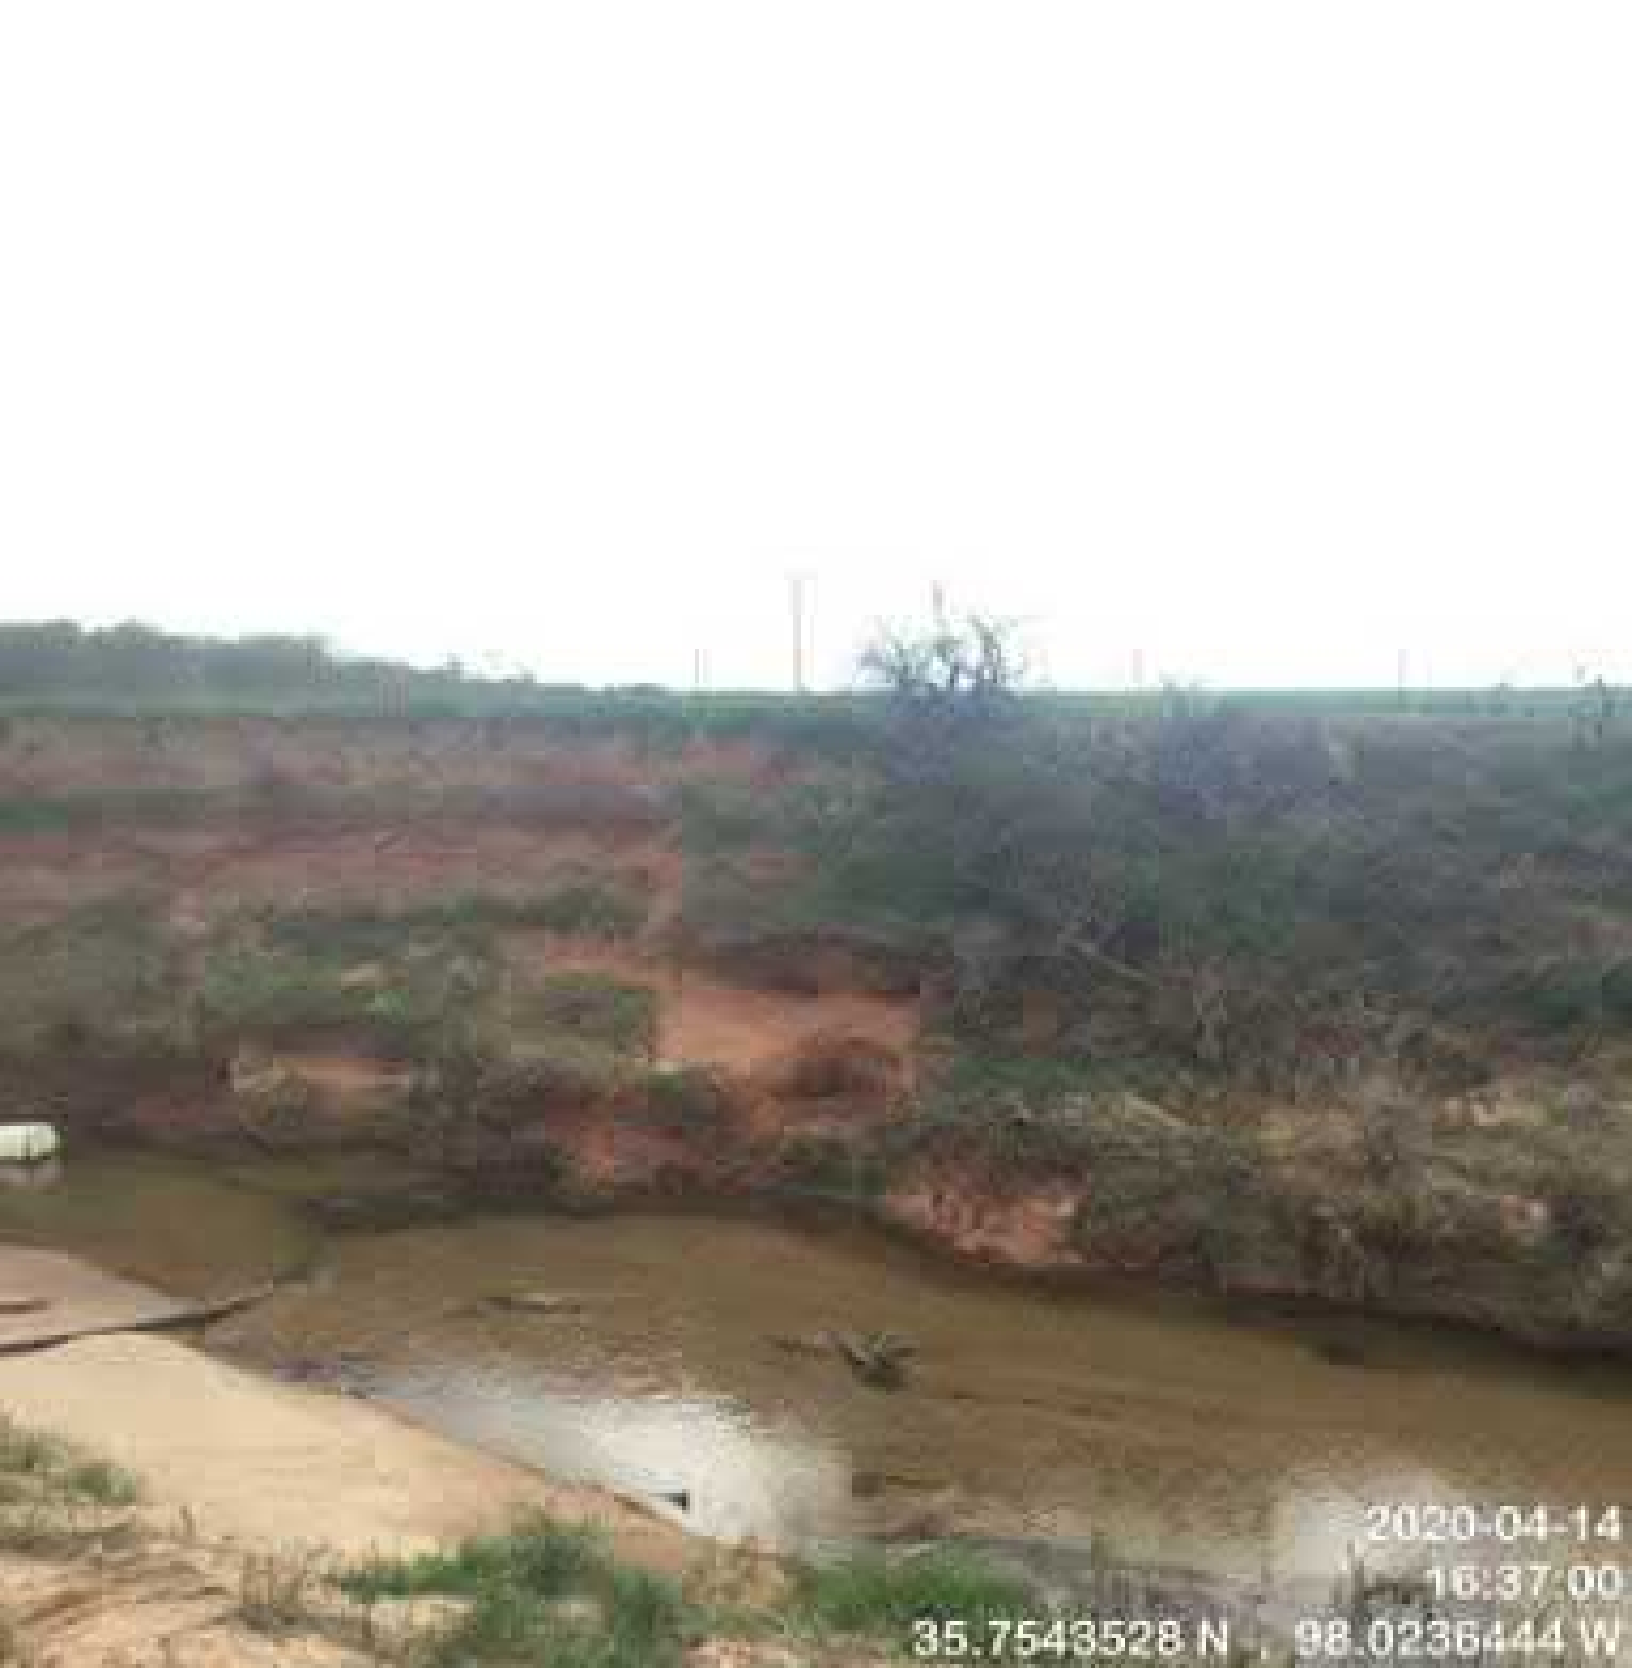
- c. Same site is to be bored by Newfield Exploration for upcoming new pipeline
- 3.) Banks of Winter Creek Tributary (SKI-015) are unstable and slipping into creek. Midship cleared vegetation at creek prior to changing crossing methods to HDD. (FERC Procedures: V.C.2-3.)

- 4.) Soil Compaction (FERC Plan: V.C.1-3.)
 - a. Off-ROW Penetrometer reading: Around 160 psi in multiple locations.
 - b. In-ROW Penetrometer reading: 300 psi limit exceeded in every on-ROW location.

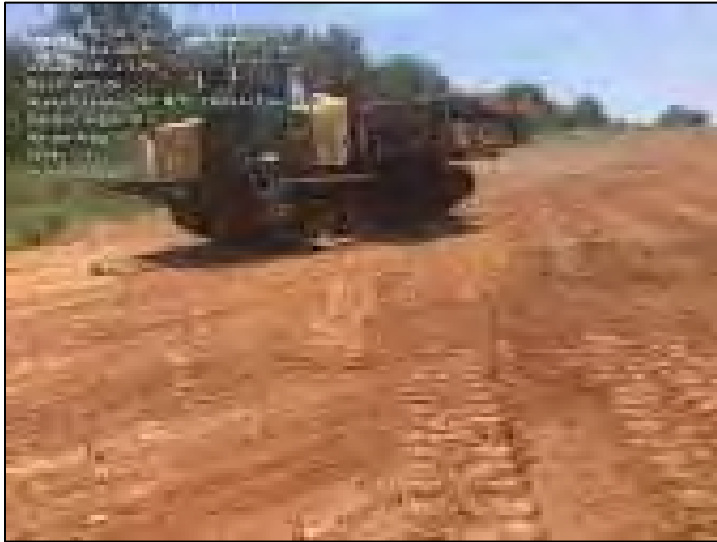
Maintenance work near MP VE8.1 on 08/04/20.

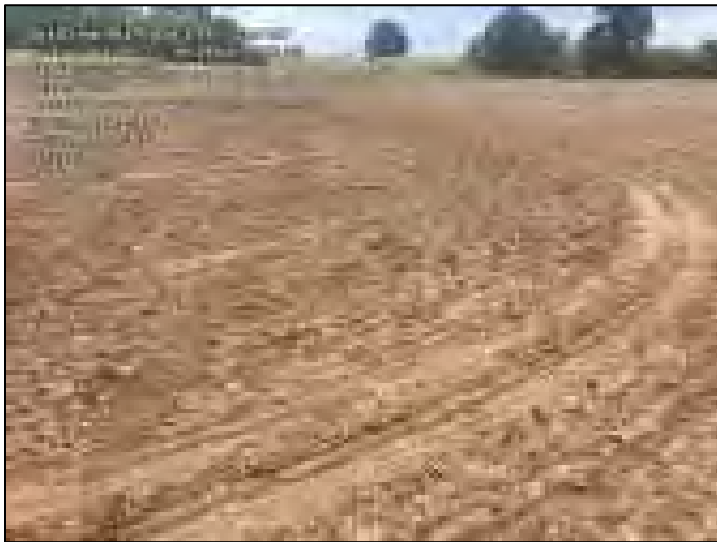
Maintenance work near MP 116.3 on 08/05/20.

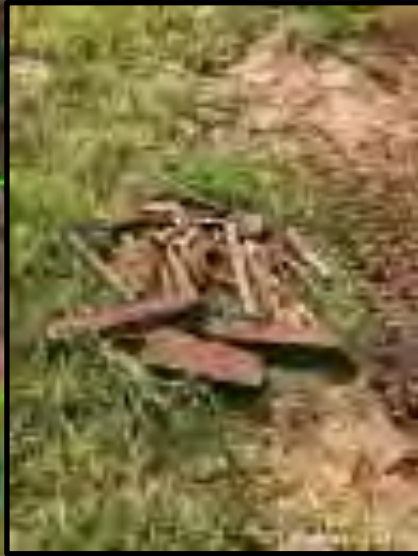
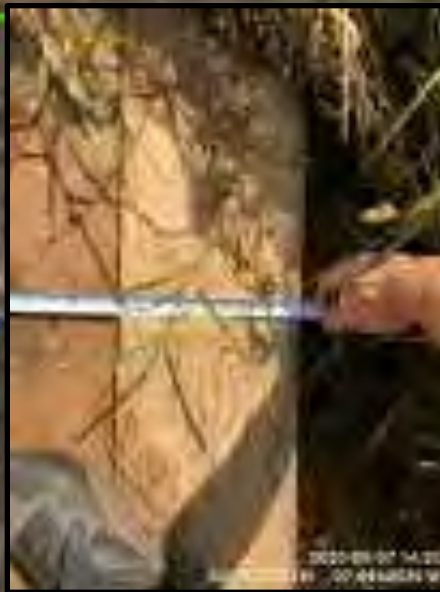
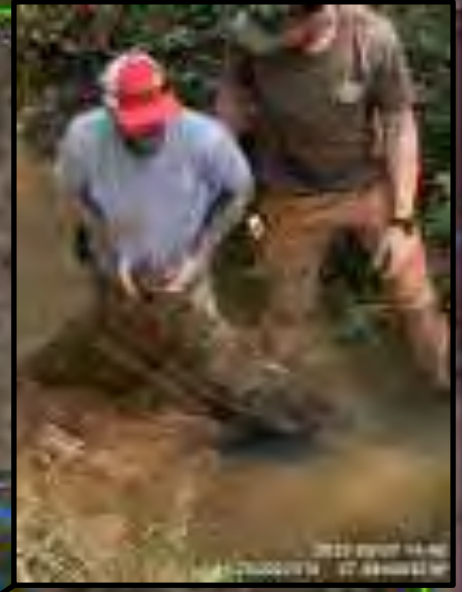
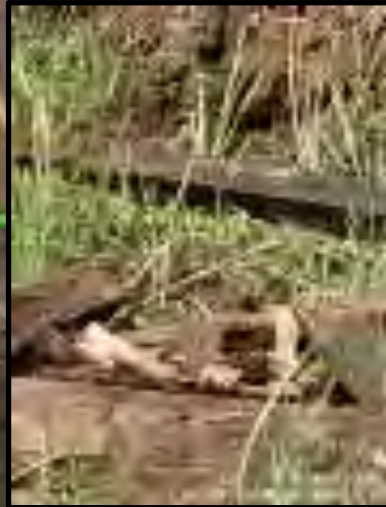
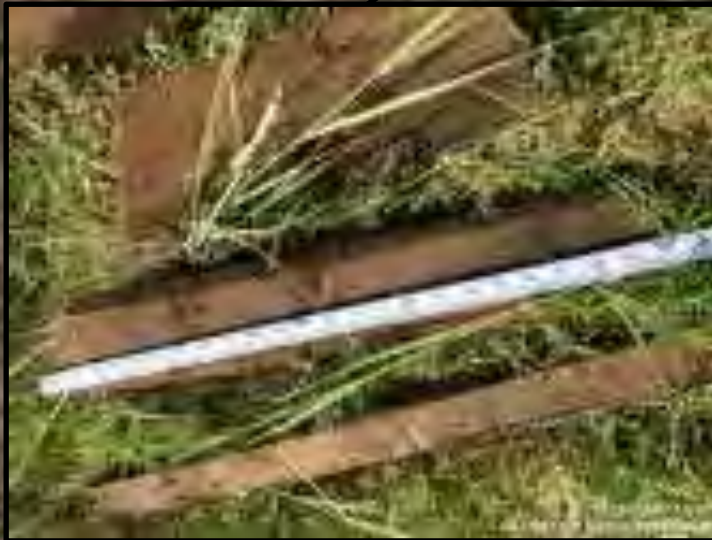
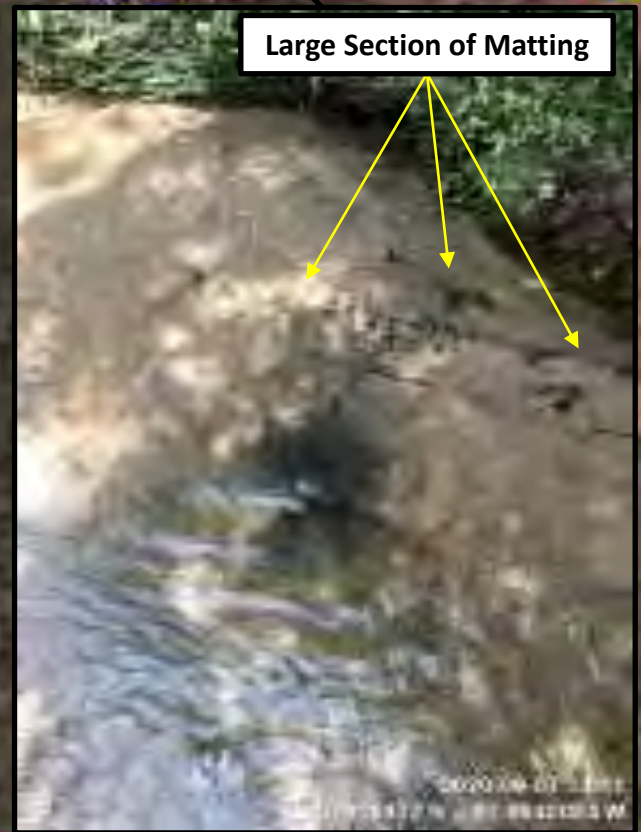
September 7, 2020 Photo Map Prepared for Mark Morris

Large Section of Matting

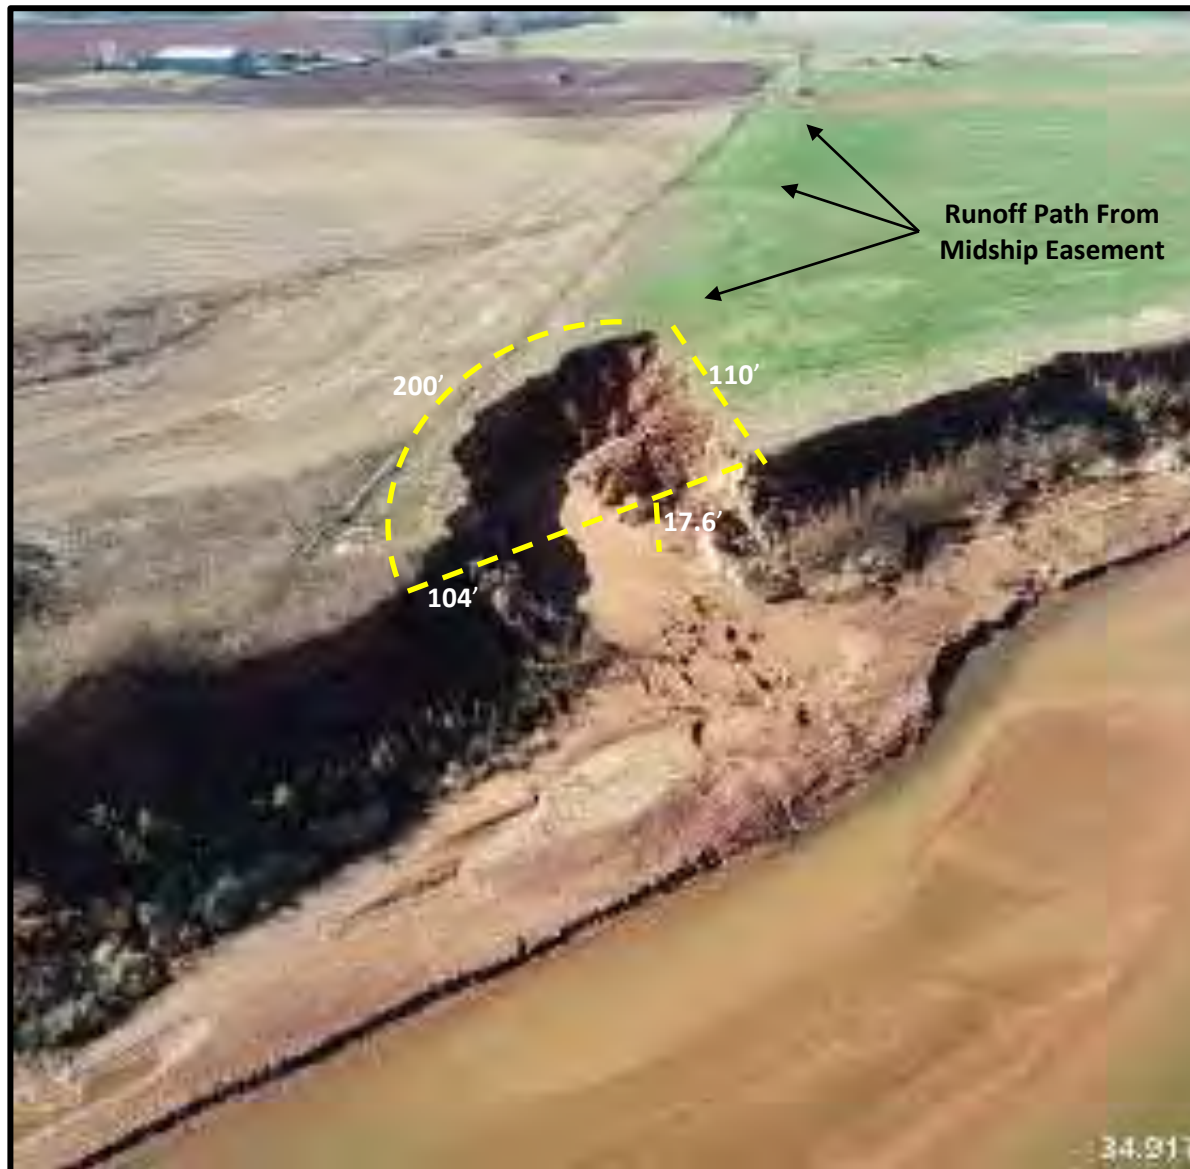
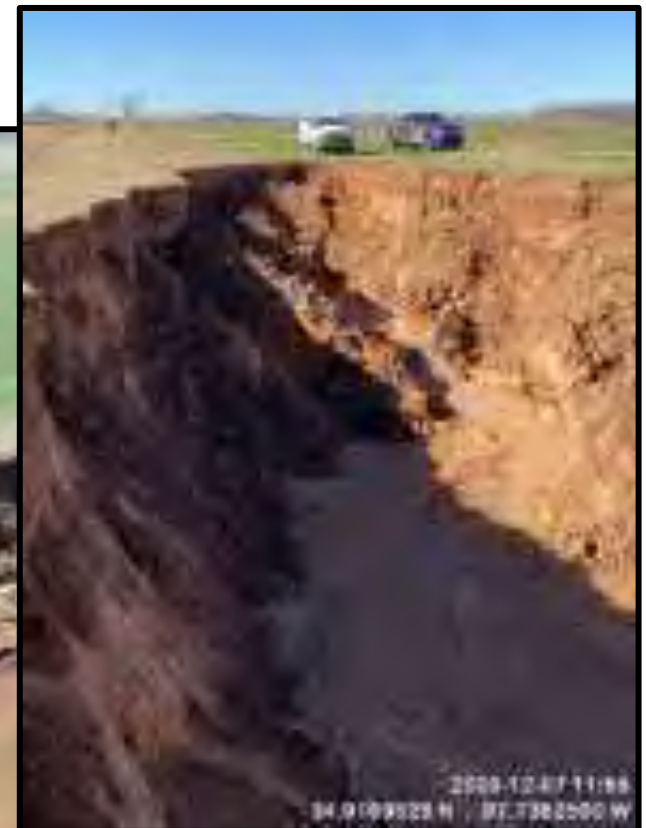
JAMES MCELVANY. TRACT GR-0310.000 (BANK EROSION ON ADJACENT OFF-LINE PROPERTY)

Approximately 3,000 Cubic Yards of Soil Will Be Needed to Fill Riverbank Erosion. Additional Stabilization and Drainage Measures May Be Needed to Avoid Erosion After Restoration.
