Robert Squires - Squires Consulting LLC
Landowner Advocate

Opening Statement for May 5, 2021 Subcommittee on Civil Rights and Civil Liberties Hearing:
“Pipelines Over People (Part II): Midship Pipeline’s Disregard for Landowners in Its Pathway”

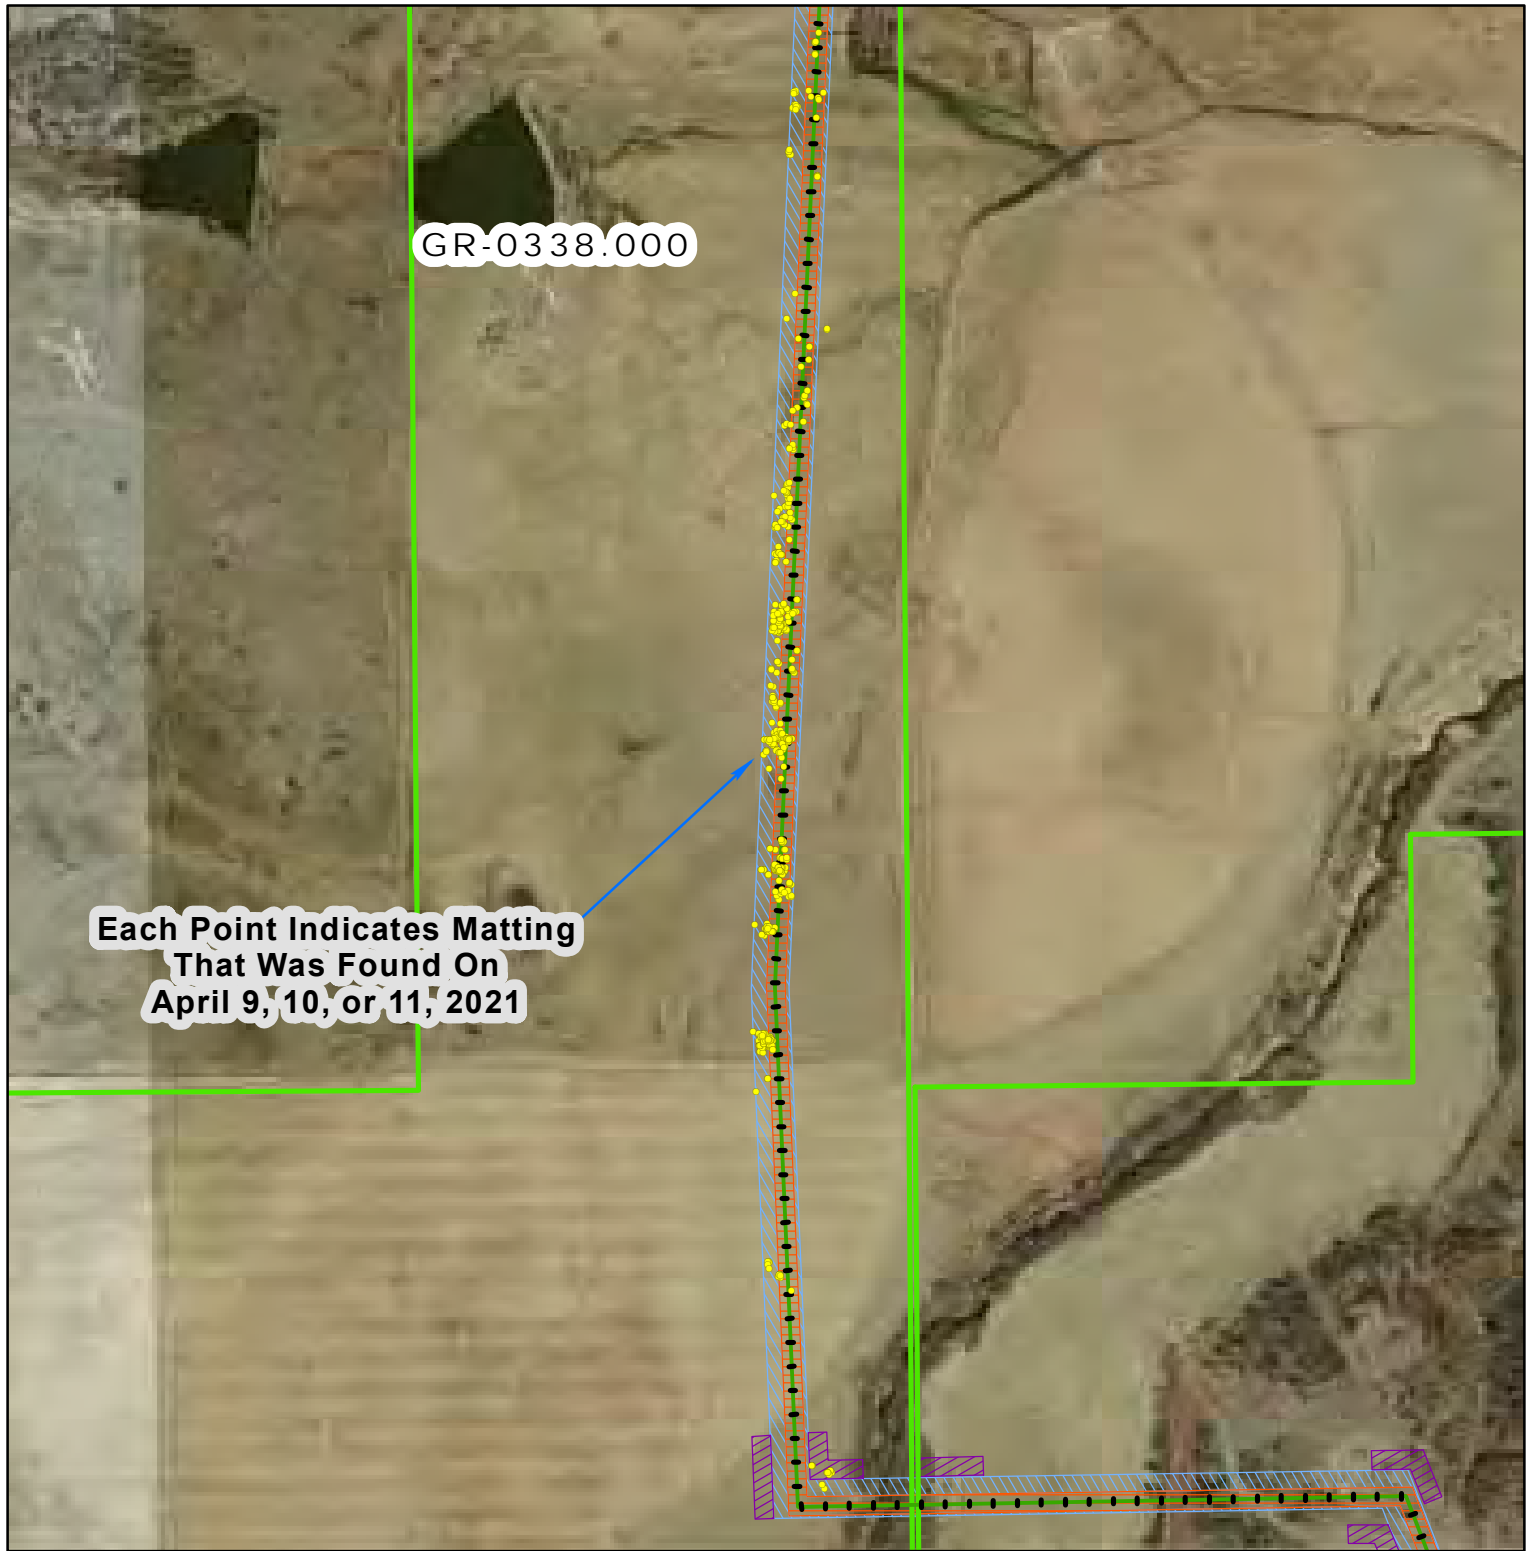
April 9 & 10 Matting Location Map Prepared For Sandy Creek Farms, Inc

7. By CLC's estimation, approximately 0.3% of the Midship easement on tract GR-0338.000 has been checked for matting to date.

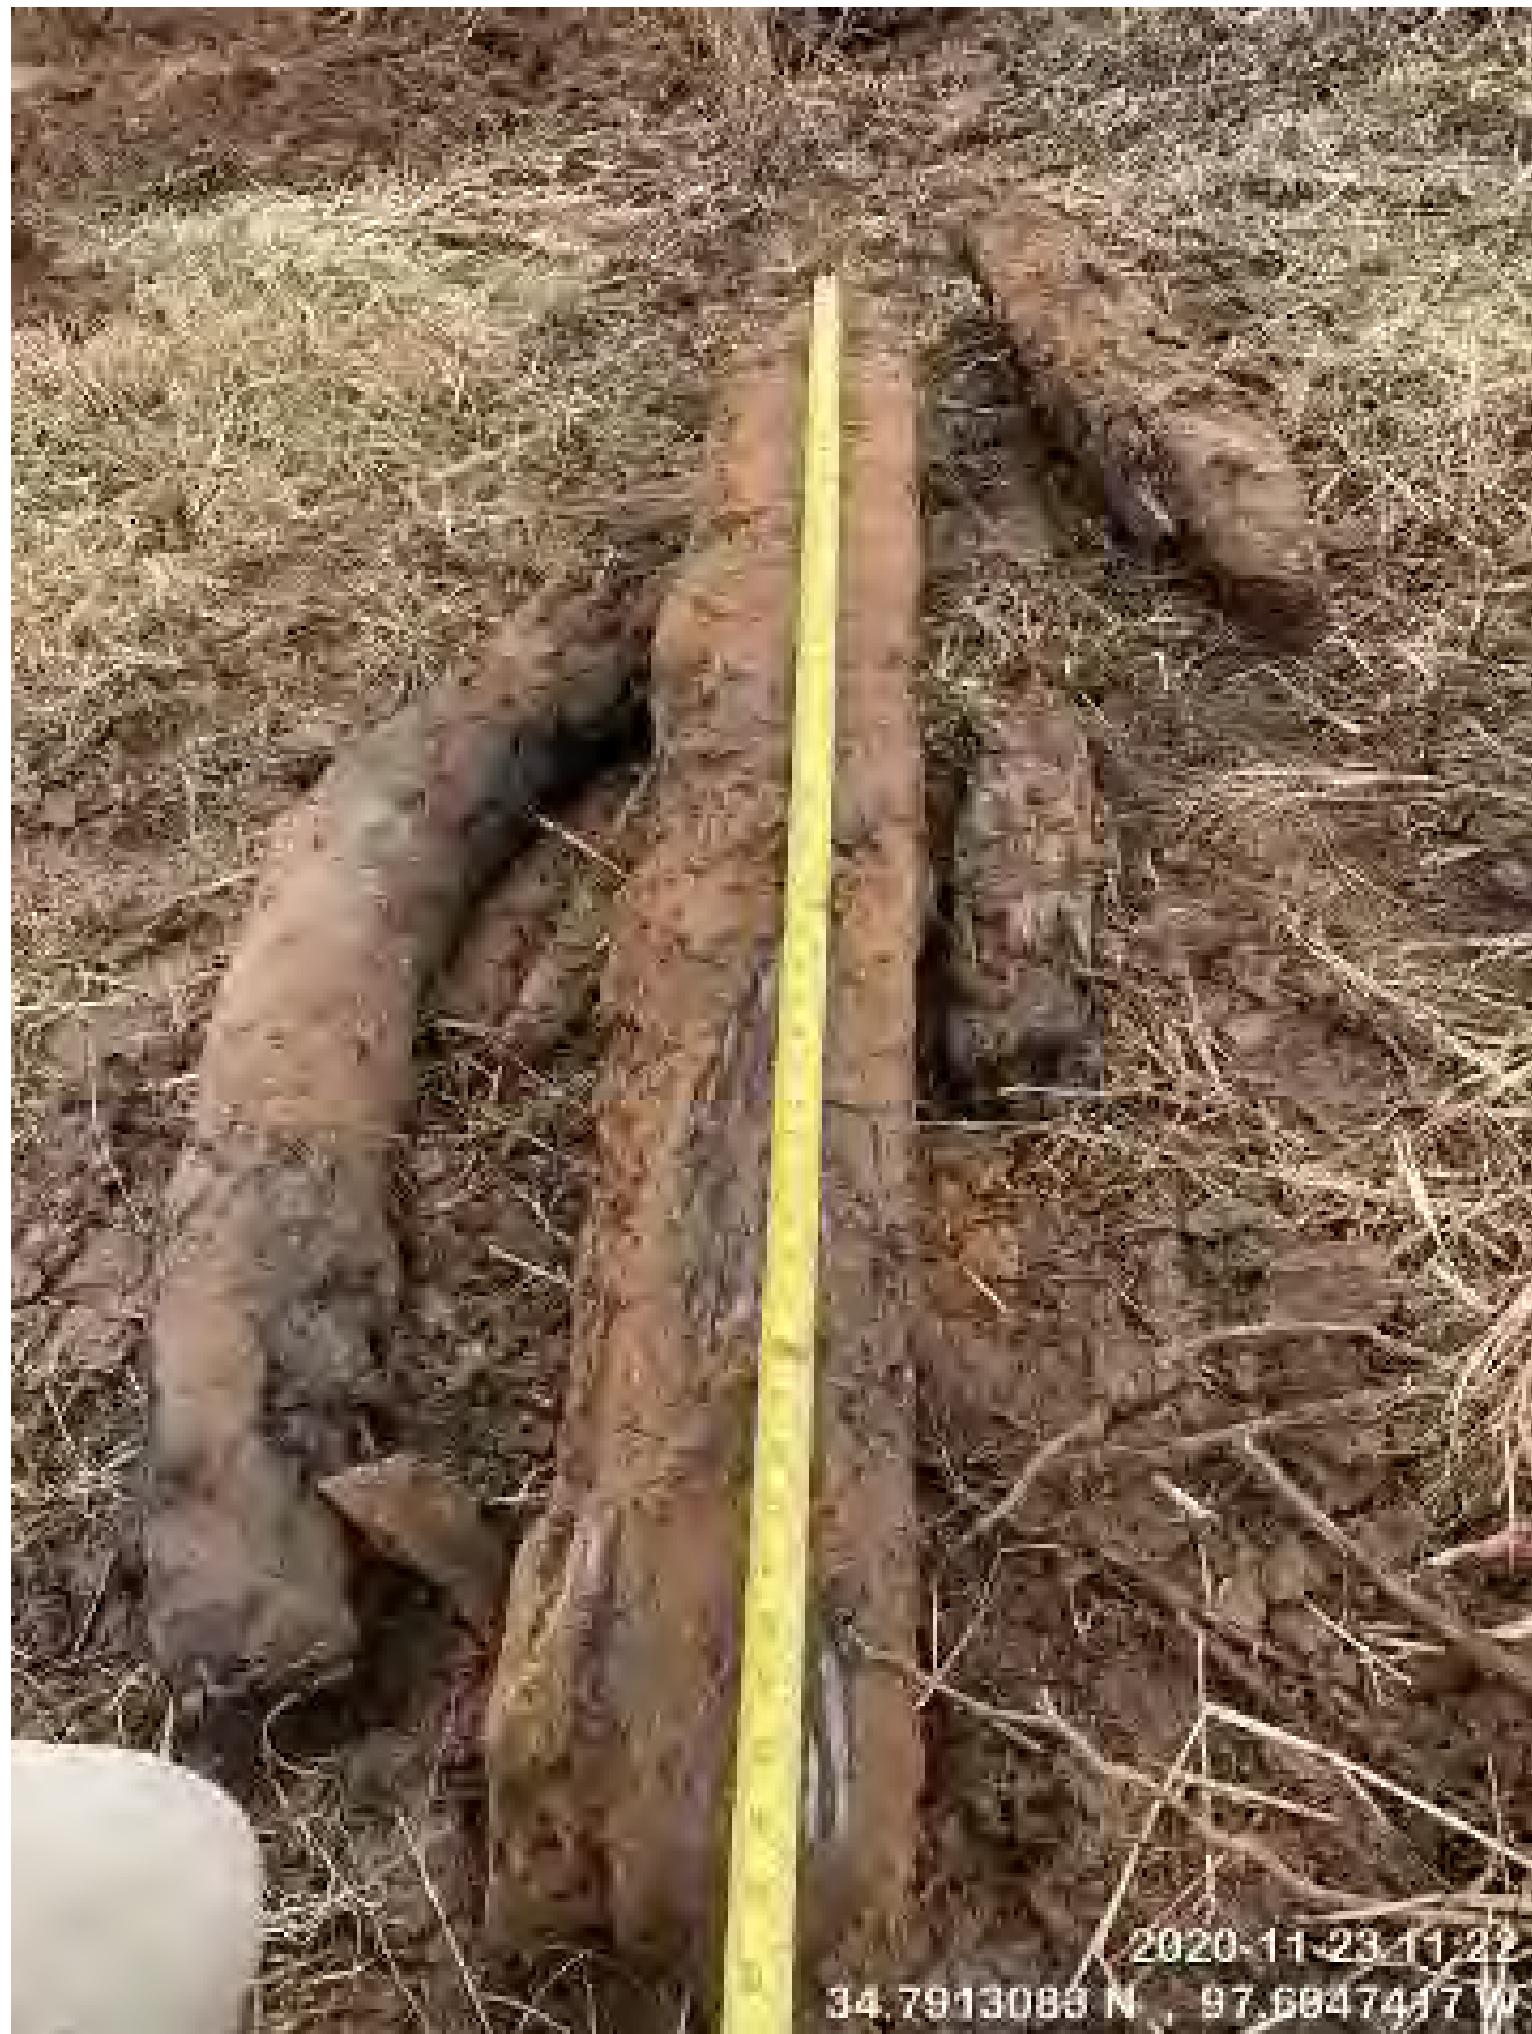
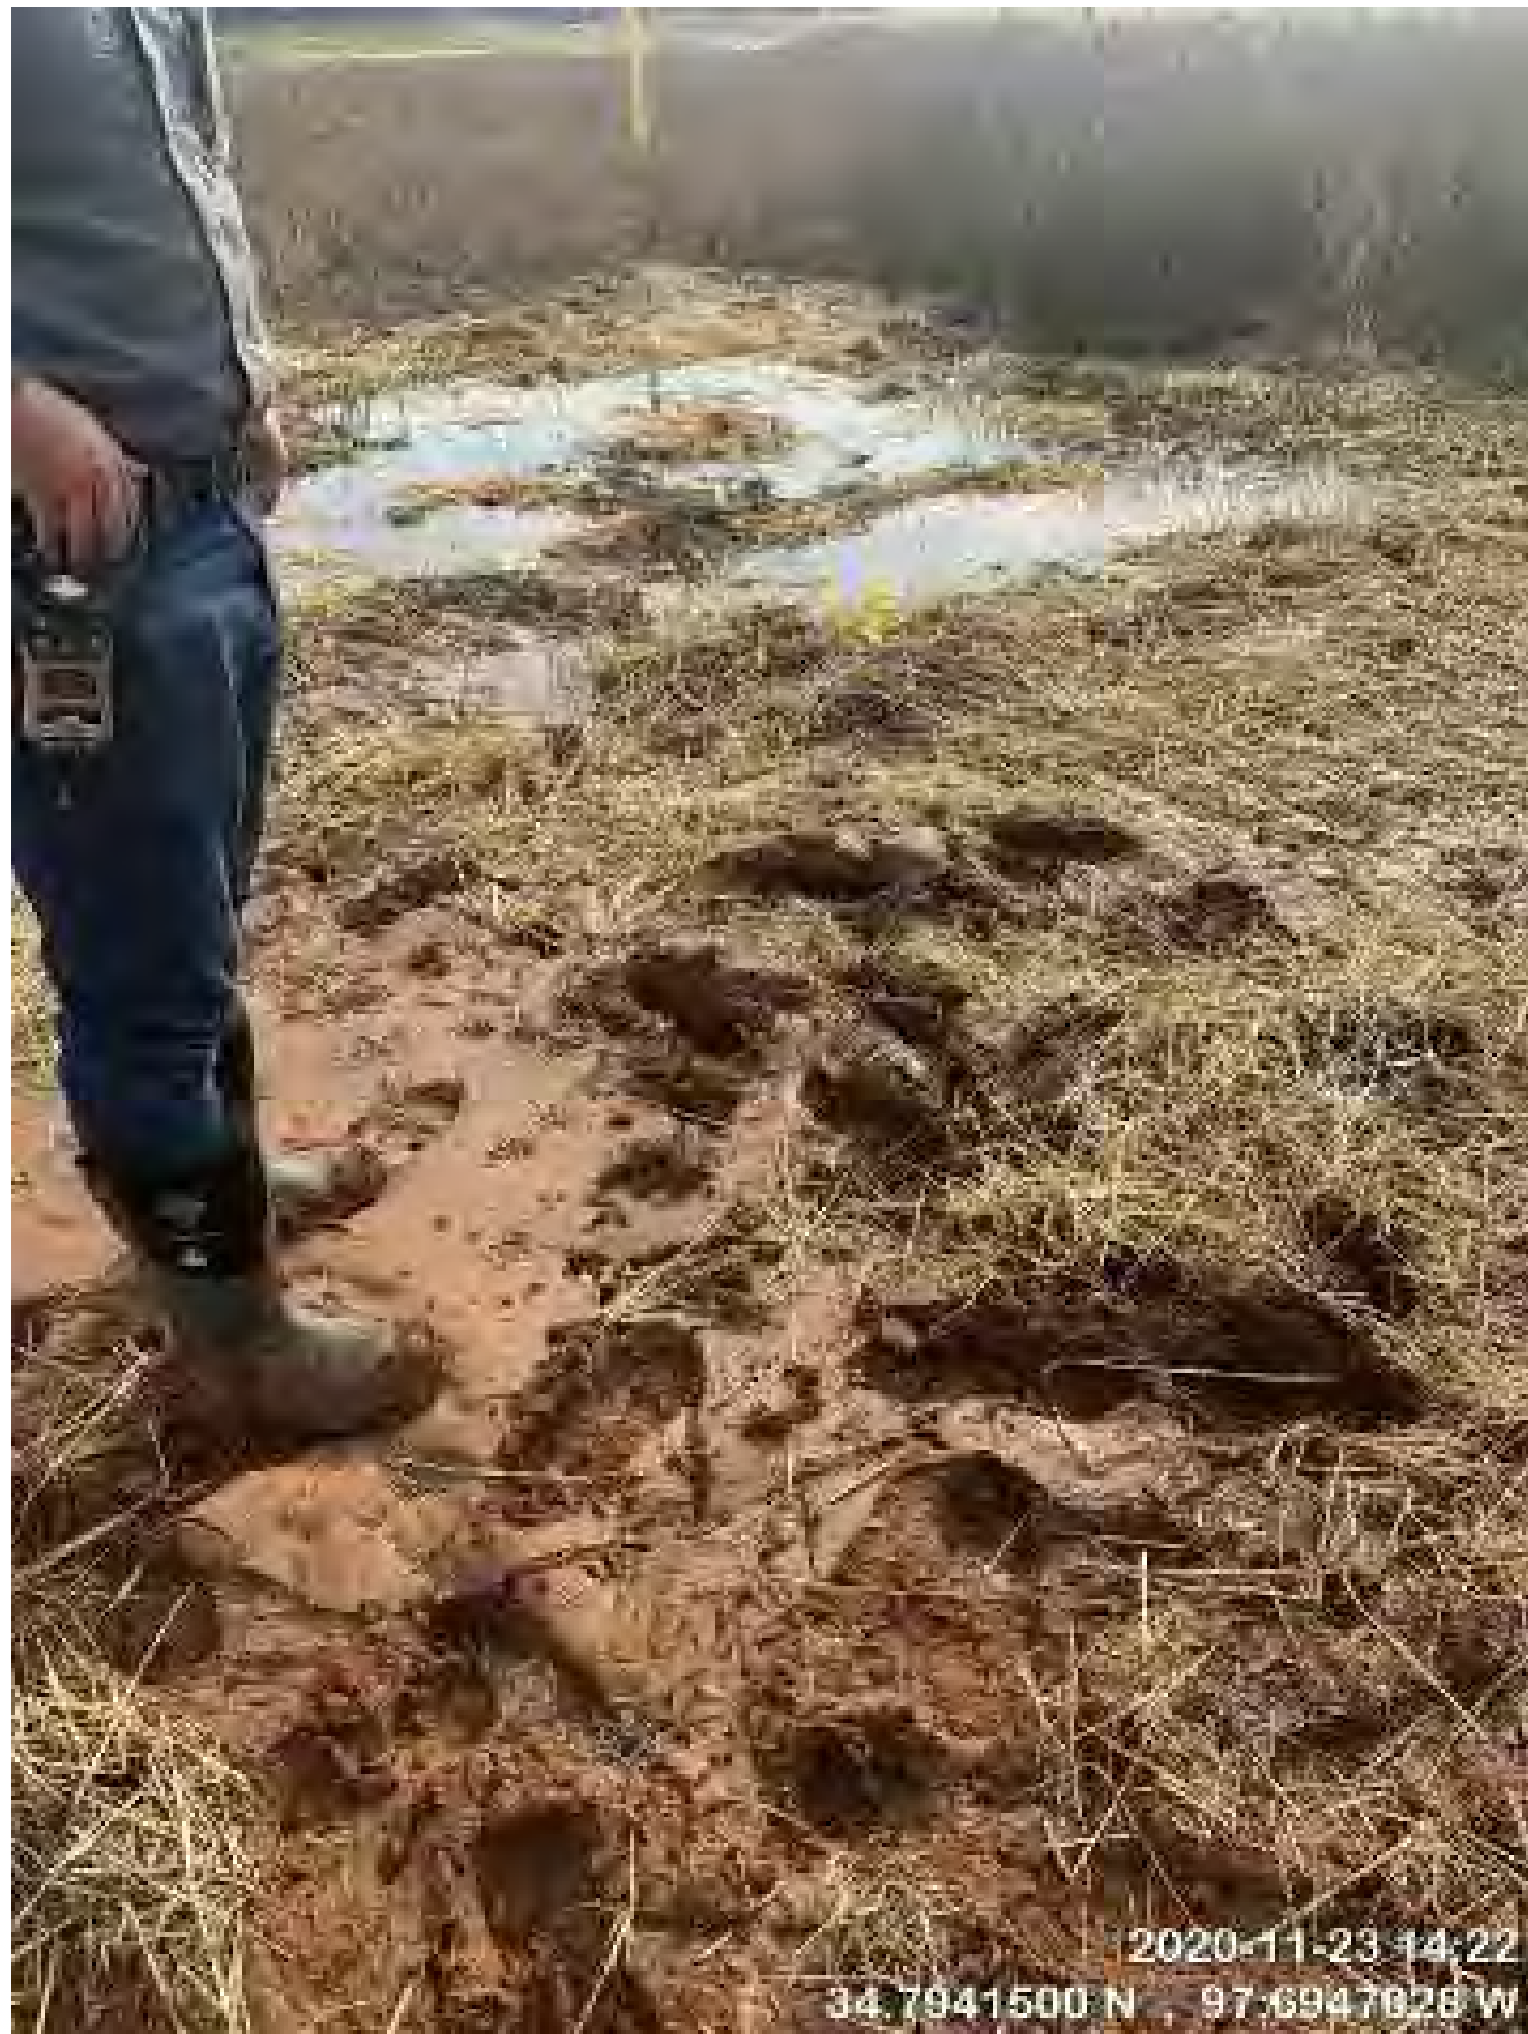
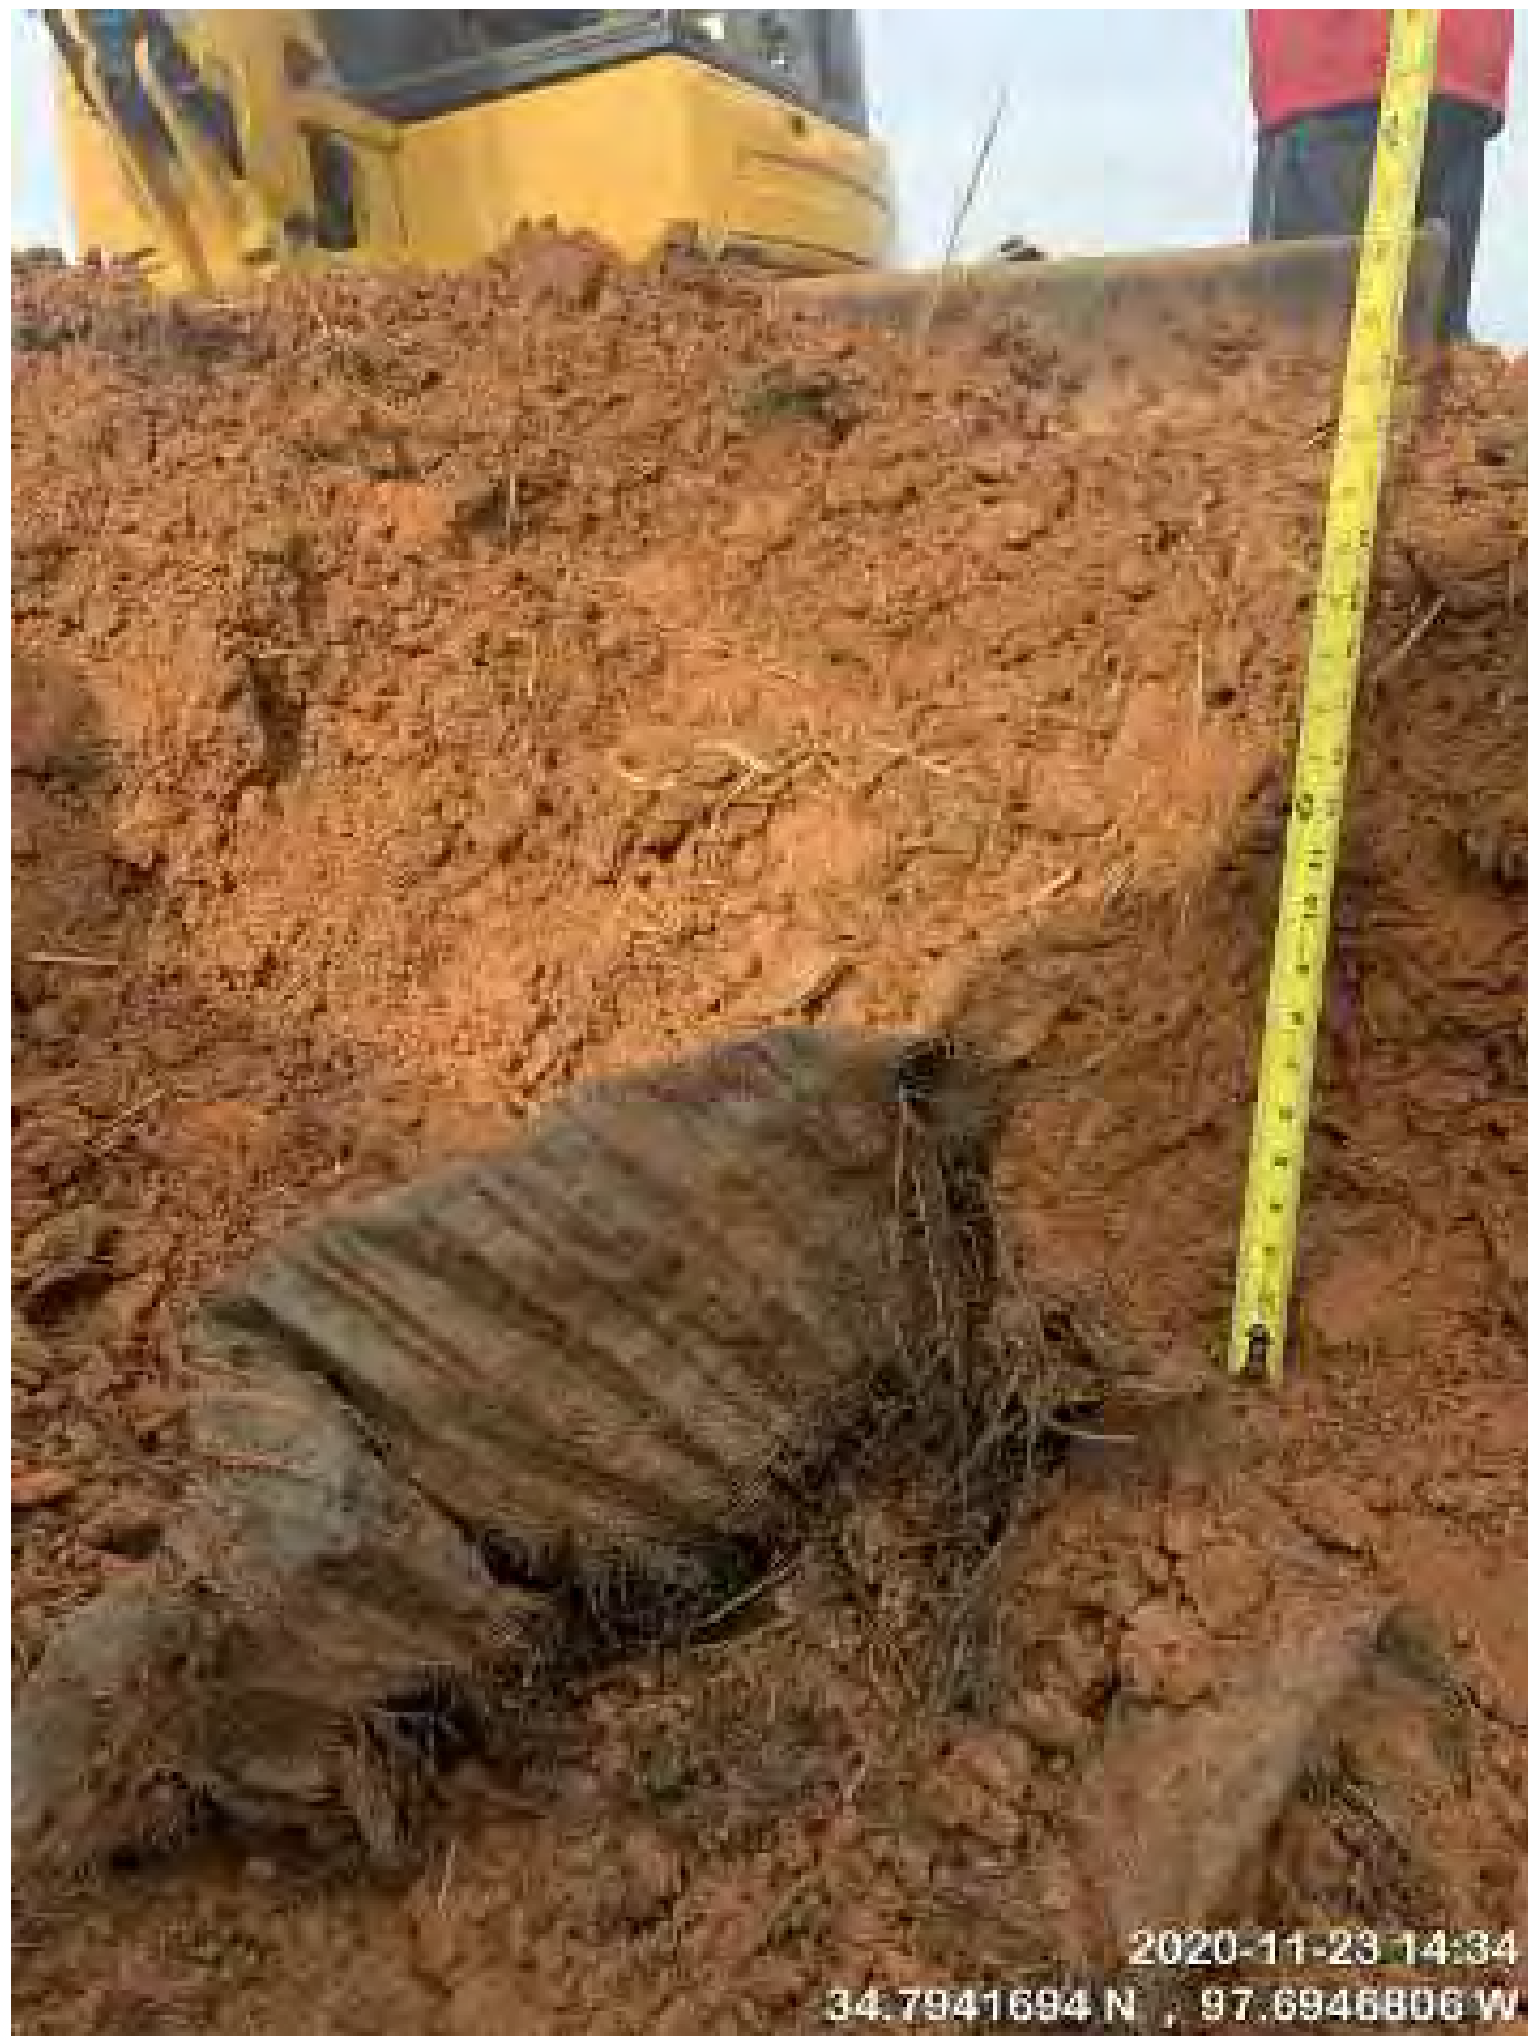
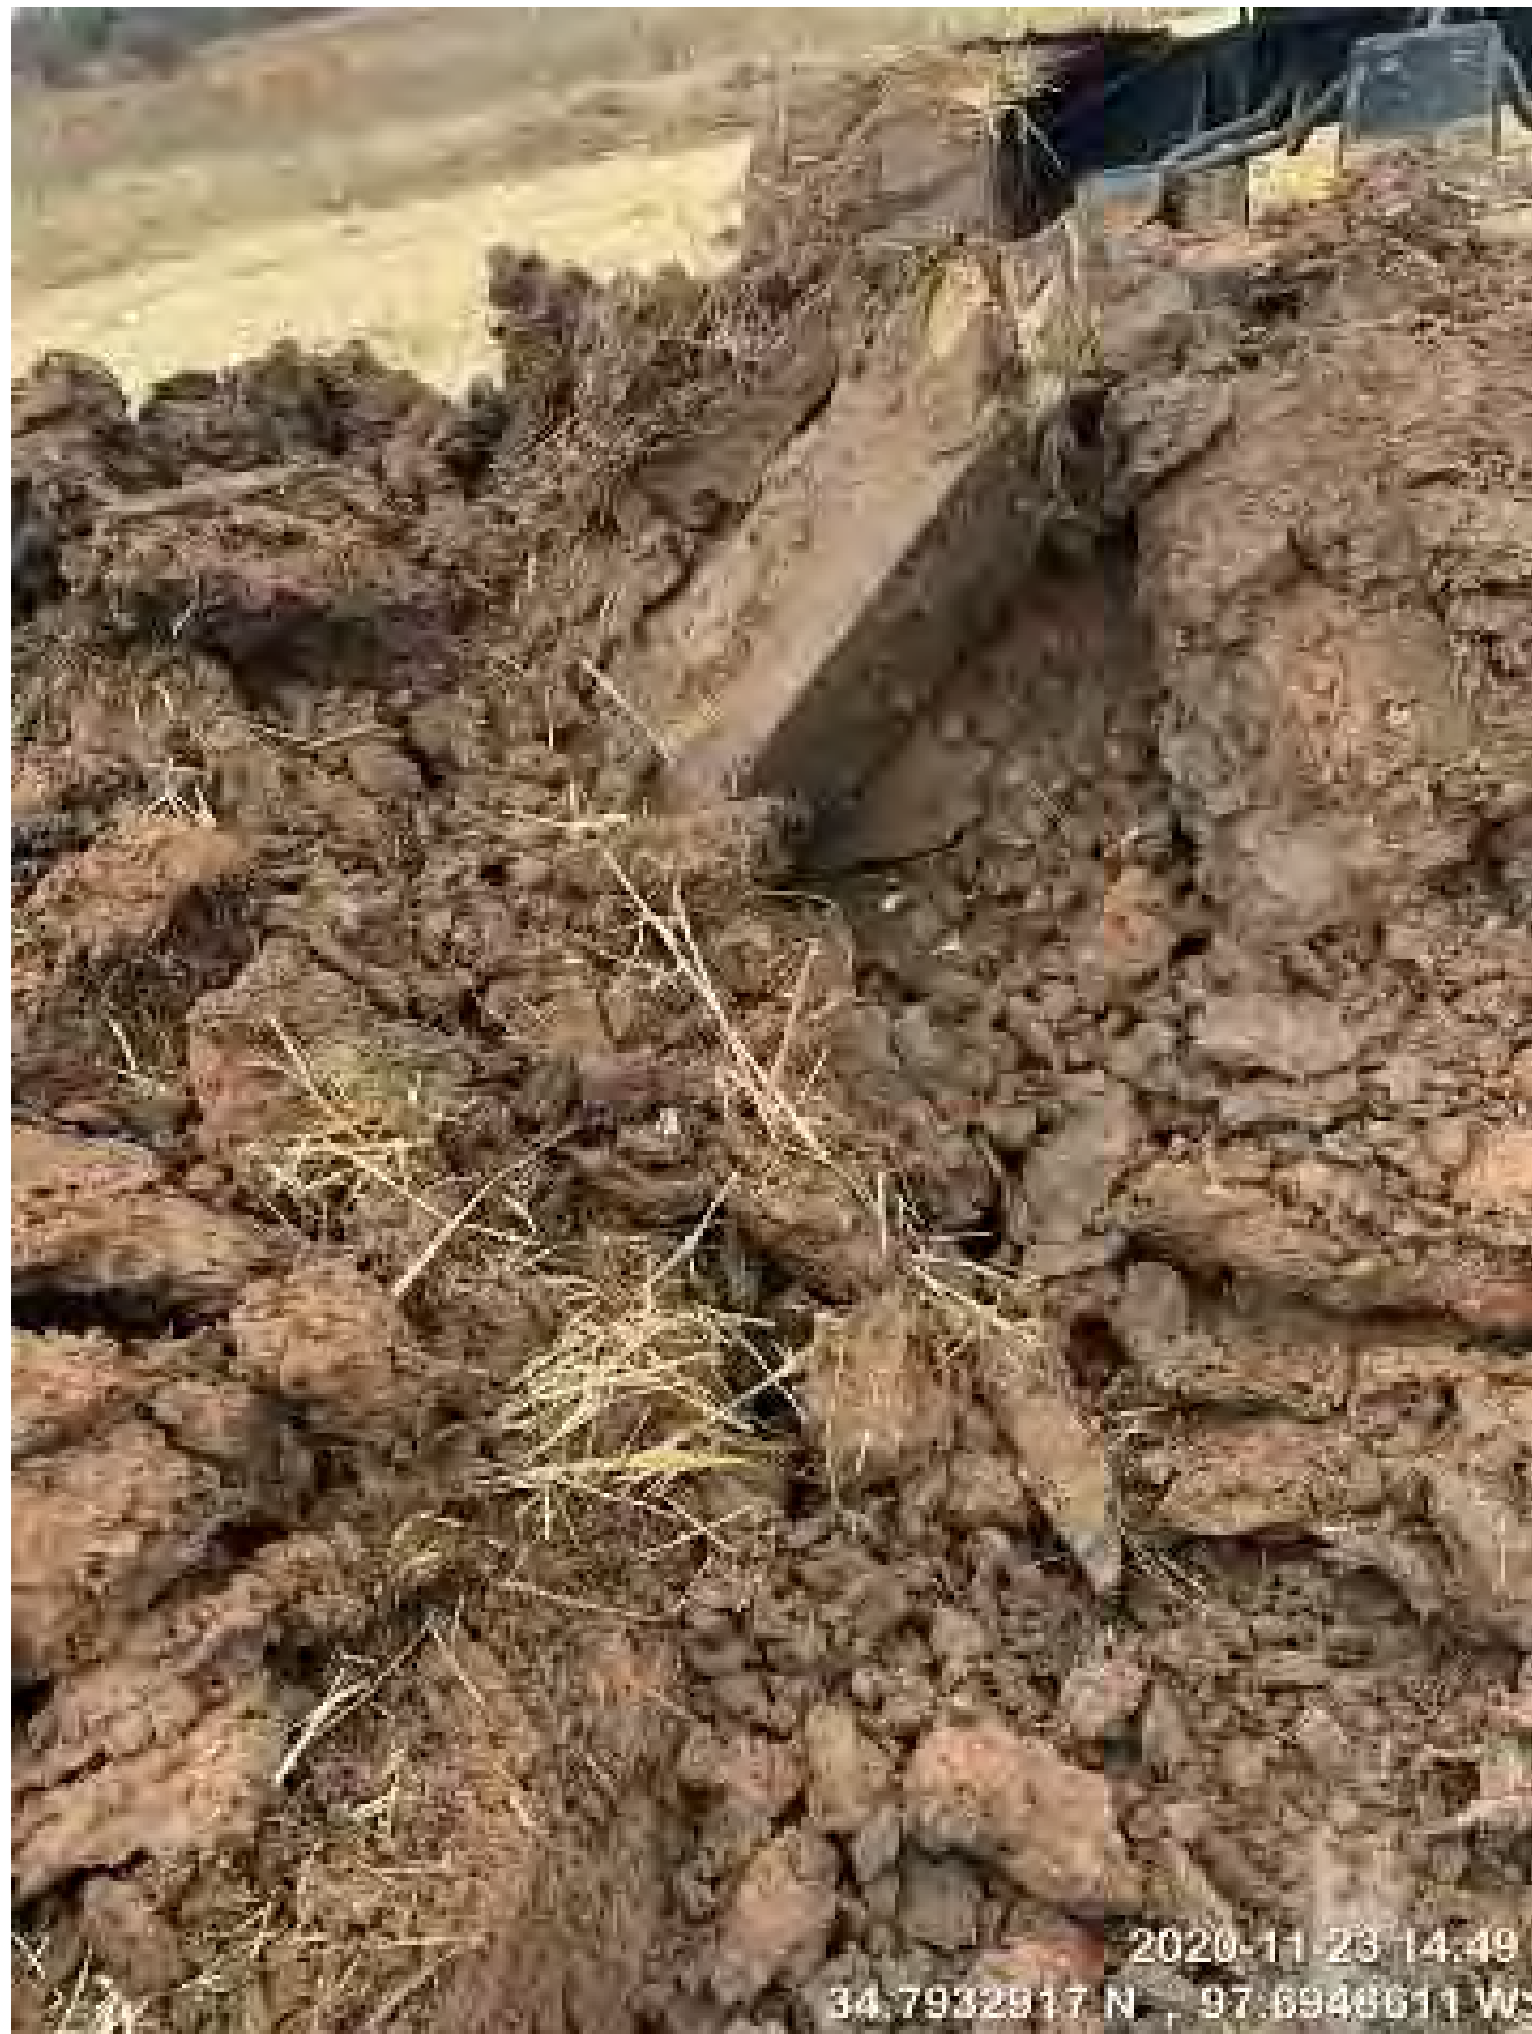
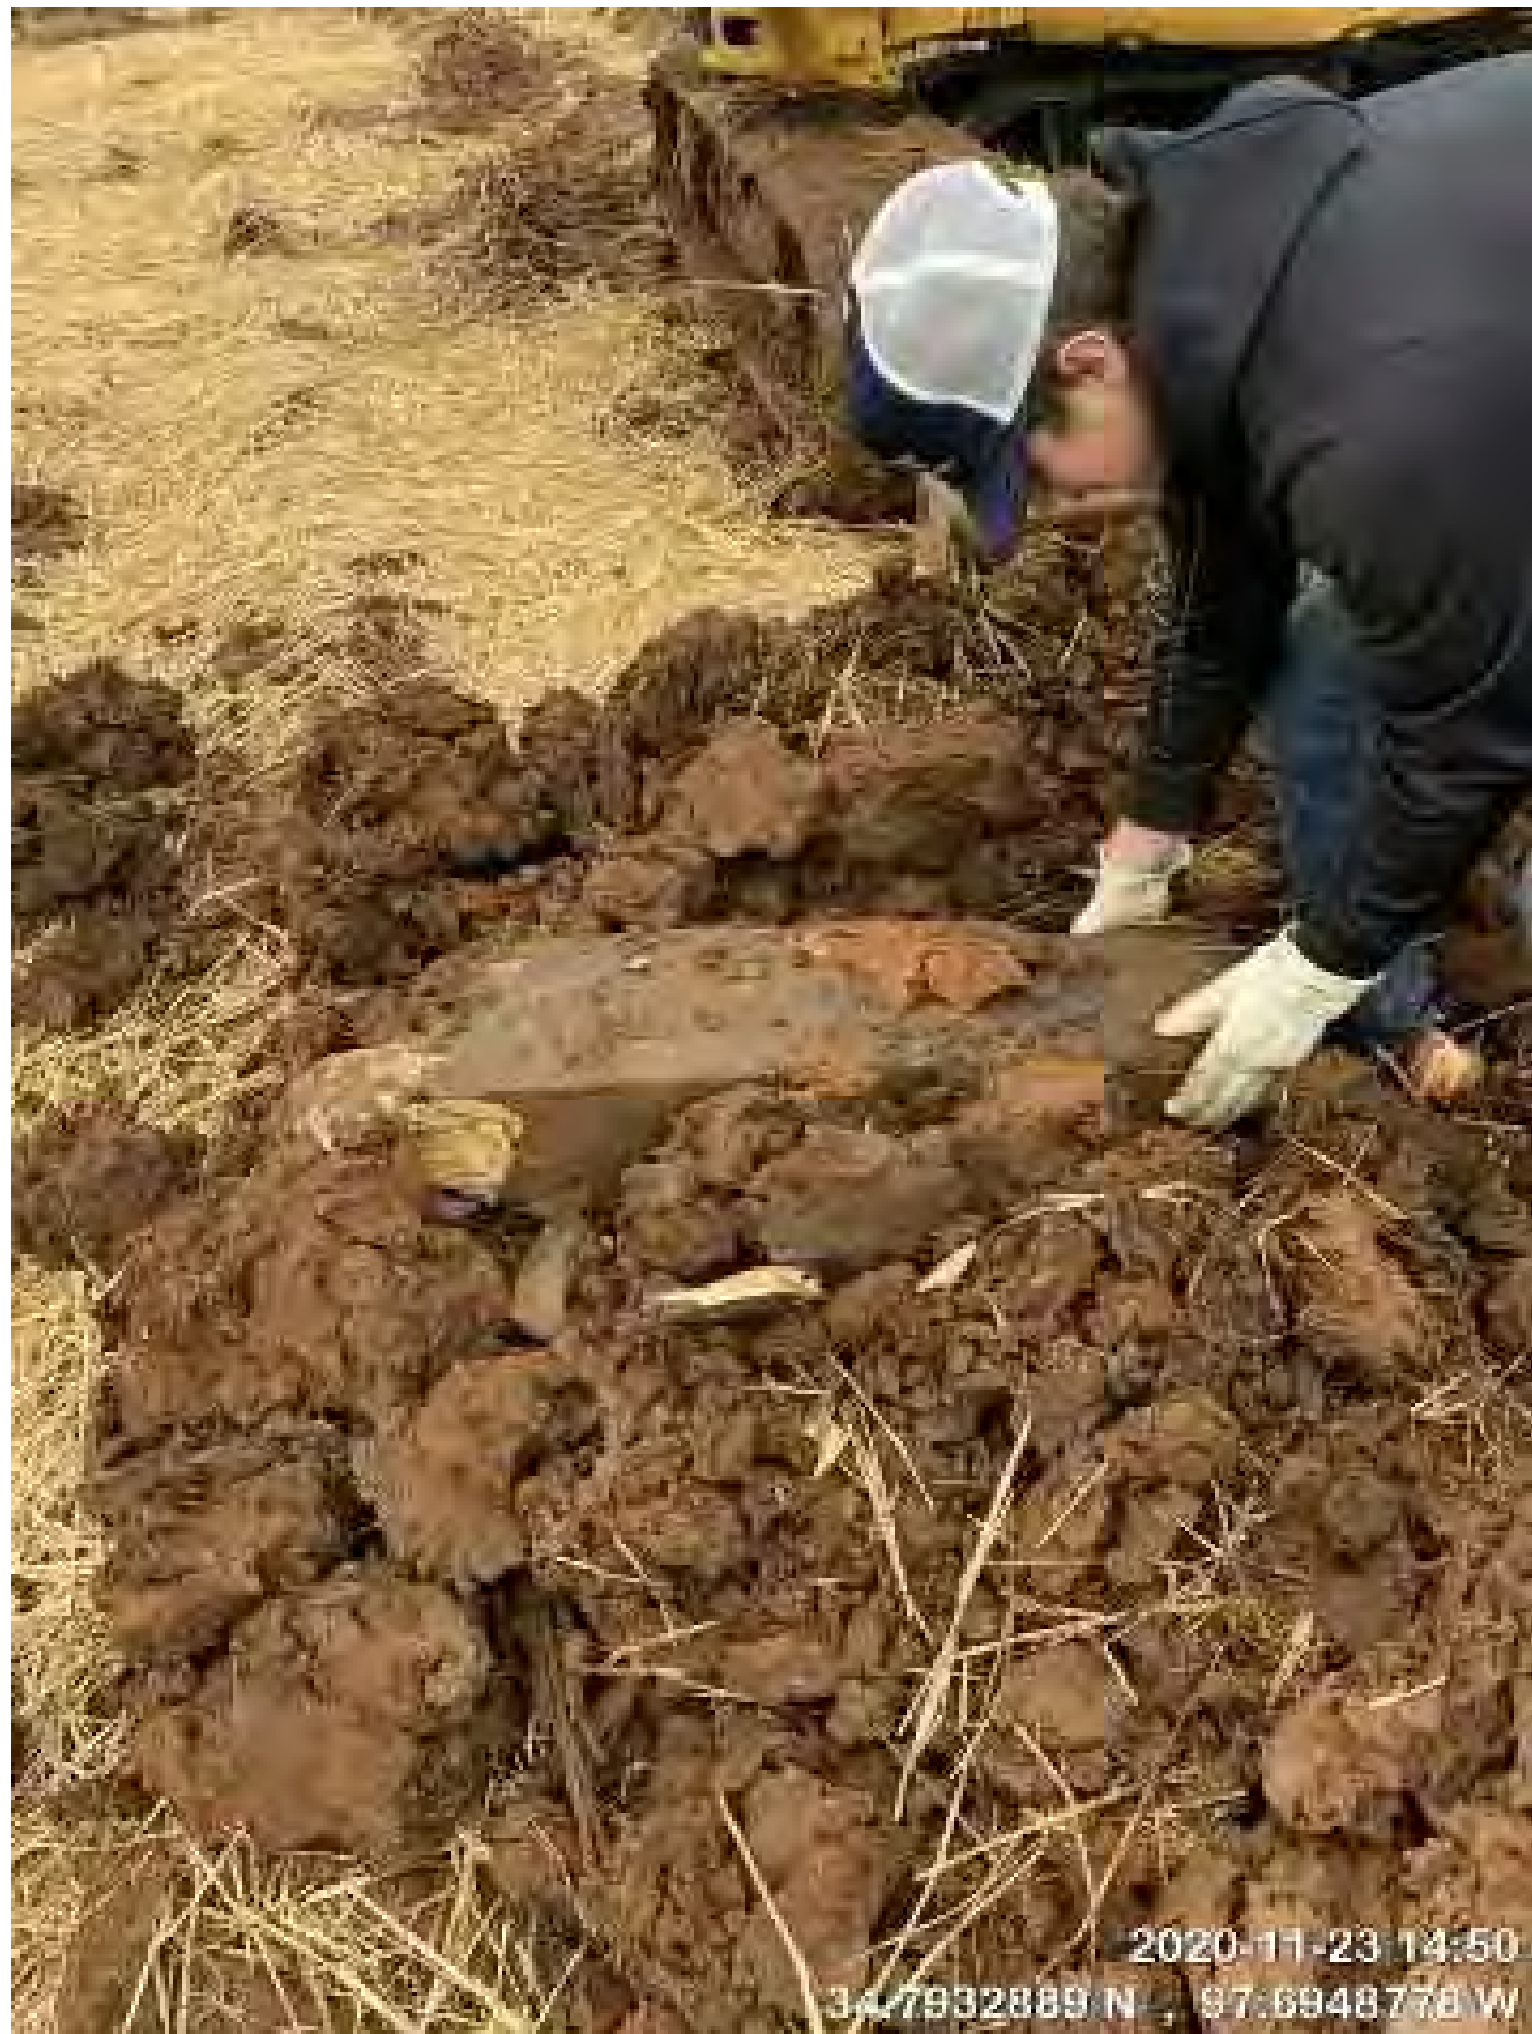
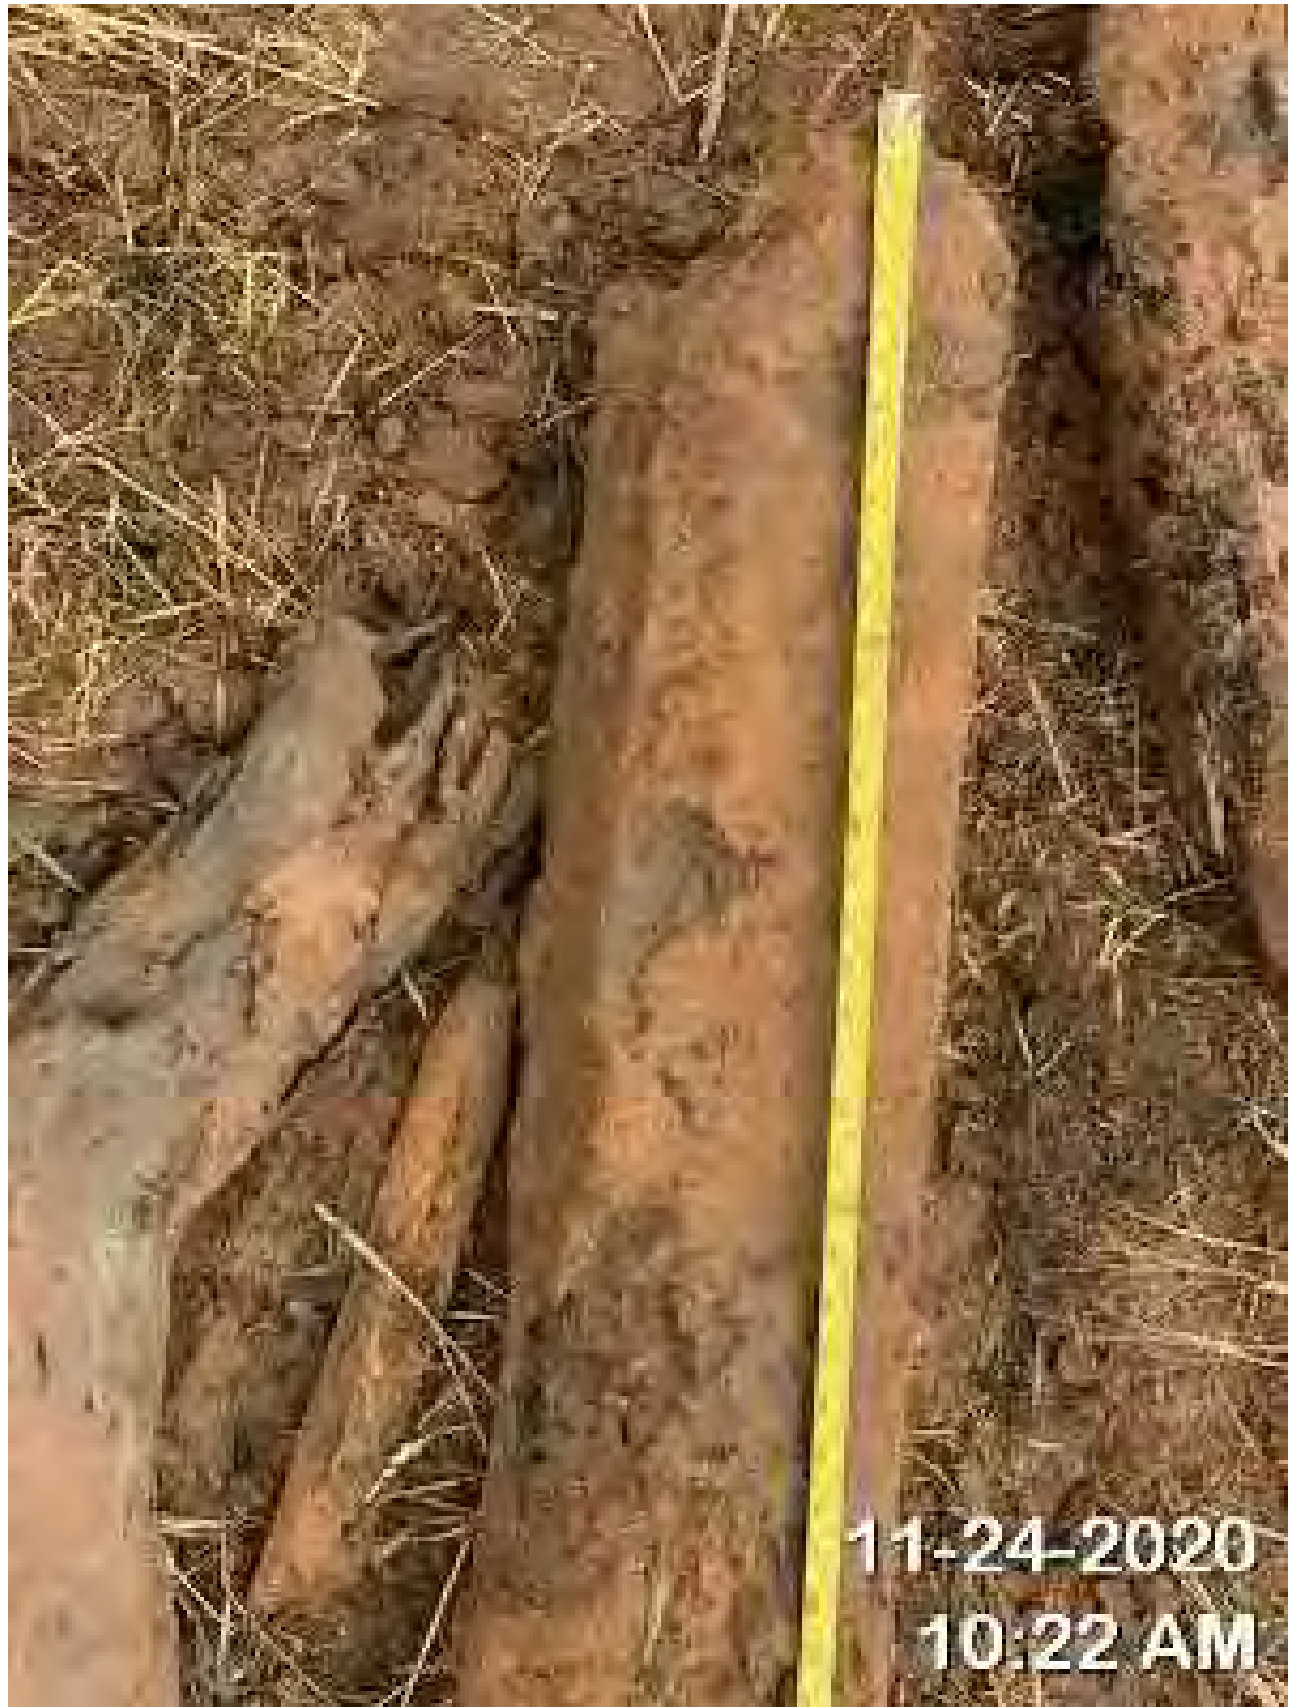
Attachment 10

November 2020 Mark Morris Construction Debris
(After Midship Stated All Debris Had Been Removed)

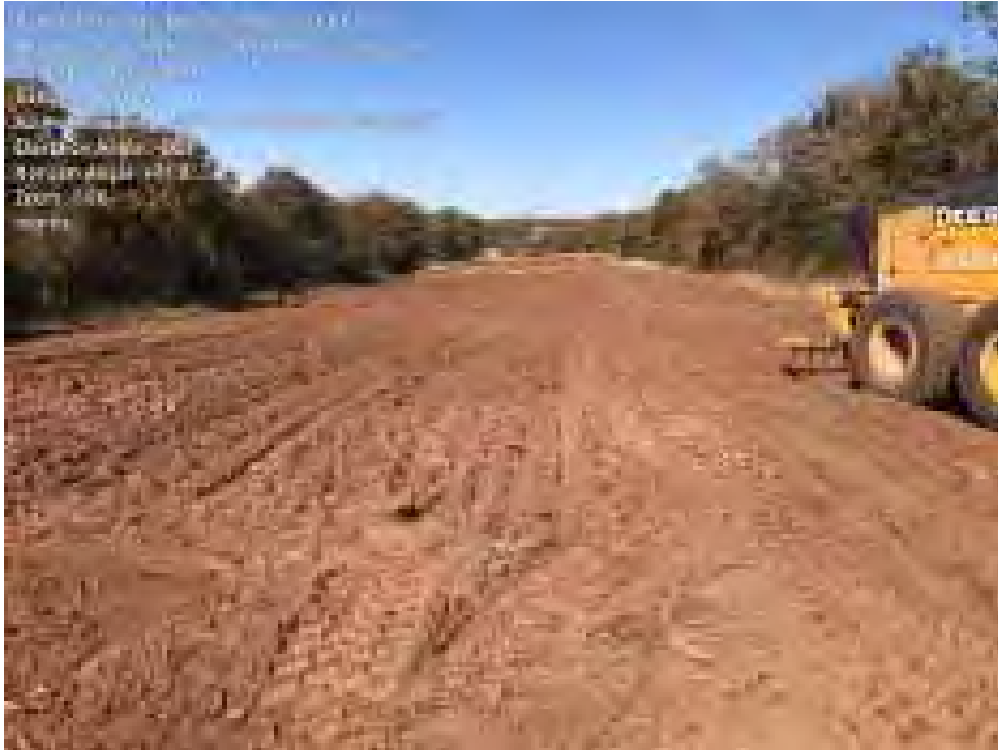
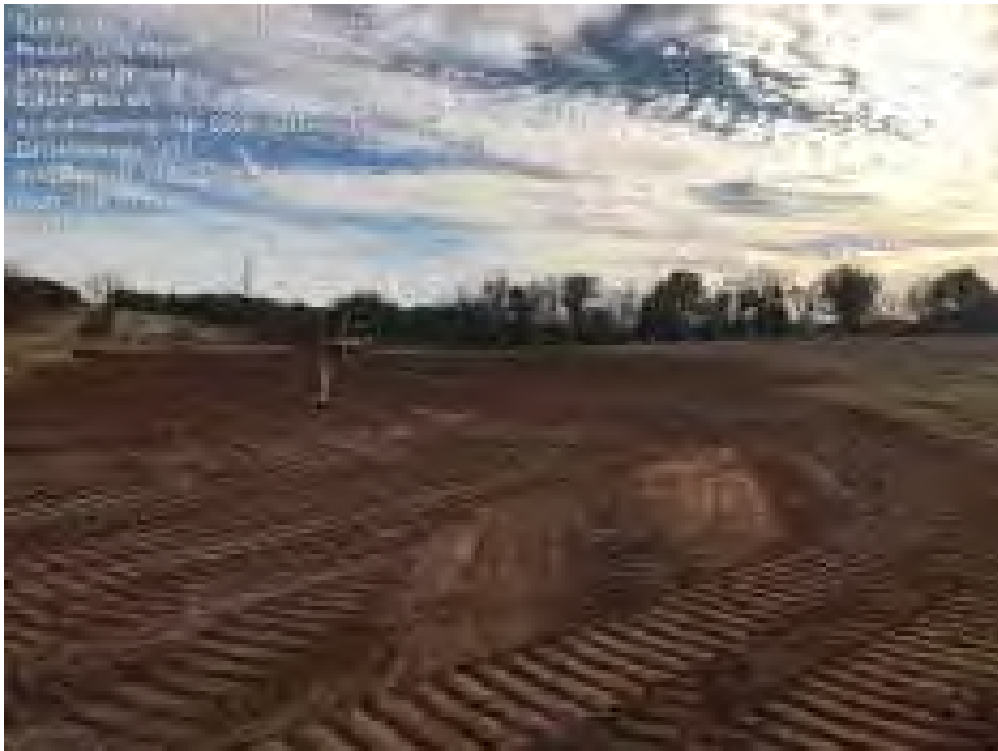
Tract Nos. GR-0353.000 and GR-0355.000

Photos of Restoration Activities on Morris Property

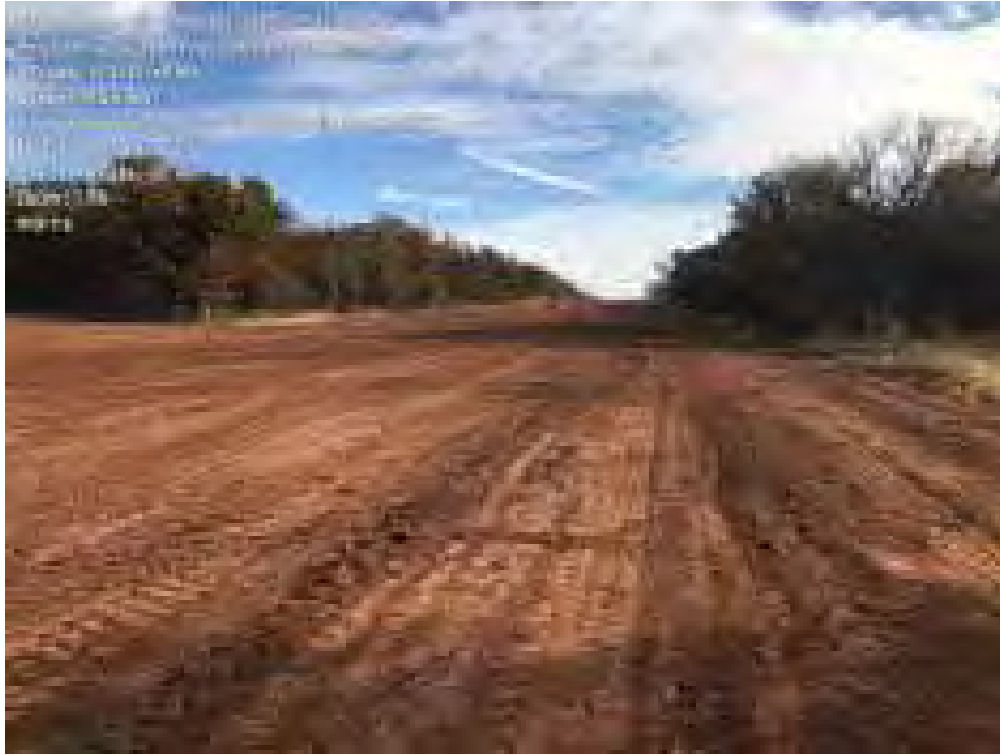
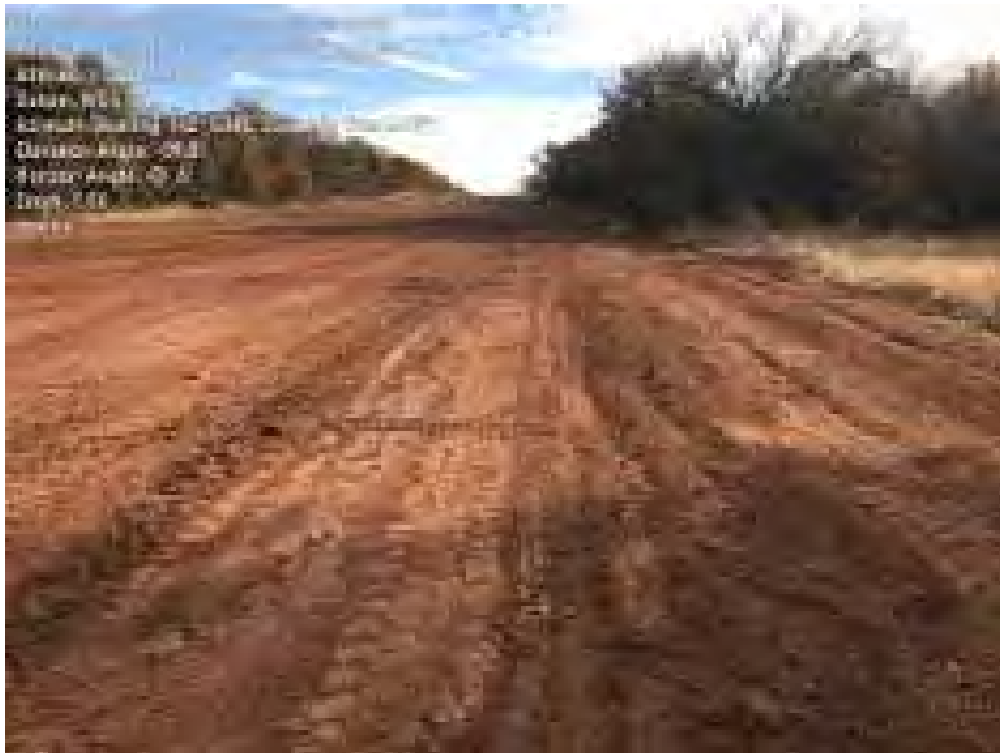
Tract Nos. GR-0353.000 and GR-0355.000

Photos of Restoration Activities on Morris Property
