Robert Squires - Squires Consulting LLC
Landowner Advocate

Opening Statement for May 5, 2021 Subcommittee on Civil Rights and Civil Liberties Hearing:
“Pipelines Over People (Part II): Midship Pipeline’s Disregard for Landowners in Its Pathway”

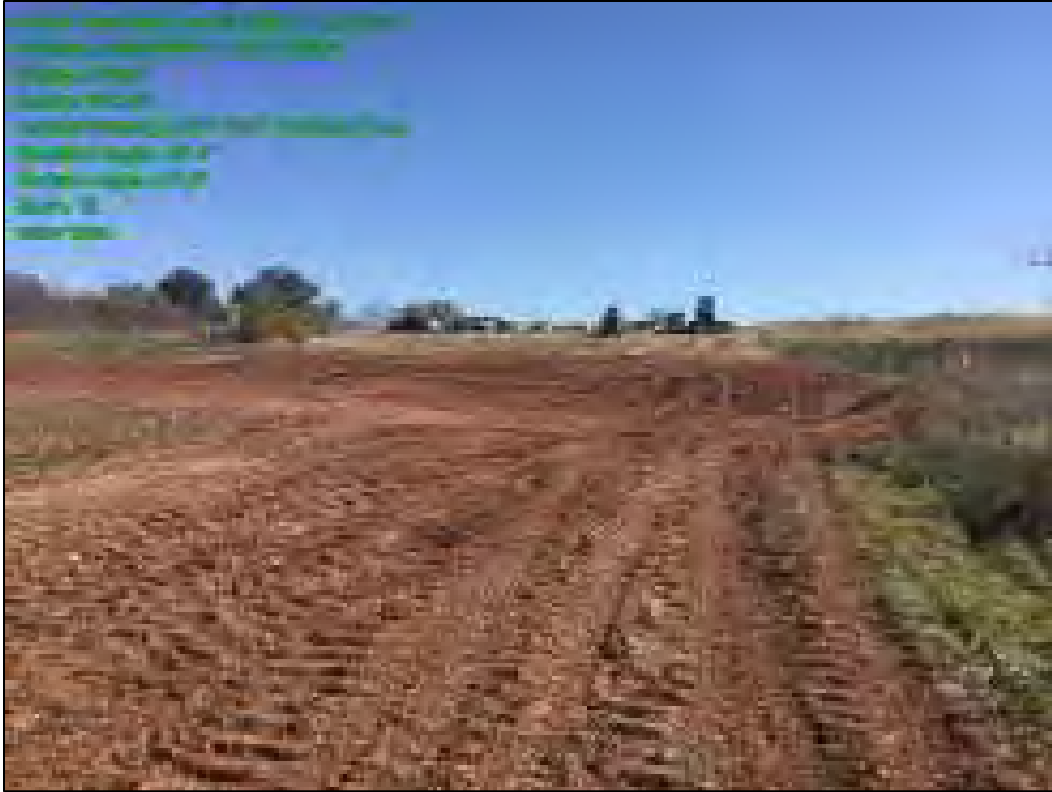
Maintenance work on Sandy Creek Farms property near MP 72.1 on 11/05/20.

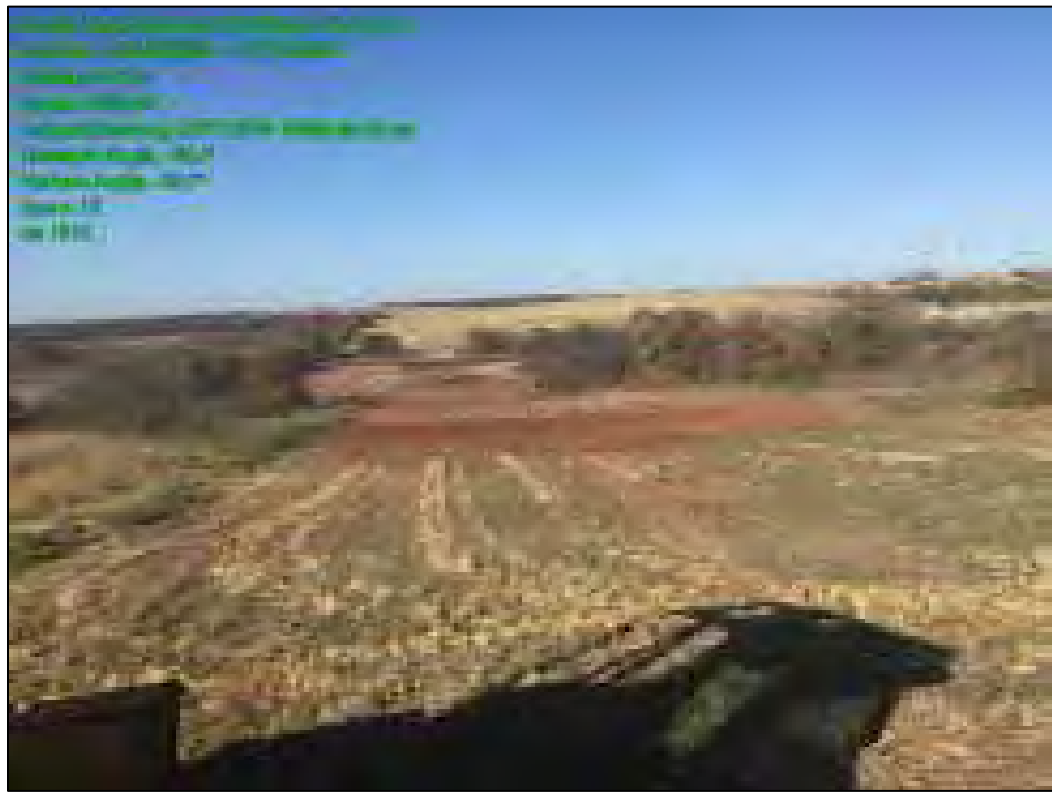
Maintenance work on Sandy Creek Farms property near MP 72.2 on 11/05/20.

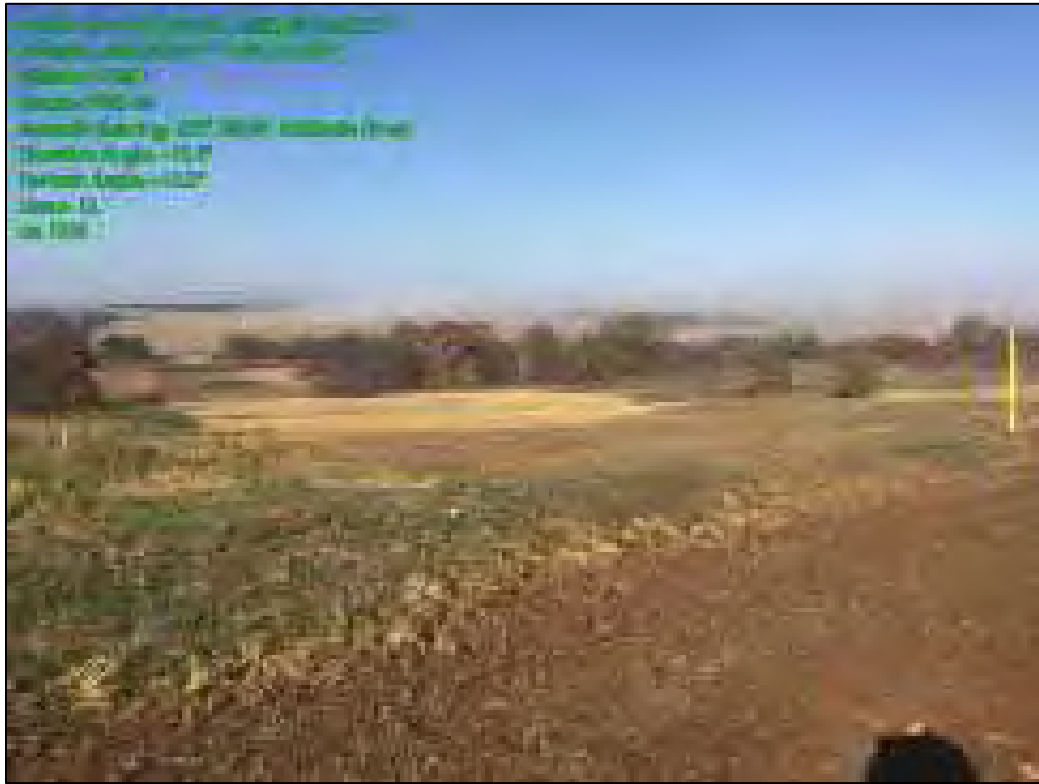
Maintenance work on Sandy Creek Farms property near MP 72.2 on 11/06/20.

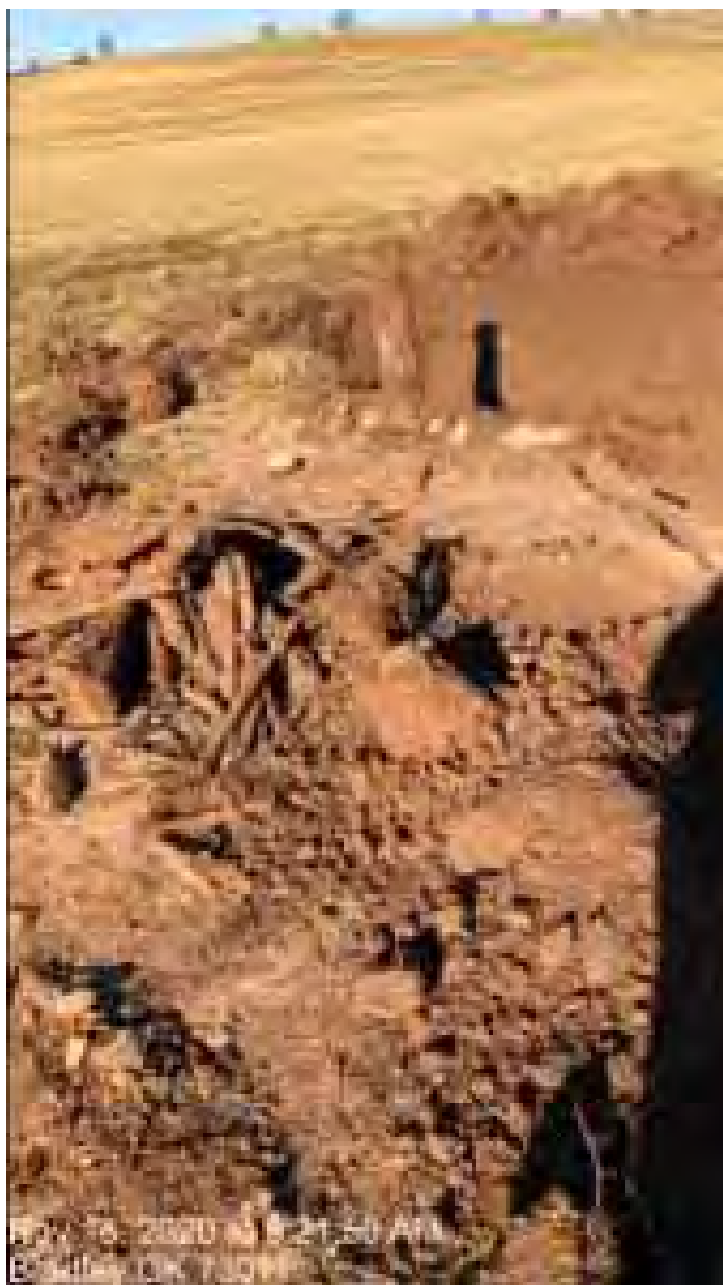
at a depth of approximately 4 to 6 feet below the surface. Midship Operations excavated the Midship Pipeline using a hydrovac in order to inspect the line. During this inspection, no gas was detected at any location along the exposed line, and no damage was observed to the pipeline. Midship backfilled the excavation of the pipeline with dry backfill material brought in on small buggies via the ROW and the work was done by hand as the Landowner would not allow Midship to use his road to bring material or equipment in to restore the ROW. Midship Operations will continue to monitor the area for any further needed work in the event that the backfill compacts and additional fill is needed to correct for low spots on this excavation.

Excavations by landowner on Nov 18, 2020, construction debris located 4 – 6 feet below surface

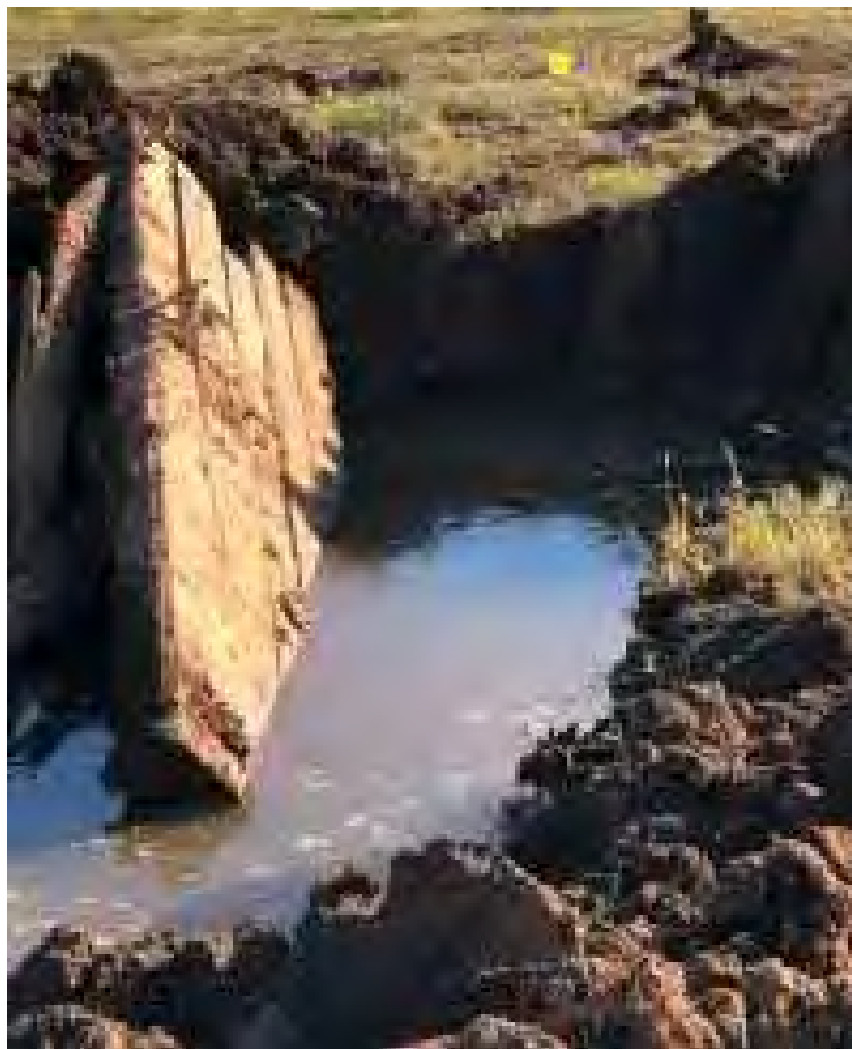
Excavations by landowner on Nov 18, 2020, mats located 4 – 4 feet below surface.

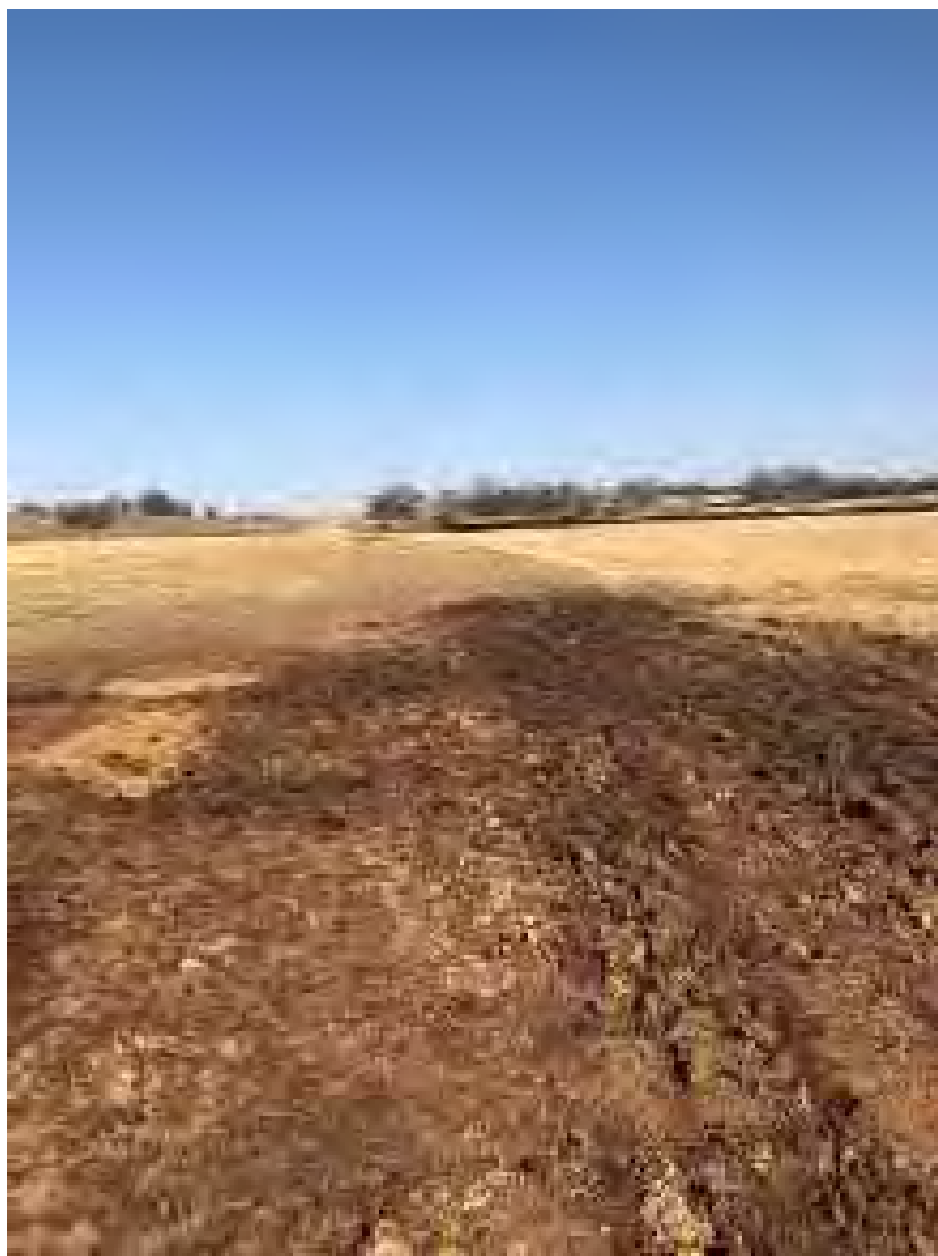
Midship Operations completed backfilling over Midship Pipeline on Nov 19, 2020

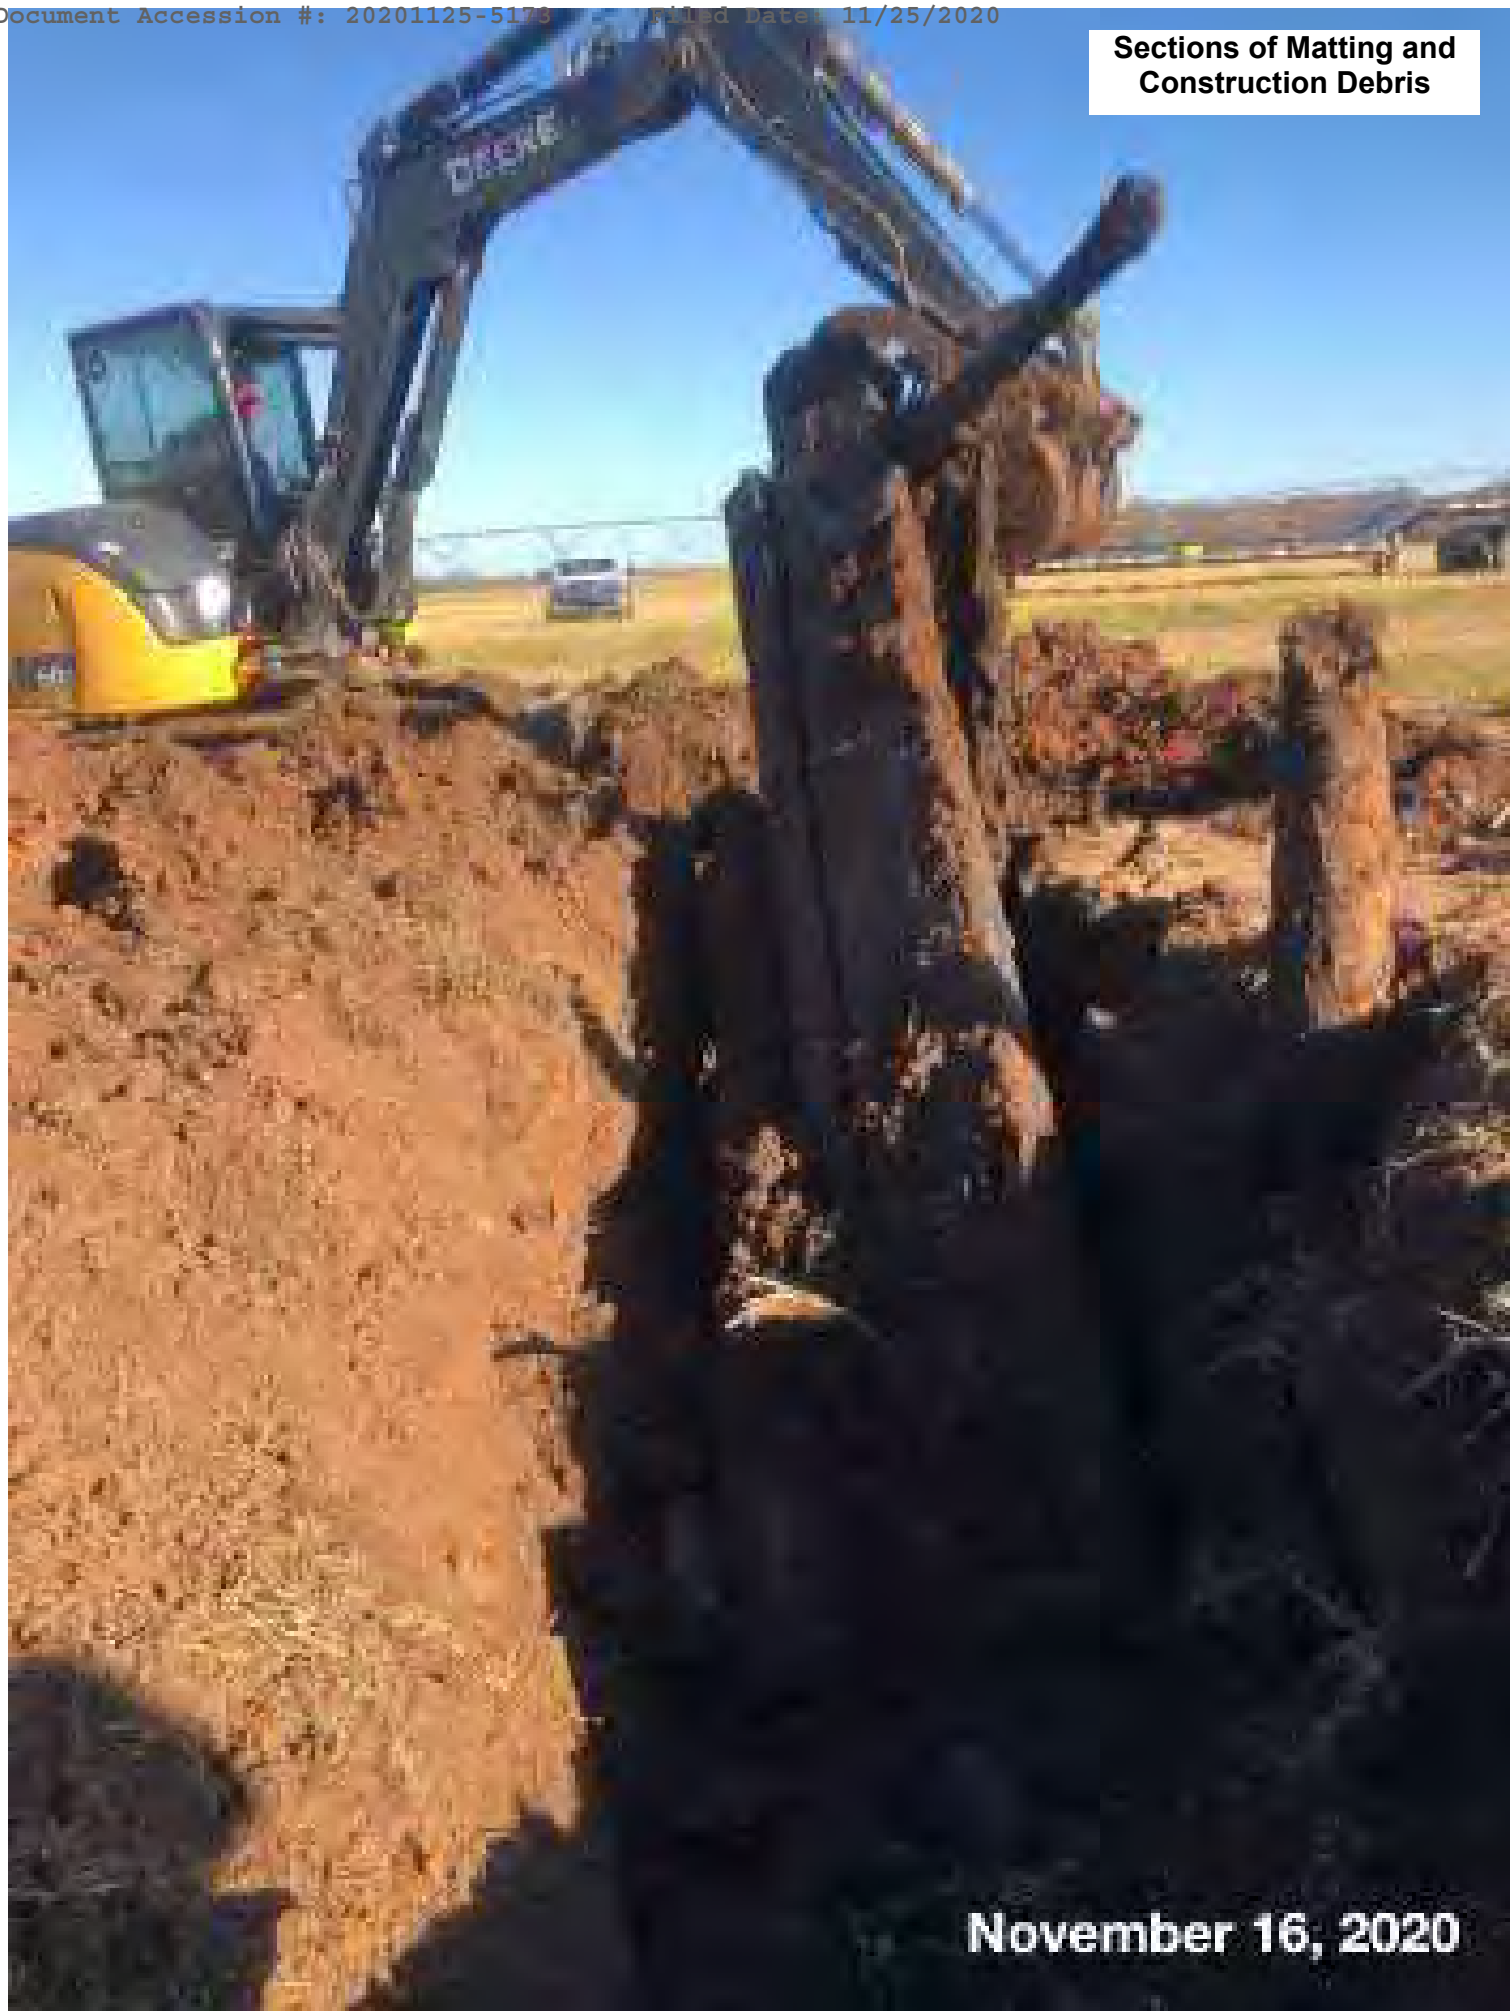
November 16, 2020

**Sections of Matting and
Construction Debris**

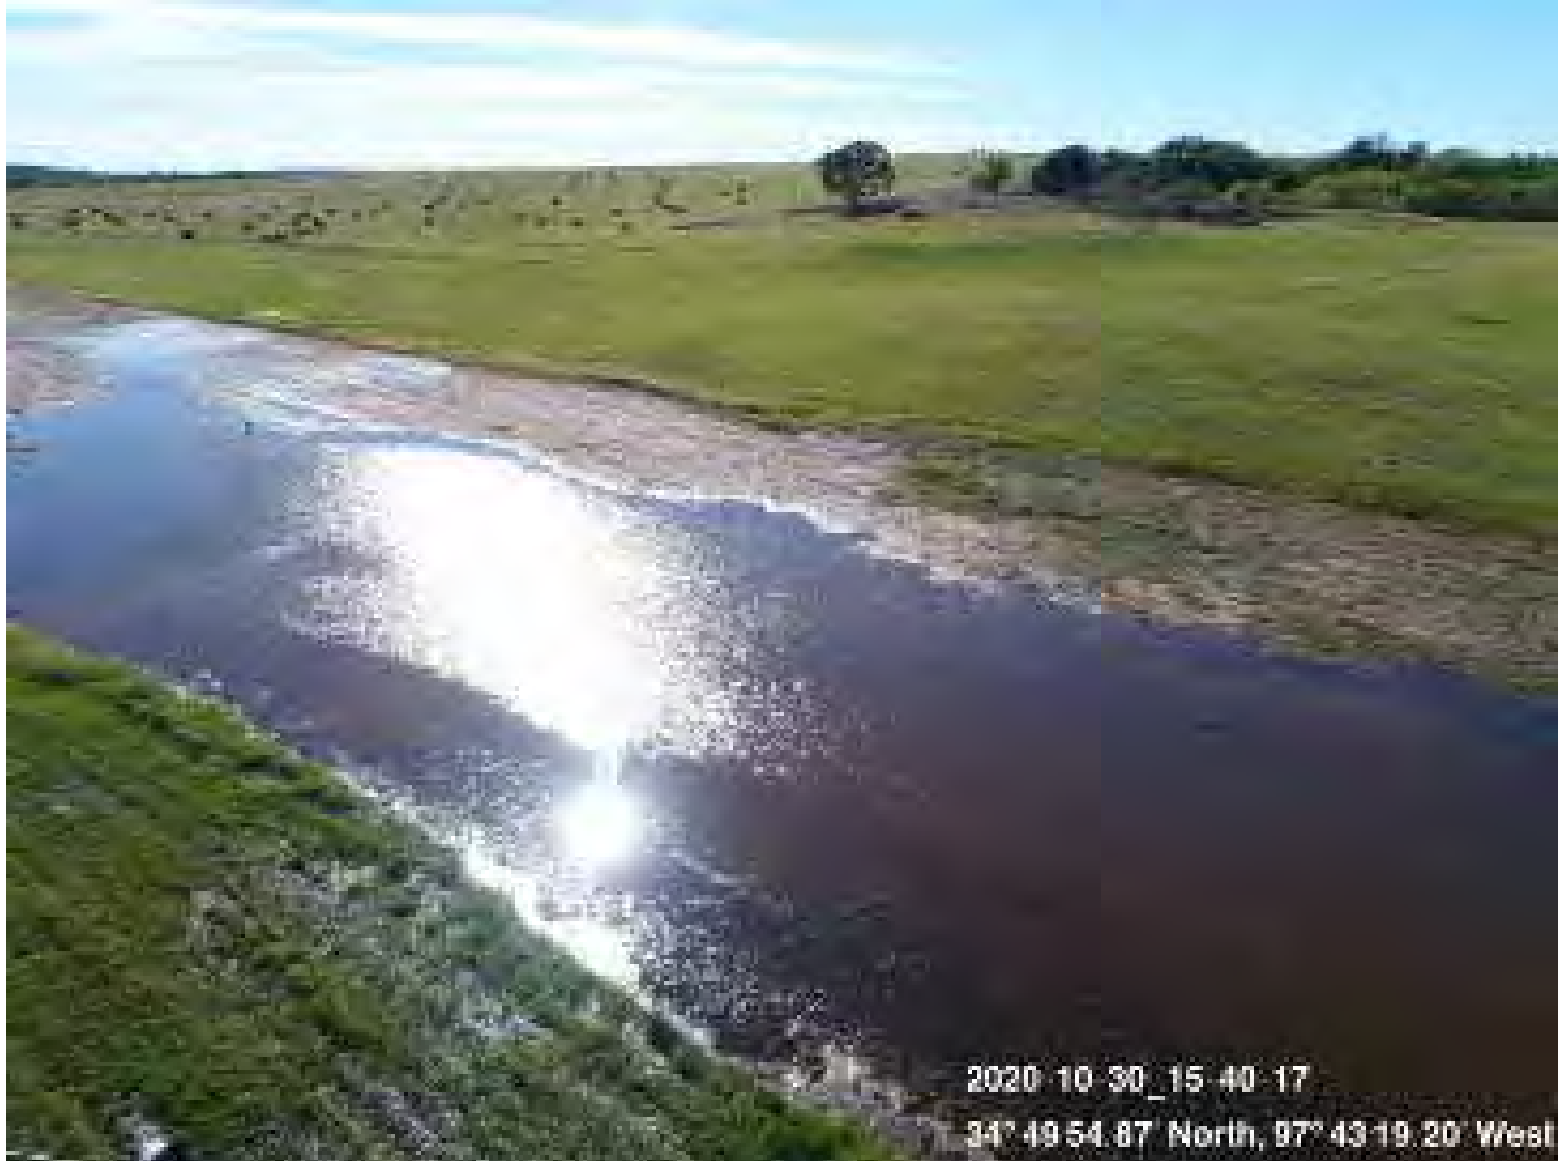
November 16, 2020

**Flooded Easement Due to the Altered Grade and Drainage
Issues the Will Need Remediated On and Off ROW**

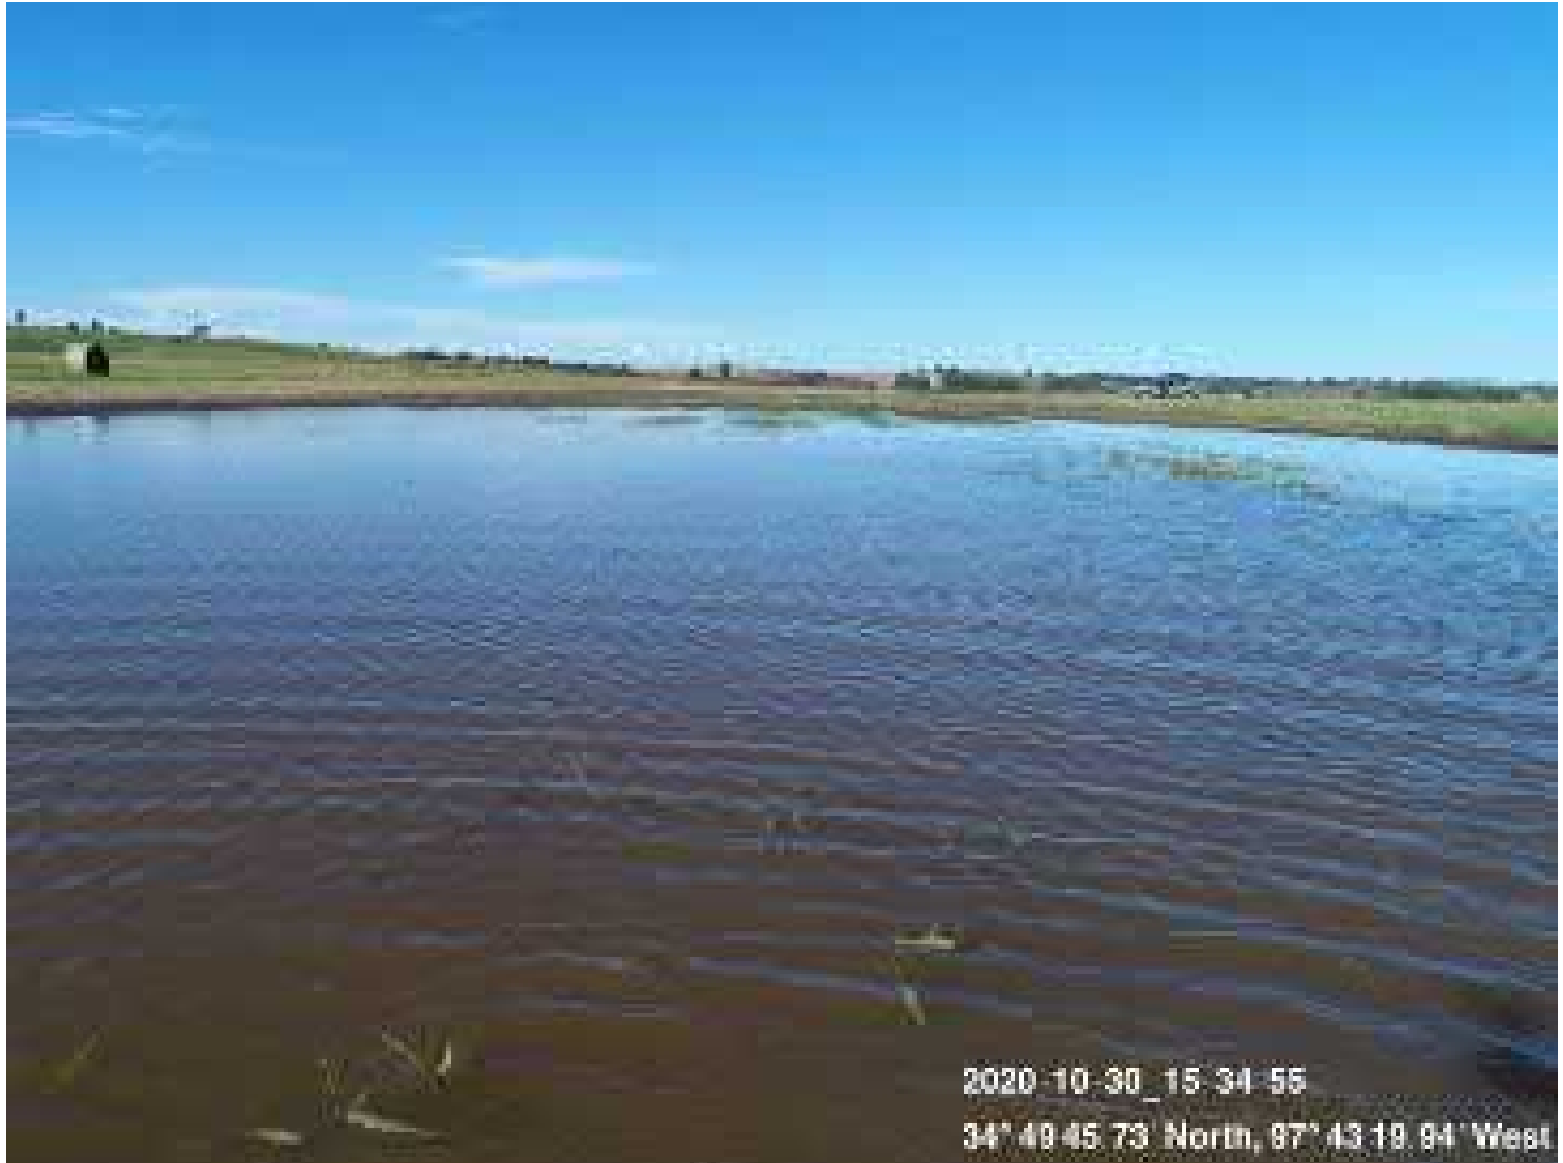
**Flooded Easement Due to the Altered Grade and Drainage Issues
the Will Need Remediated On and Off ROW**

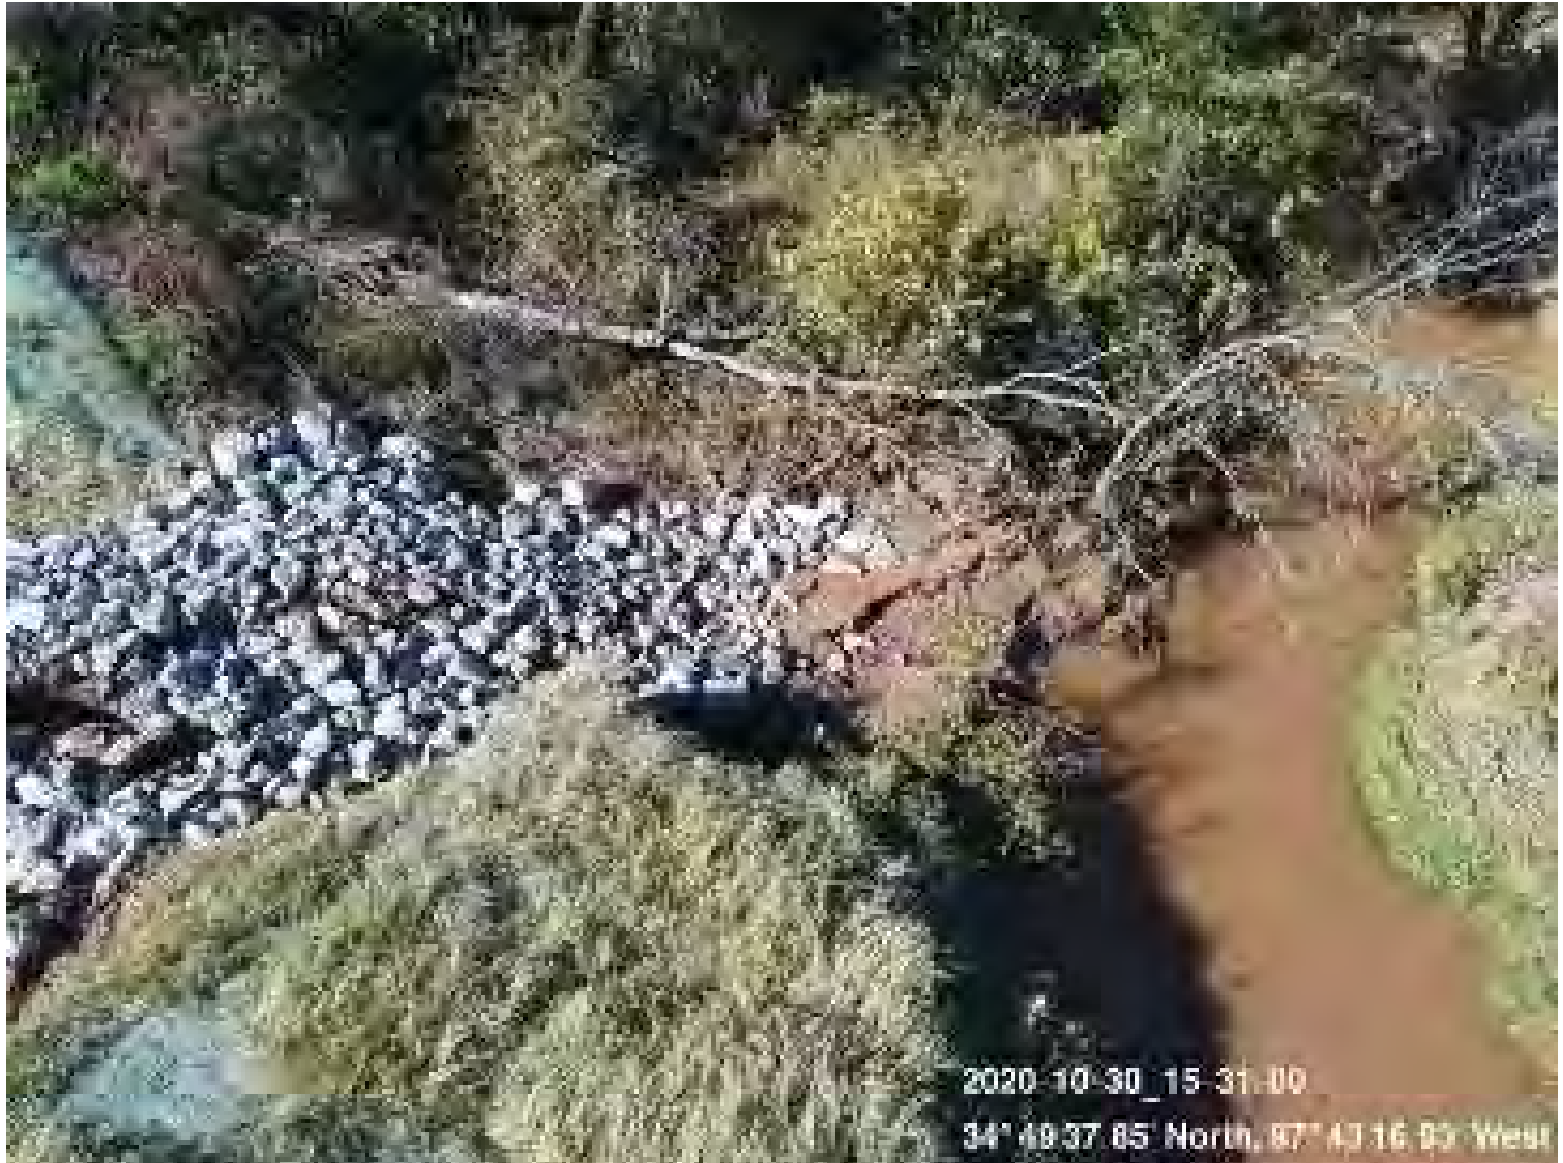
**Sections of the Sandy Creek Bank Have Slipped Causing Erosion
and Timber is Falling into the Creek. The Drainage has Been Altered
Causing Consistent Runoff**

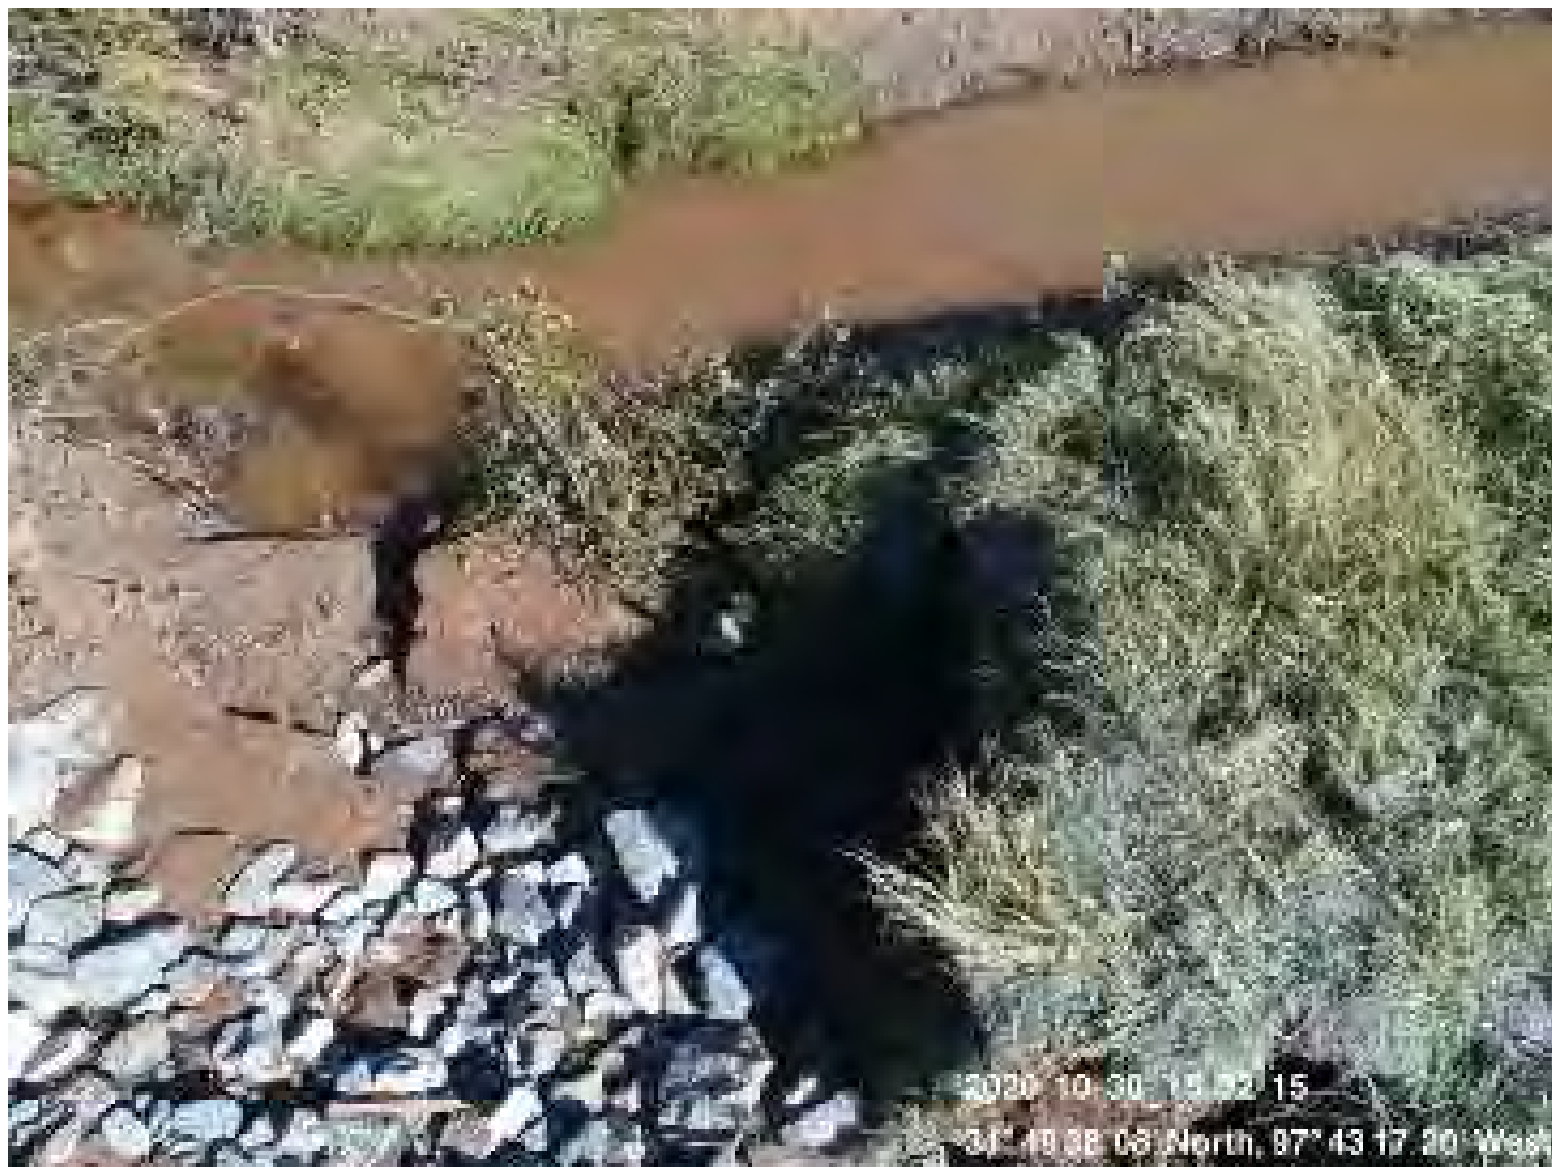
**Excessive Erosion Patterns Have Been Created Causing Stormwater
Runoff and Drainage Issues**

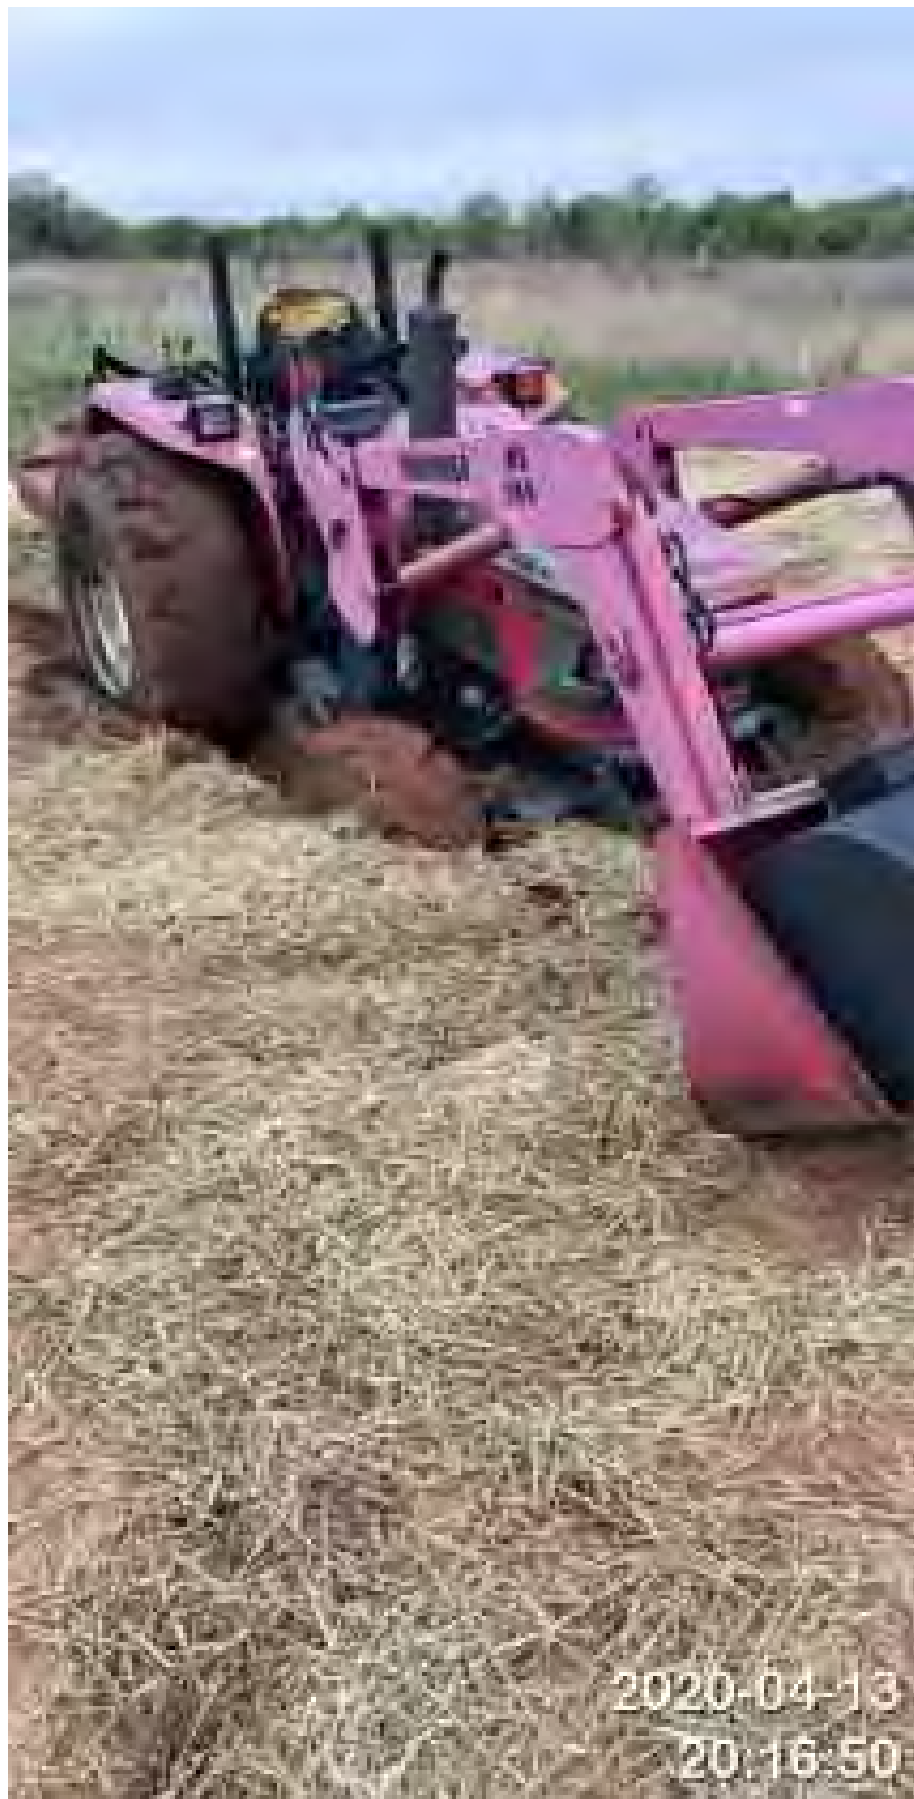
Section 1

Tractor Unable to Cross Easement

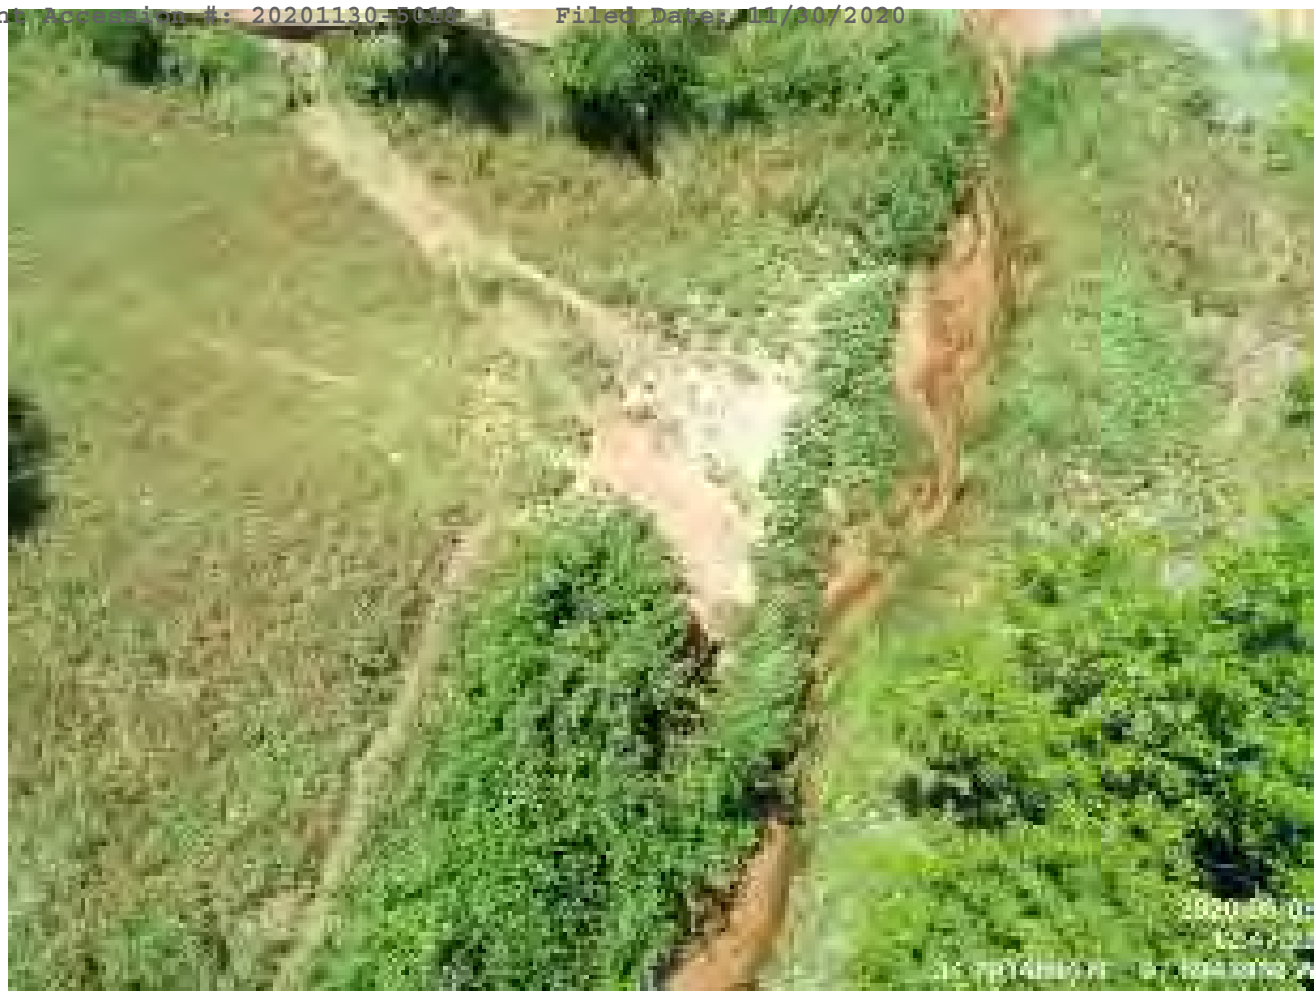
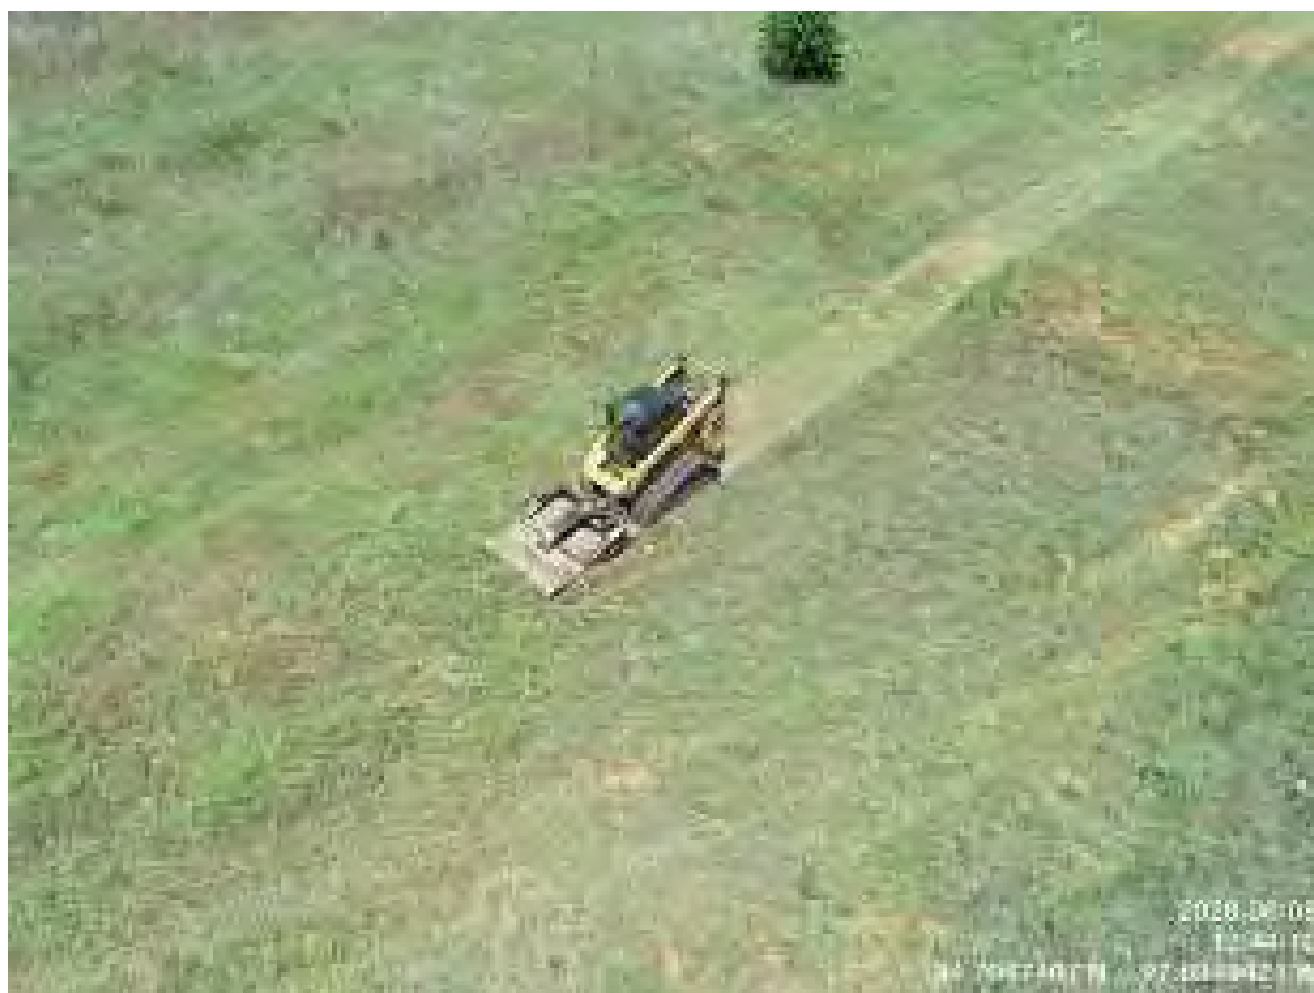
Section 2

Off-ROW Activity on June 8, 2020
