Robert Squires - Squires Consulting LLC
Landowner Advocate

Opening Statement for May 5, 2021 Subcommittee on Civil Rights and Civil Liberties Hearing:
“Pipelines Over People (Part II): Midship Pipeline’s Disregard for Landowners in Its Pathway”

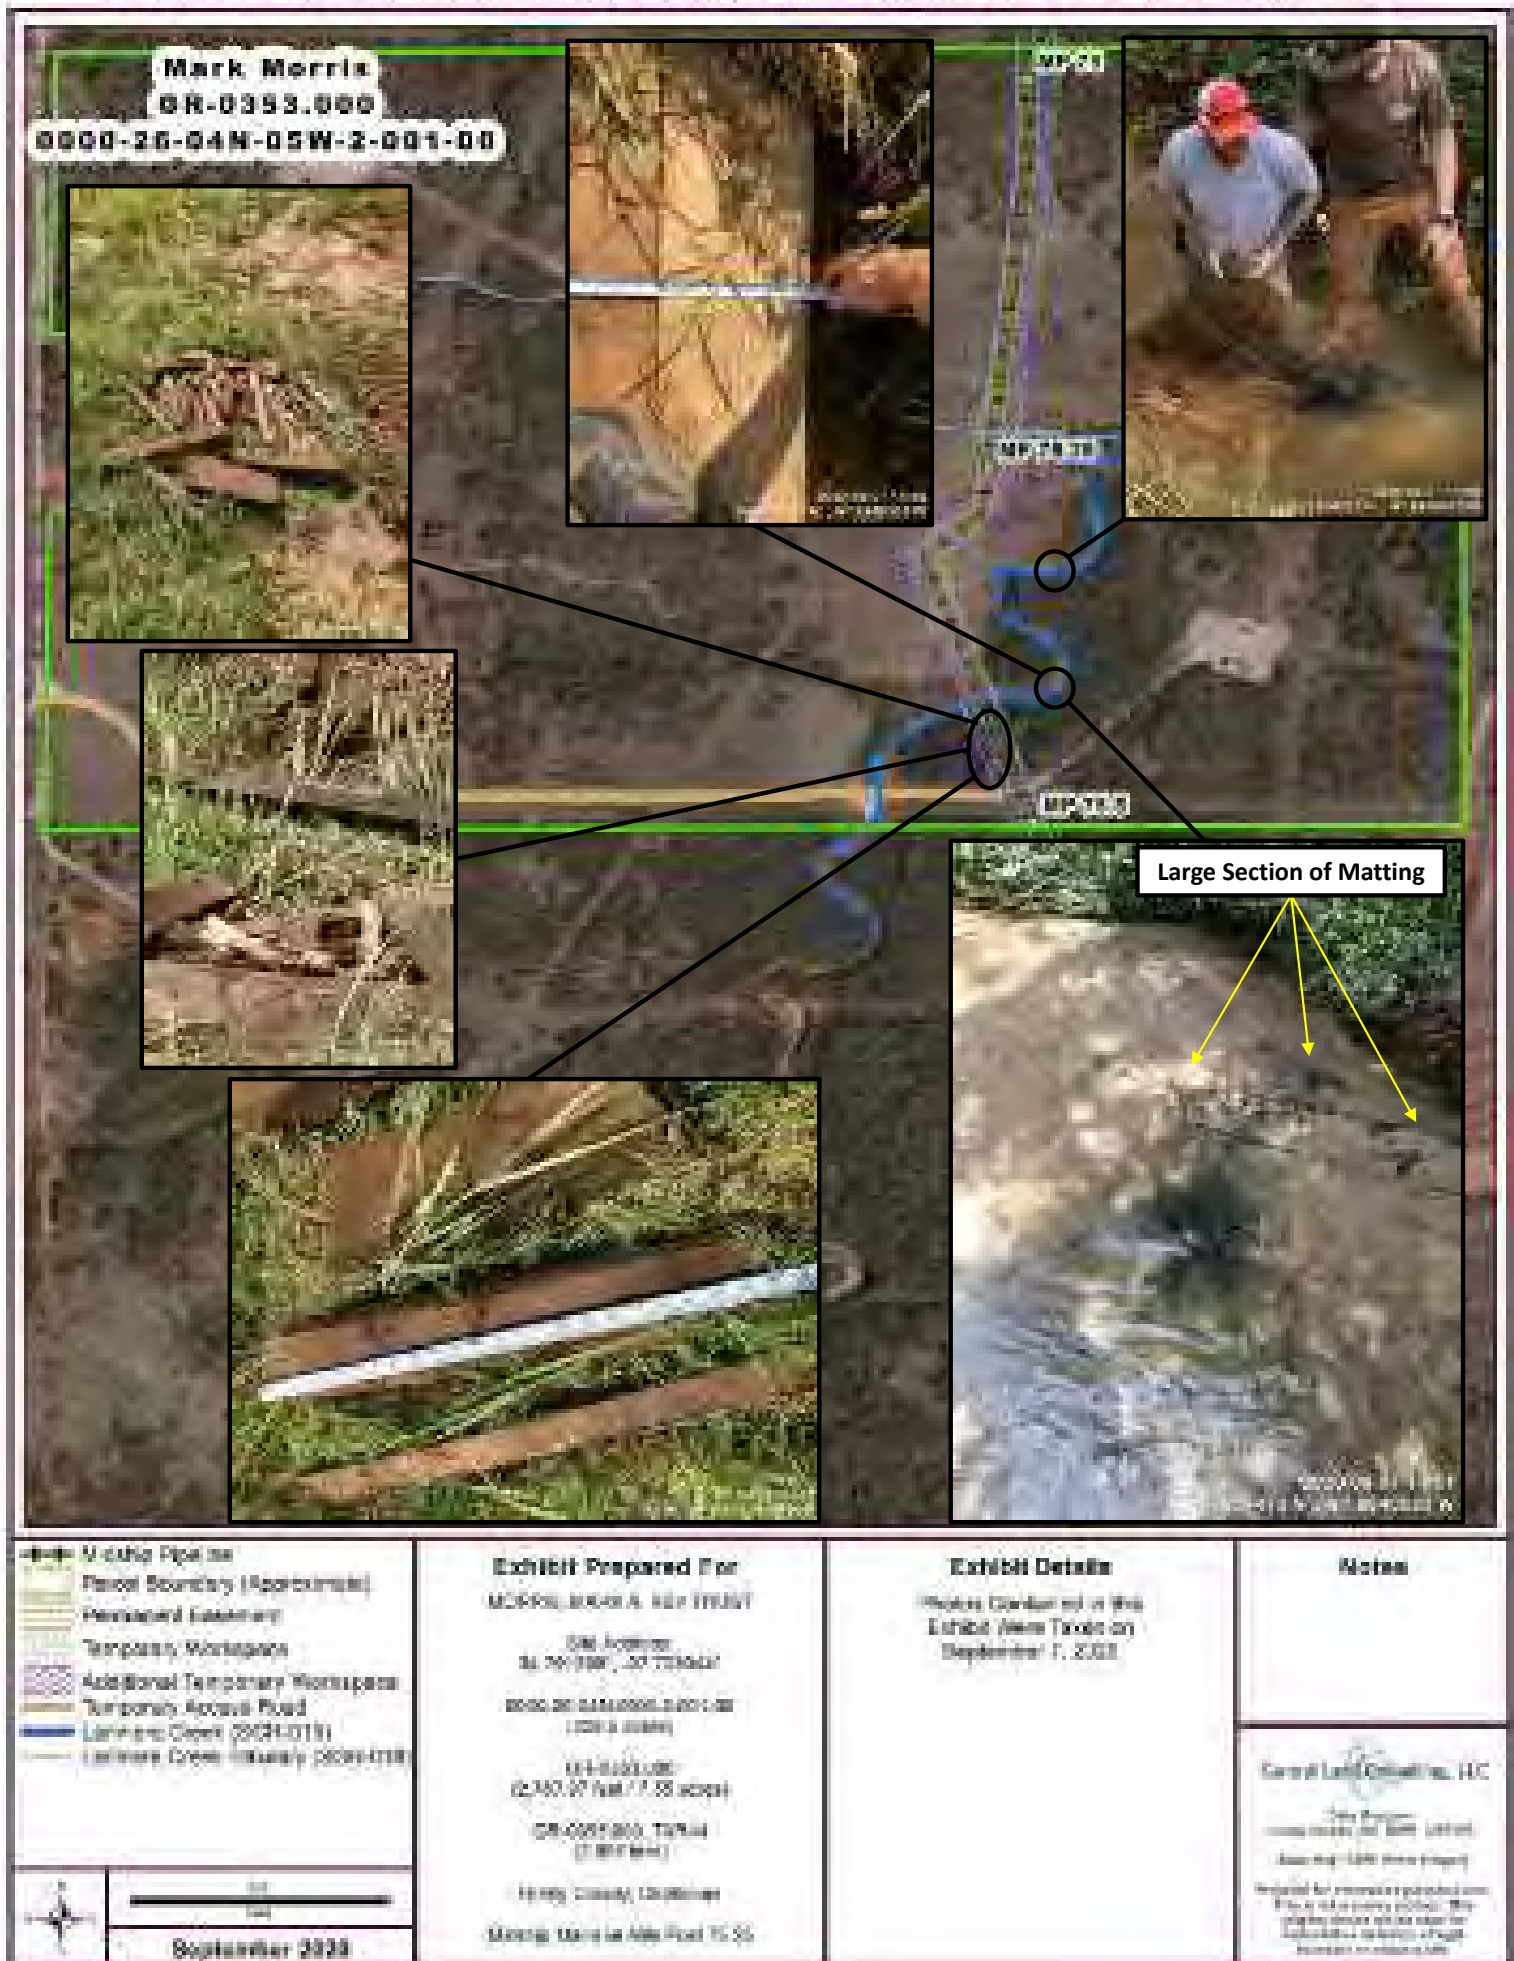
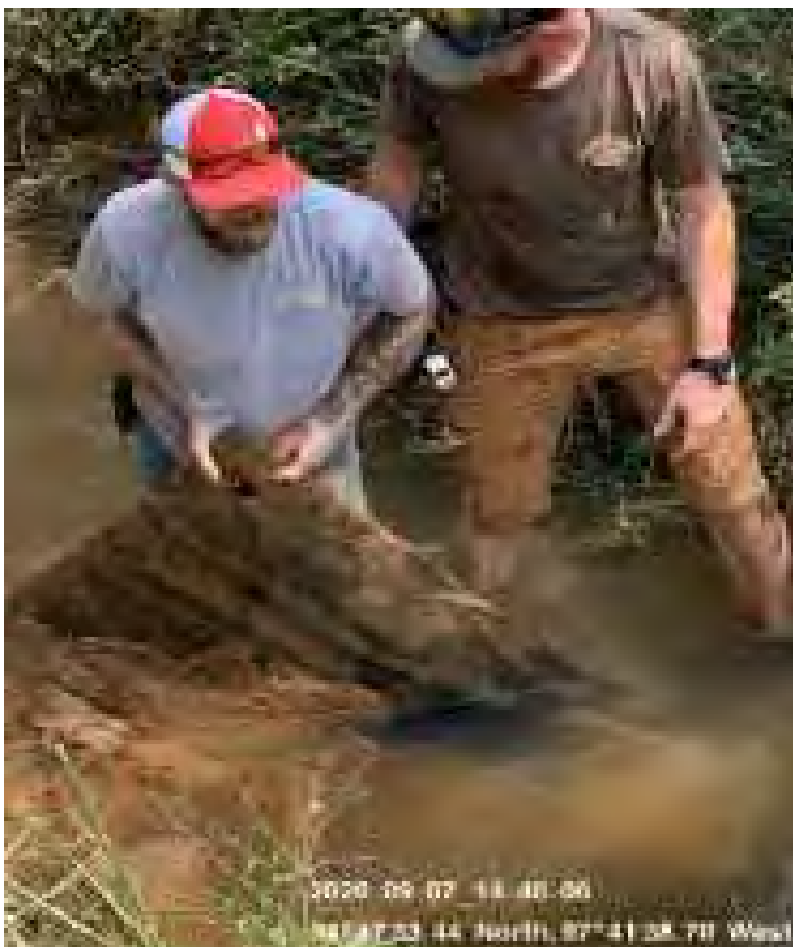
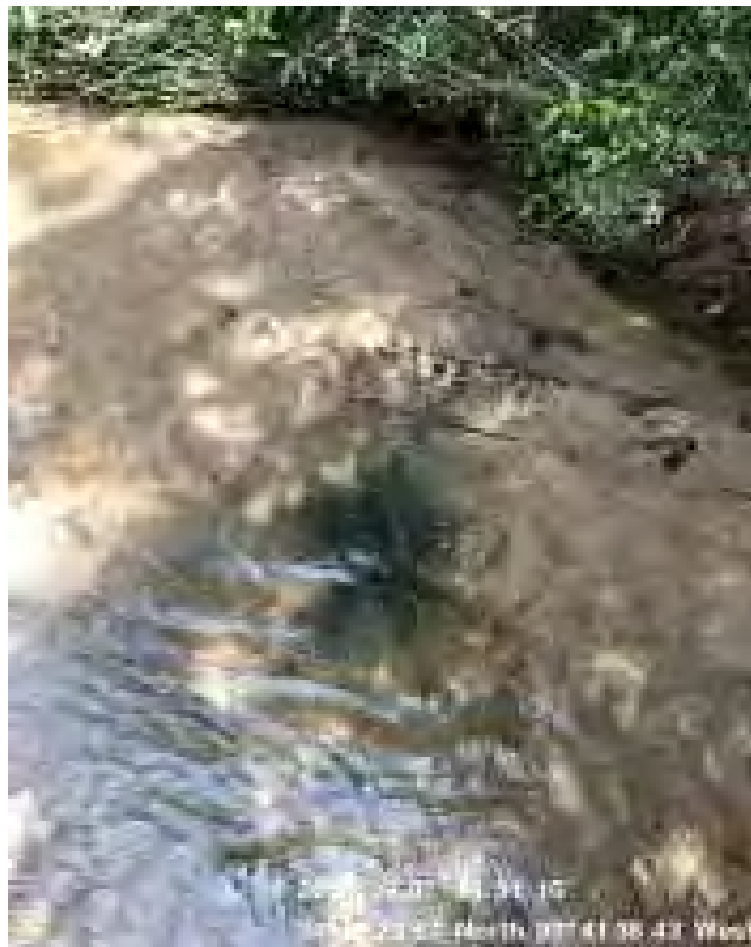
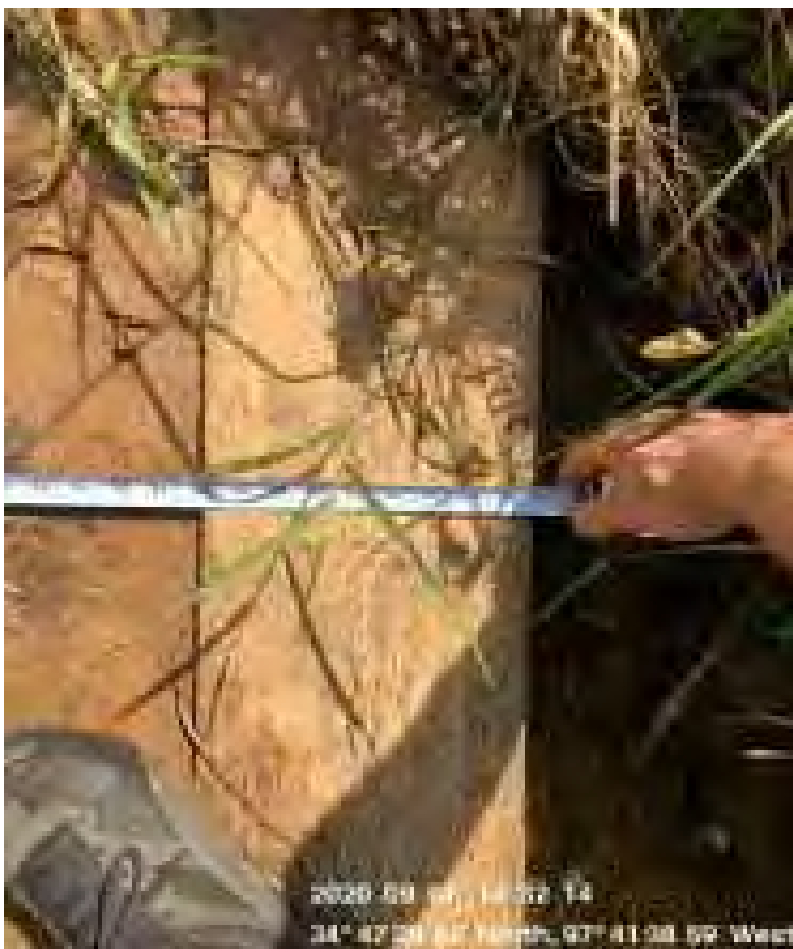
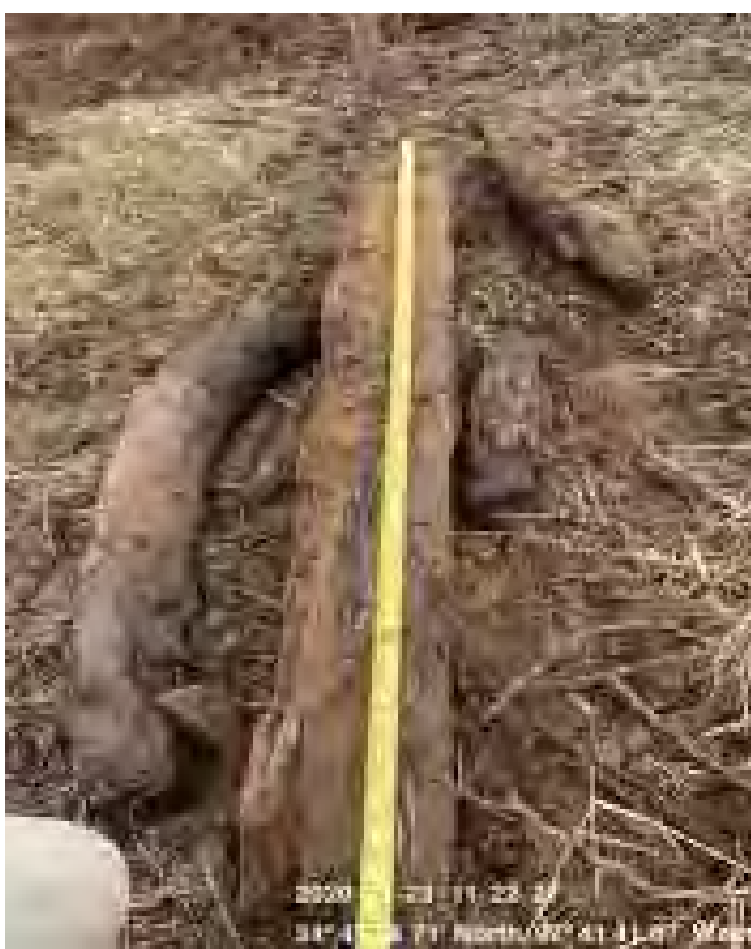
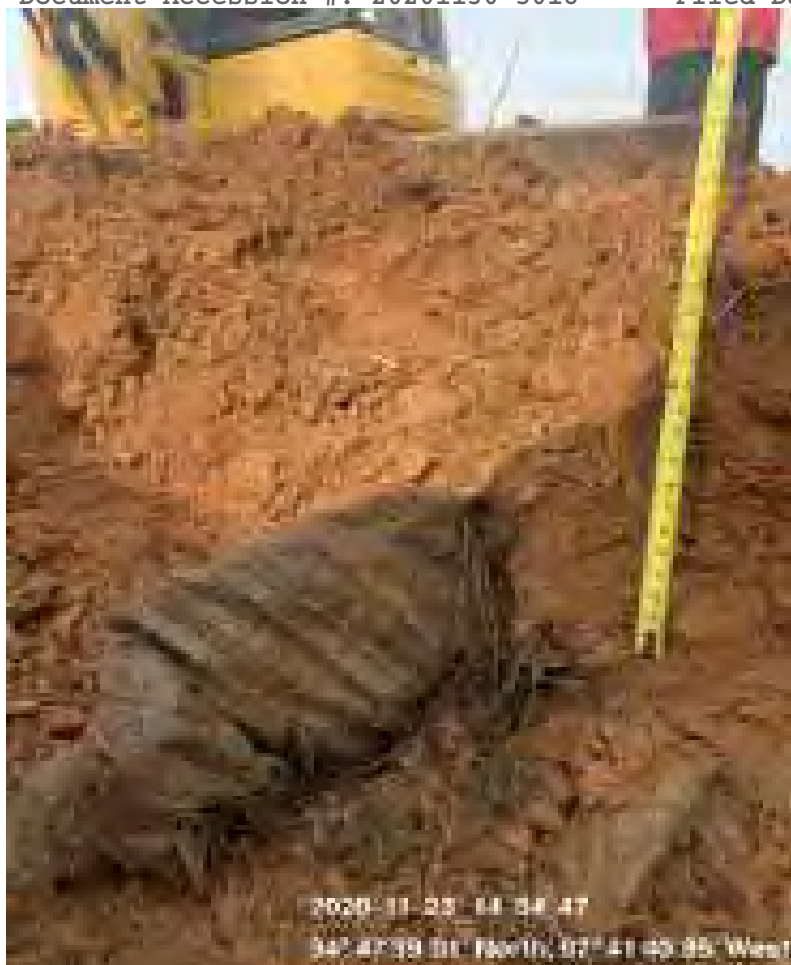
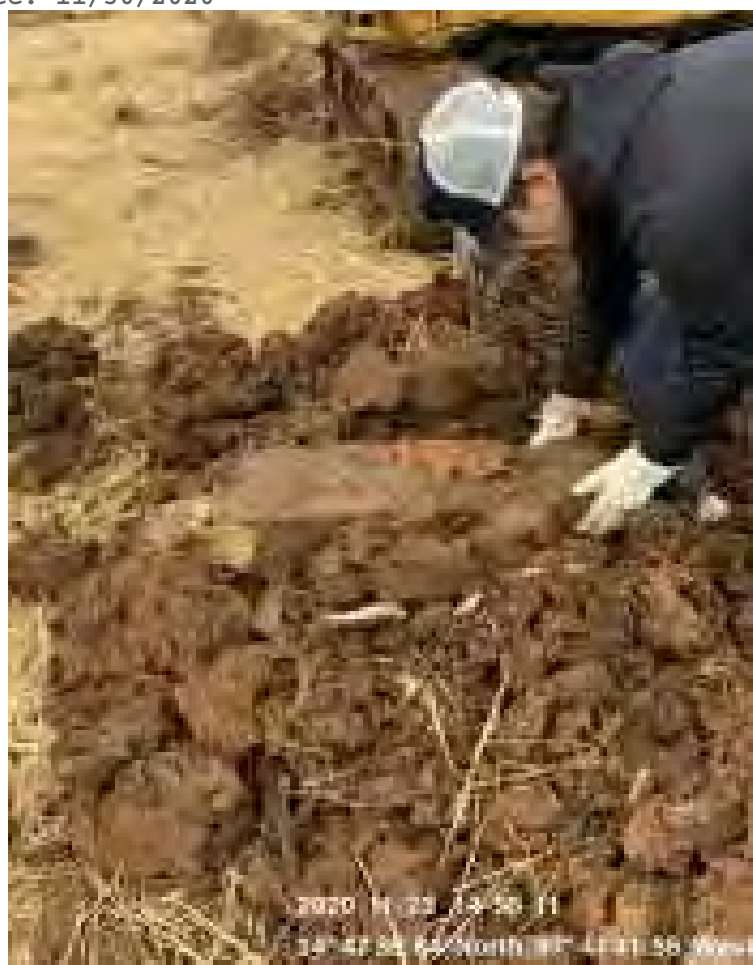
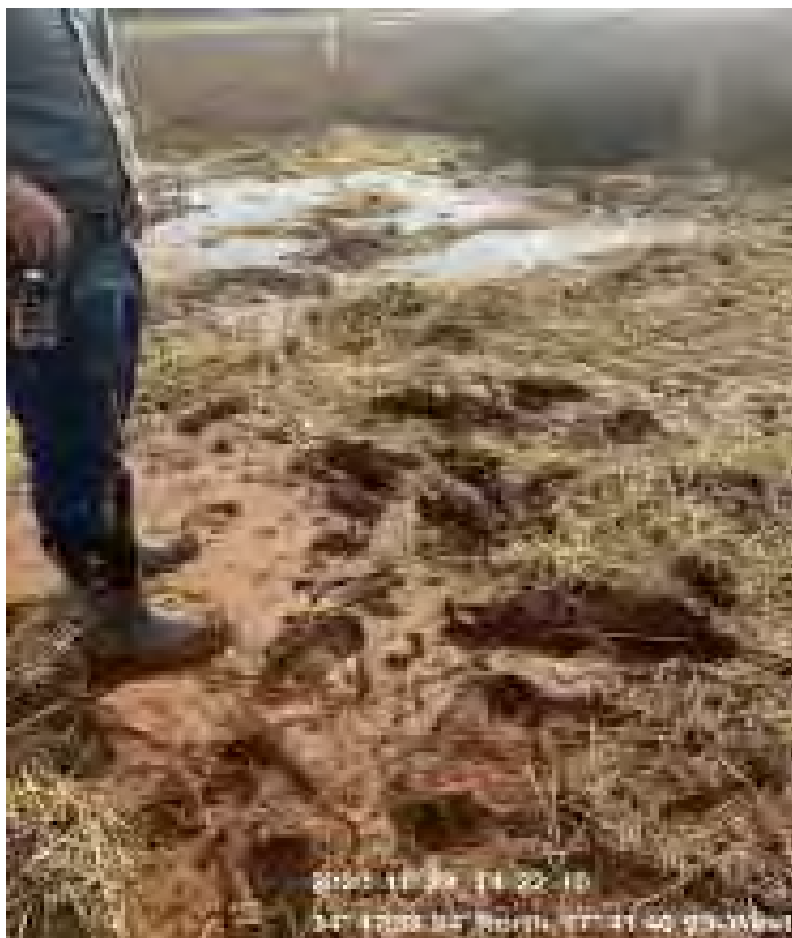
September 7, 2020 Photo Map Prepared for Mark Morris

On 9/24/2020, I observed the following conditions:

This is an apparent violation of:

- ☐ Open Burning
 ☒ Open Dumping
 ☐ Fugitive Dust
 ☐ Highway Spill Remediation
☐ Allowing Sewage to Surface or Discharge
 ☐ Failing to Properly Operate or Maintain Sewage Disposal System
☐ Installing Unapproved Sewage Disposal System
 ☐ Installing >10 Sewage Disposal Systems w/o Being Certified

☒ This apparent violation should be corrected
 by 10/09/2020, by doing the following:

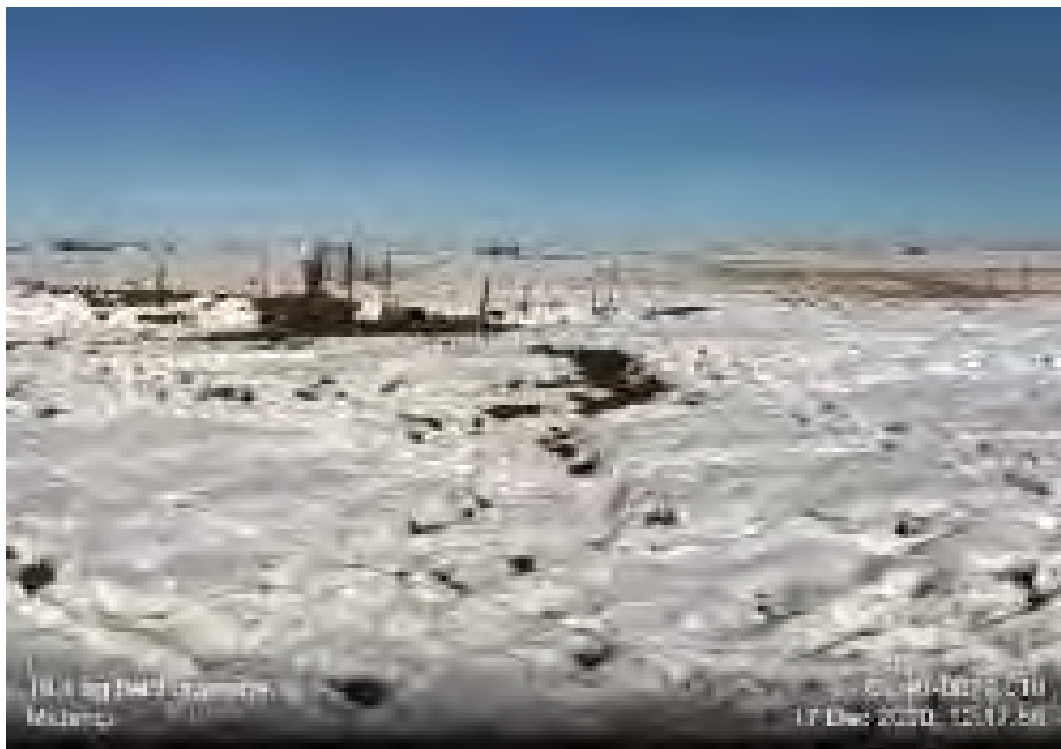
Photo 2: View of non-project related agricultural field drainage gully intersecting the right-of-way on tract CL-KI-0079.010, Chisholm Lateral, North Spread, MP 19.3 (see EV-8932 issued on 12/17/2020).

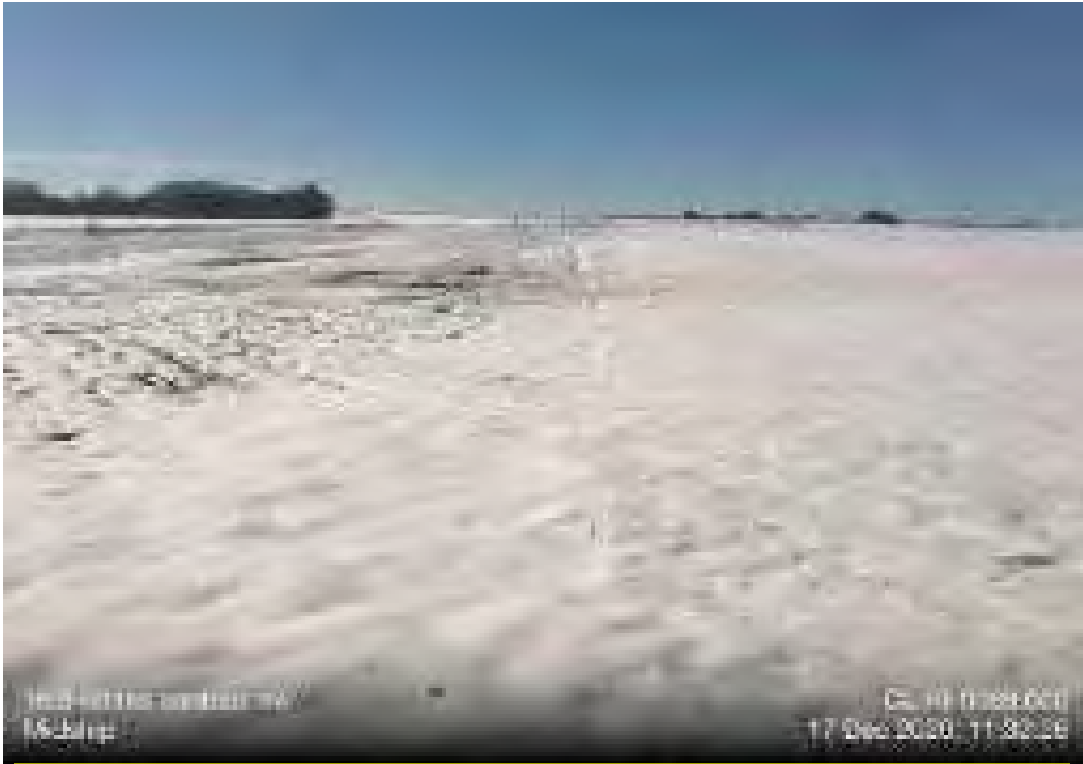
Photo 3: View of restored contour on tract CL-KI-0069.000, Chisholm Lateral, North Spread, MP 16.9 (see EV-8933 issued on 12/17/2020).

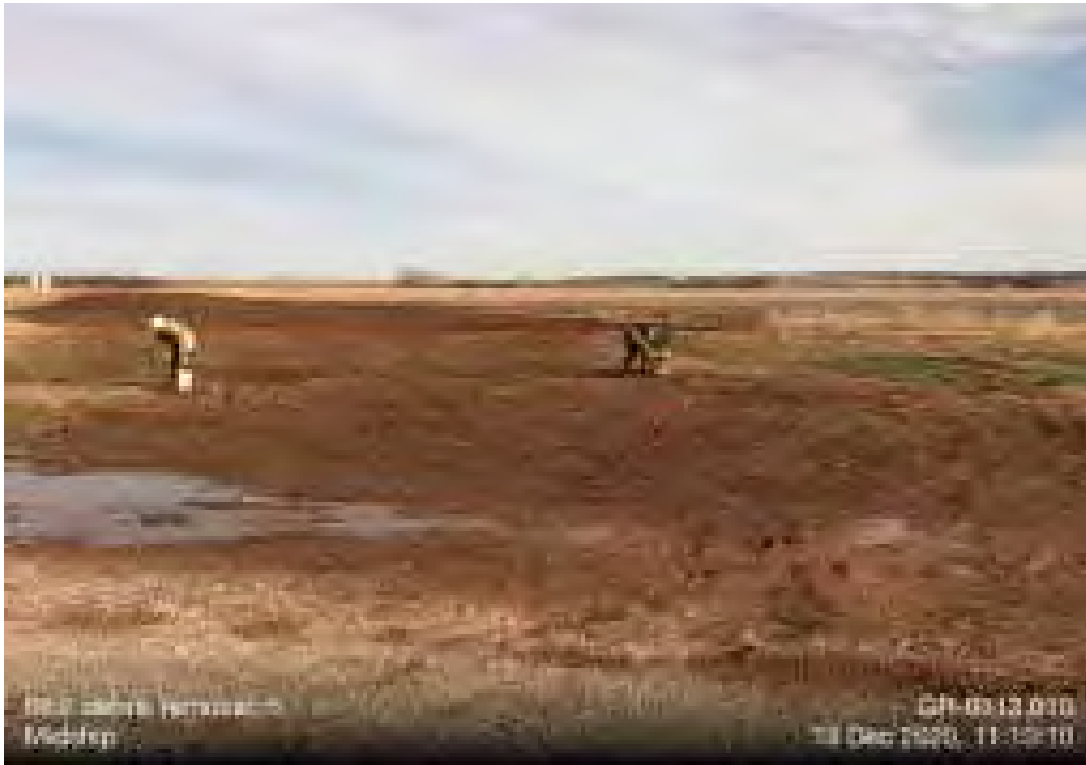
Photo 4: View of debris removal on tract GR-0312.010, North Spread, MP 66.1 (see EV-8935 issued on 12/18/2020).

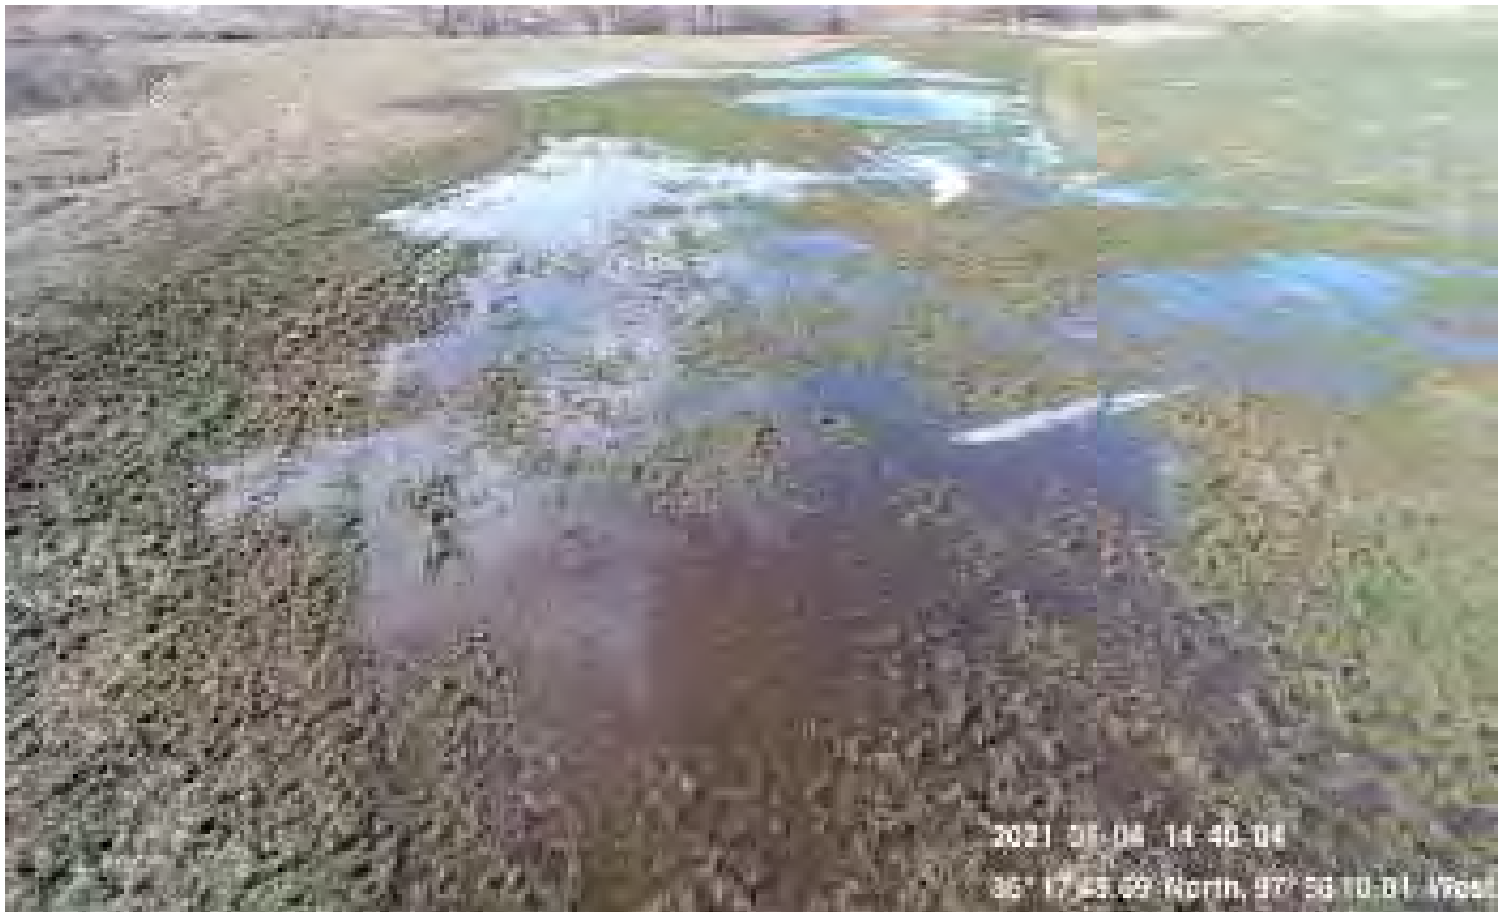
Ponding in Several Portions of the Easement

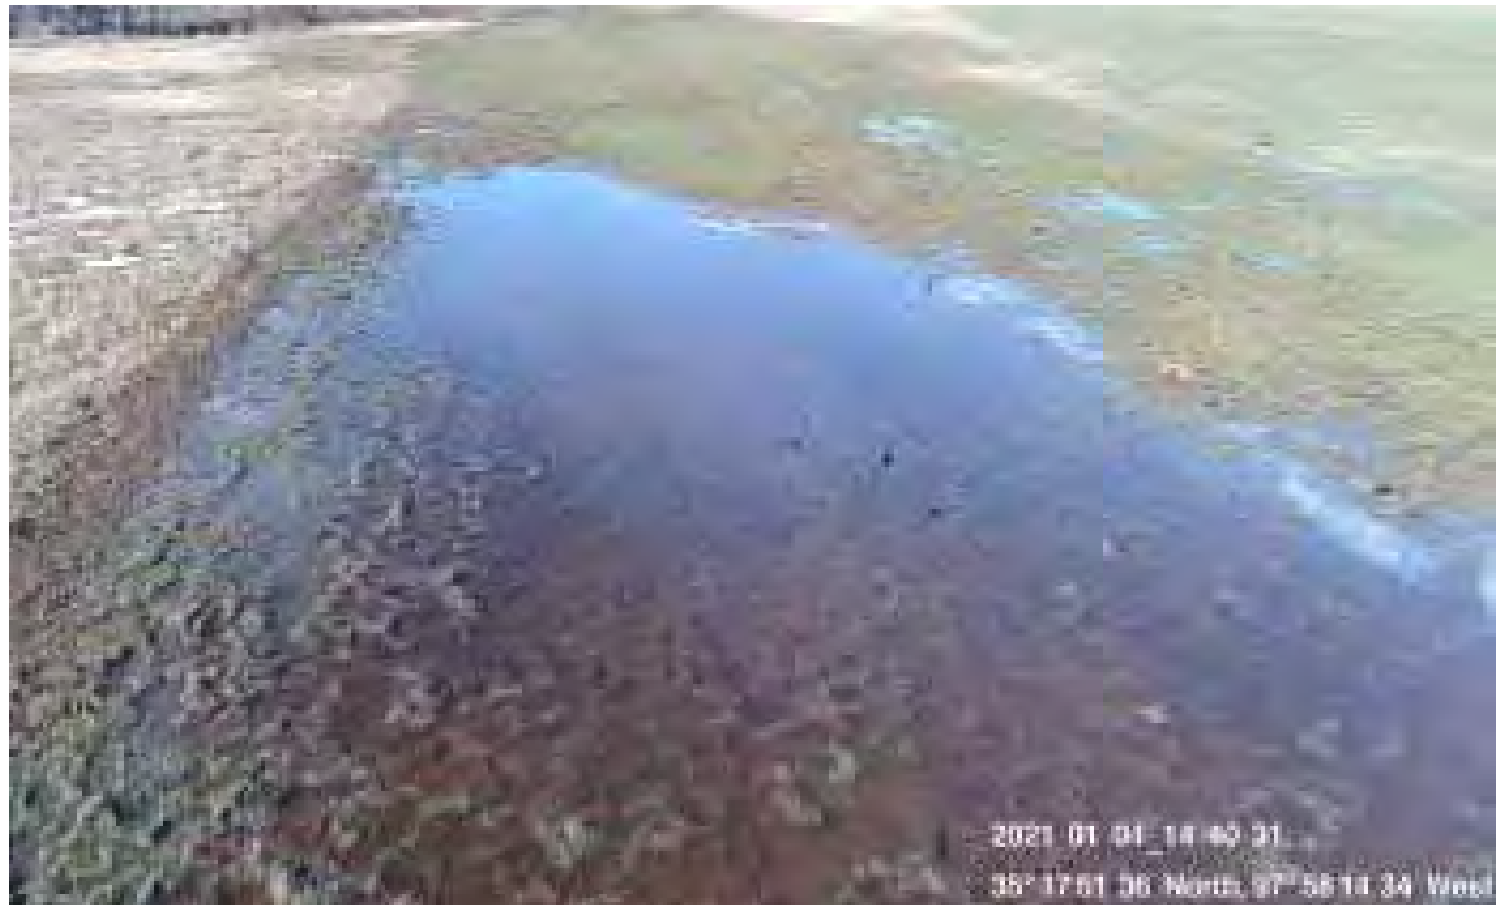
The Grade Has Not Been Restored Causing Ponding and Additional Compaction

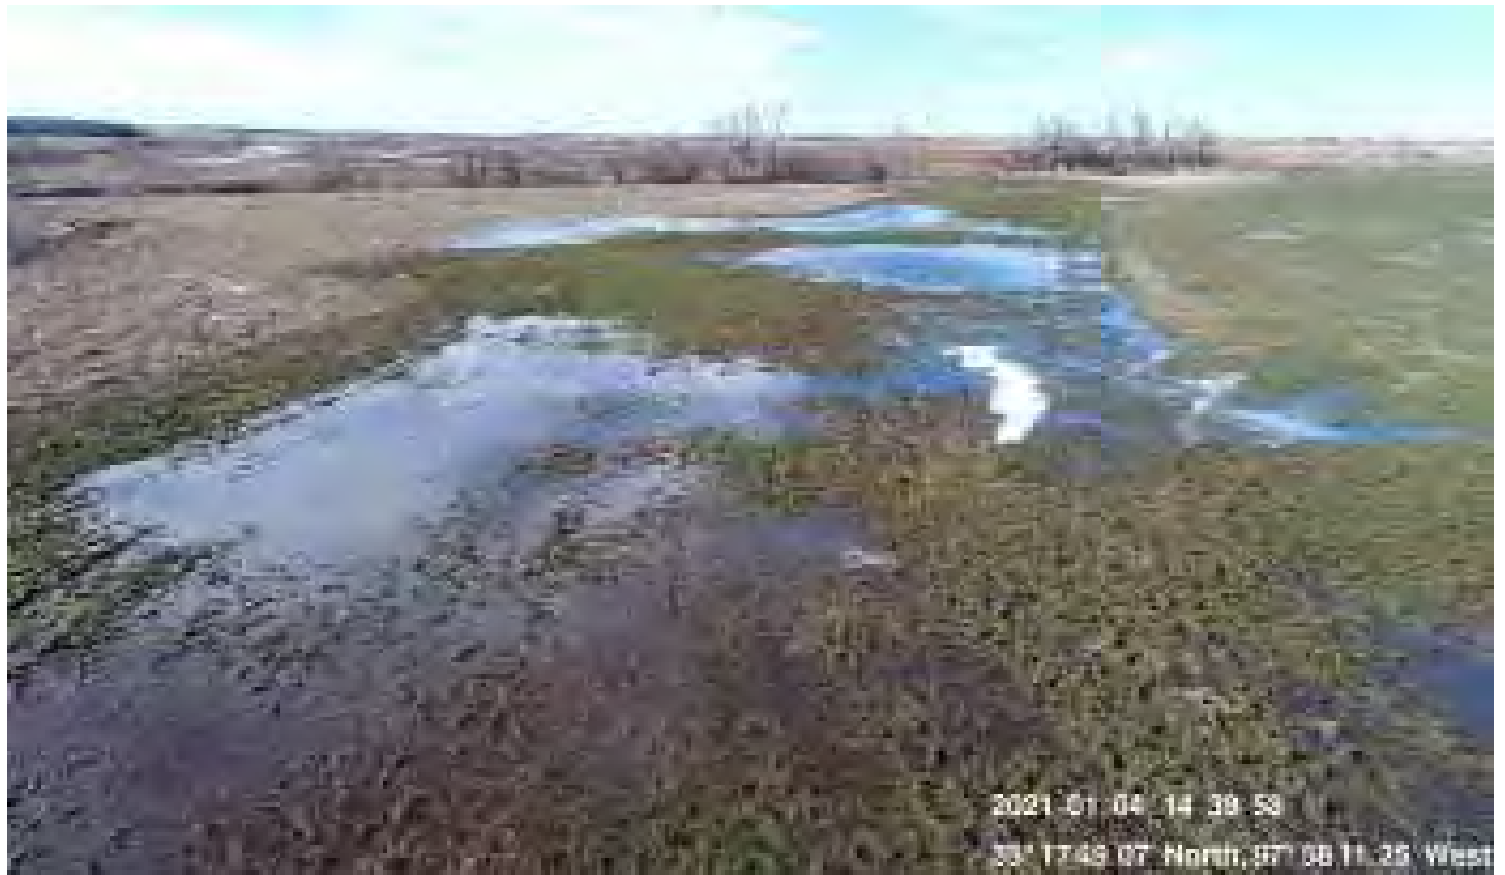
The Ponding Has Been Flooding Out the Easement for Several Months

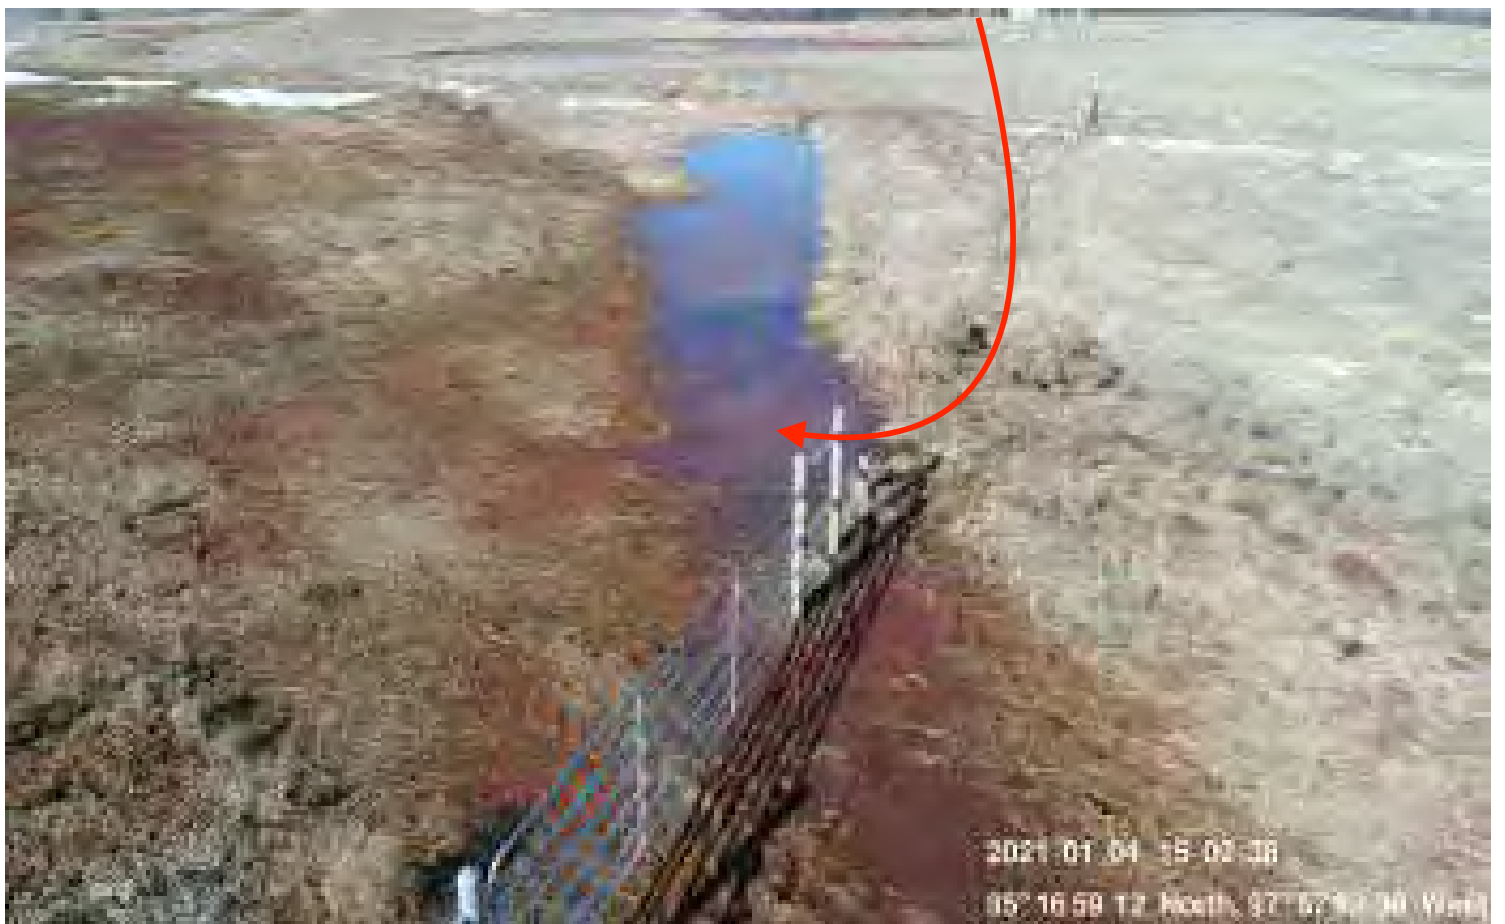
Drainage Issues and Lack of Revegetation

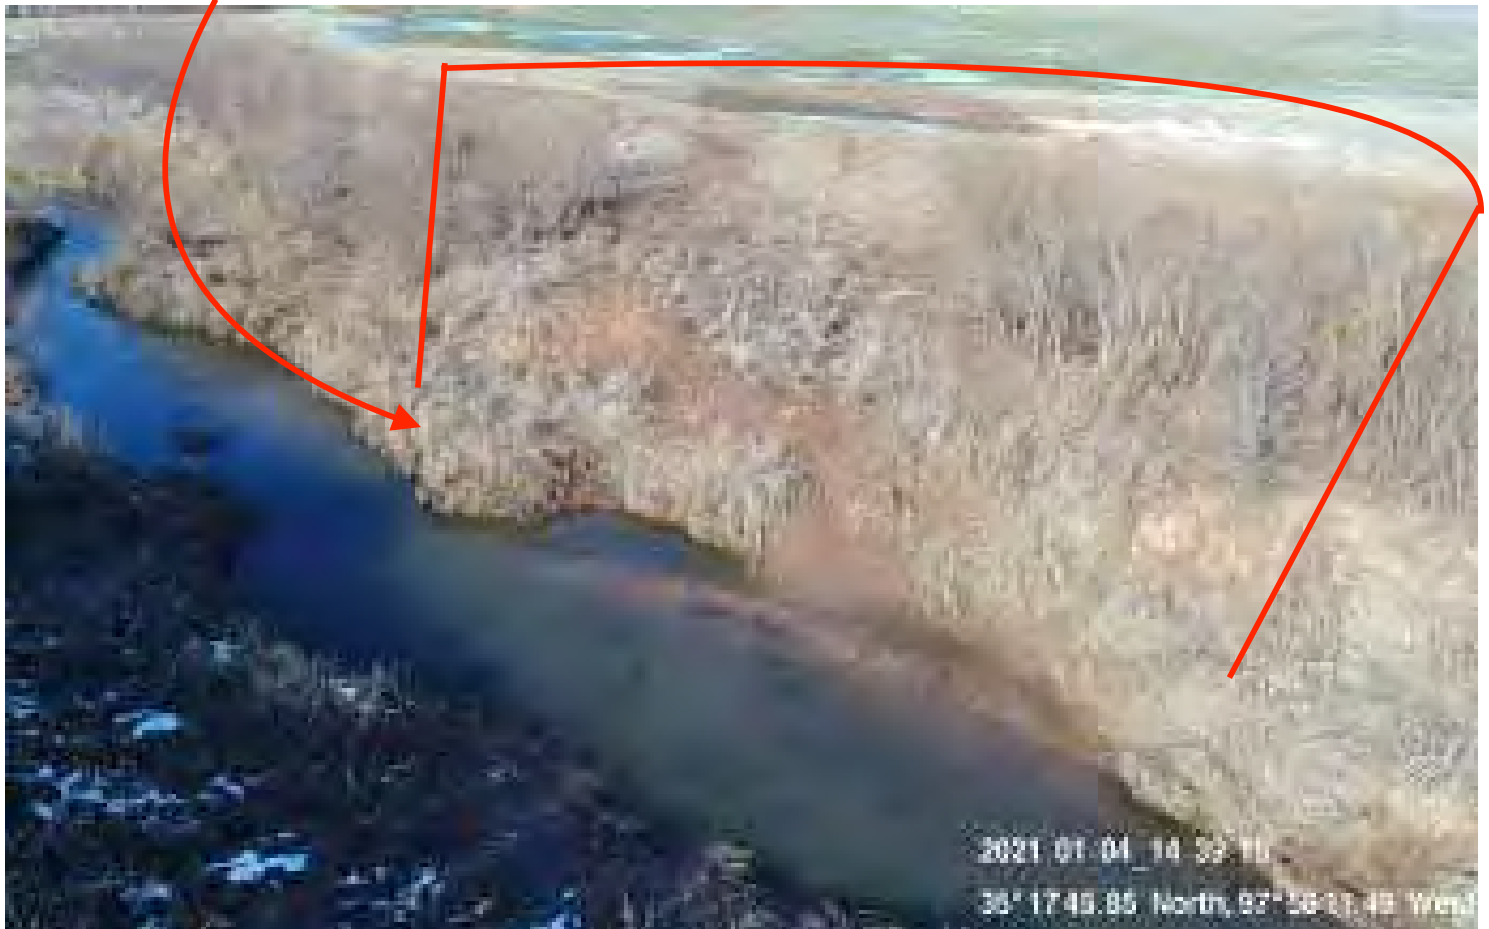
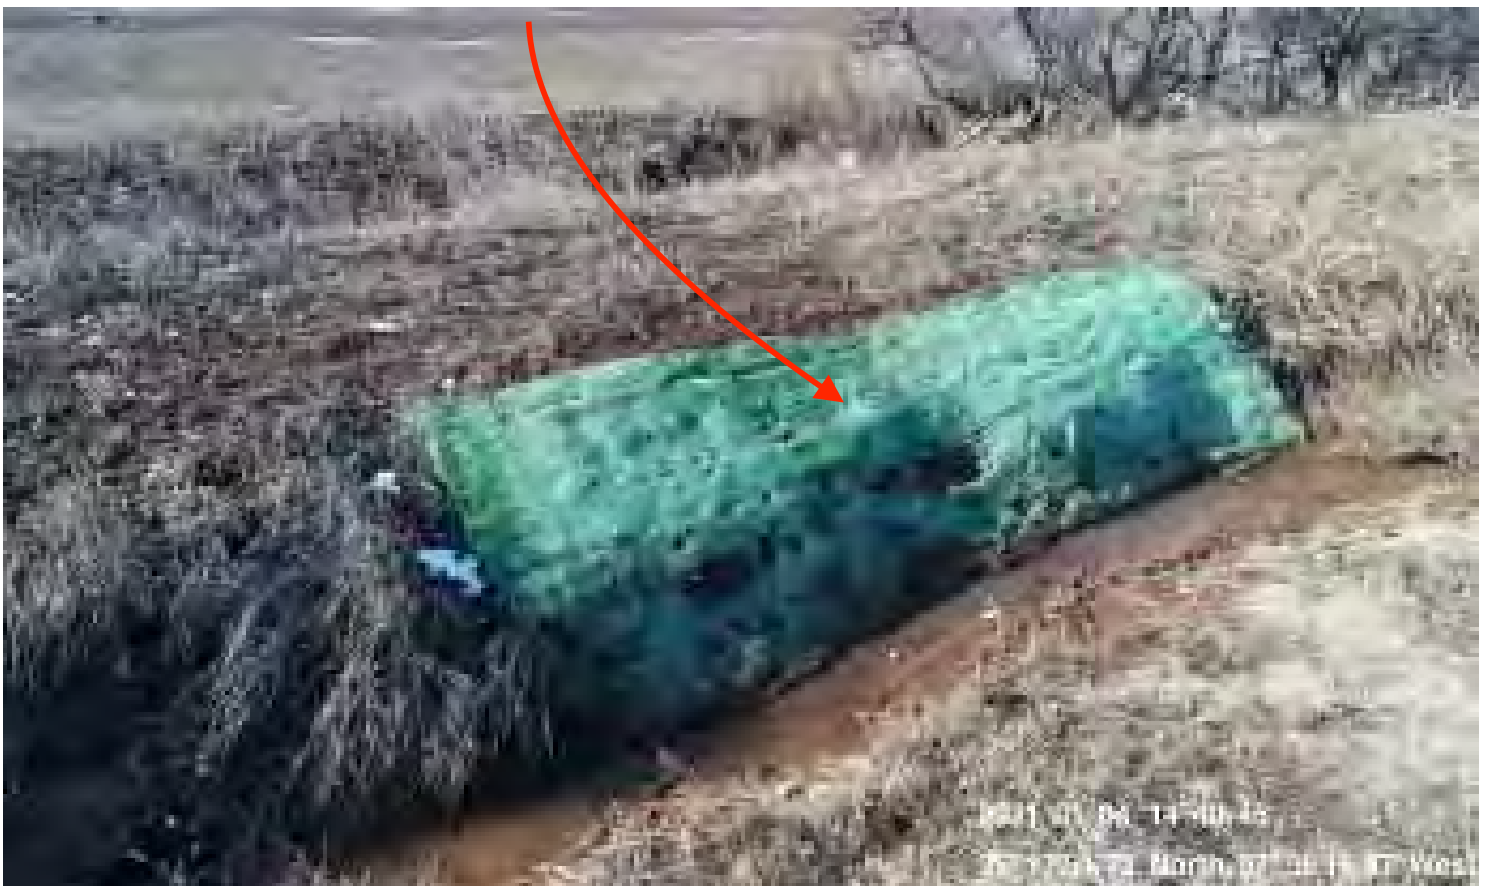
Chairman James Dandy states in the December 30, 2020 letter that during the compliance monitor's inspection Buggy Creek was stabilized and no further mitigation was needed. The FERC can make their own determination from the two photos below.

The Stream Will Need Additional Stabilization

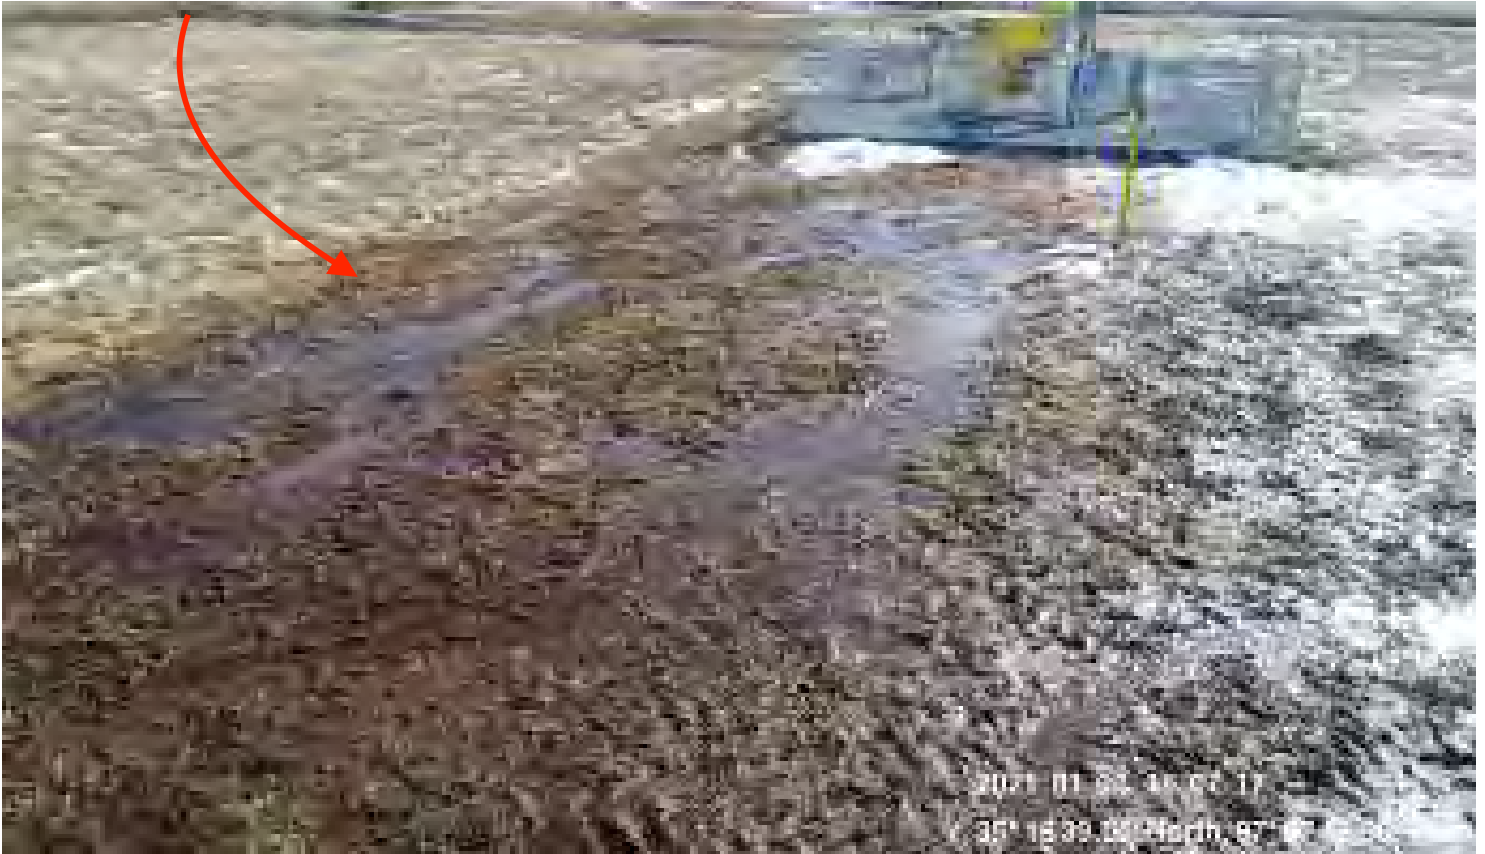
Chairman James Danly states the "topsoil was removed from the McComas' property at the Mainline Valve as the site required leveling, and excess soil had to be hauled offsite; leaving it onsite would not allow the surrounding area to be restored to the appropriate grade." The photos below show differently

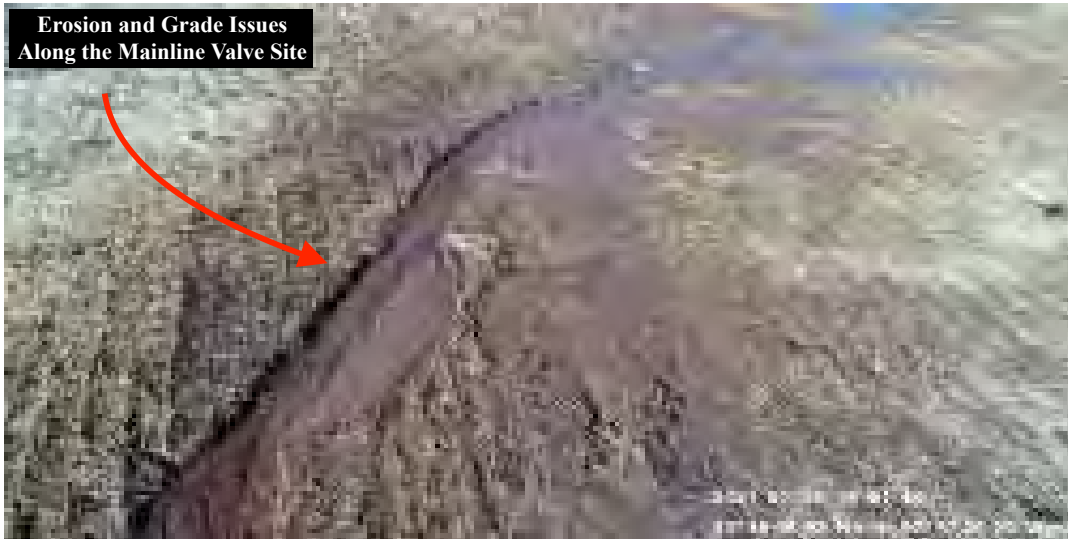
**Erosion and Grade Issues
Along the Mainline Valve Site**

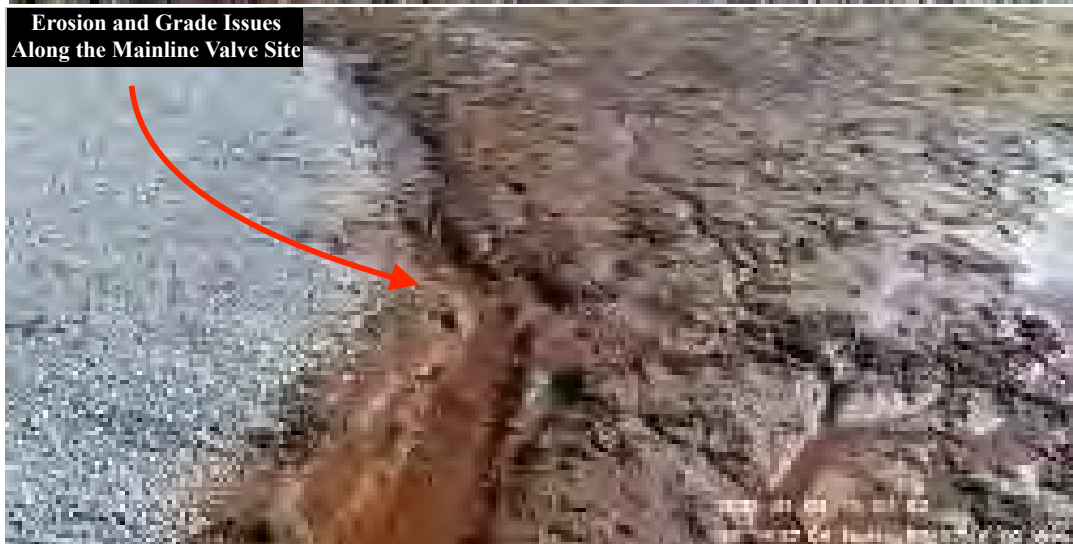
**Erosion and Grade Issues
Along the Mainline Valve Site**

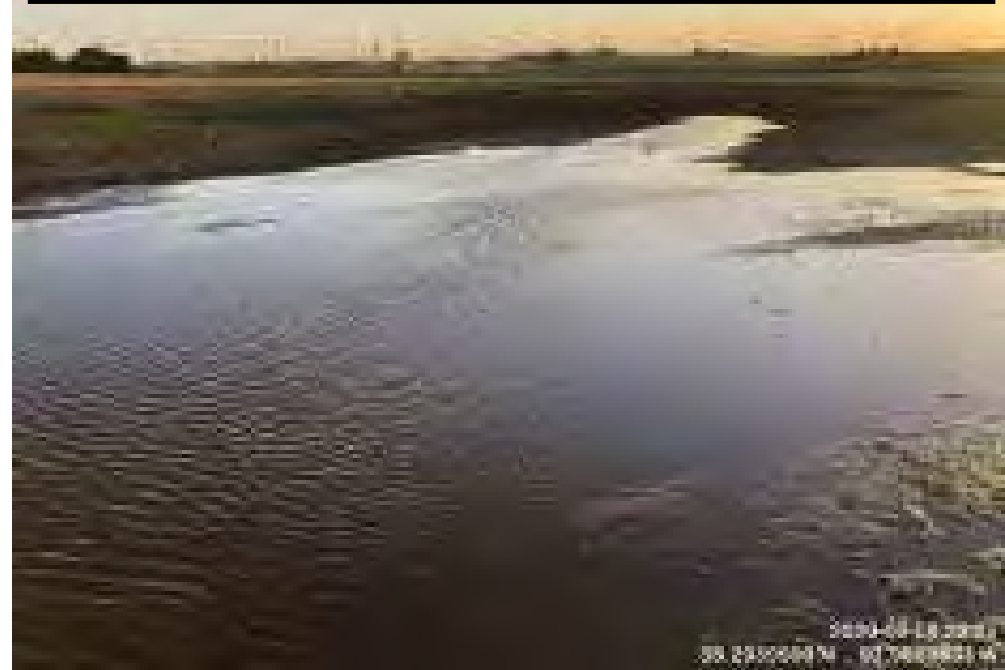
Large Area of Off-ROW Ponding Due to Impacted Drainage
