Robert Squires - Squires Consulting LLC
Landowner Advocate

Opening Statement for May 5, 2021 Subcommittee on Civil Rights and Civil Liberties Hearing:
“Pipelines Over People (Part II): Midship Pipeline’s Disregard for Landowners in Its Pathway”

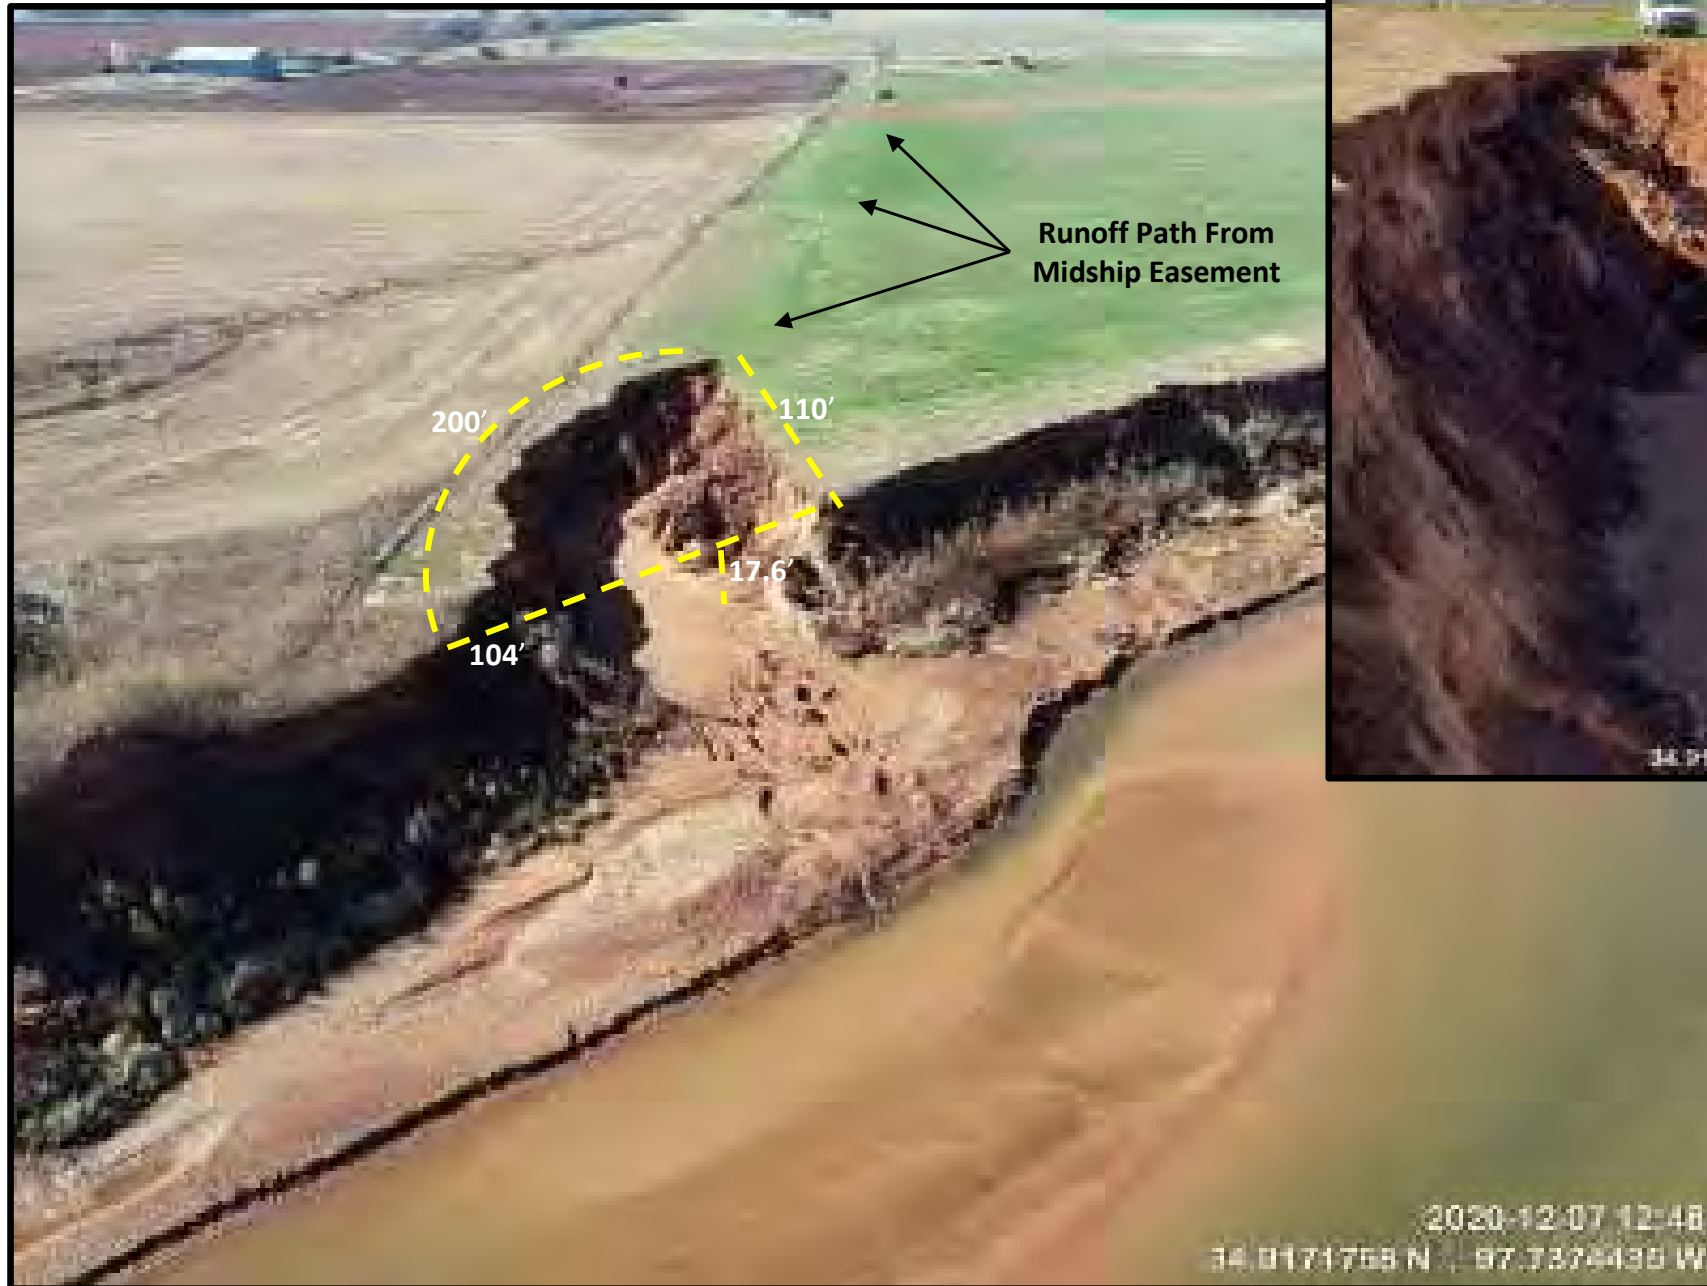
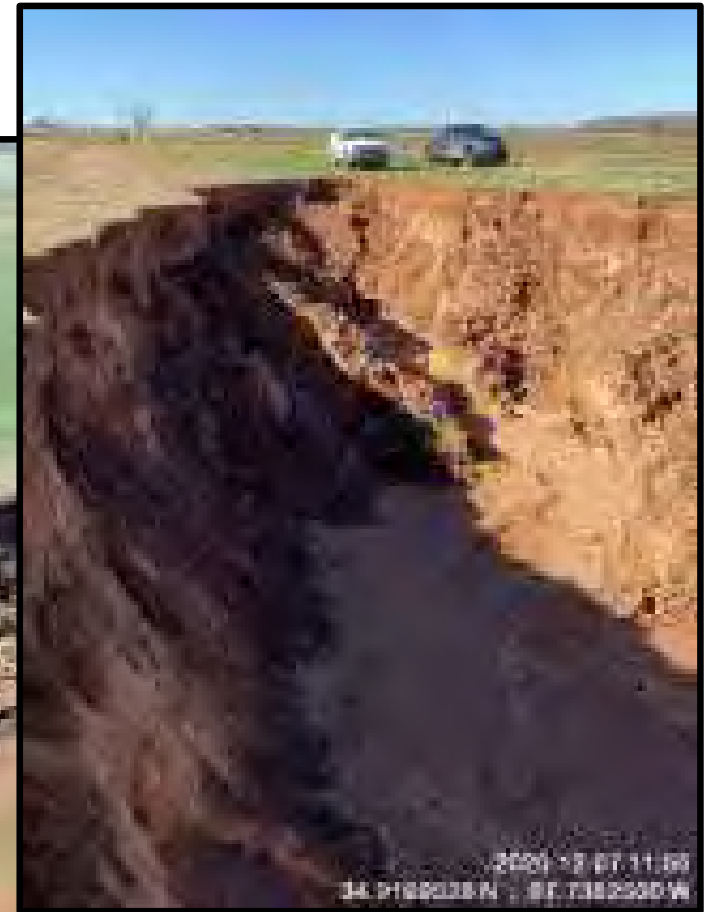
JAMES MCELVANY. TRACT GR-0310.000 (BANK EROSION ON ADJACENT OFF-LINE PROPERTY)

Approximately 3,000 Cubic Yards of Soil Will Be Needed to Fill Riverbank Erosion. Additional Stabilization and Drainage Measures May Be Needed to Avoid Erosion After Restoration.

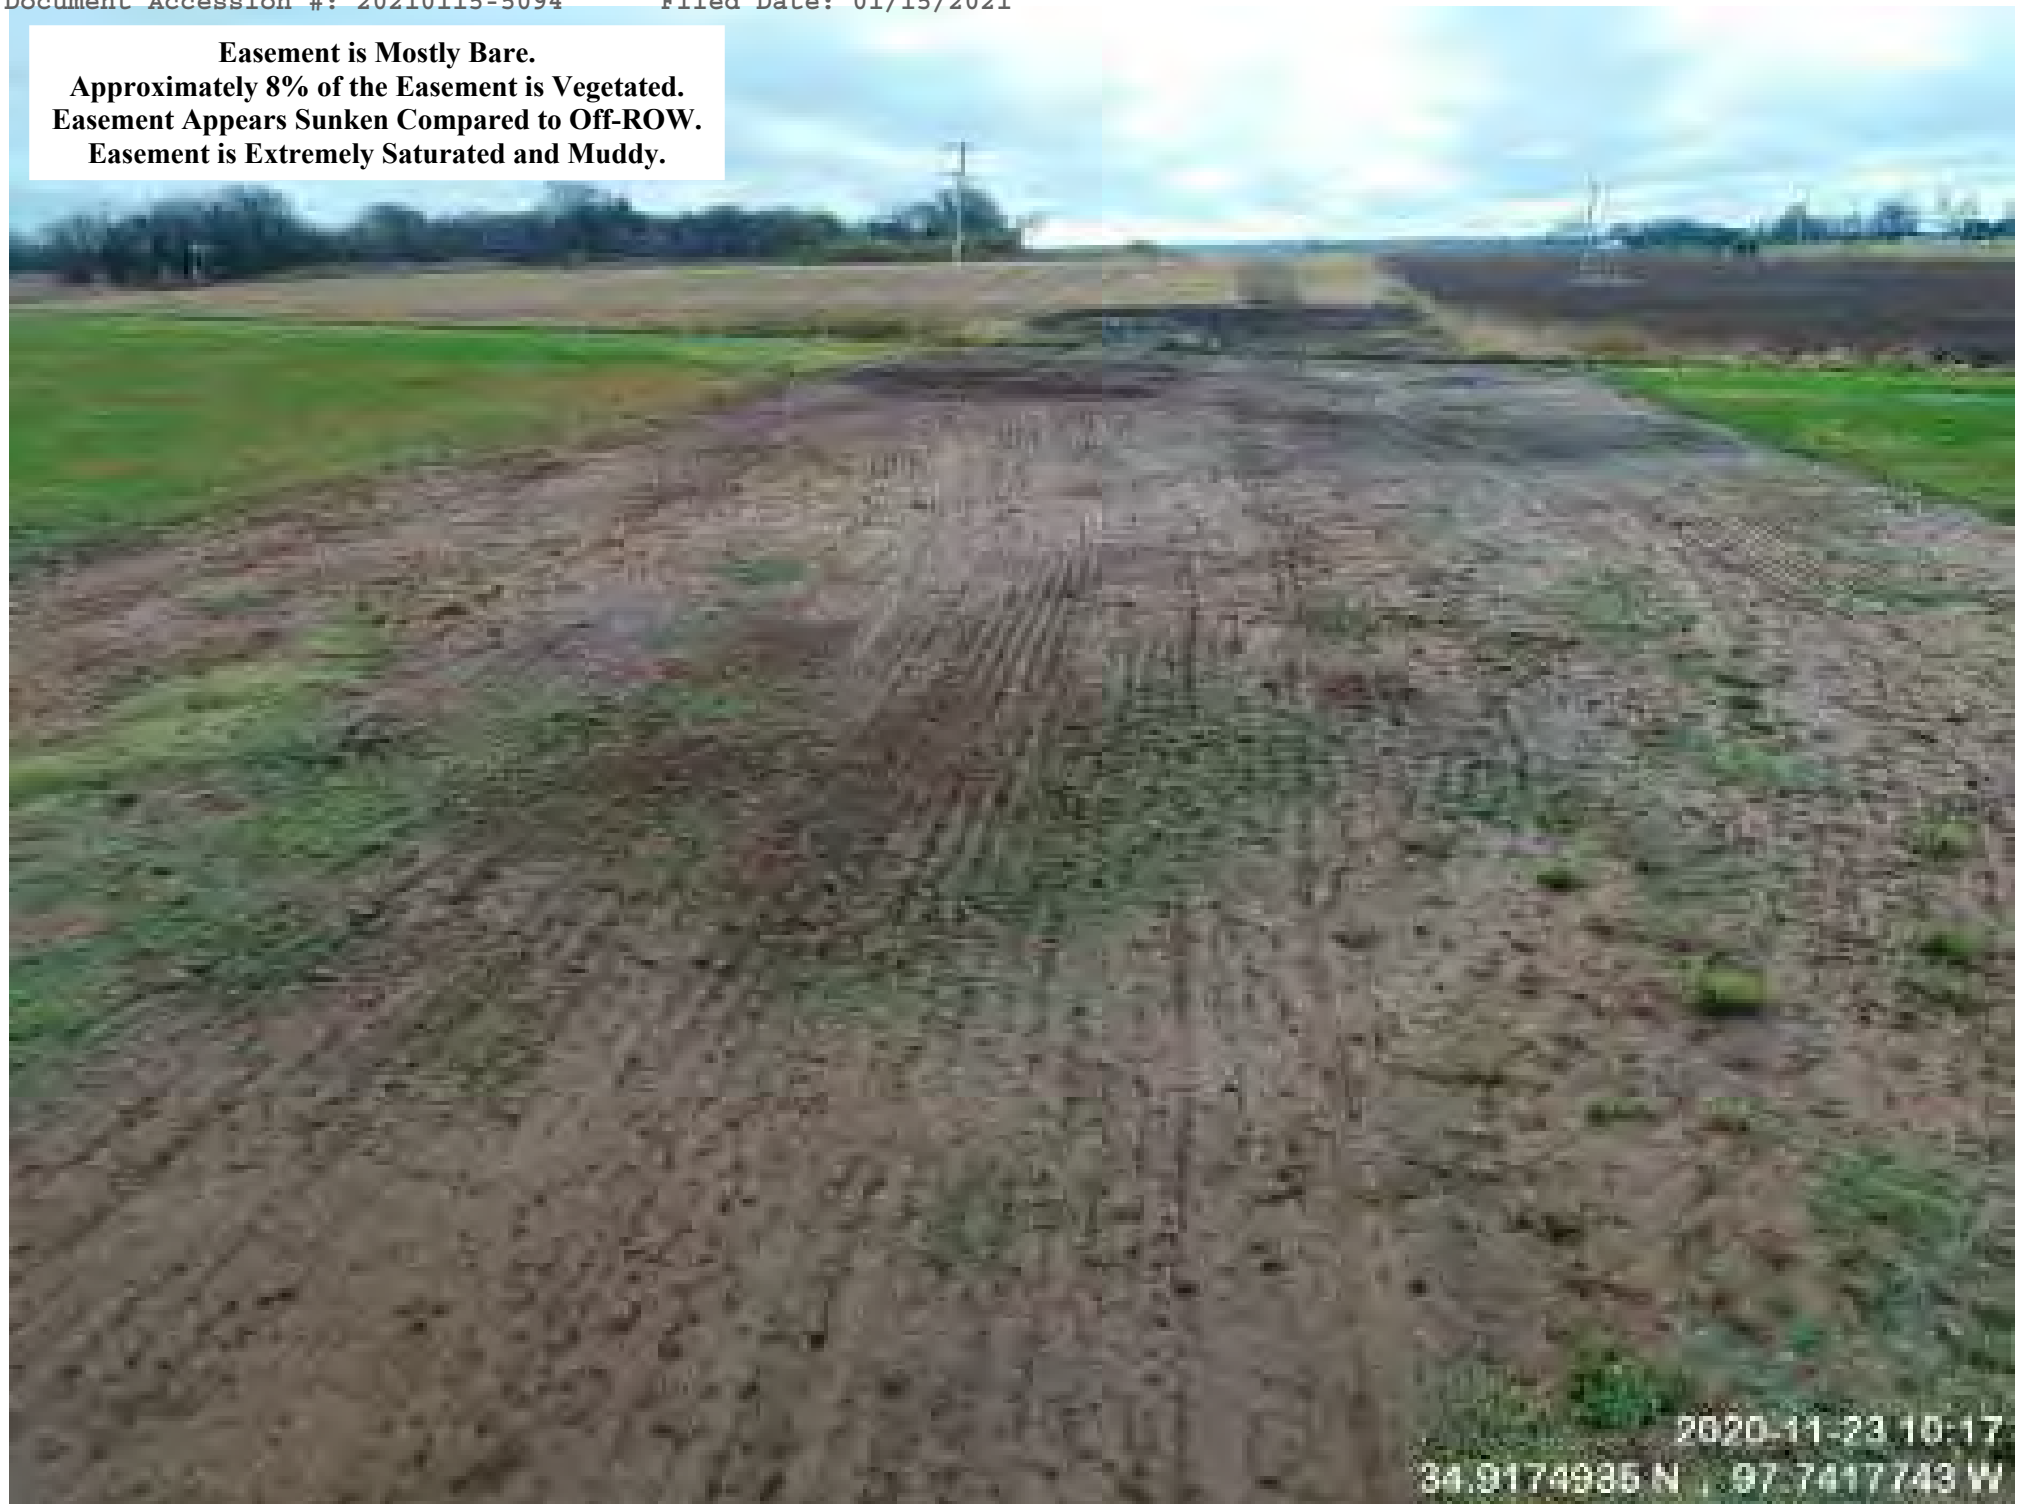
**Easement is Mostly Bare.
Approximately 8% of the Easement is Vegetated.
Easement Appears Sunken Compared to Off-ROW.
Easement is Extremely Saturated and Muddy.**

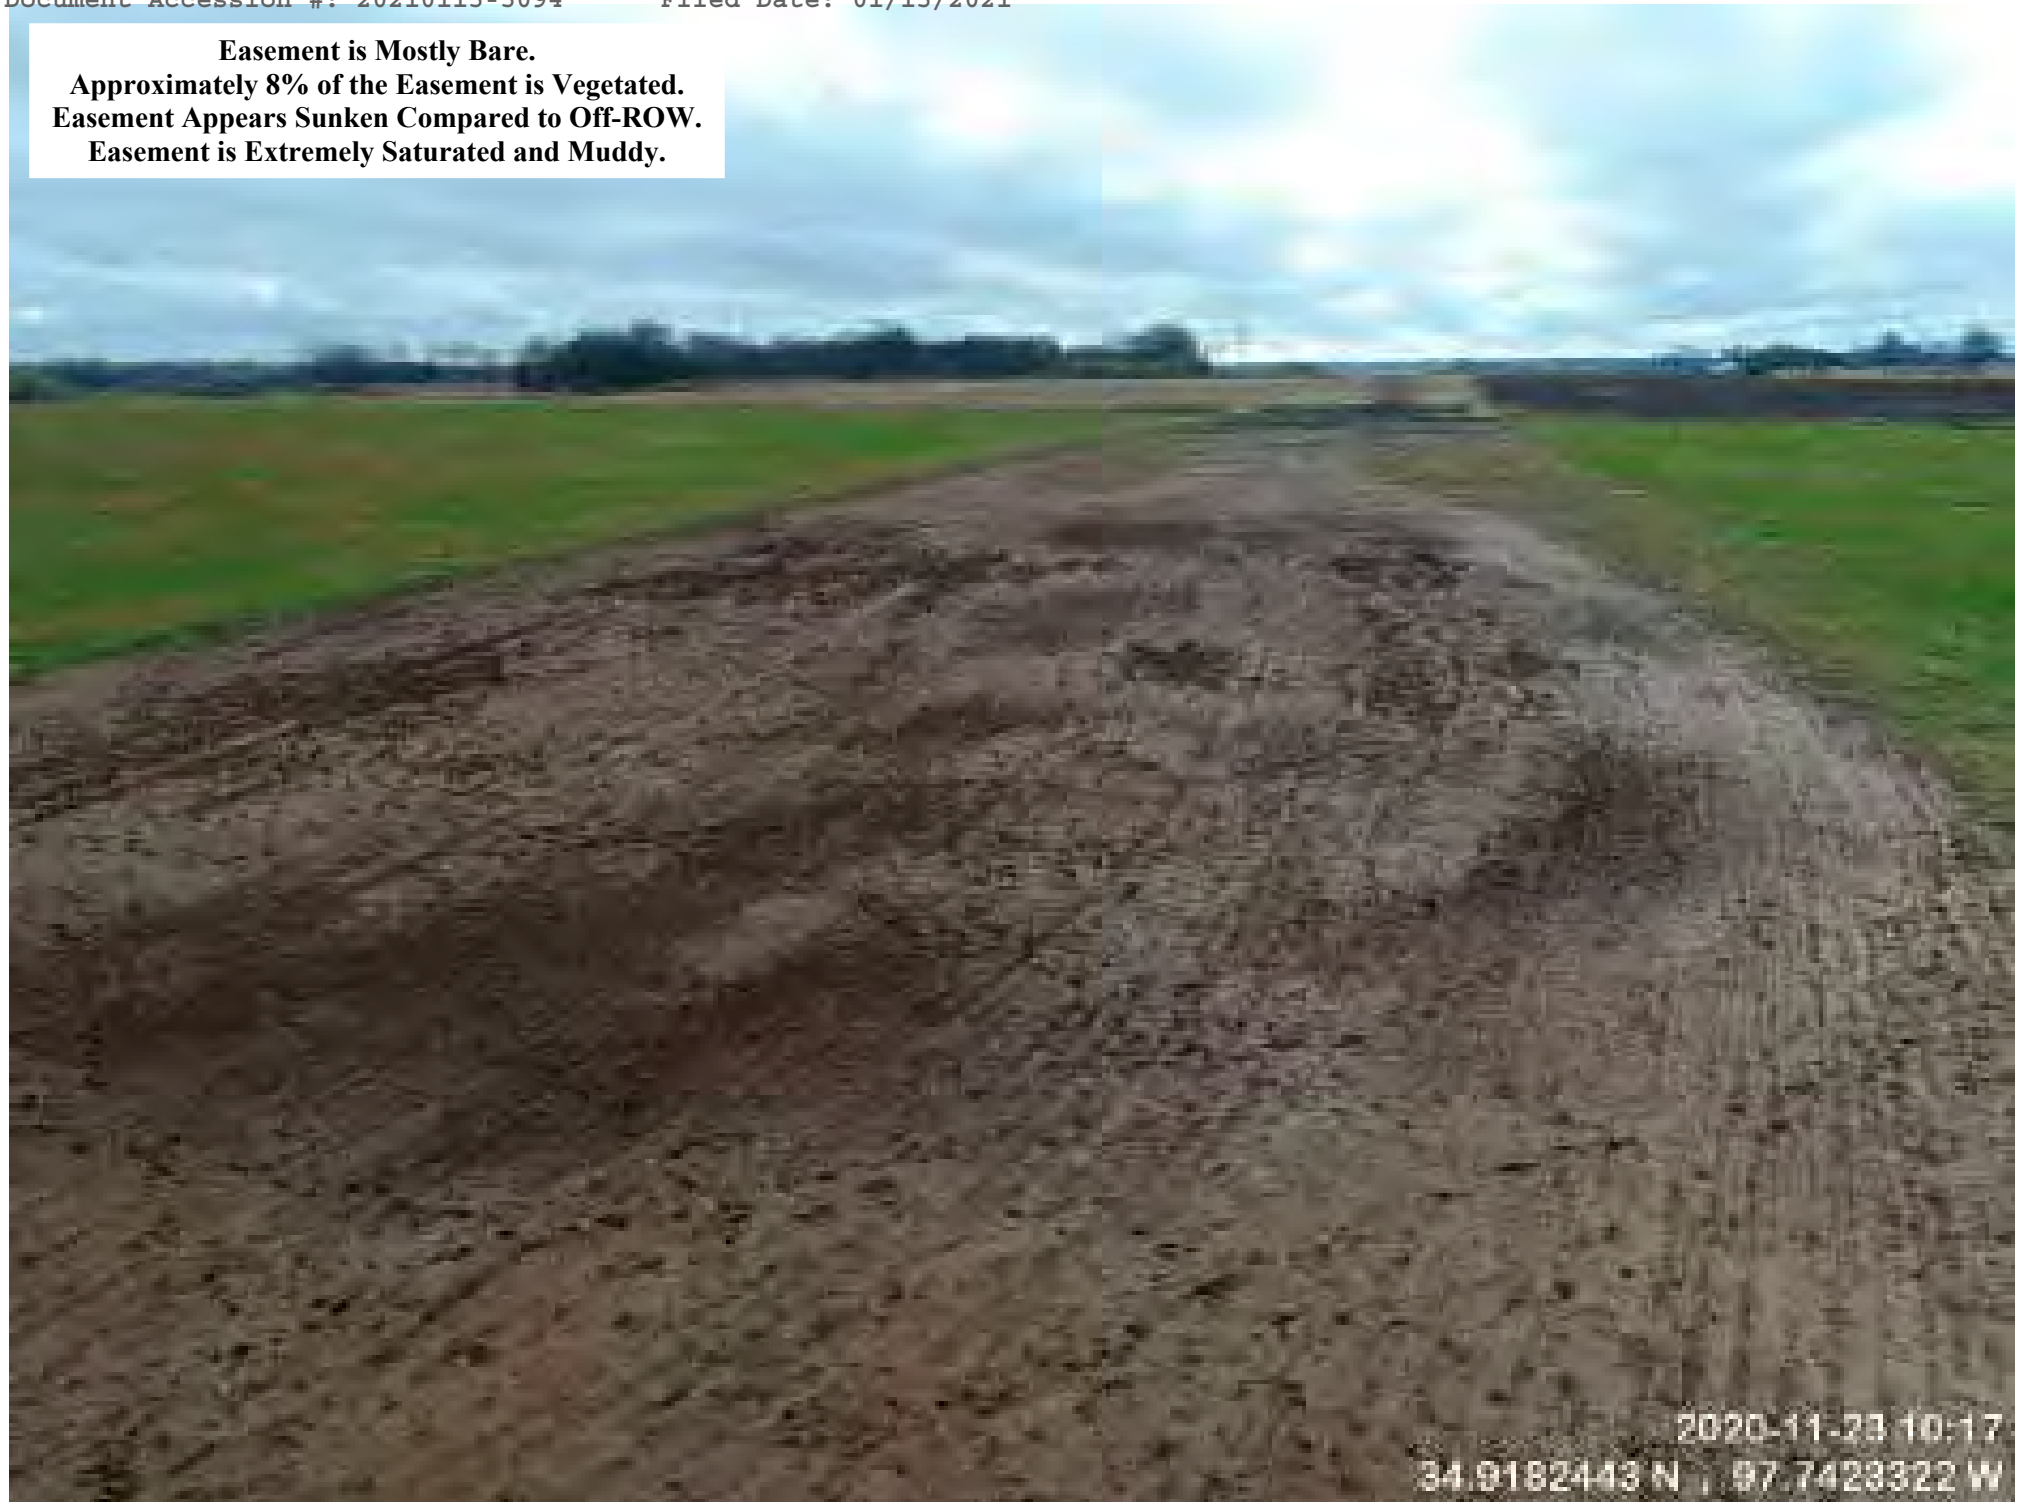
Easement is Mostly Bare.
Approximately 8% of the Easement is Vegetated.
Easement Appears Sunken Compared to Off-ROW.
Easement is Extremely Saturated and Muddy.

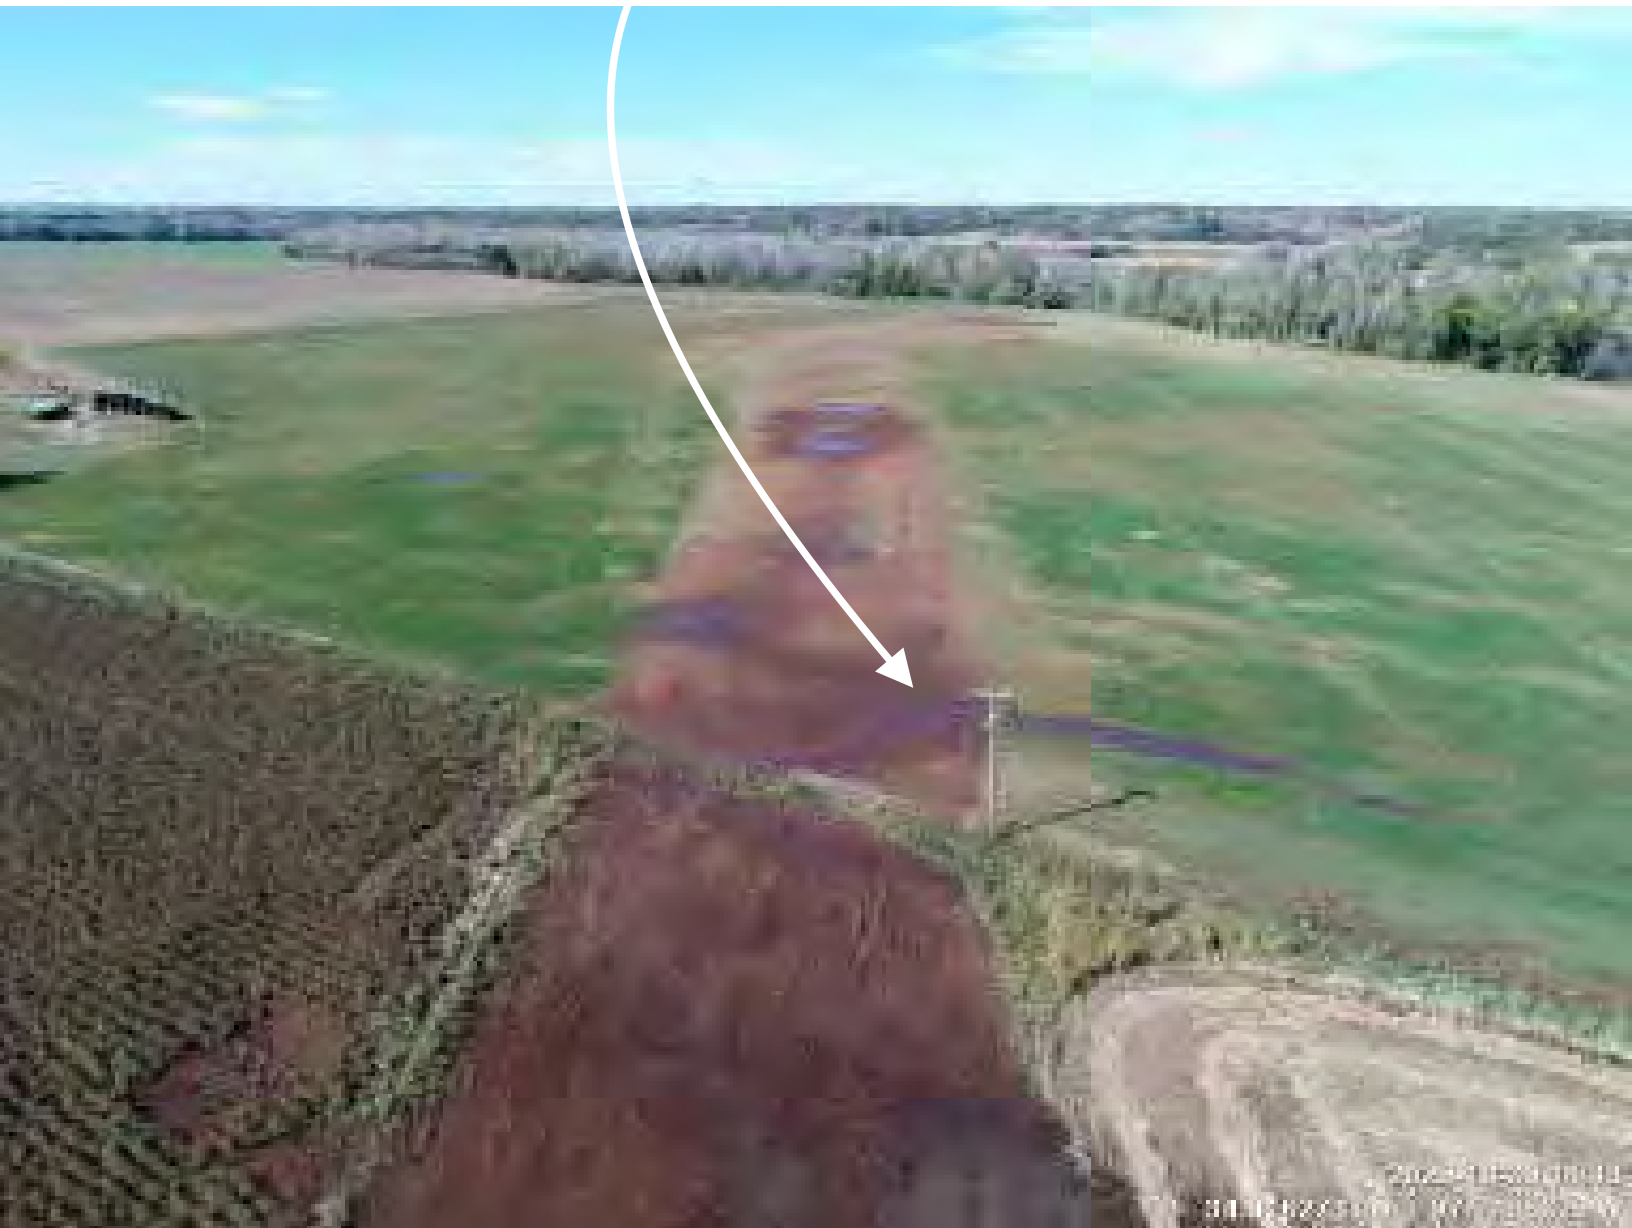
**Lack of Vegetation, Drainage Issues Causing Erosion and
Runoff Patterns Towards Washita River**

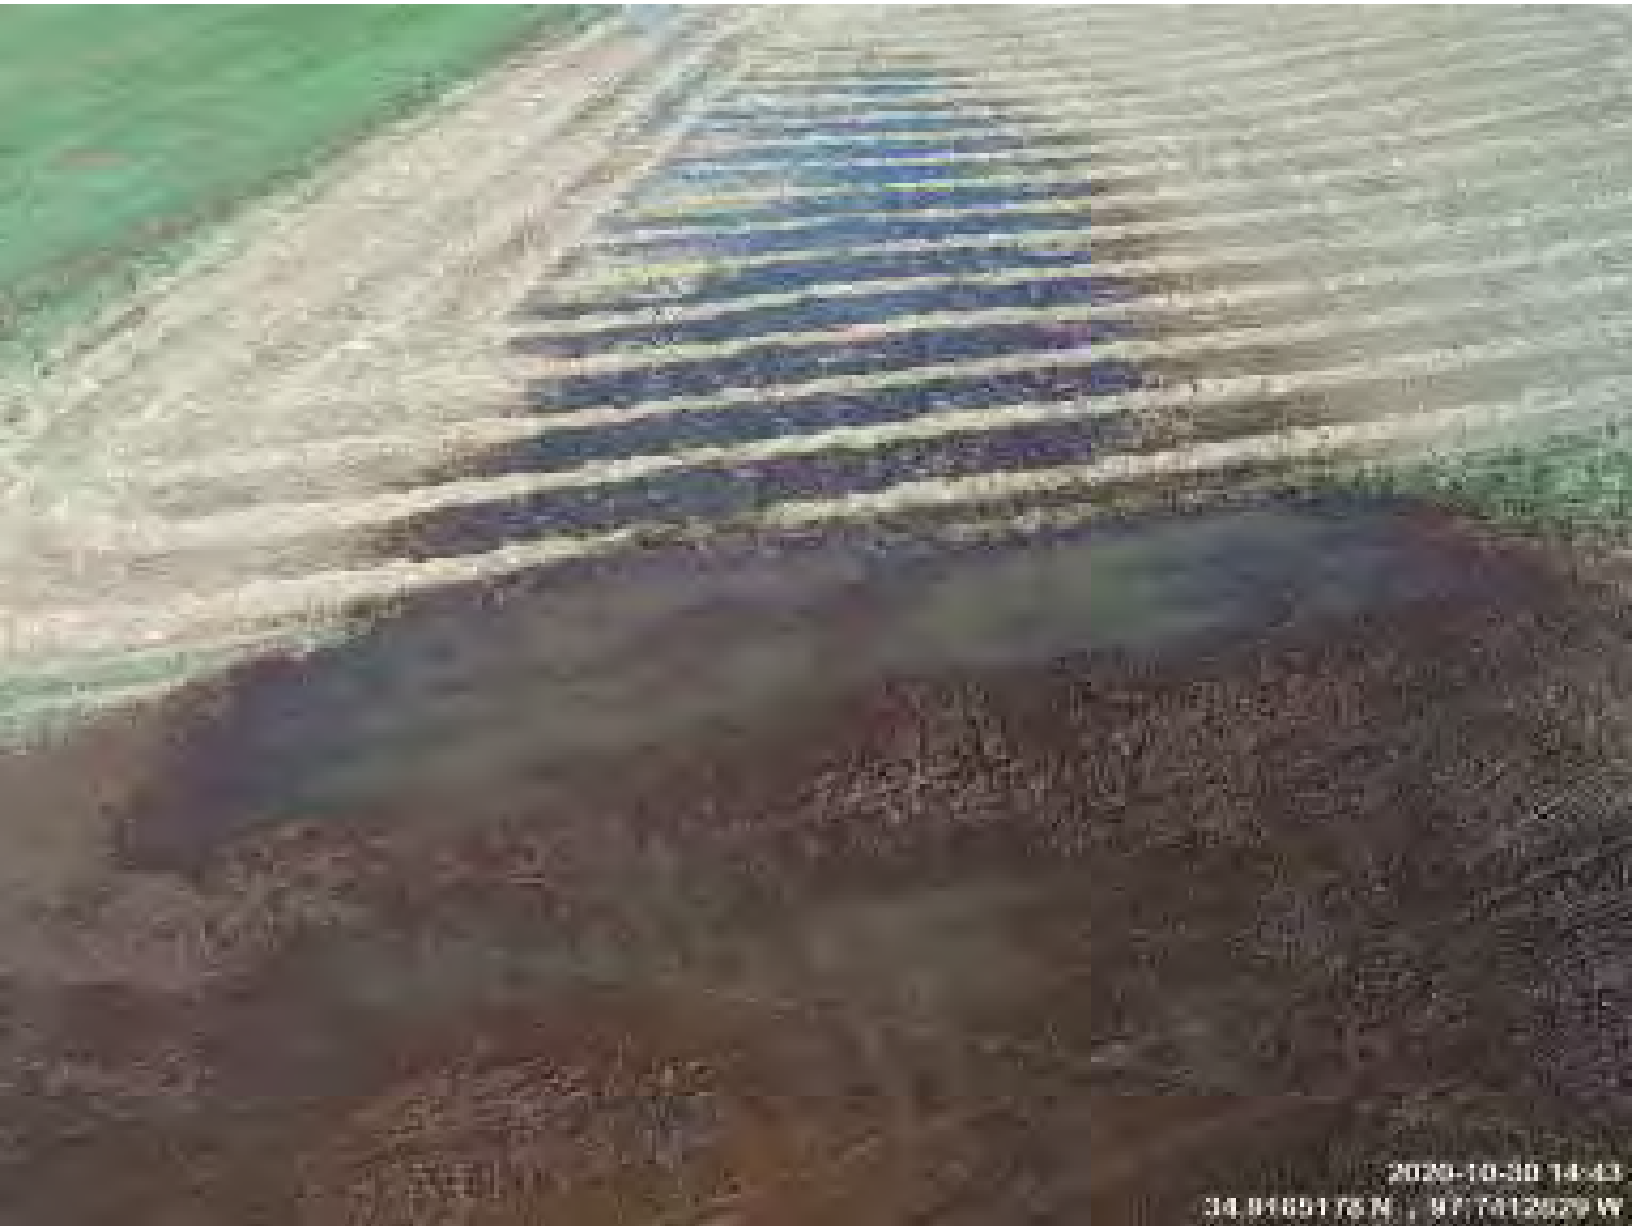
Off-Row Ponding , Grade and Drainage Issues

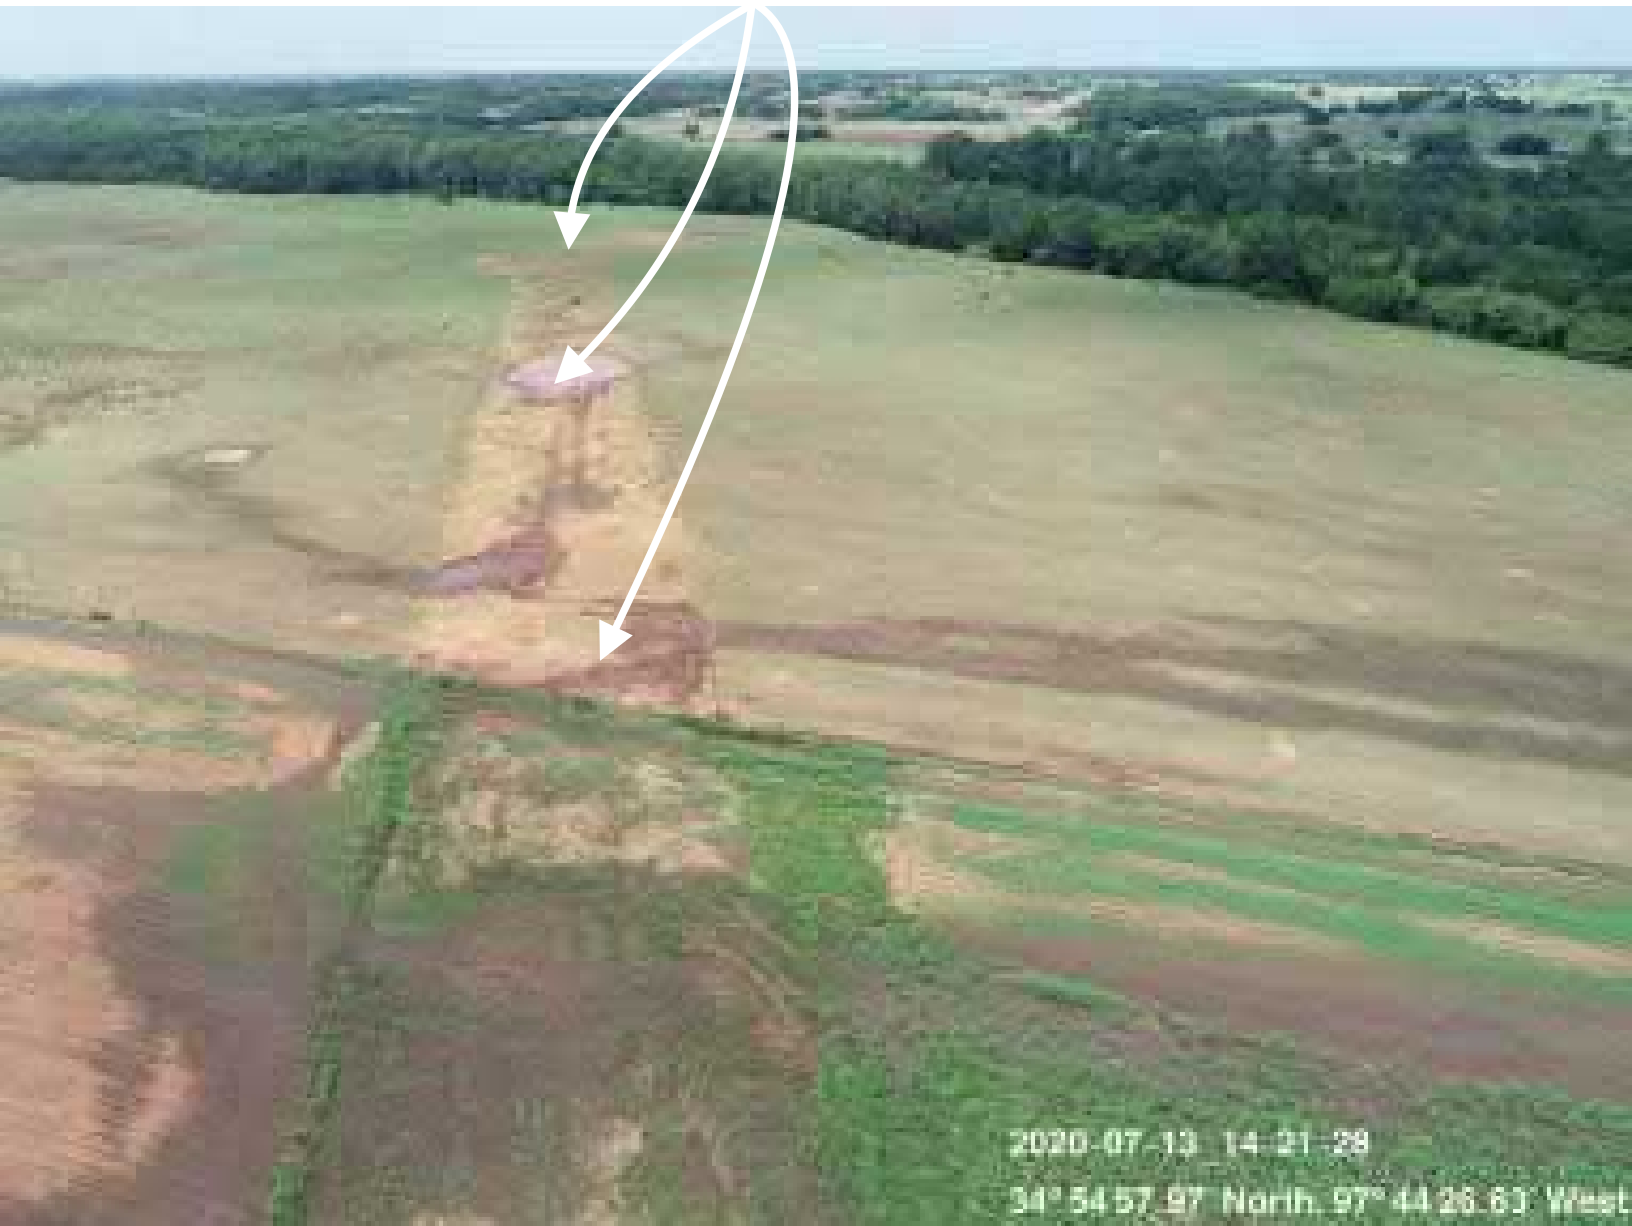
**Lack of Vegetation, Drainage Issues Causing Erosion and Runoff
Patterns, Grade has been Altered, Topsoil Importation and Grading
Work Will Be Required**

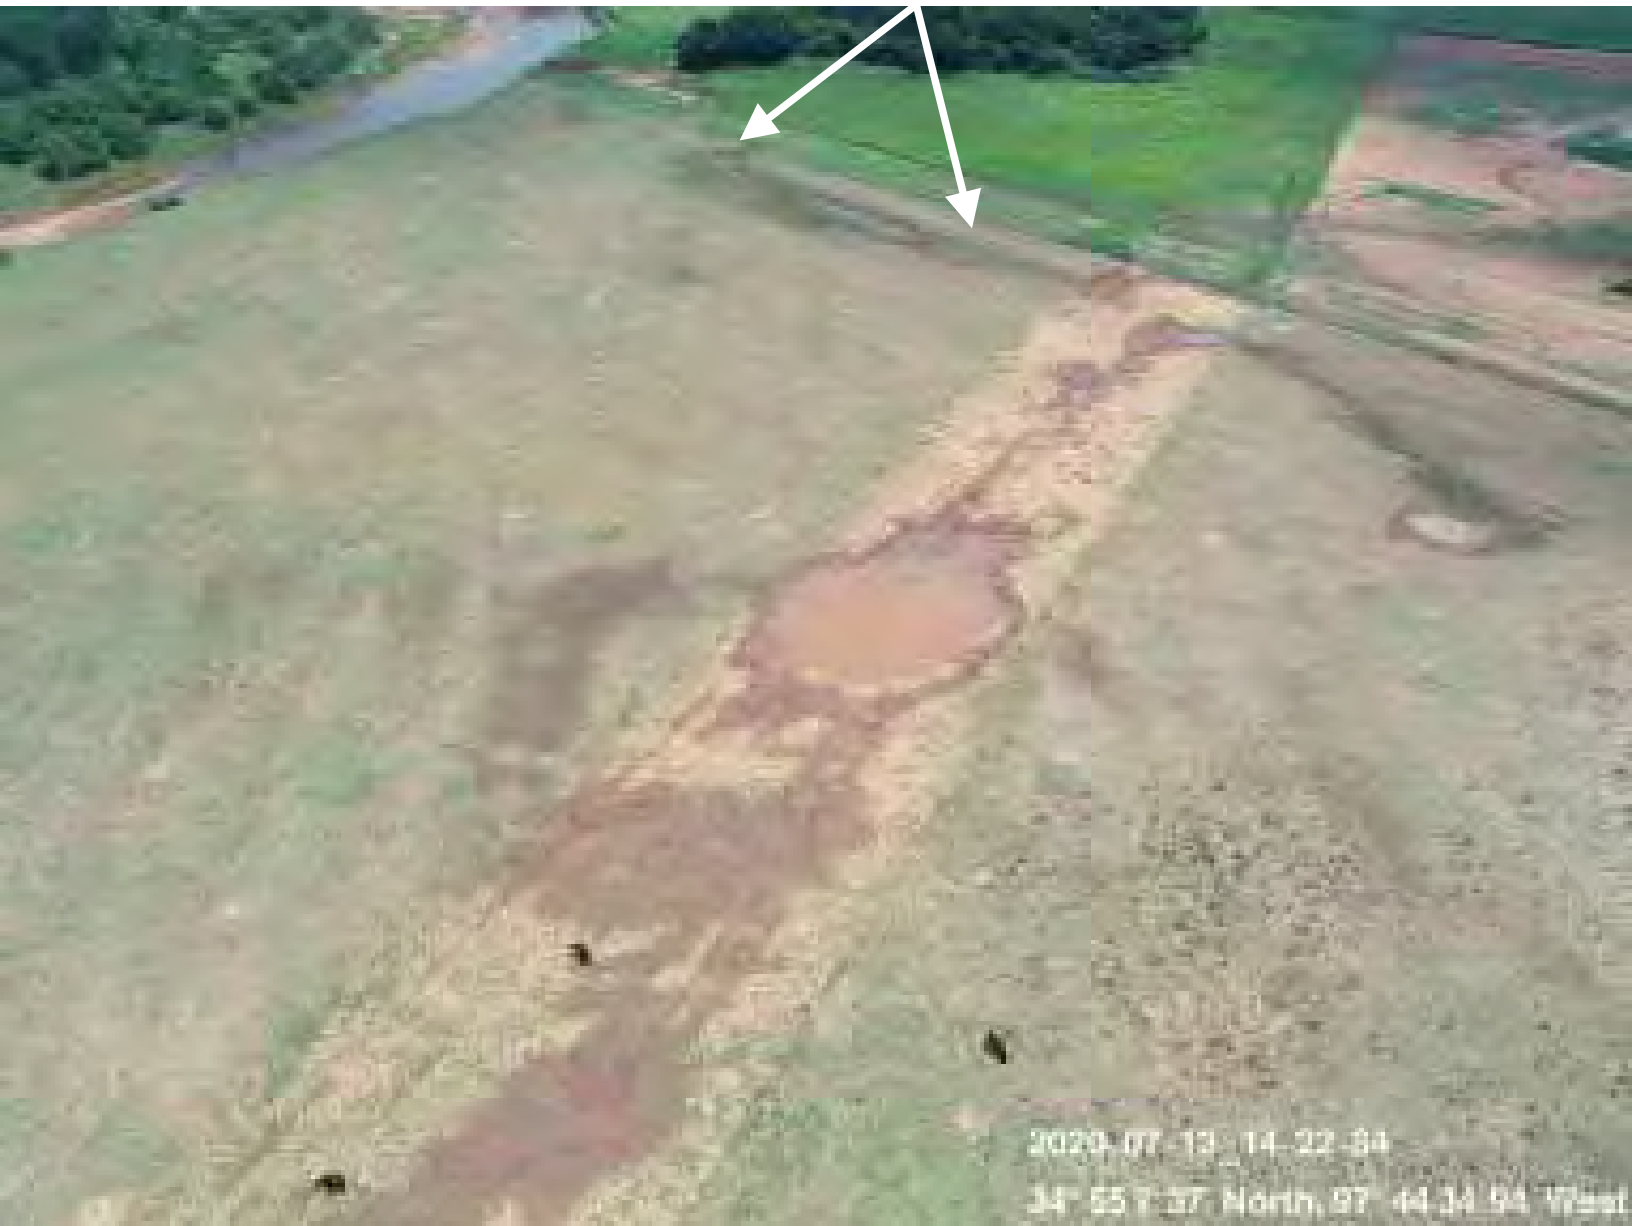
**Lack of Vegetation, Drainage Issues Causing Erosion and Runoff
Patterns Towards Washita River**

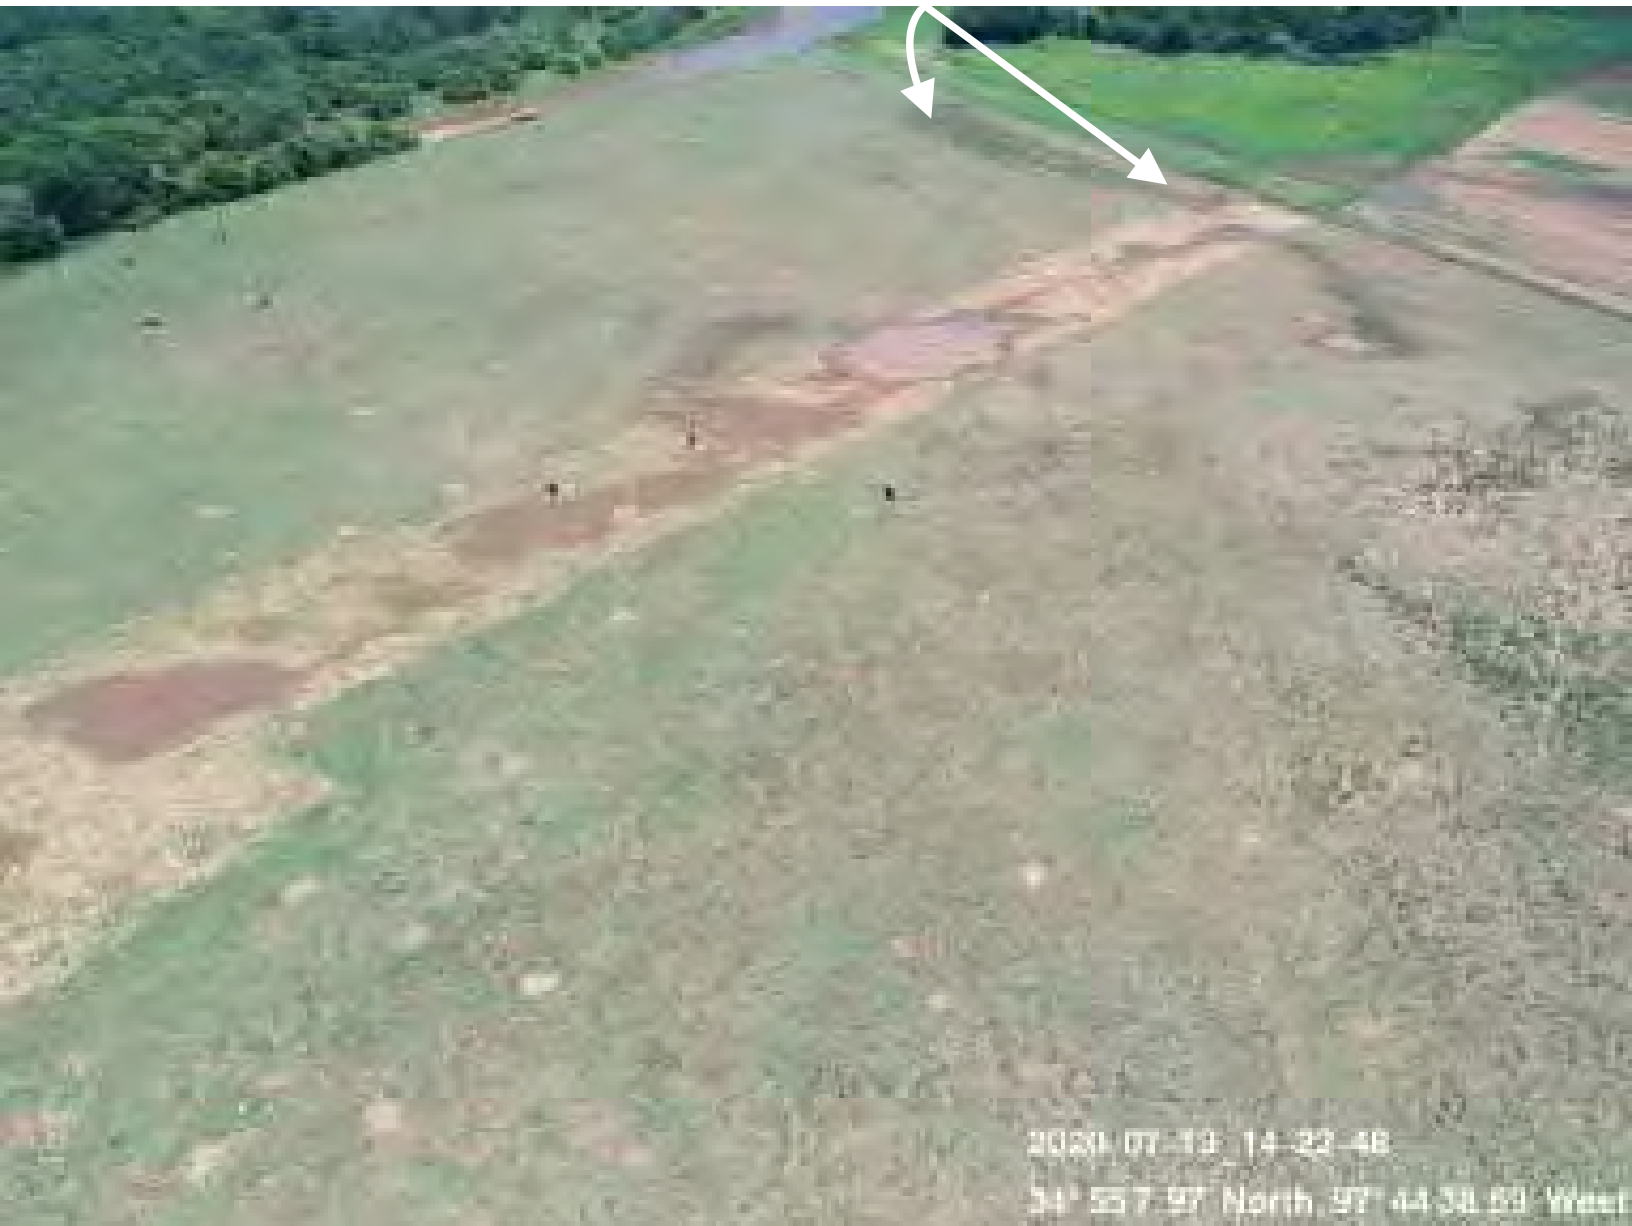
**Lack of Vegetation, Drainage Issues Causing Erosion and
Runoff Patterns Towards Washita River**

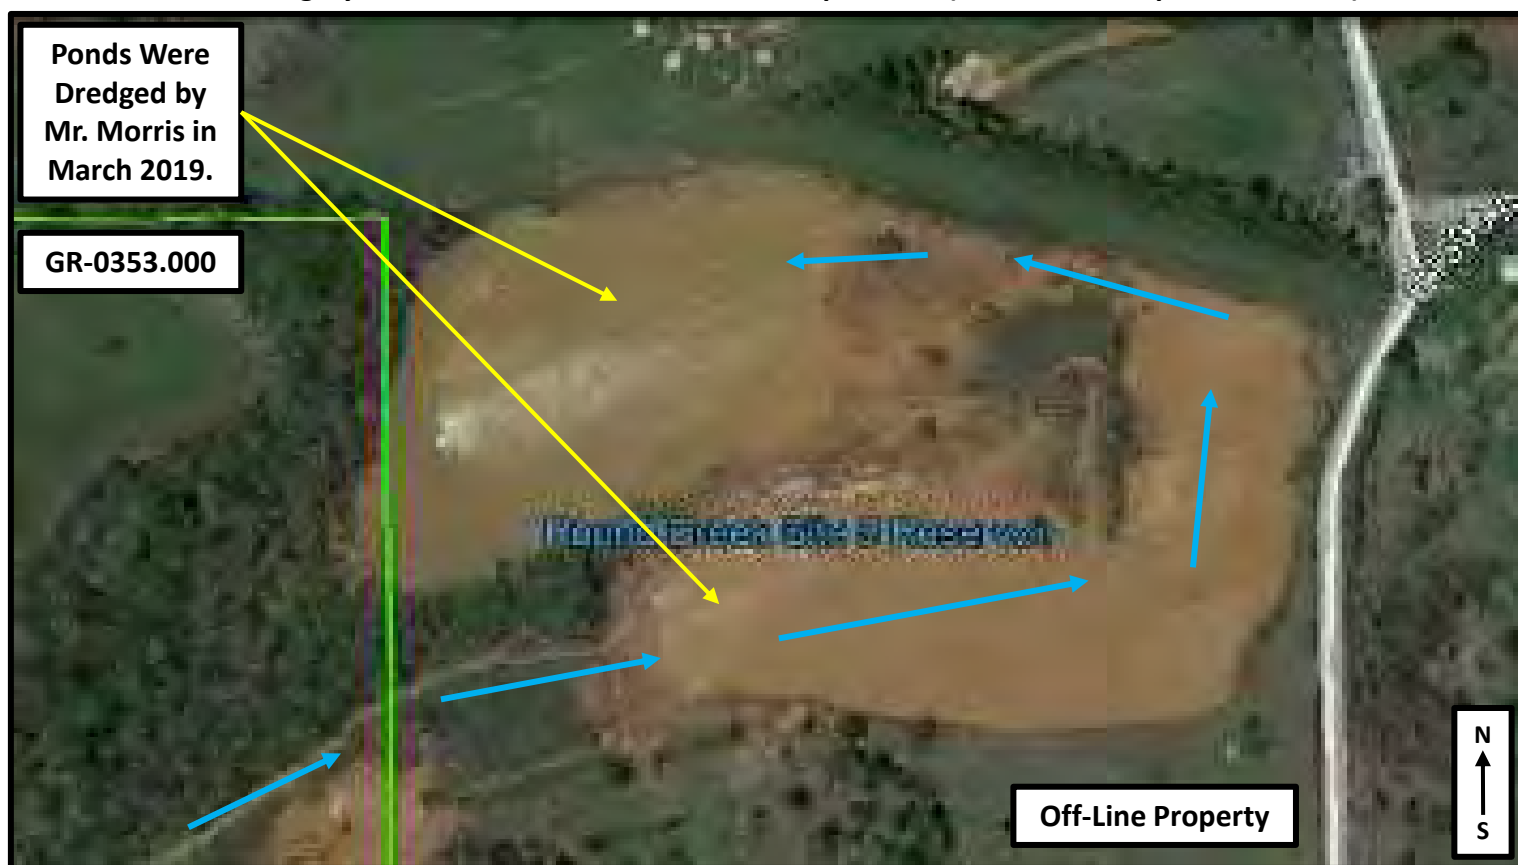
MARK MORRIS, TRACT GR-0353.000 & ADJACENT OFF-LINE PROPERTY

Aerial Imagery of Flood Control Reservoirs from December 11, 2020.
