Robert Squires - Squires Consulting LLC
Landowner Advocate

Opening Statement for May 5, 2021 Subcommittee on Civil Rights and Civil Liberties Hearing:
“Pipelines Over People (Part II): Midship Pipeline’s Disregard for Landowners in Its Pathway”

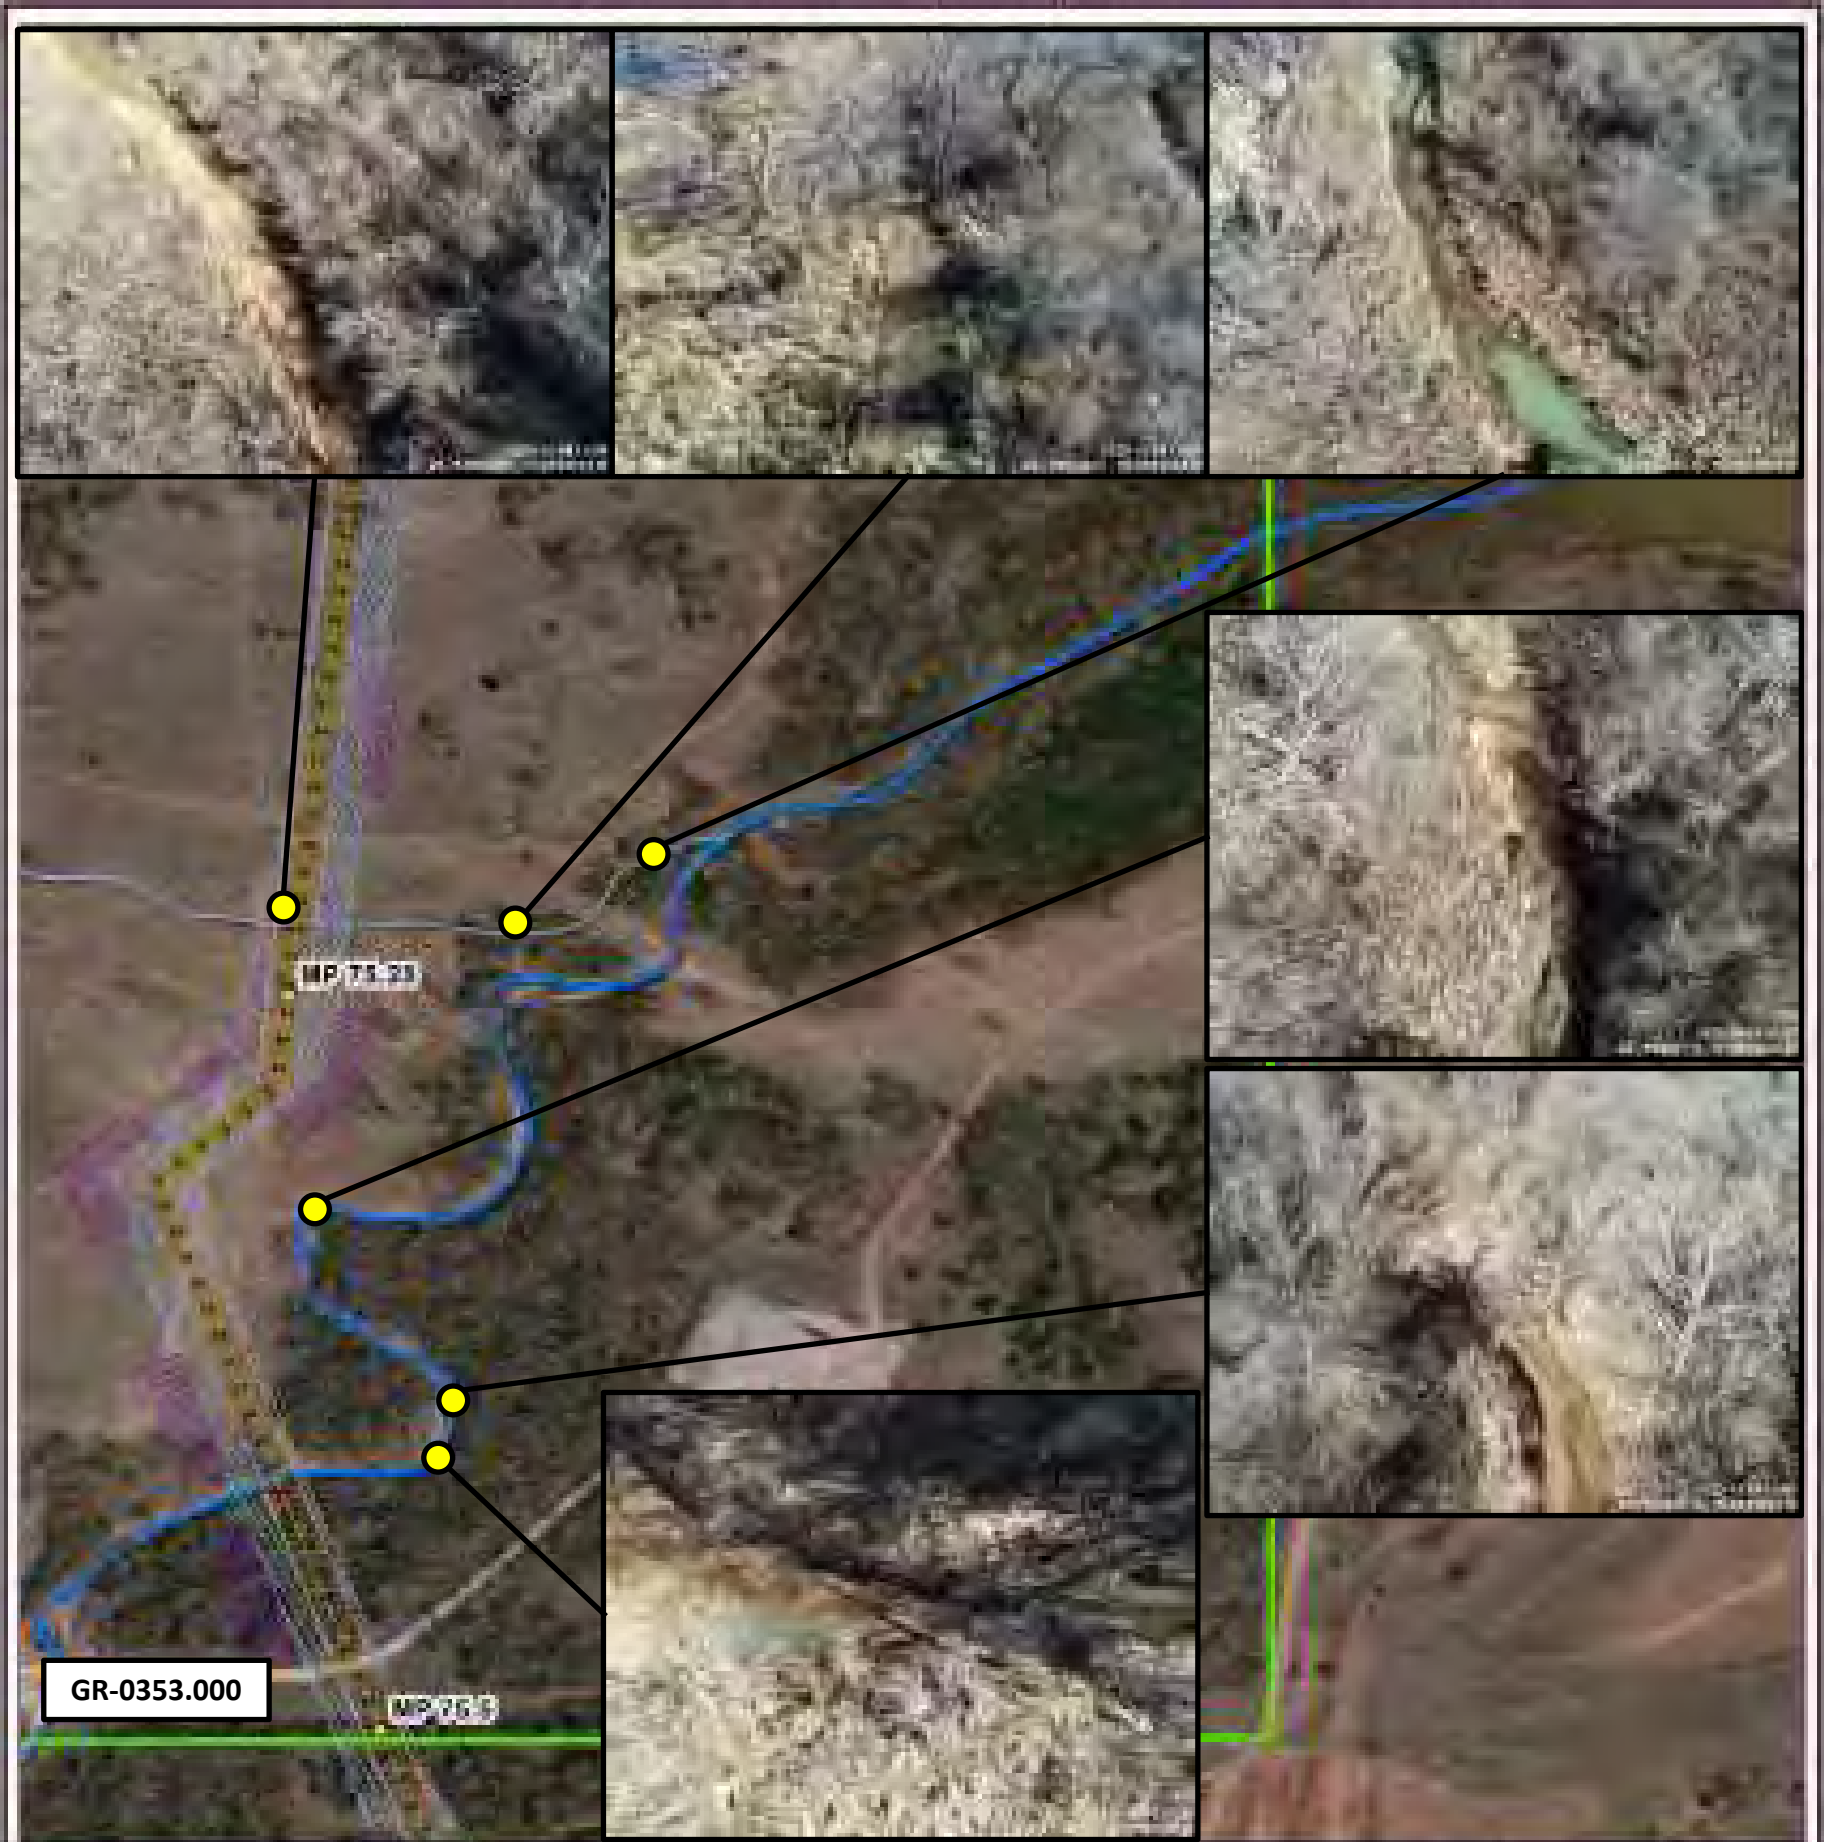
12. The bottom agriculture land is extremely saturated blocking the landowner from crossing, temporary removal of saturated soils and replacement approximately four acres.

"Removed debris; repaired grading and ponding issues; stabilized tract (completed 11/07/20). Midship meeting scheduled with Mr. Morris on December 9, 2020 to identify and discuss any remaining issues."

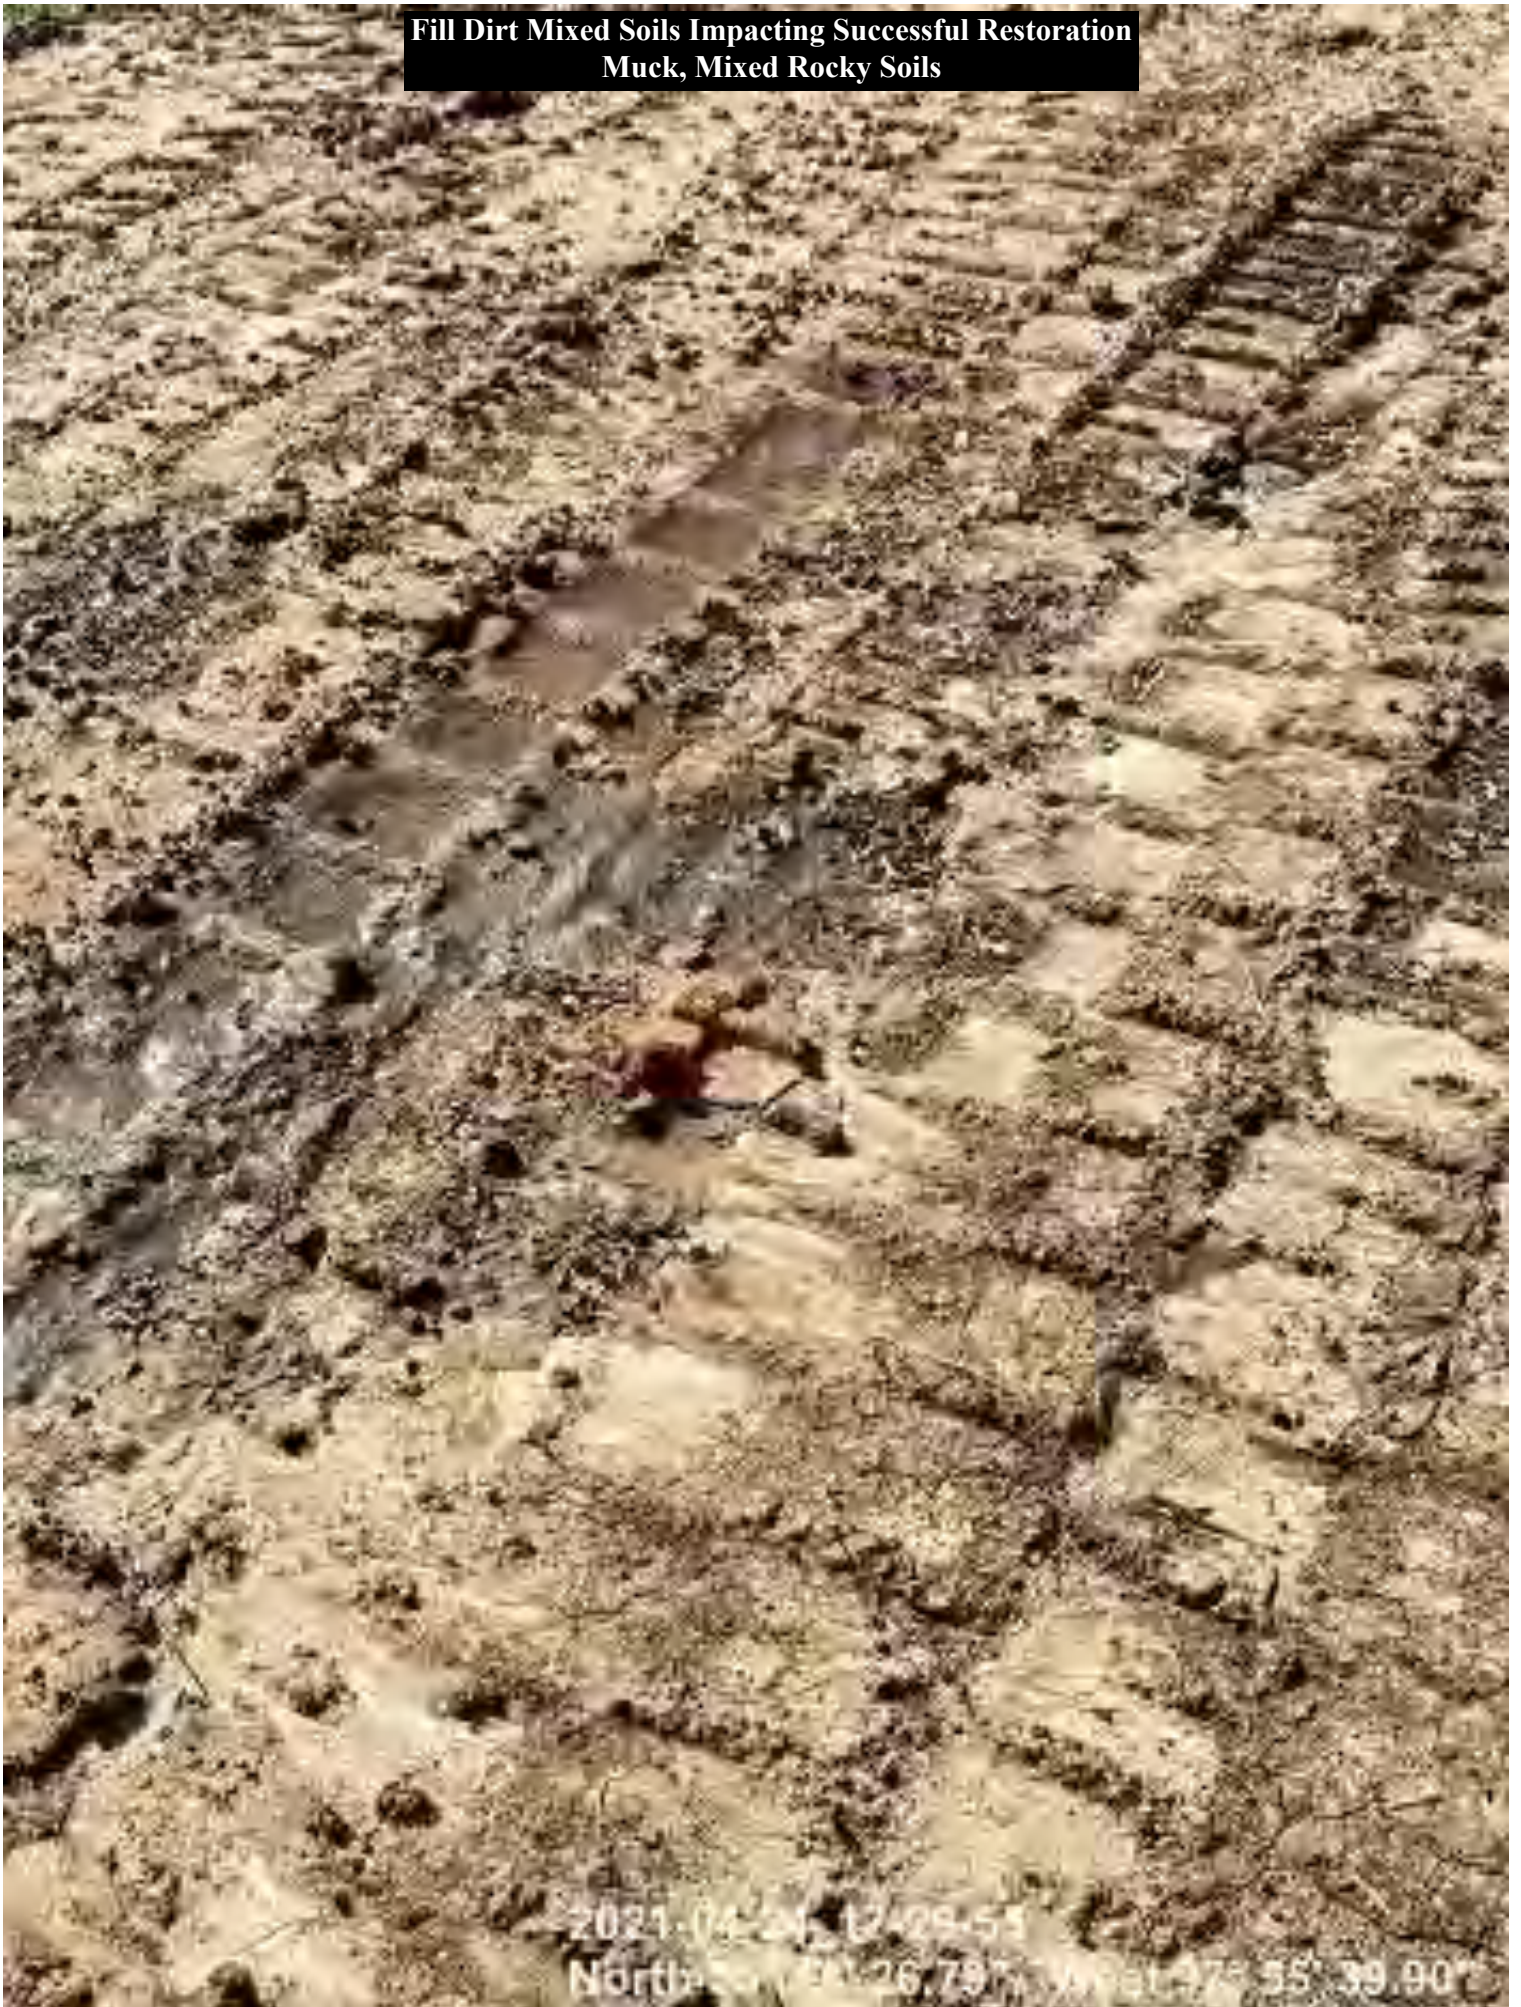
North 35° 14' 26.20" West 97° 55' 39.62"

**Fill Dirt Mixed Soils Impacting Successful Restoration
Muck, Mixed Rocky Soils**

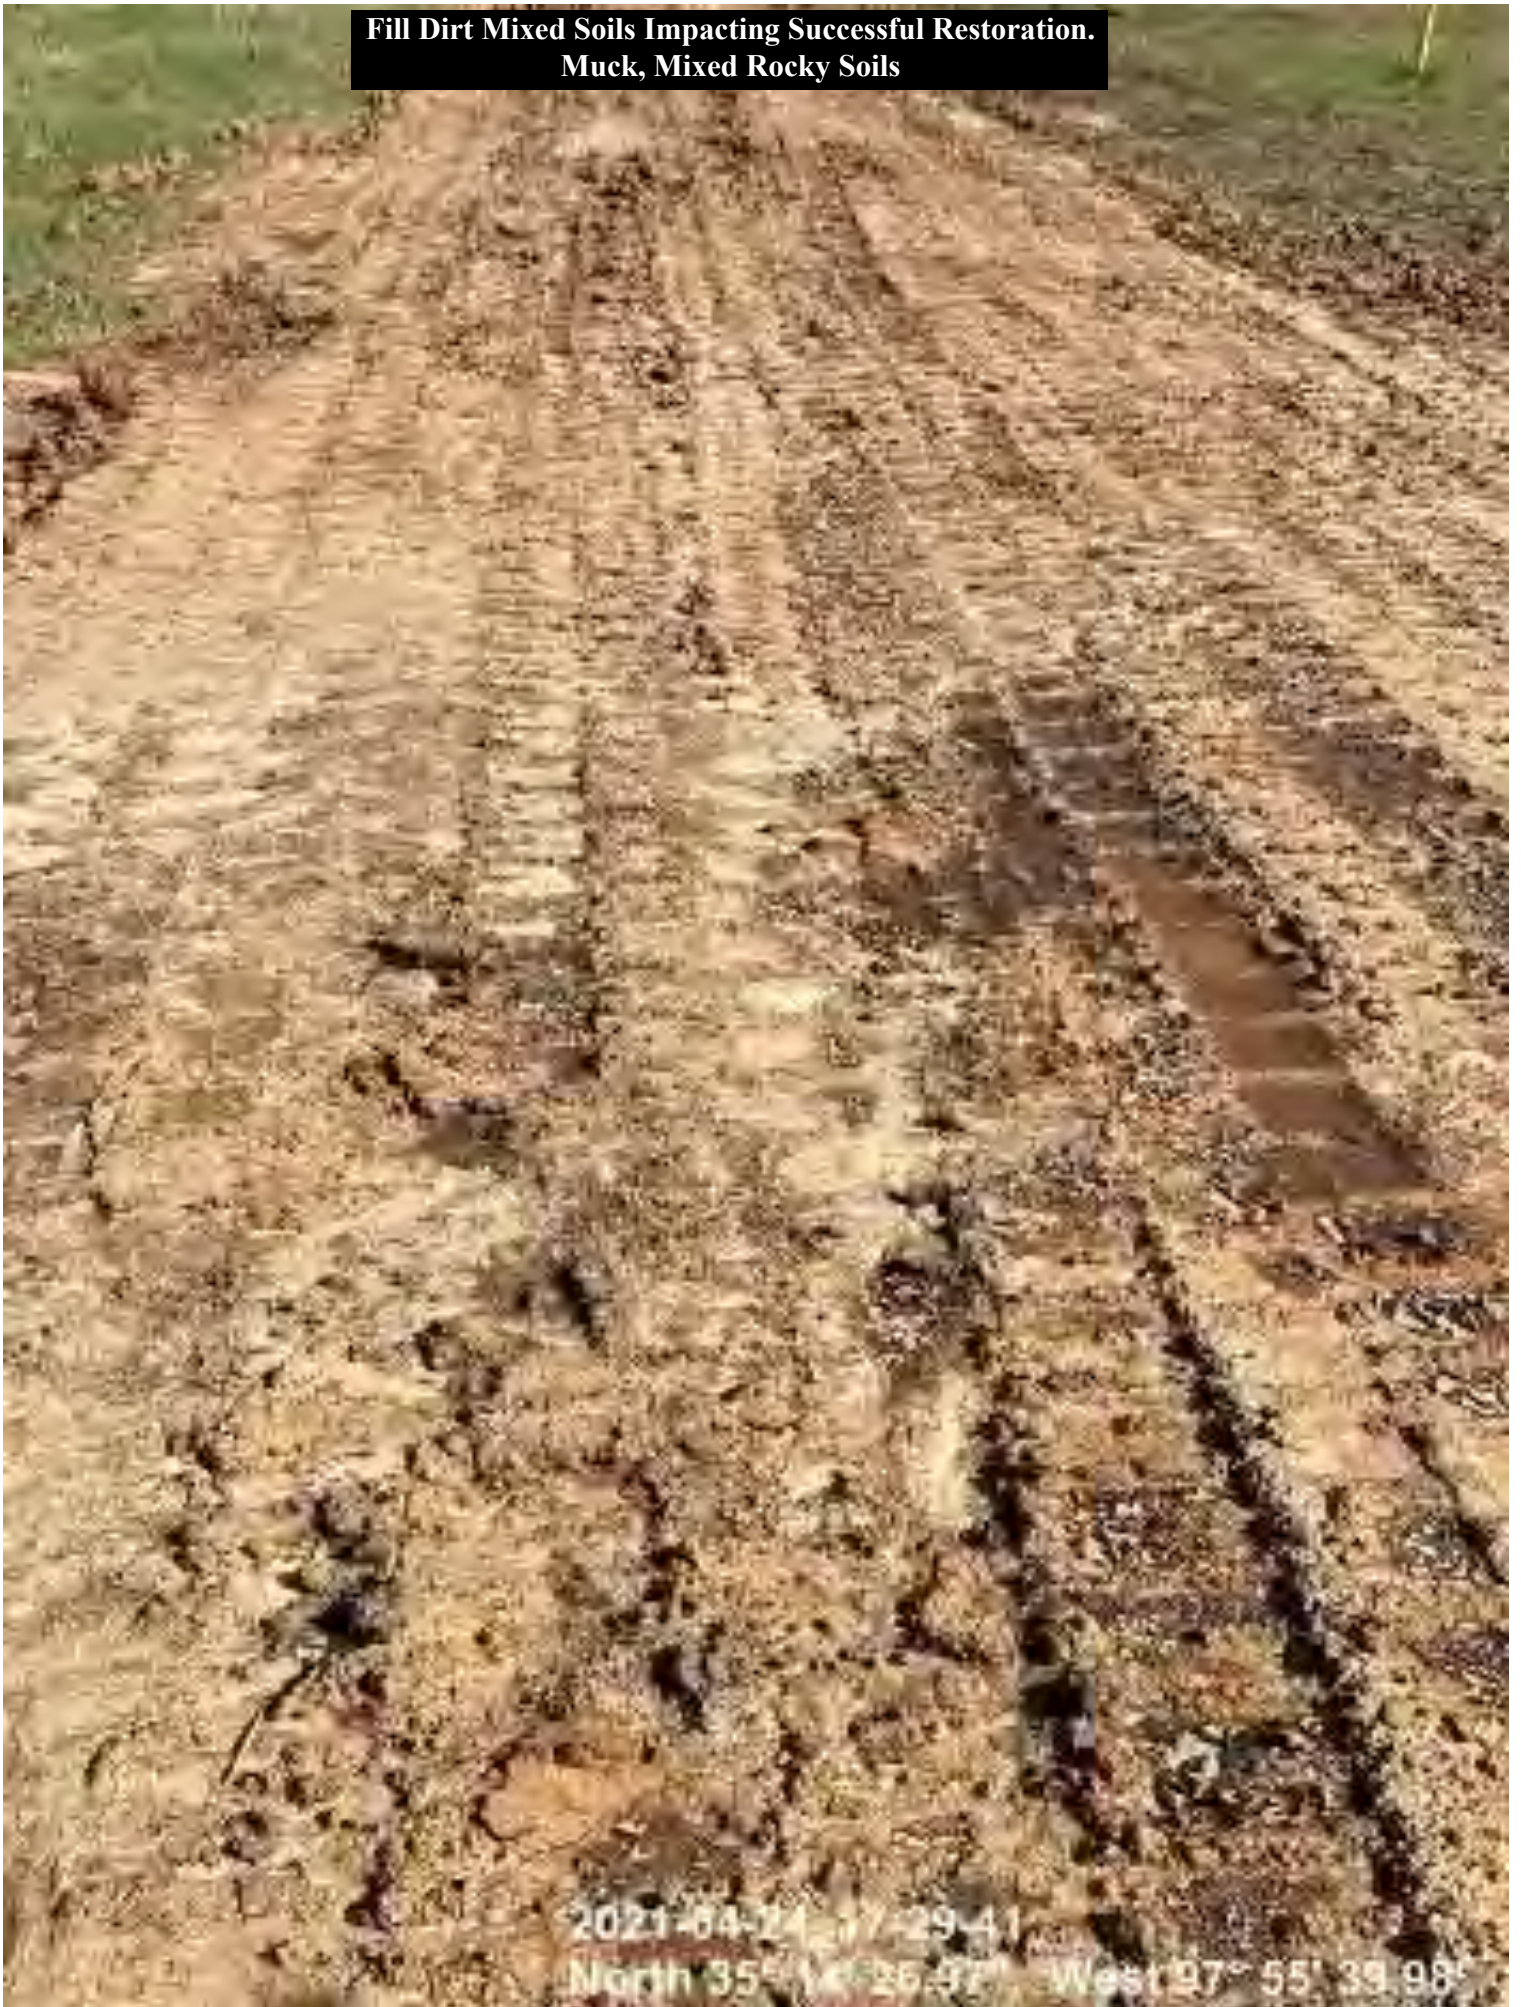
2021-04-24 12:29:54
North 31° 26' 79" West 97° 55' 39.90"

**Fill Dirt Mixed Soils Impacting Successful Restoration.
Muck, Mixed Rocky Soils**

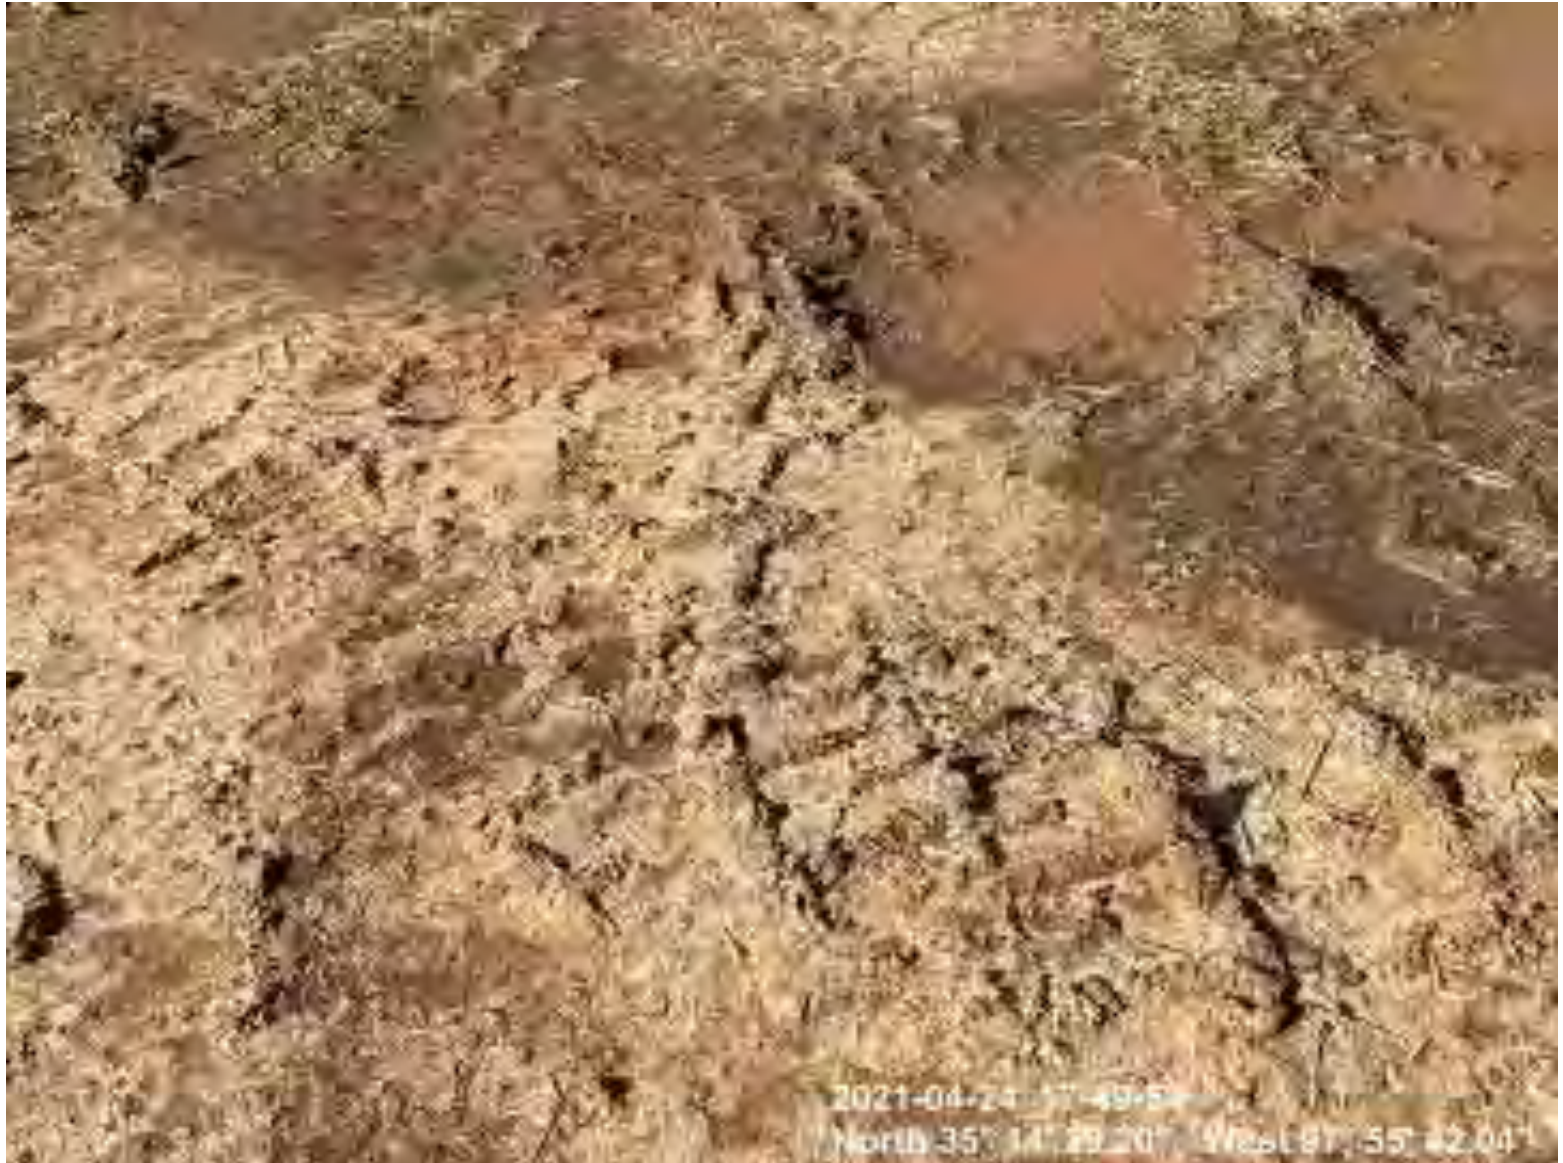
Fill Dirt Mixed Soils With Additional Erosion

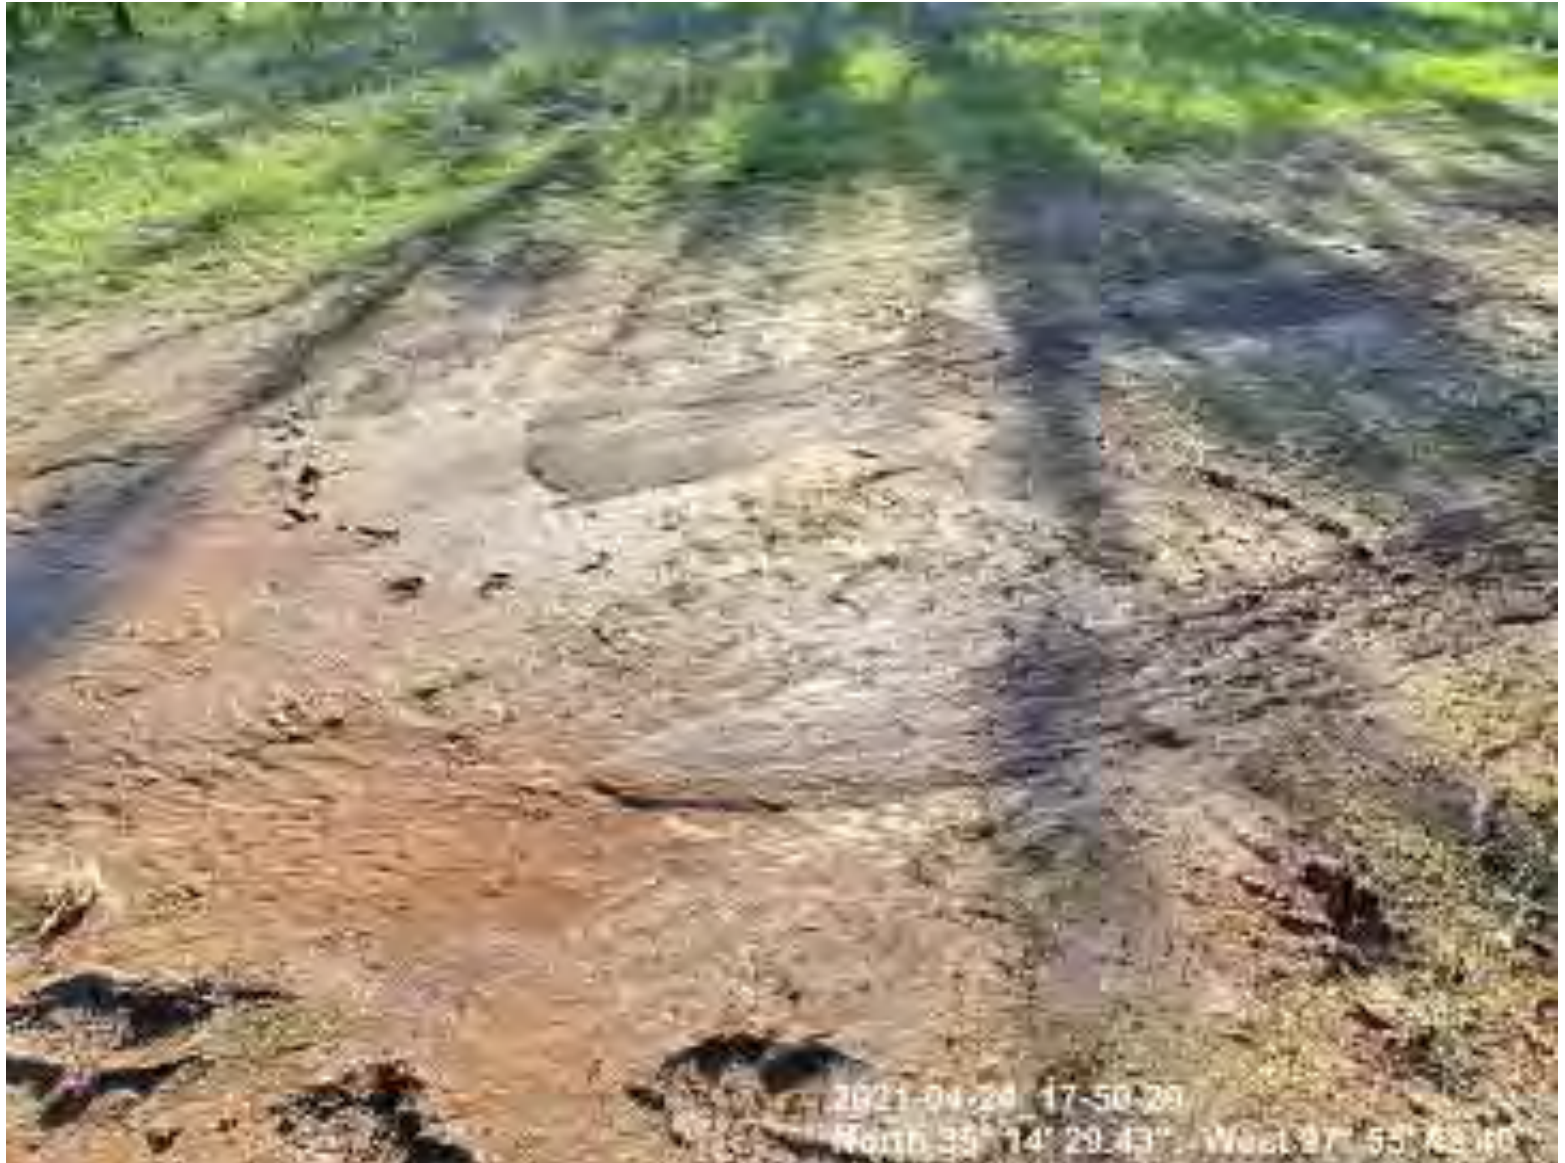
Fill Dirt Mixed Soils Overtop Matting

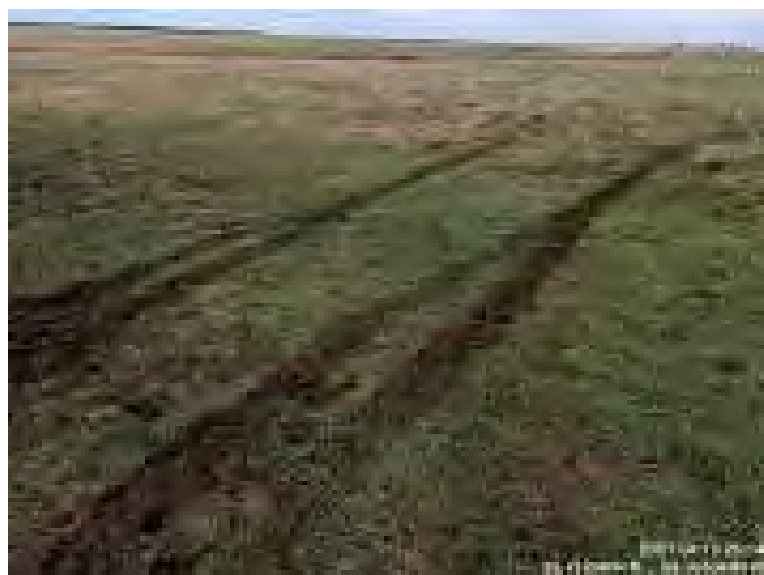
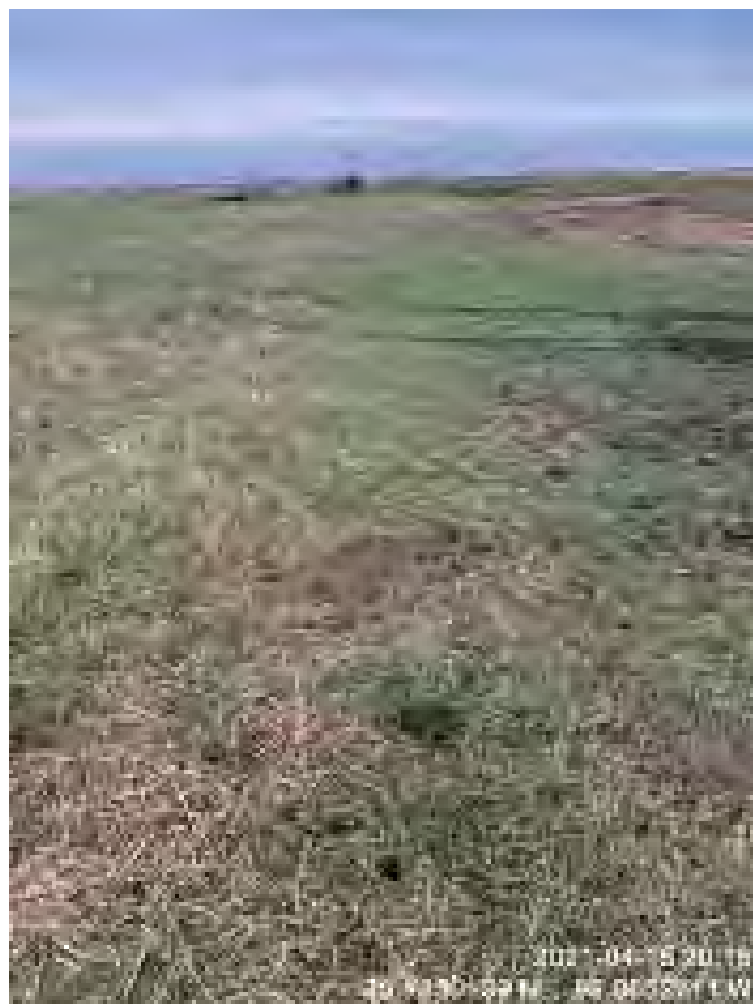
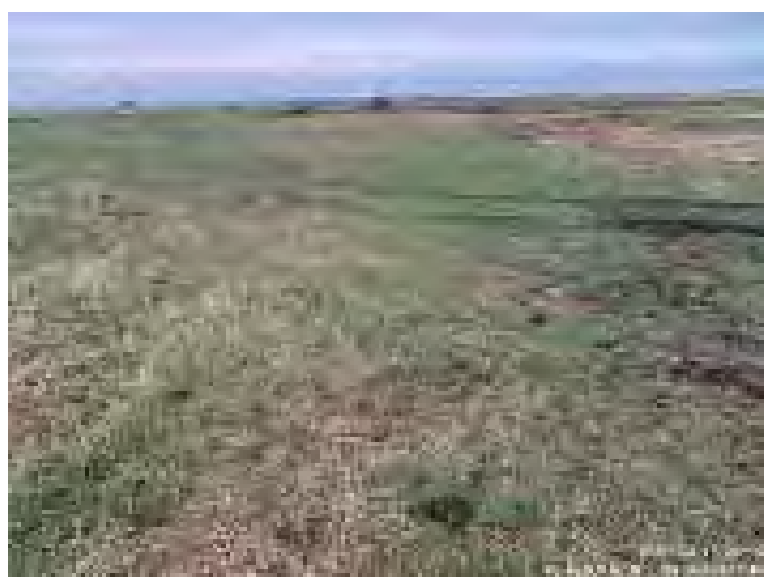
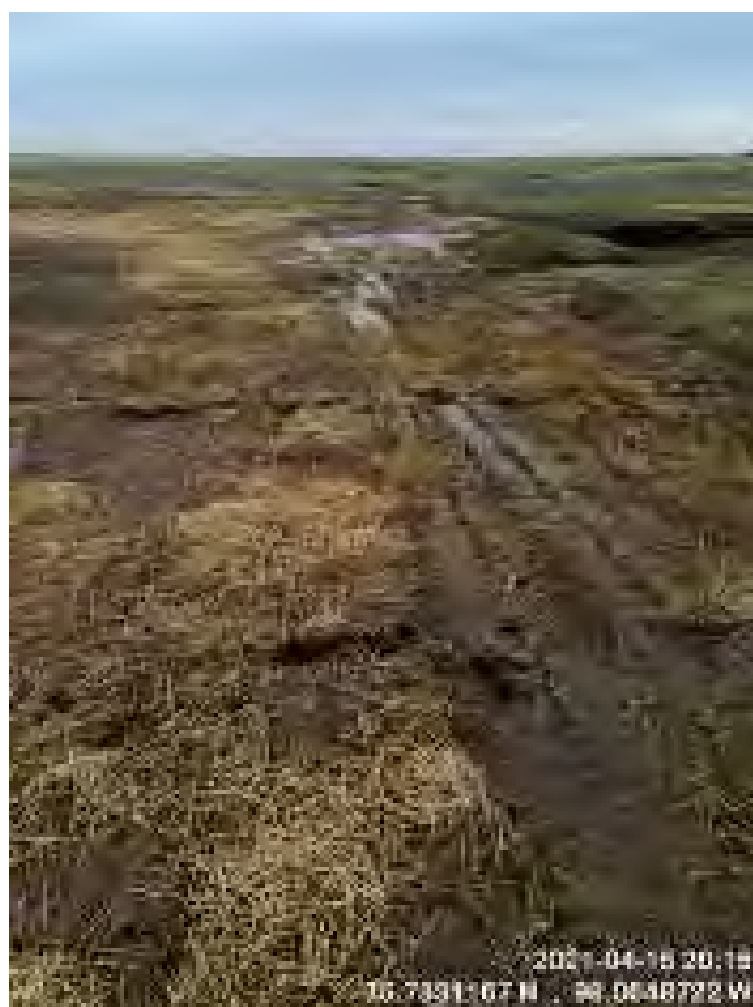
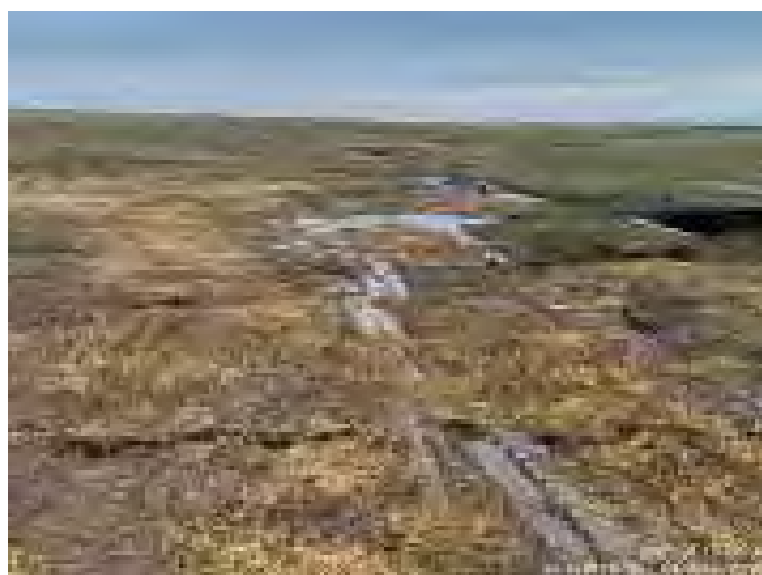
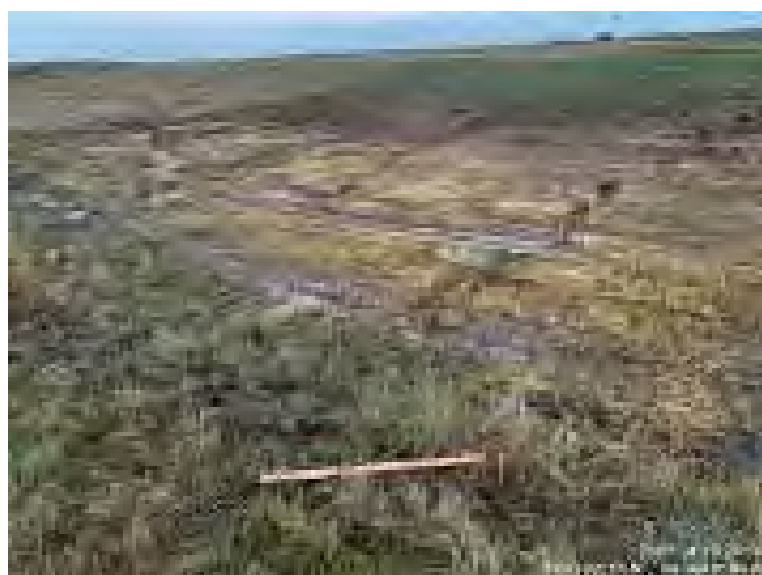
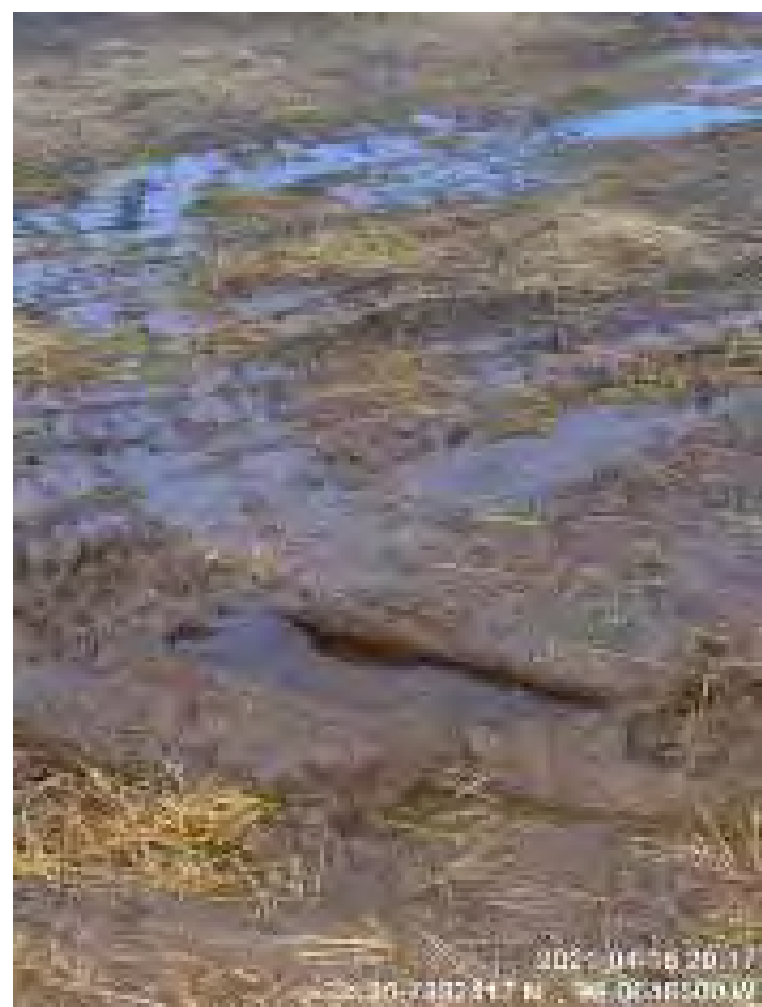
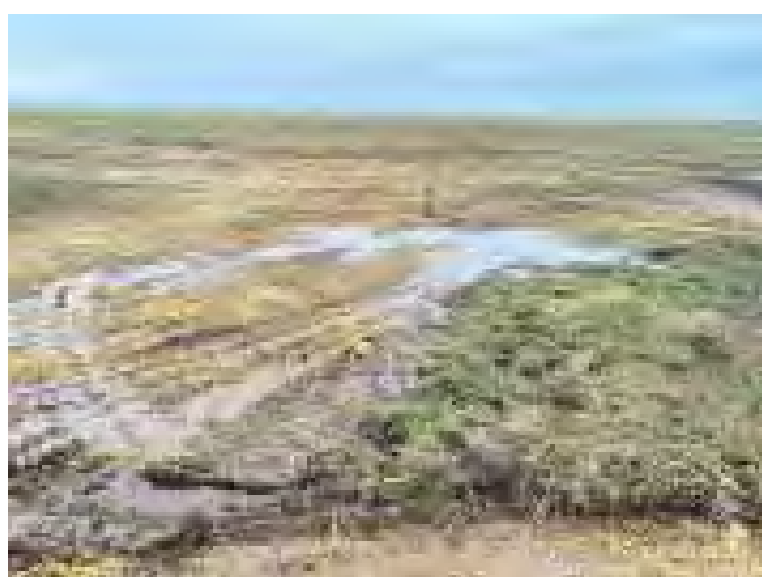
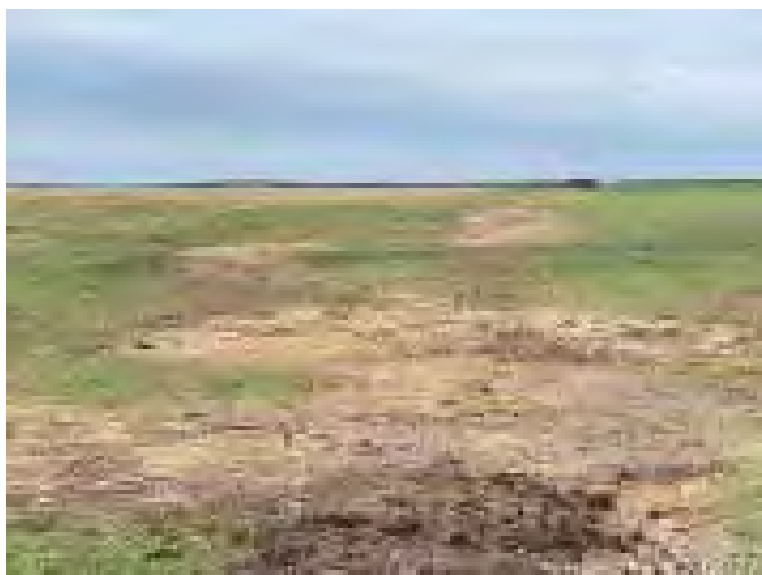
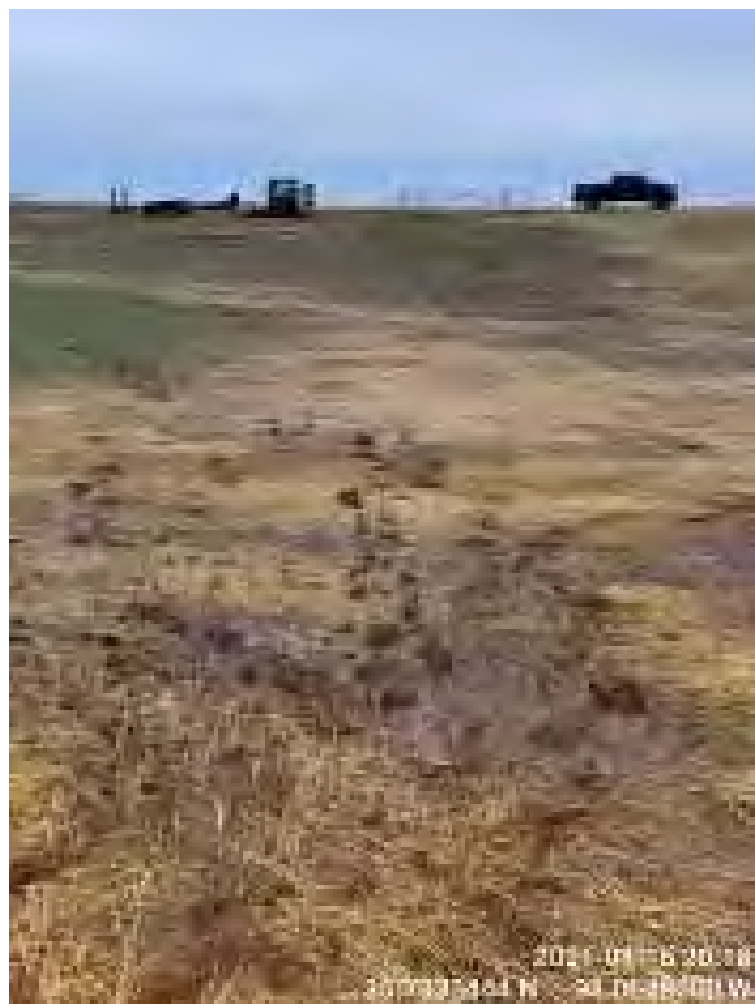
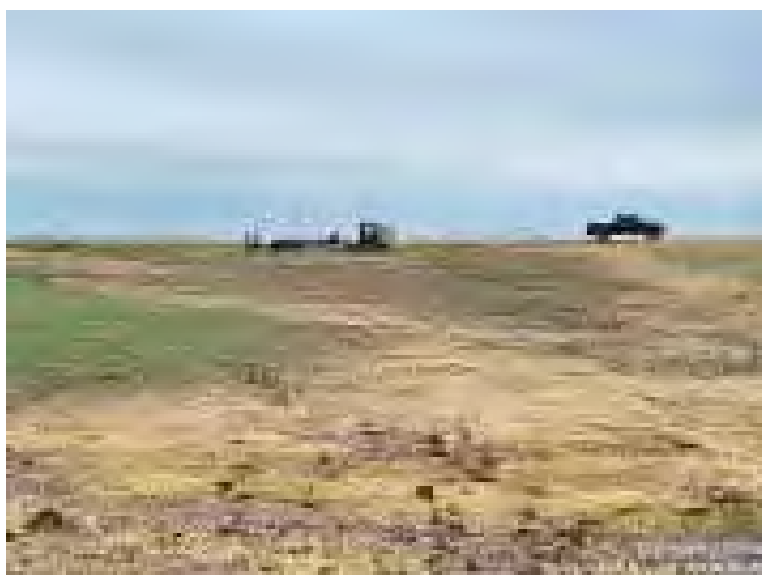
- 5 Terraces are blocked by easement which is causing water to pond and disrupt farming operations.
- 1 terrace is crossed by easement twice, so 6 repairs total. Need to restructure terraces where they cross the easement so that the property drains properly.

- Drainage pattern west of CH 19.5 is blocked and causes ponding during rainfall. Drainage pattern needs to be restored to ensure proper flow. Contours of drainage pattern have not been properly restored.

- Alkali solids are surfacing from underground across portions of the tract due to prolonged ponding and soil saturation. This alters the soil's chemistry and will require additives to correct.
